Bridge #M3079(Routine)

SH 138-03 LM 7.82 over Lower Cut-Off Creek

Team Lead: Sharon Hooks Inspection Date: August 26, 2020

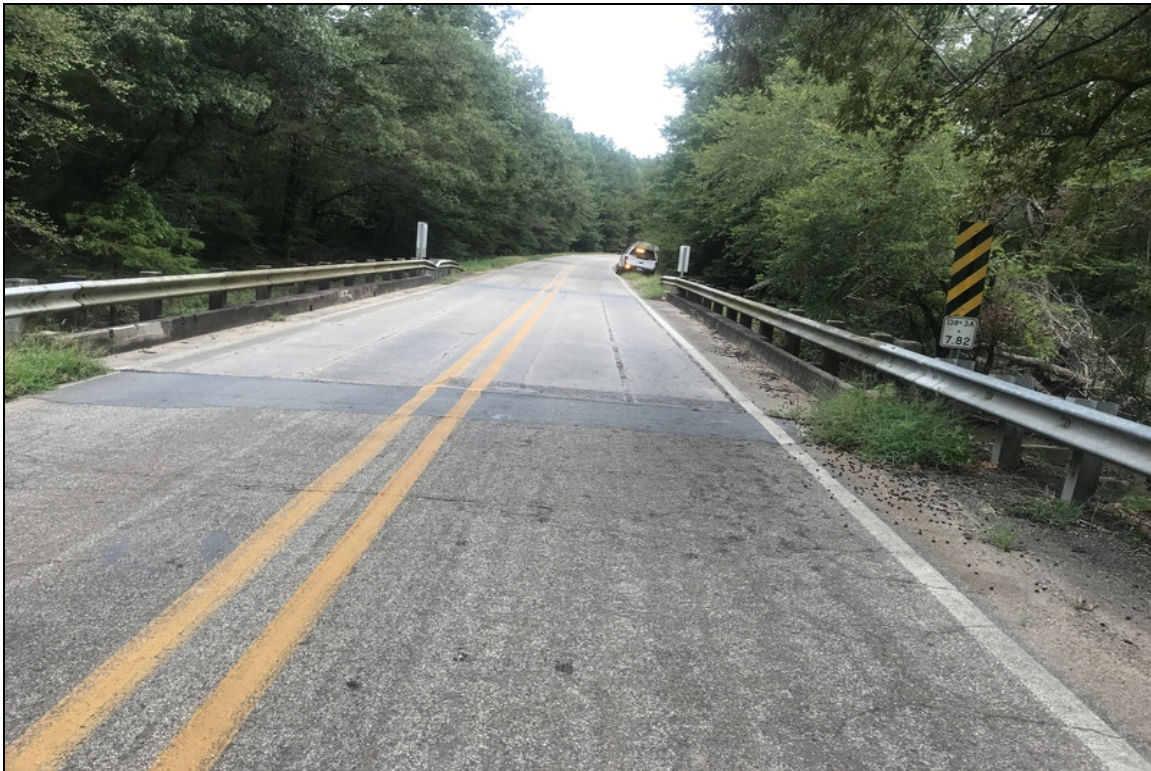
Approach.

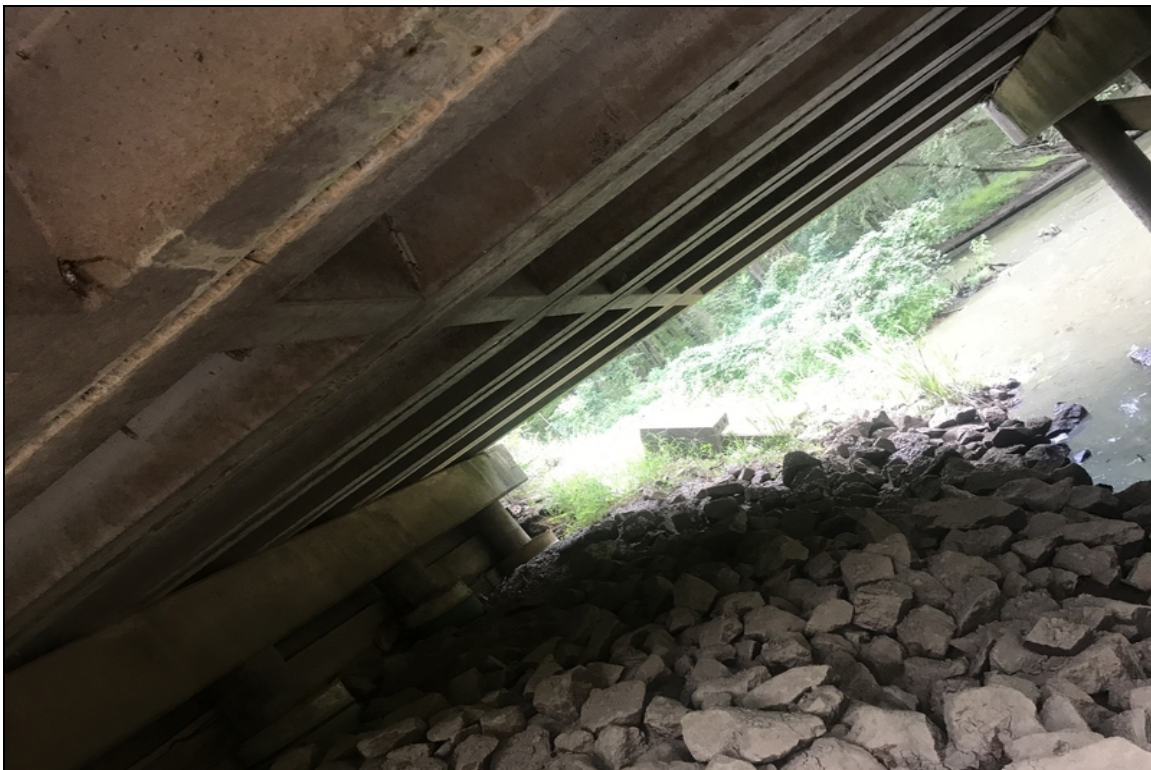
Under view of span1.

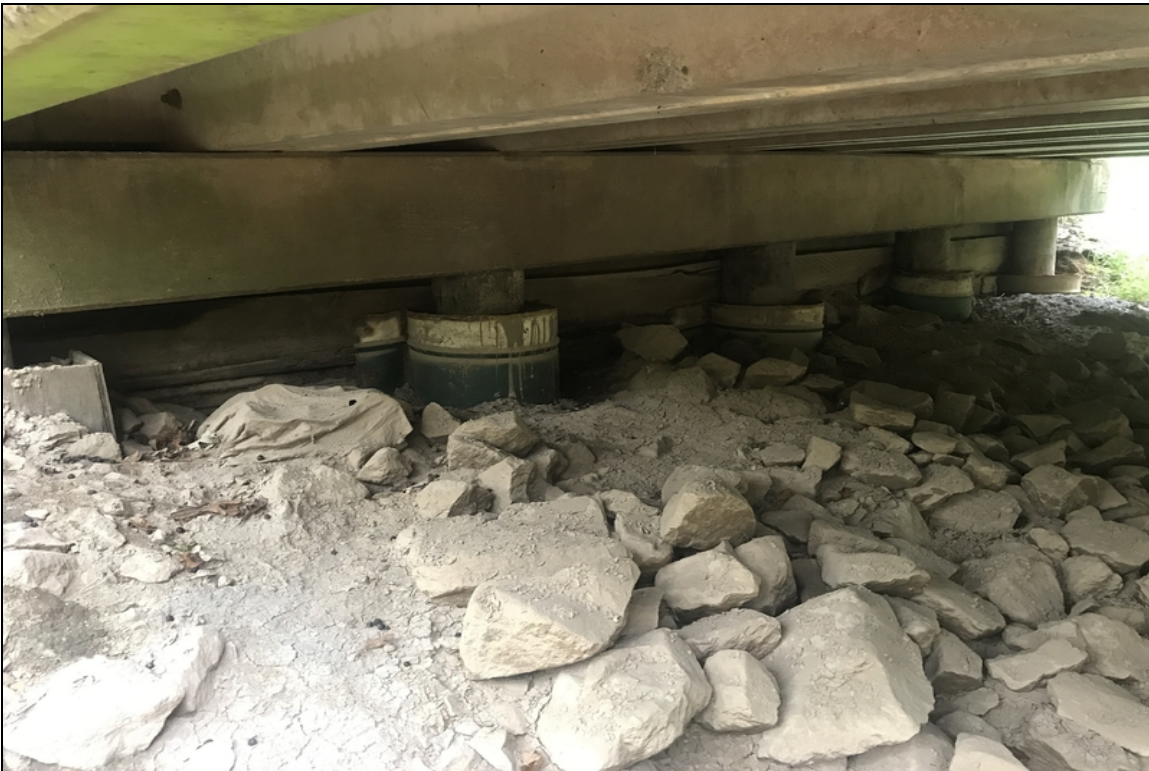
(228) Pile: 5 each bents 1-4 Small checks with initial inside decay starting on most pile  Bent 2 pile 2 large checks. Bent 2 pile 4 large checks. Bent 2 Pile 5: Decaying with large checks - CS3 decay.  Bent 3 pile 1 checking. Bent 3 pile 2 checking. Bent 3 pile 3 checking Bent 3 pile 4 checking.							
"Old Notes." These pile have been repaired by State Forces 2020

Bent 1 pile repaired.

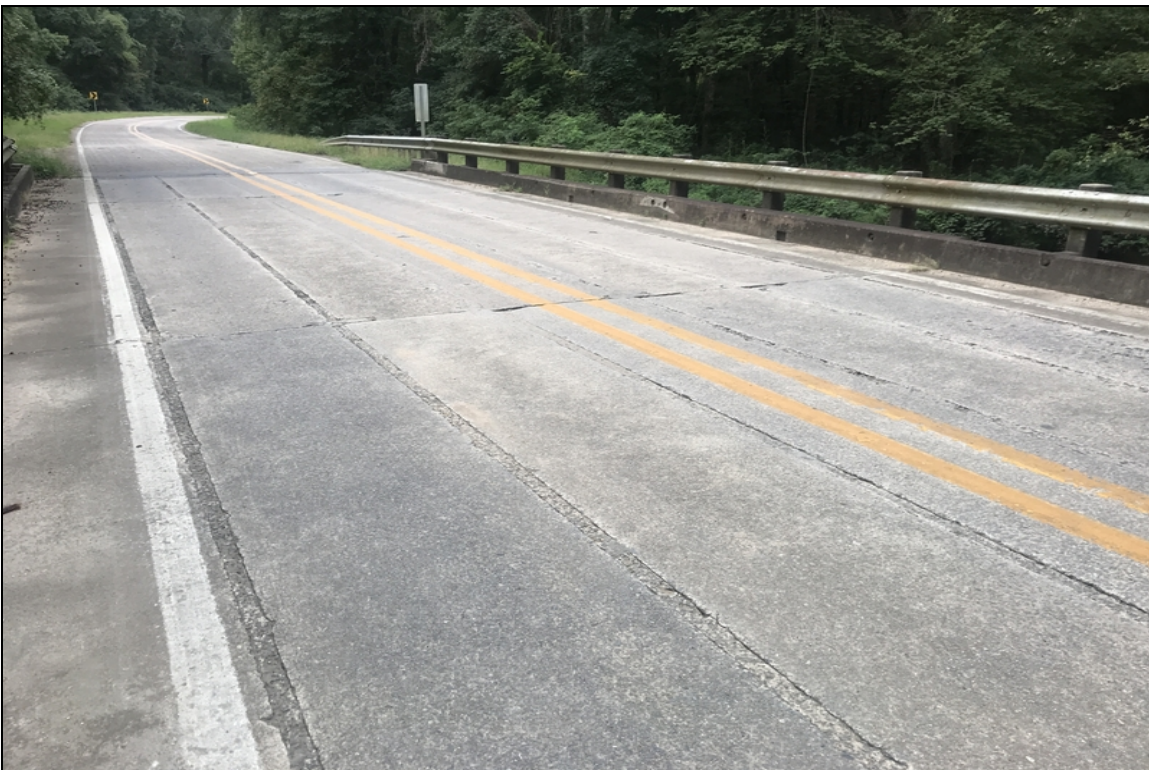
Deck over view.

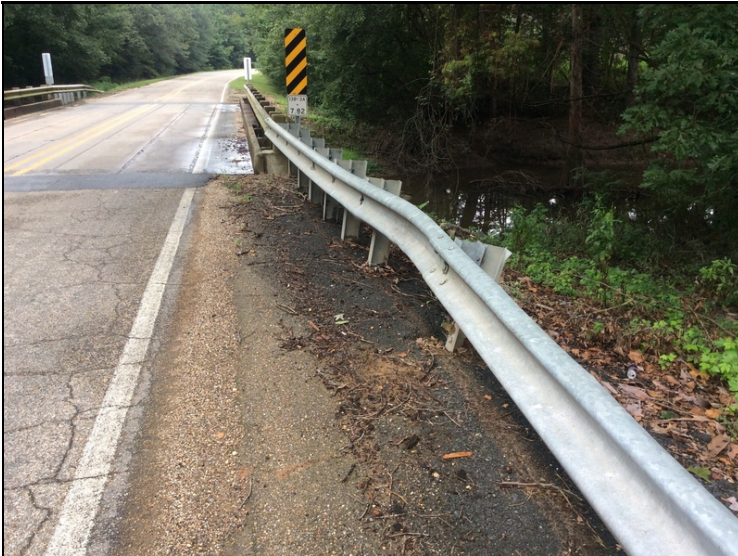
Approach railing - Bent 1 right: Minor collision damage to railing and a couple of posts.

Approach railing - Bent 1 right: Damage

Repaired by State forces.

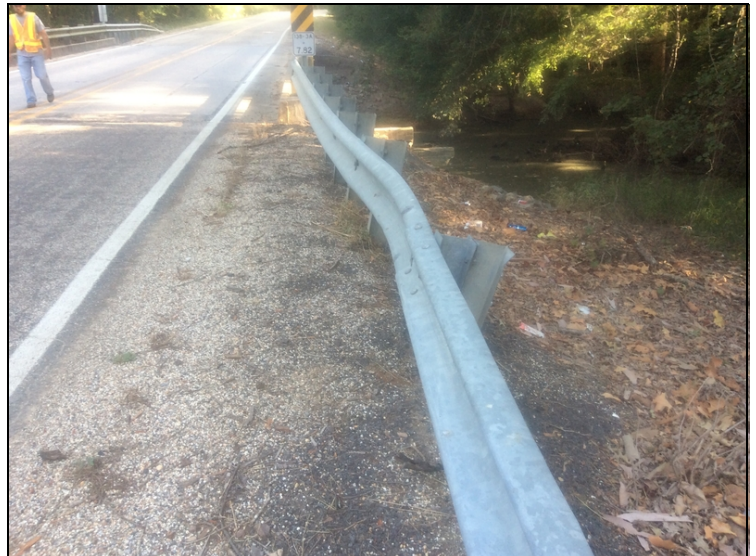
South east end of bridge, Guard rail damage

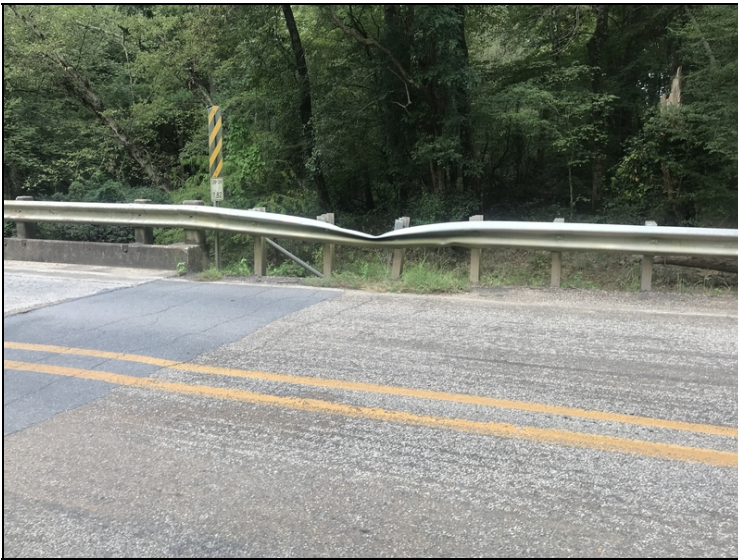
Bent 4 left guard railing has damage.

Bent 4 left approach railing on eastern end of bridge has damage.
