District 02, Drew County

Bridge #M3081(Routine)
SH 138-03 LM 9.60 over Cut-Off Creek Relief
Location: 9.60 Mi N US 278-Mt Tabor

Team Lead: Greg Loomis Inspection Date: August 03, 2021

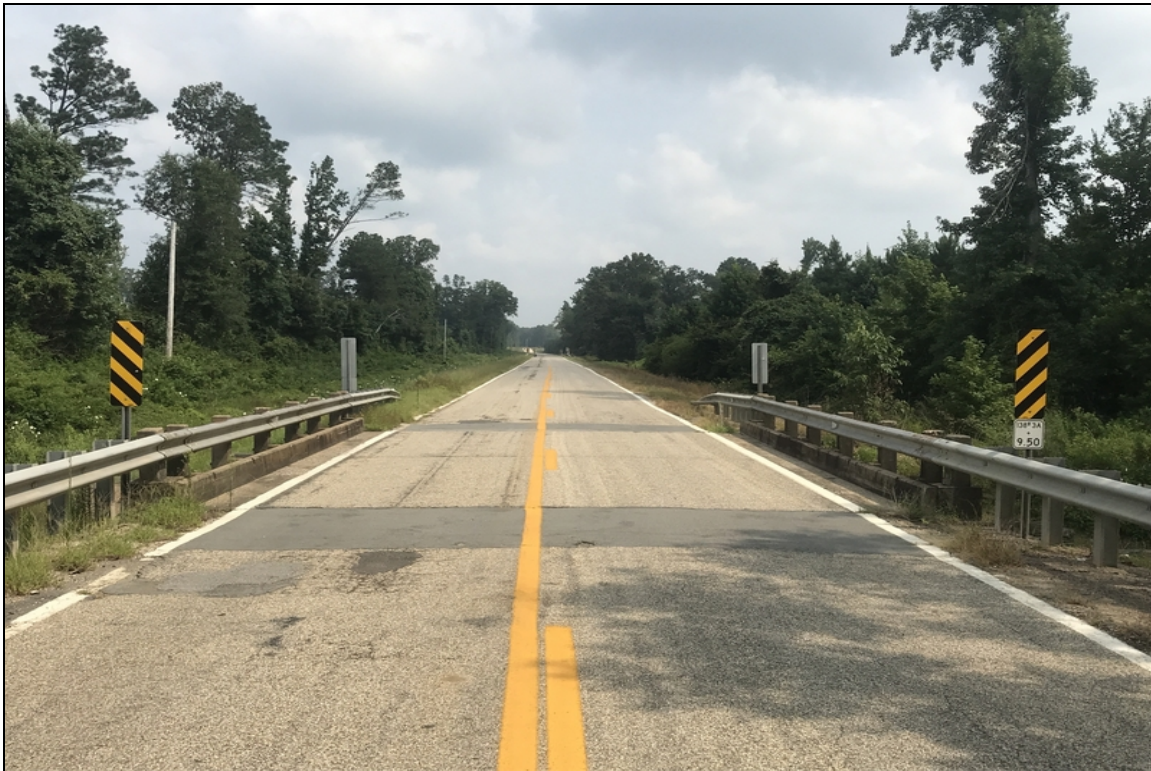
Roadway view

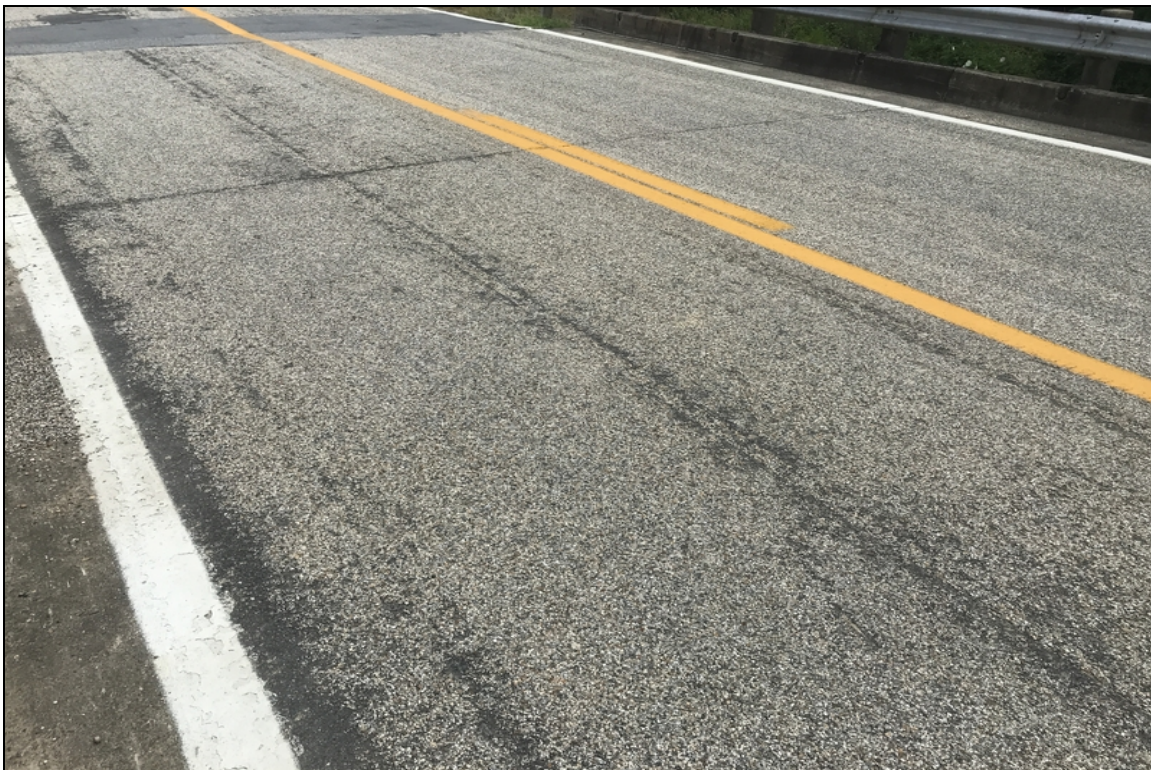
Deck - Spans 1-2: Typical

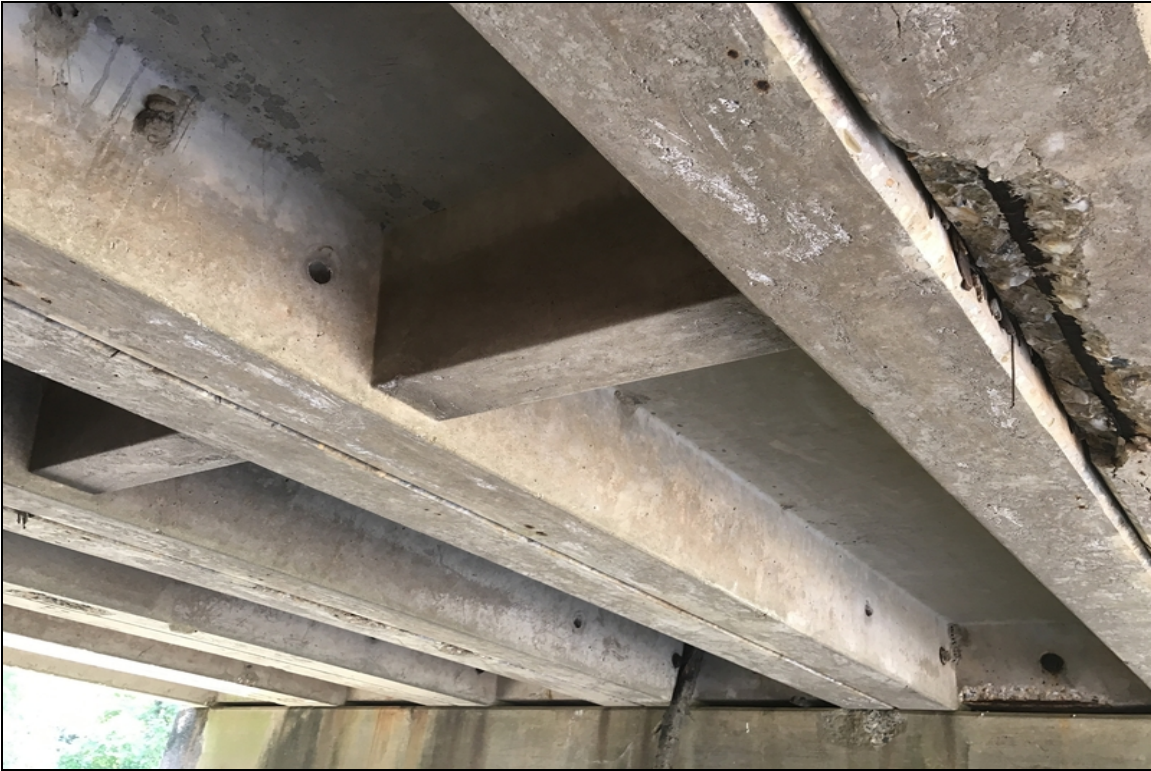
Soffit - Span 2: Typical

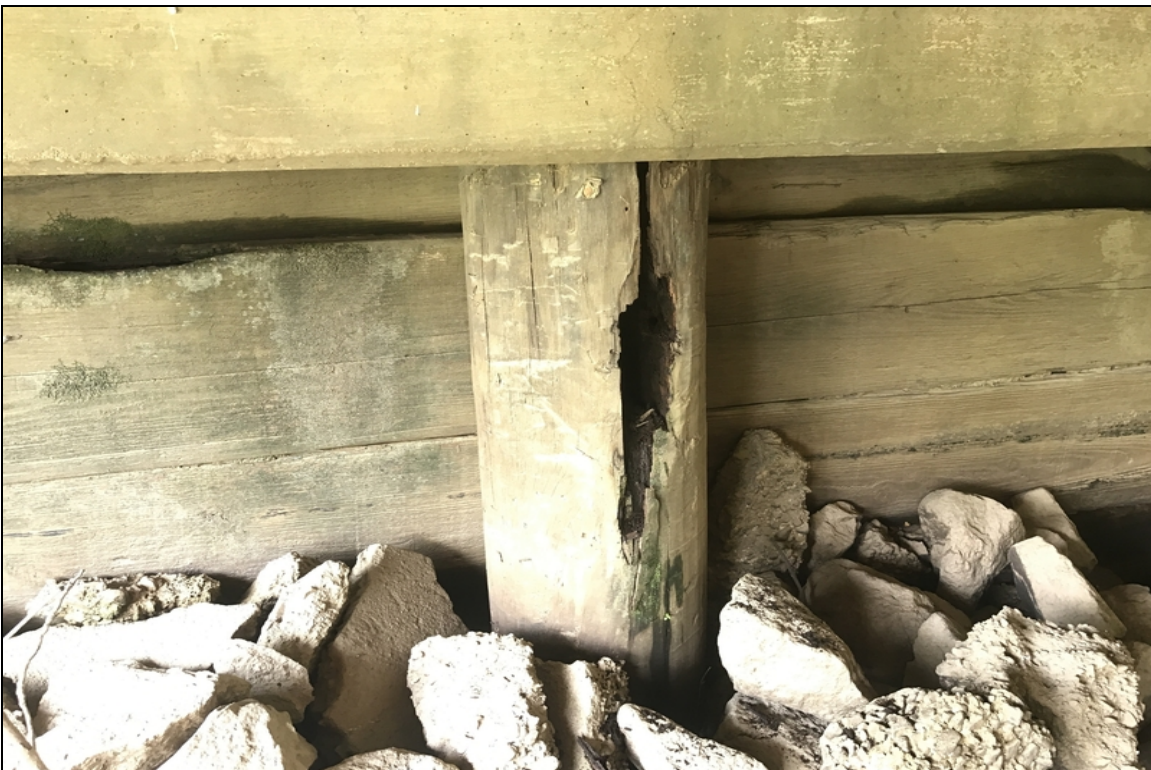
Bent 3 Pile 2: Decay

Bent 3 Pile 2: Hollow/decayed – CS3 decay.

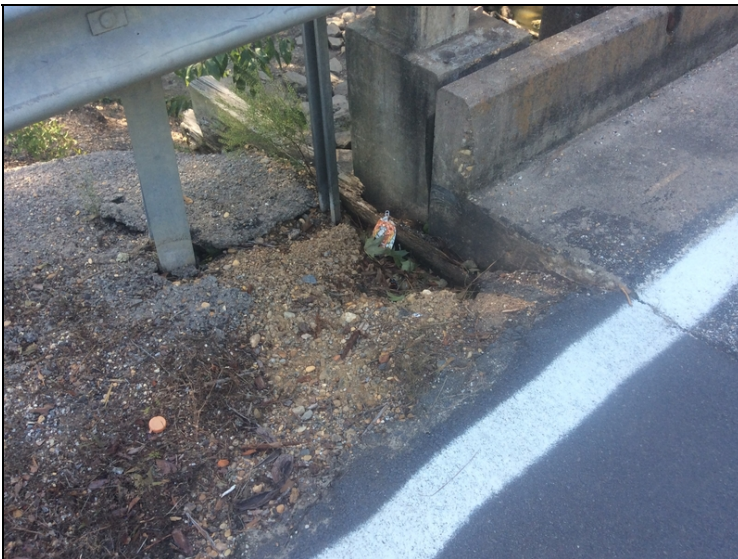
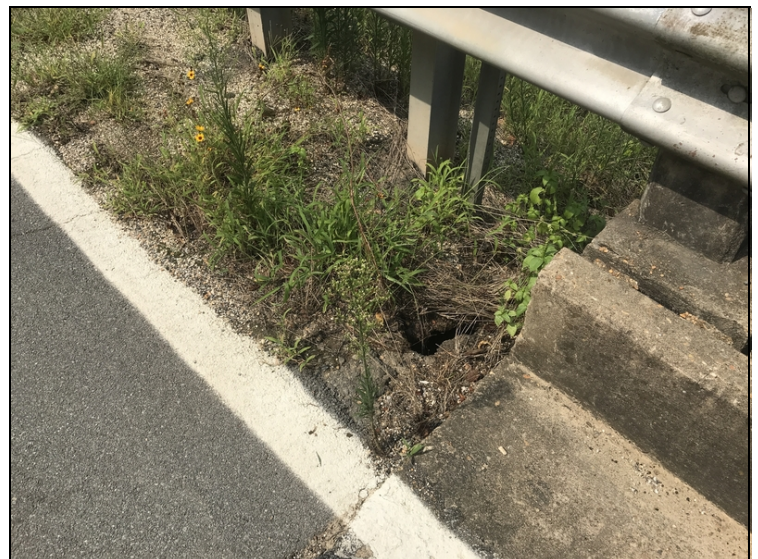
Approach roadway - all 4 corners of bridge: Some minor erosion at edge of roadway surface, especially at Bent 1 left (small hole just inside curb/outside of edge line).

Approach roadway - Bent 1 left: Erosion

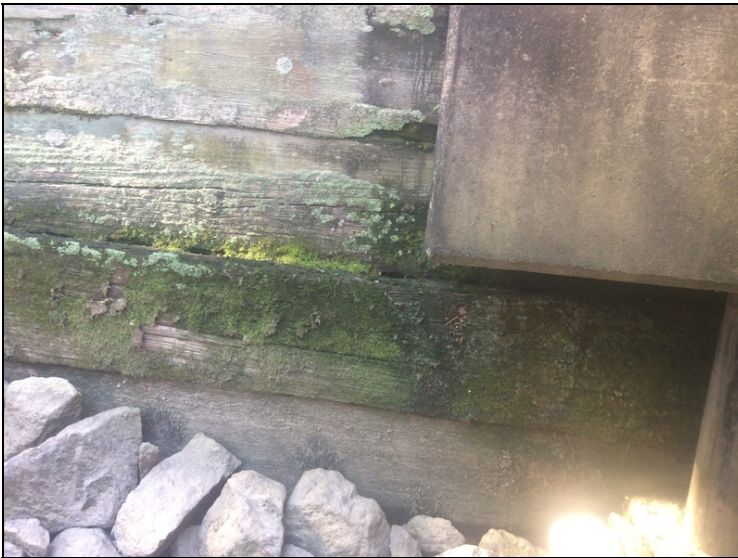
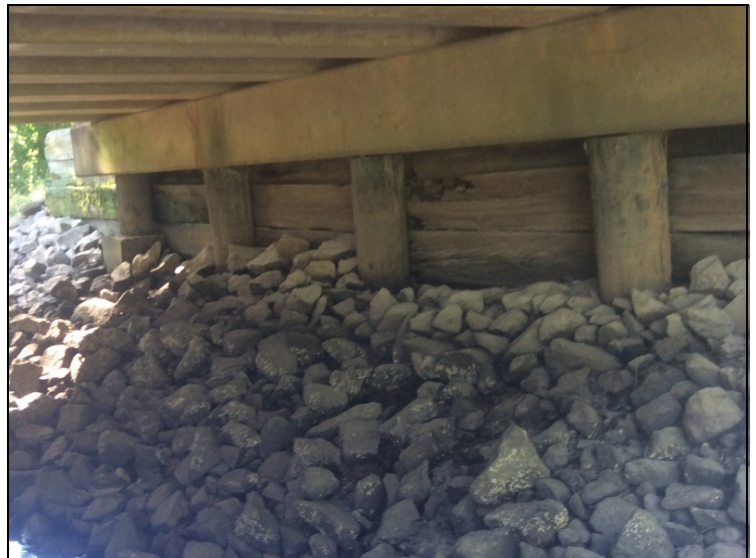
Backwalls - both back-walls have some decay.

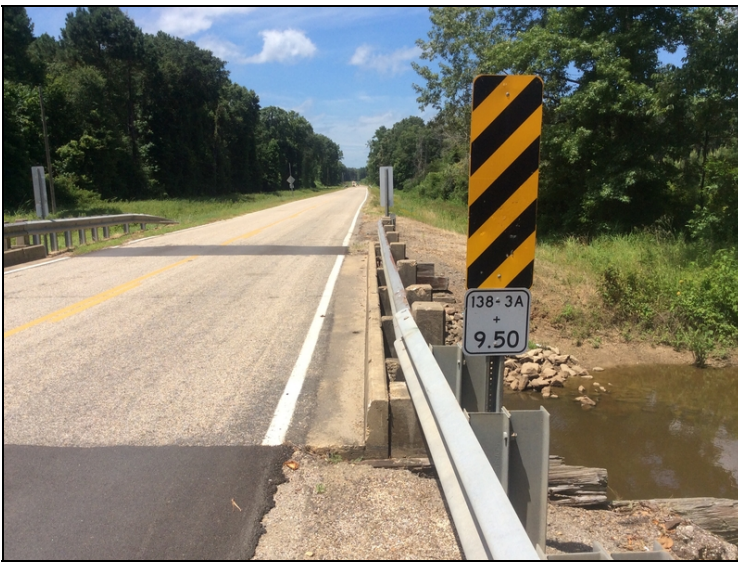
Log mile signs - both ends: Signs read "9.50" - should read "9.60".

Log mile sign - Bent 1 right (incorrect numbers)
