Bridge #M3082(Routine, Underwater type 2)

SH 138-03 LM 9.75 over Cut-Off Creek Relief

Team Lead: Greg Loomis Inspection Date: August 03, 2021

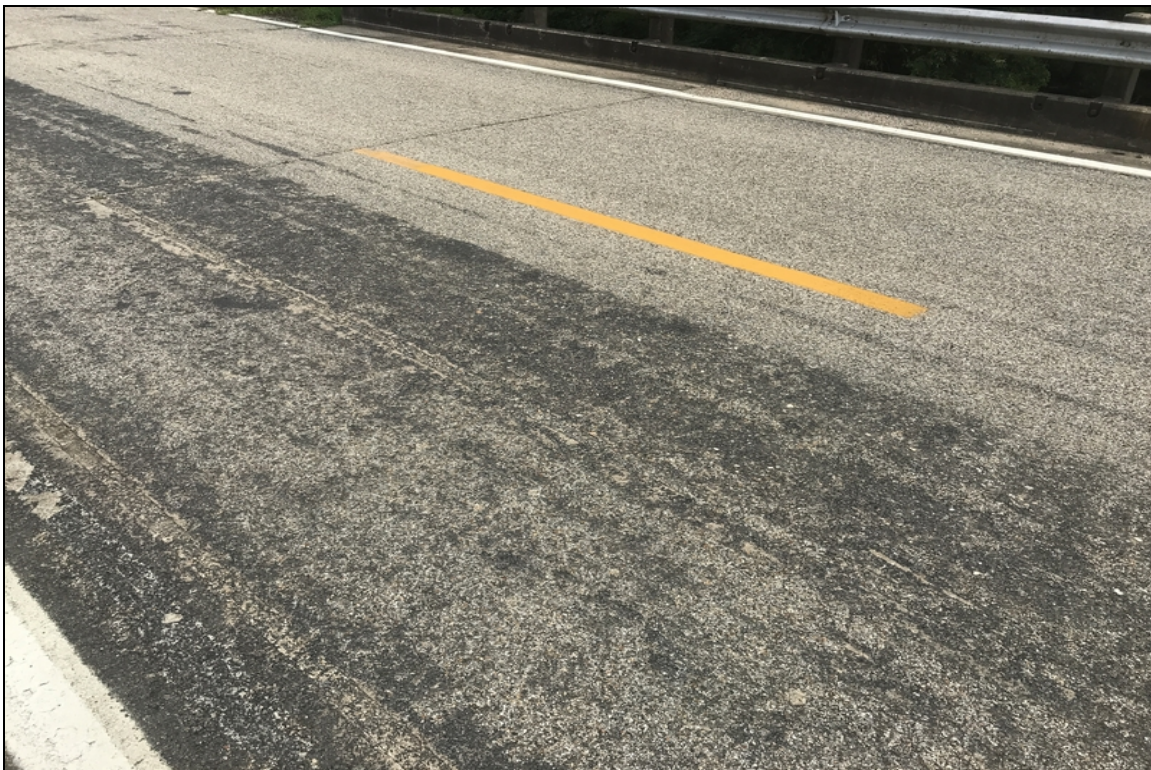
| ELEM | DESCRIPTION | UNITS | TOTAL | CS1 | CS2 | CS3 | CS4 |
|--|---|---|---|---|---|---|---|
| (16) Deck: 25'-1" wide x 38' long = 953 sqft. (Unable to determine existence or condition of grout due to wearing surface.) Wearing surface (chip seal overlay of 1/2"): 22' wide x 38' long = 836 sqft. | | | | | | | |

Deck - Spans 1-2: Typical

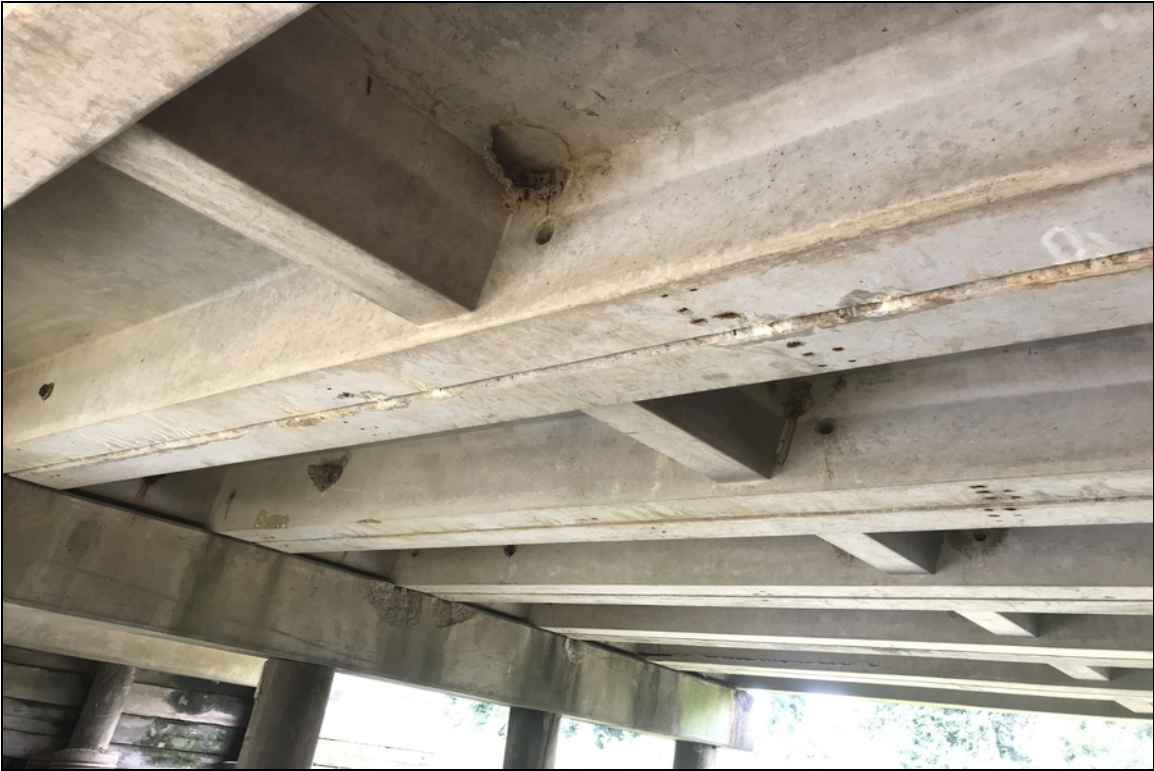
Soffit - Span 2: Typical

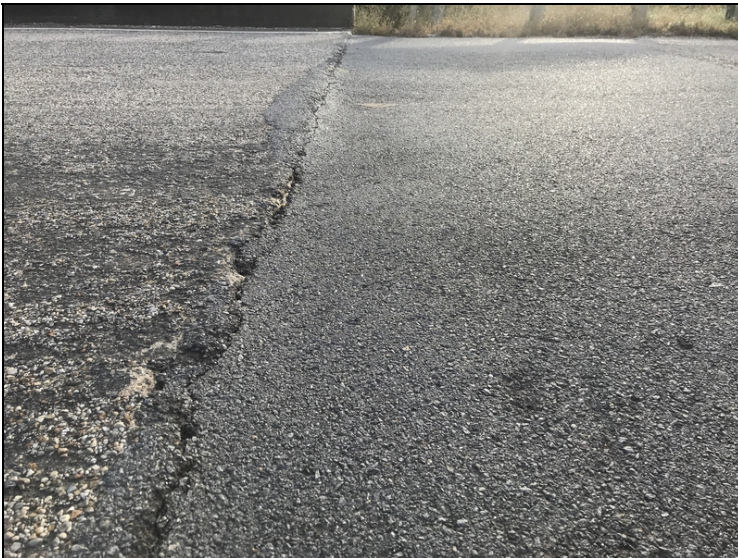
CORRECTED - Approach roadway south end has settlement 1-3in drop coming off of deck.

Approach roadway has 2-3 in drop .

08-03-2021 GGL-PRD: Asphalt patch has been applied at bridge end / no bump remains.

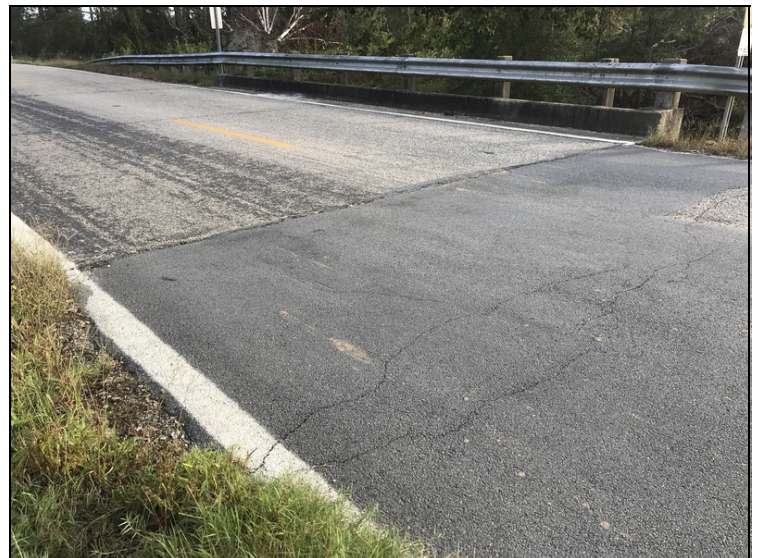
Approach roadway south end has settlement about 2-3 in drop.

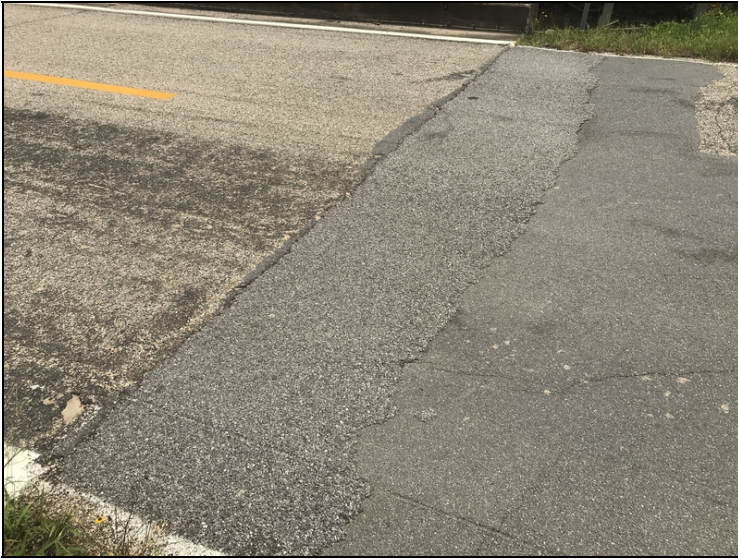
CORRECTED - Approach roadway - Bent 1:
Asphalt patch applied/no bump

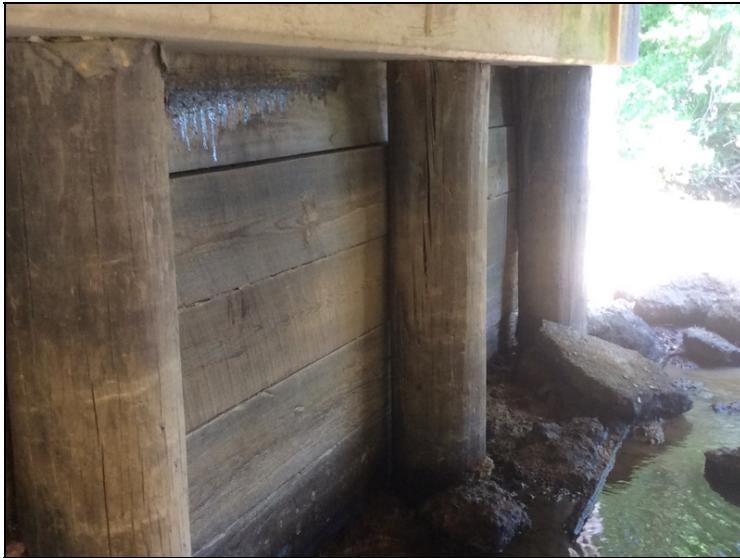
CORRECTED - Bent 3 Pile 4: Moderate- to large-sized checking on left side in top 4' - deteriorating and hollow in same area.

"Note" bent 3 pile 4 has continued to deteriorate and is now in the "A" priority on 4/2/2019 SDH

Bent 3 Pile 4 (decay)

Repaired by State Forces

Cut and replaced.

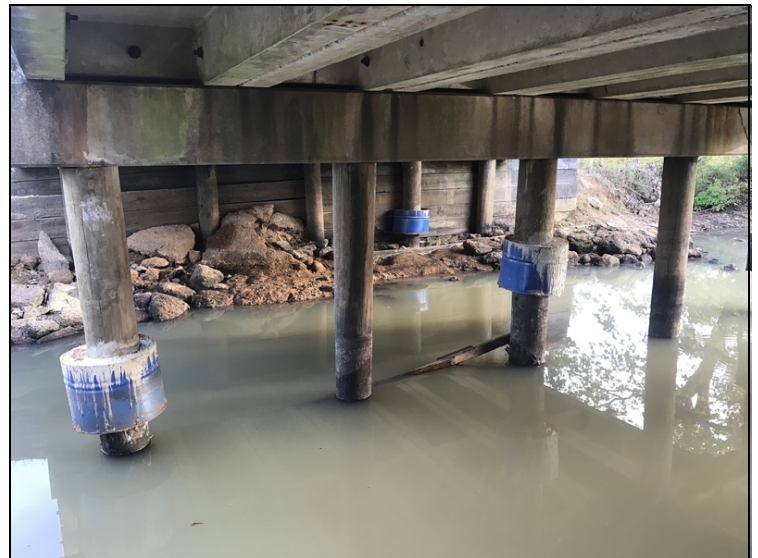
CORRECTED - Bents 2&3 pile repairs.

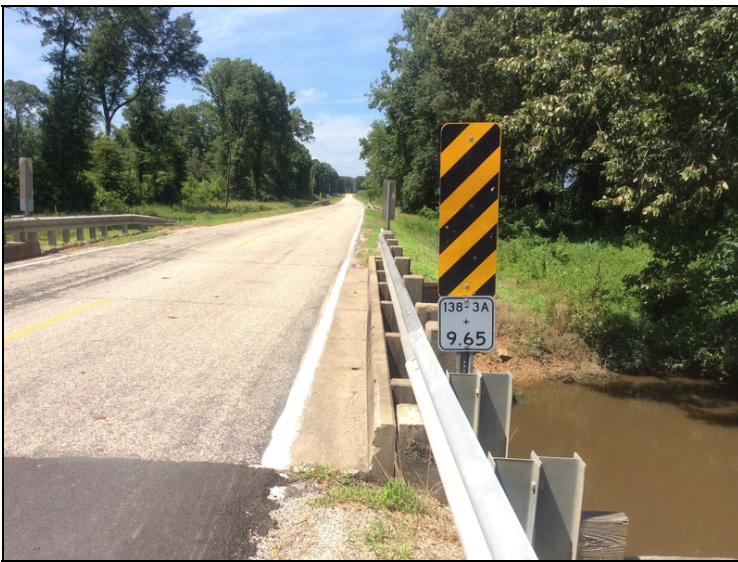
Log mile signs - both ends: Signs read "9.65" - should read "9.75".

Log mile sign - Bent 1 right (incorrect numbers)

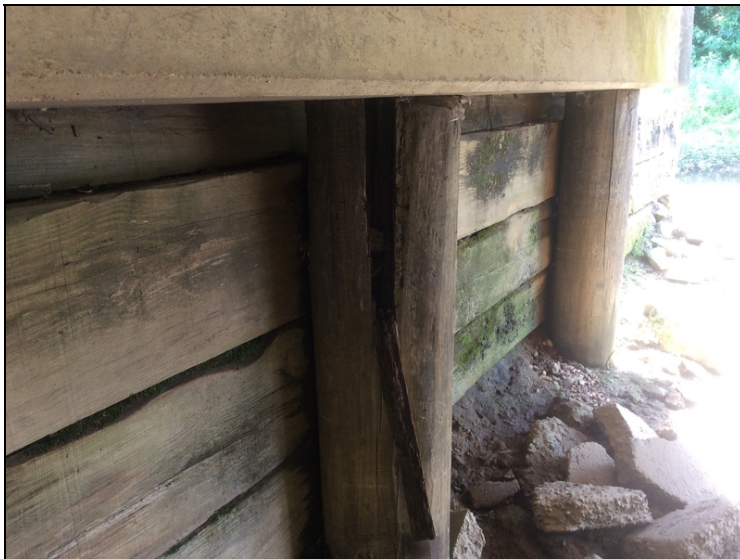
CORRECTED - Bent 1 Piles 1-4: Significant deterioration (hollow) in the top 4-6' of each pile.
Bent 2 Pile 3 Hollow

"Note" bent 1 pile 1 & 2 have continued to deteriorate and are now in the "A" priority on 4/2/2019 SDH

Bent 1 Piles 1-2 (decay)

Repaired by State Forces

Cut and replaced

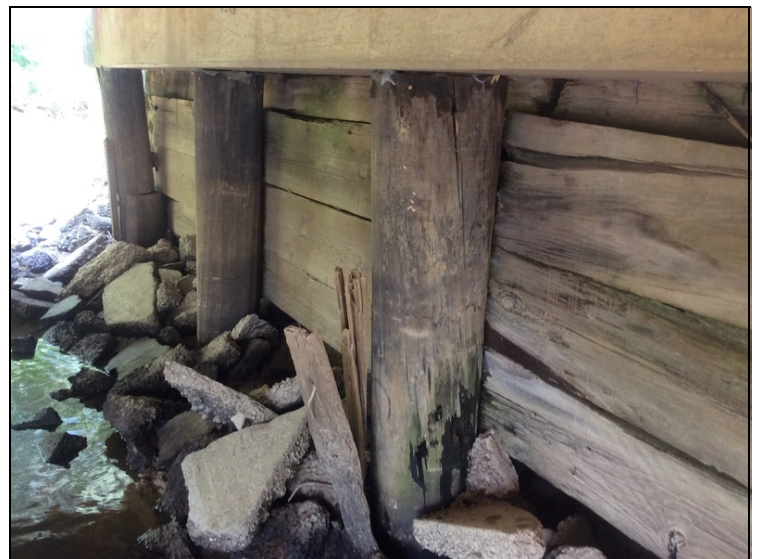
Bent 1 Piles 3-4 (decay)

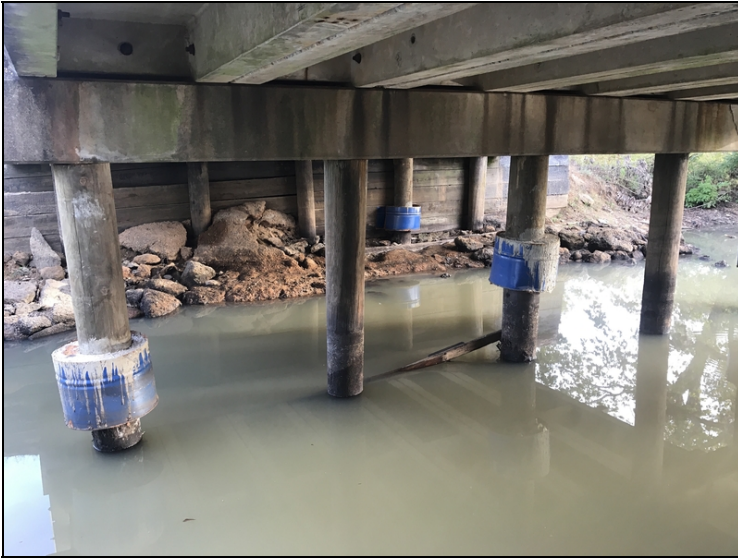
CORRECTED - Bents 2&3 pile repairs.

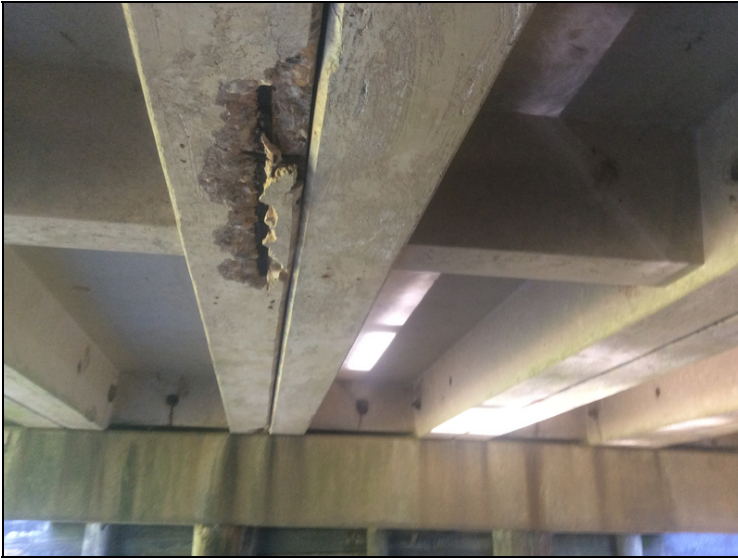
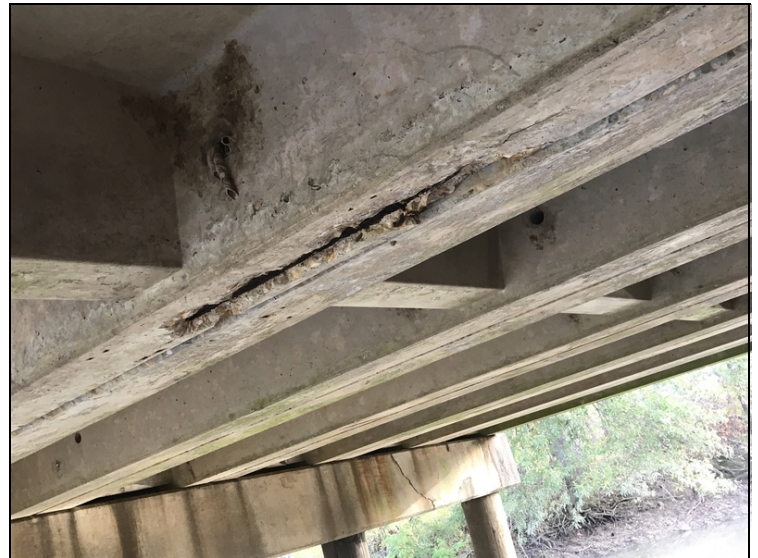
Girders (precast channel beam legs) -
Span 1 Unit 2 right: Spall with exposed rebar.
Span 1 Unit 4 right leg: Small spall with exposed rebar.
Span 1 Unit 7 right leg: Spall with exposed rebar.
Span 2 Unit 2 left leg: Spall with exposed rebar.

Span 1 girder 2 has spall with exposed rebar.

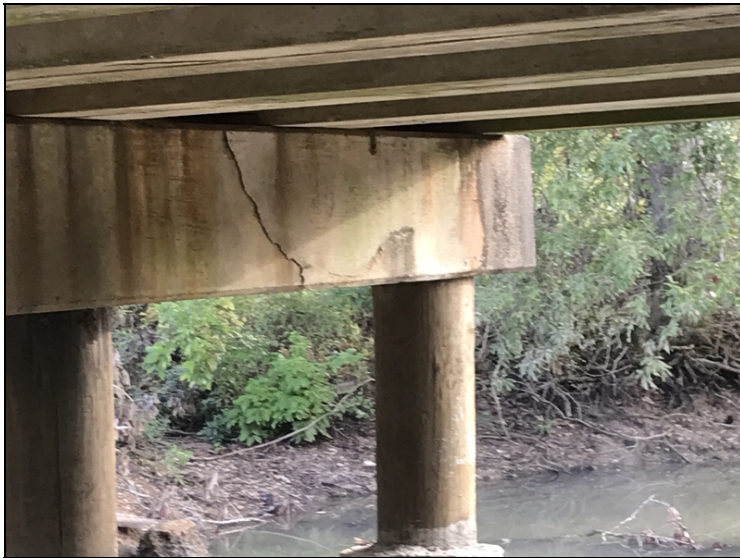
| ELEM | DESCRIPTION | UNITS | TOTAL | CS1 | CS2 | CS3 | CS4 |
|--|---|---|---|---|---|---|---|
| Caps: 28' each / Bents 1-3. Bent 2 right: Delamination/cracking on back face. Bent 2: Contact spalls on ahead face. | | | | | | | |

Cap -
Bent 2 right: Delamination/cracking on back face .
Bent 2: Contact spalls on ahead face.

Bent 2 cap behind has cracking with delam.

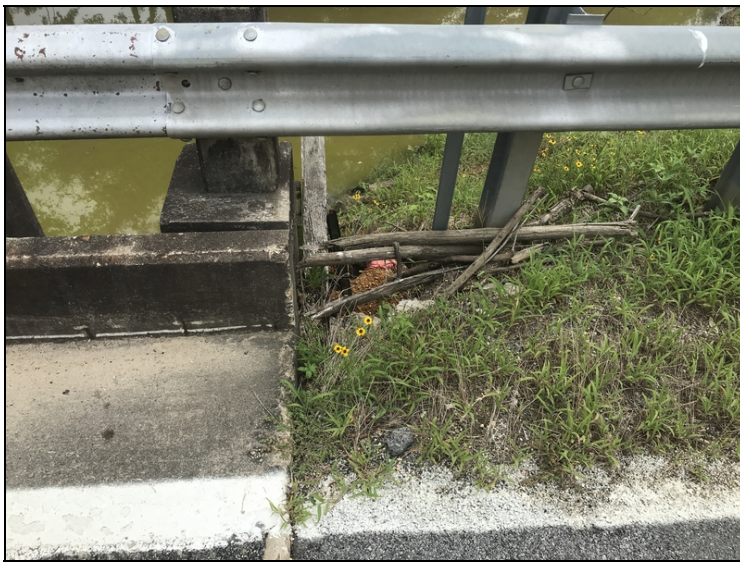
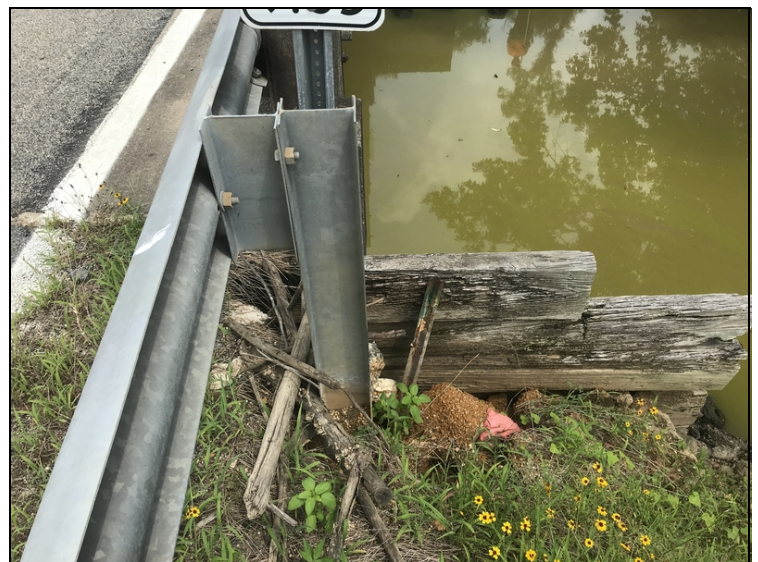
Approach roadway - Bent 1 right: Area of active erosion at bridge end - behind wing-wall/back-wall (just beginning to reach inside curb / eroding around log mile post and railing post).

Approach roadway - Bent 1 right: Erosion
