Bridge #M3083(Routine, Other Special Recurring)

SH 138-03 LM 9.82 over Cut-Off Creek

Team Lead: Greg Loomis Inspection Date: August 03, 2021

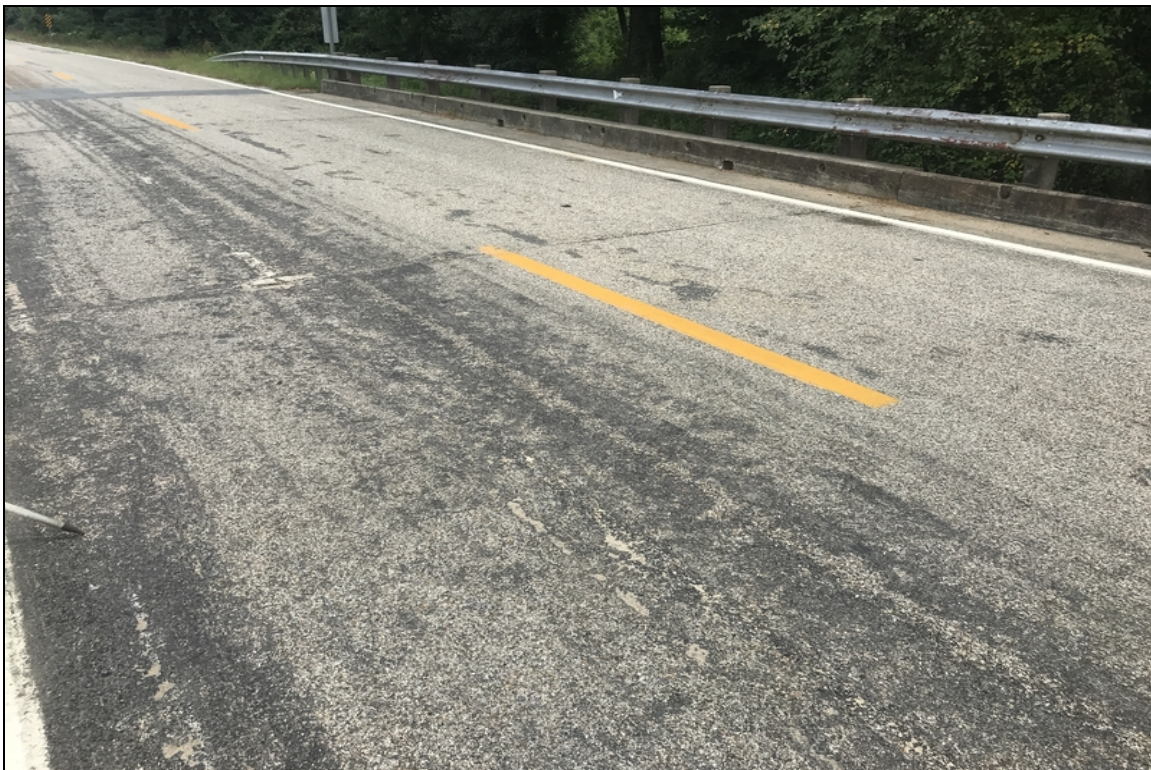
Deck - Spans 1-3: Typical

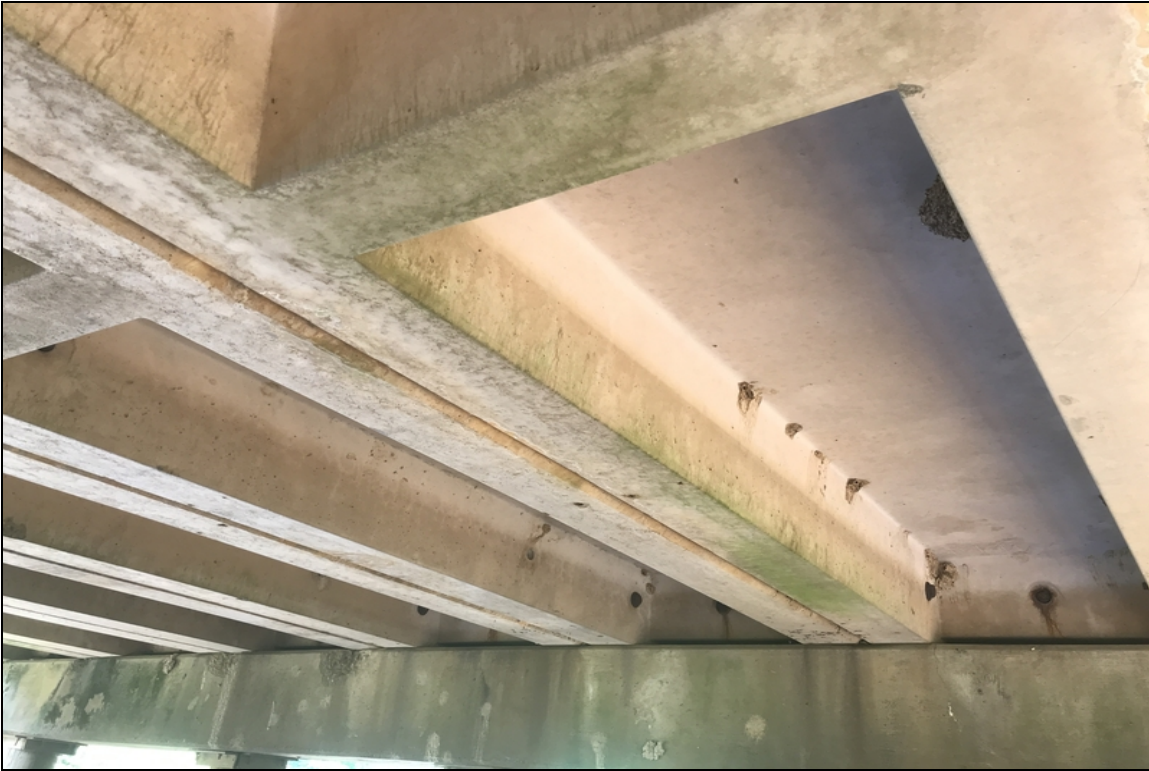
Soffit - Span 1: Typical

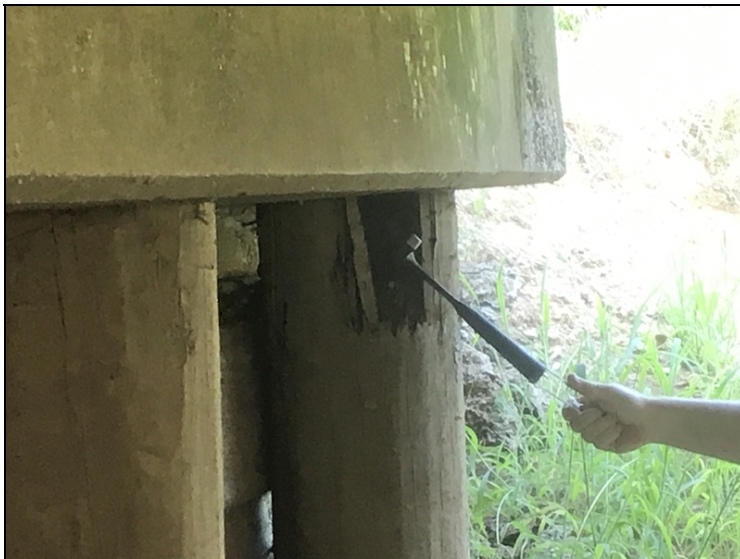
Bent 1 pile 1 hollow and decayed at cap.

08-03-2021 GGL-PRD: Piling at Bents 1, 3, & 4 have been repaired/replaced.

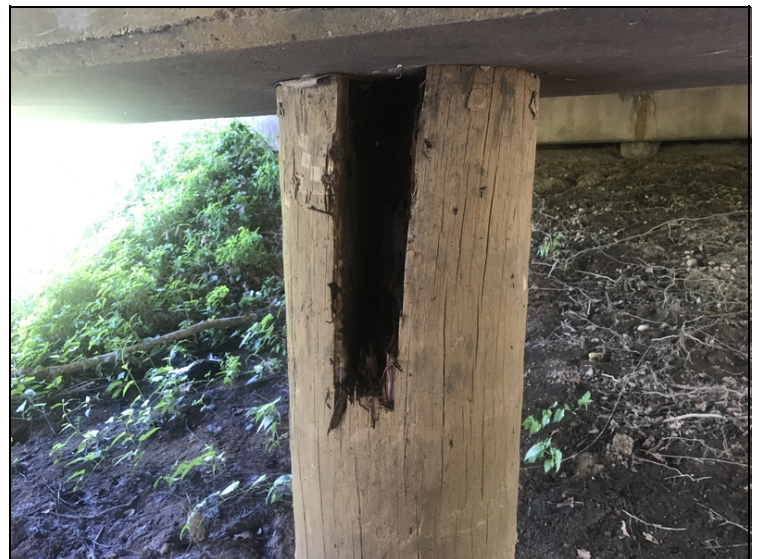
Bent 3 pile 3 heavy decay with small core.

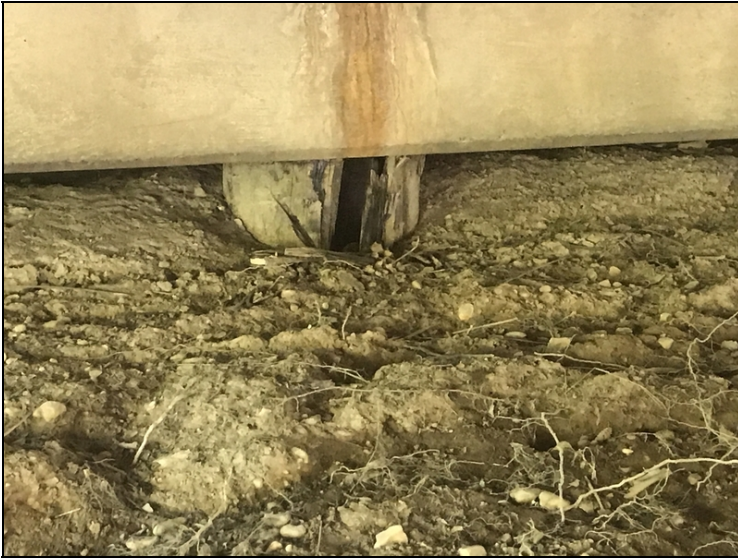
Bent 4 pile 3 hollow with heavy decay.

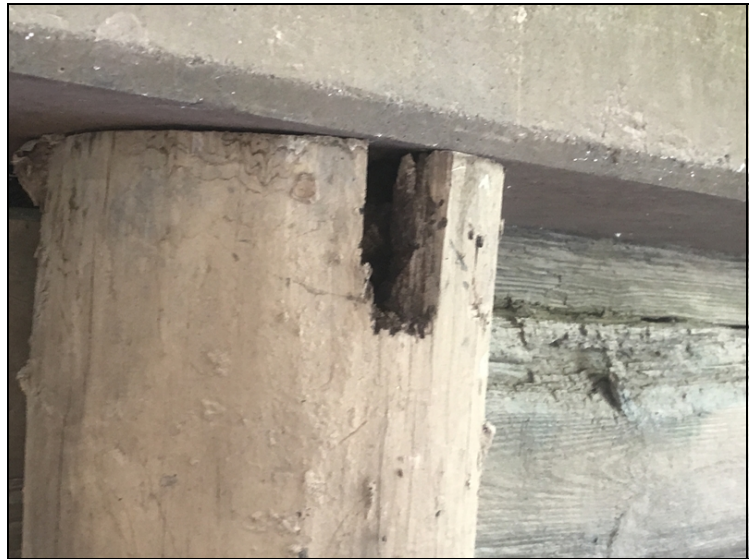
Bent 1 pile 3 hollow and decayed at cap.

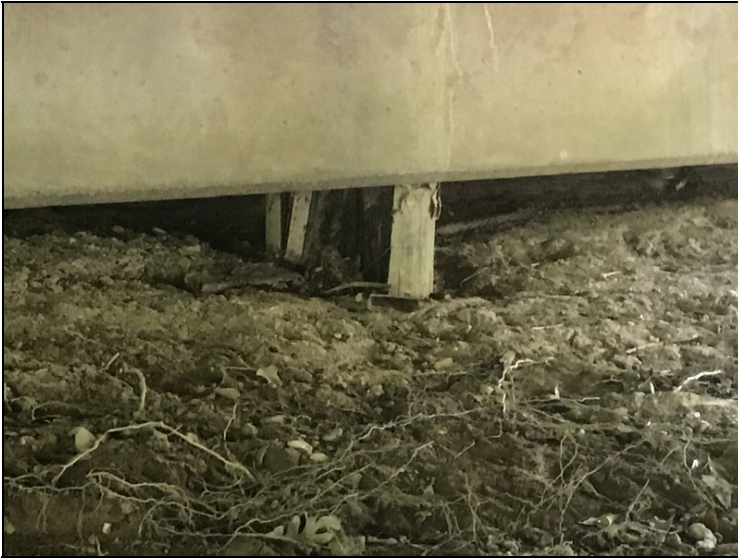
Bent 4 pile 4 hollow with heavy decay.

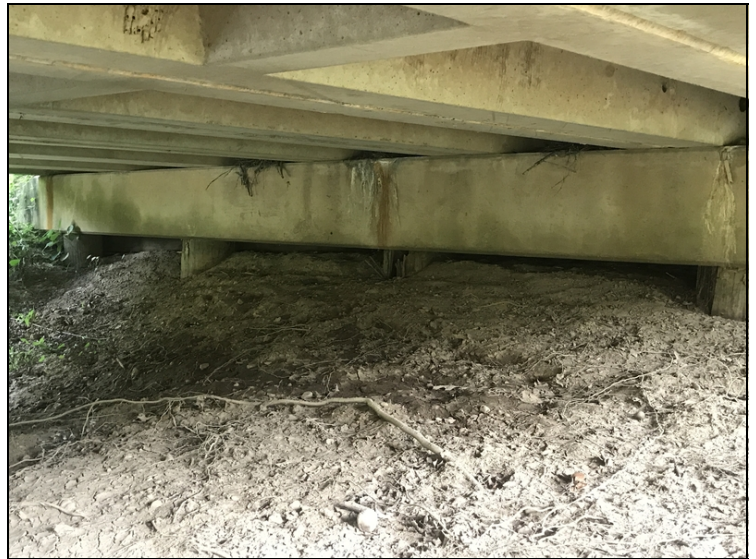
Bent 4 pile 2 and 3 have decay. Pile 3 has no bearing capacity.

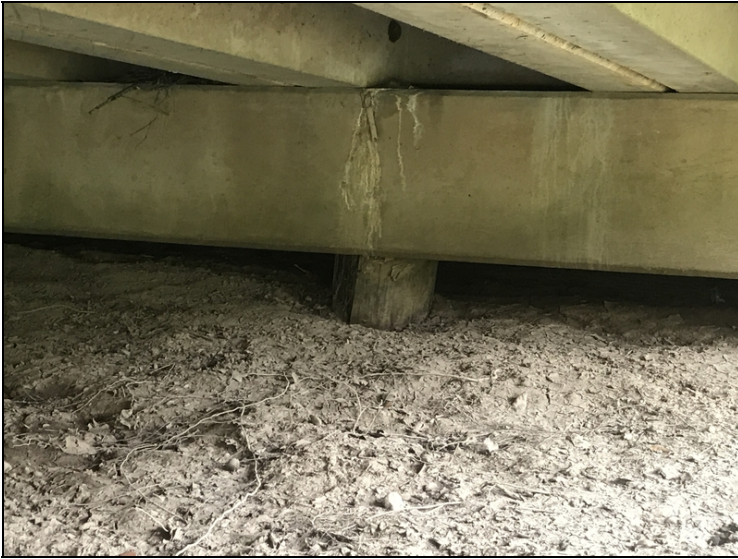
Bent 4 pile 4 has heavy decay.

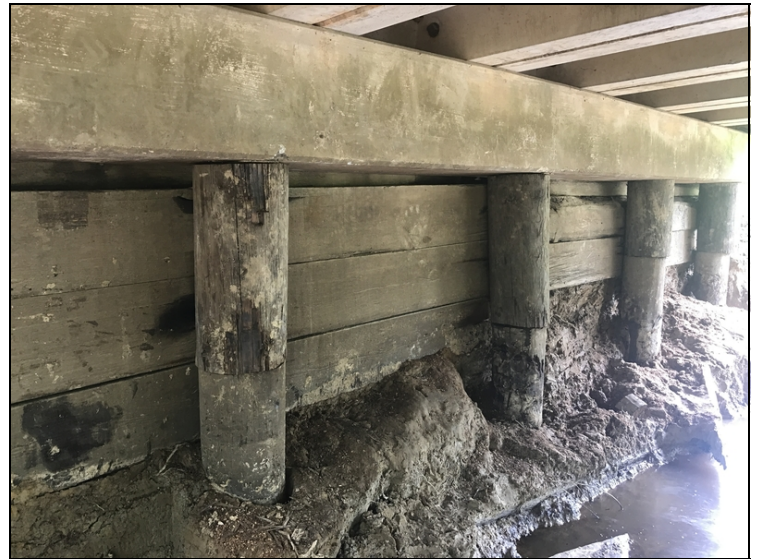
CORRECTED - Bent 1 Piles 1-4: Decay

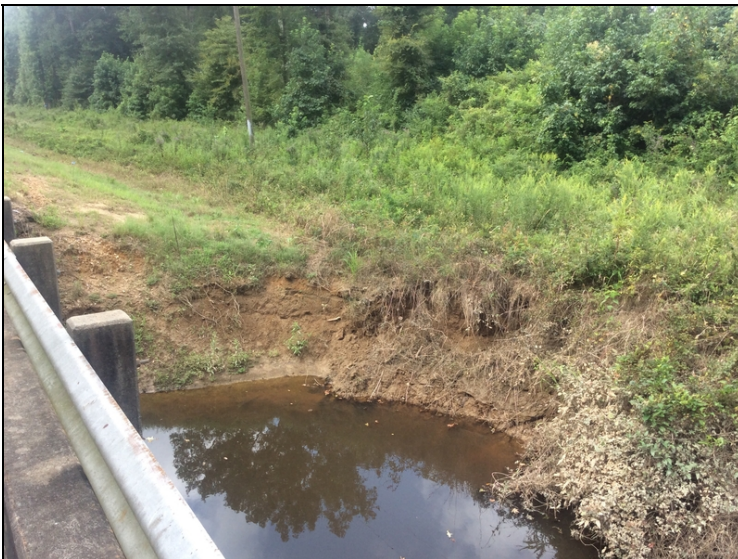
Channel - Spans 1 & 2 left: Significant, active erosion along channel bank and up to piling at Bent 2. Sounding of the channel along piling indicate the bottom of the channel is 14' below the bottom of the cap at Pile 1 (pile length is unknown). Channel bottom also falls approximately 4' from right to left side of bent.
NOTE: 2019 shows to be 12.1 below cap with no additional erosion at pile.

Channel - Spans 1 & 2 left: Erosion

David: Need to fill this hole with rip-rap
