District 02, Desha County

Bridge #03404(Routine)
SH 138-04 LM 8.27 over Canal Number 43

Location: 4.6 Mi W SH 1-Kelso

Team Lead: Sharon Hooks **Inspection Date:** January 21, 2020

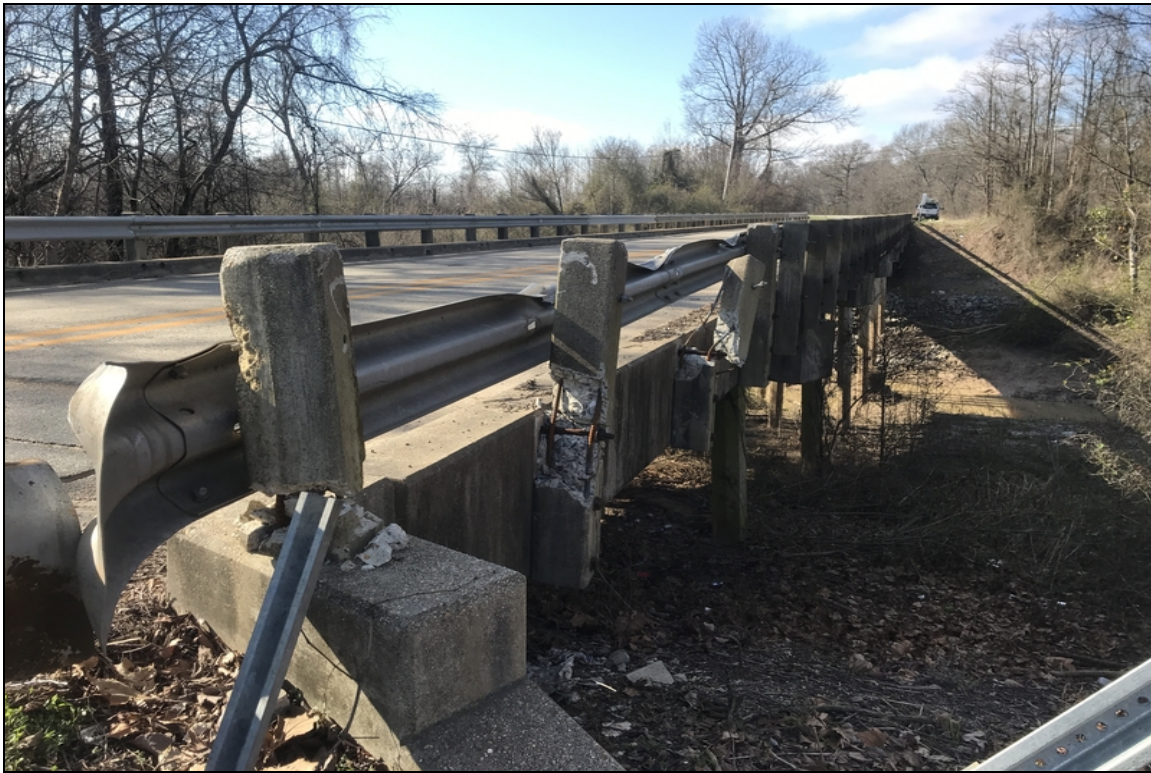
Concrete railing post damage at span 8 near bent 9.

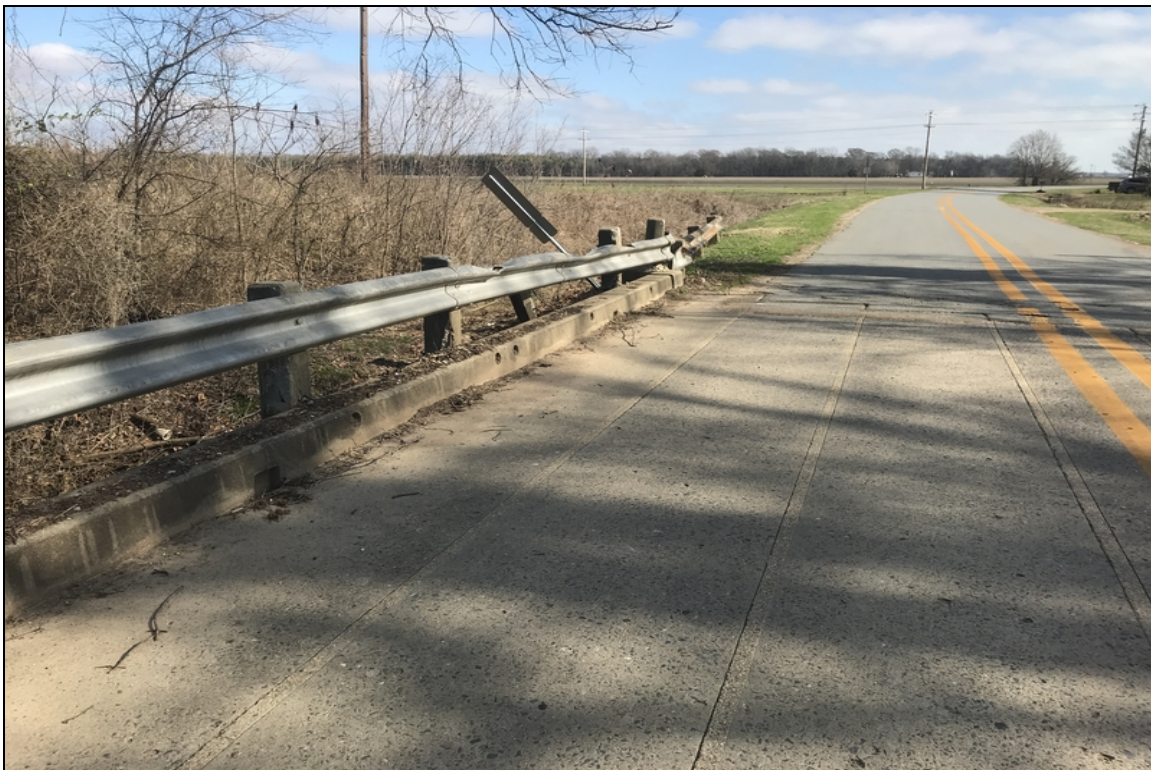
Gaurdrailing and concrete post damage at bent 9 left side ..

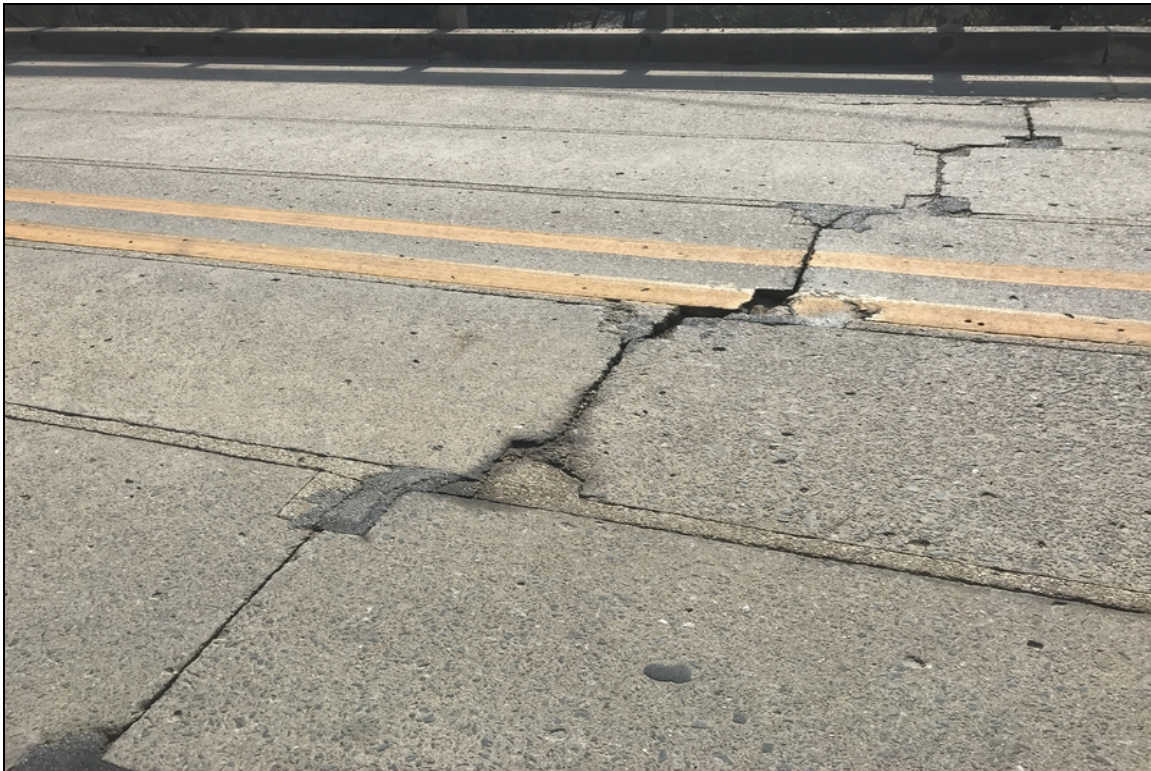
(16)							
Deck: 26' wide x 251' long. Joints are completely grouted and grout is in good condition except for some deterioration and spalling of grout in key-ways at ends of spans in various locations.							
Span 1 Unit 2, Span 2 Unit 6, Span 4 Units 2 & 6, Span 6 Units 2 & 6, and Span 7 Unit 6 have some delaminations and cracking along sides of units close to ends of spans.							
Abrasive wear with scattered loss of course aggregates in all units - except the exteriors (1/2 CS3, 1/2 CS2).							
110	Reinforced Concrete Open Girder/Beam	LF	1736	1736	0	0	0

Spalls at ends of top flange deck slabs.

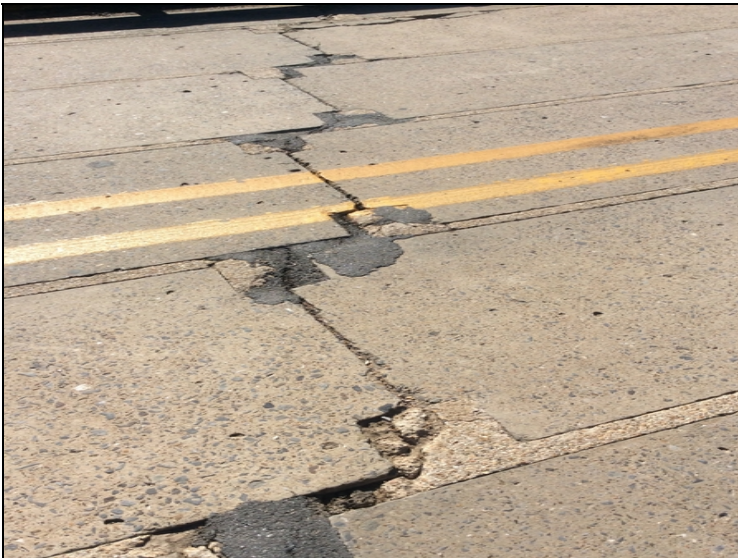
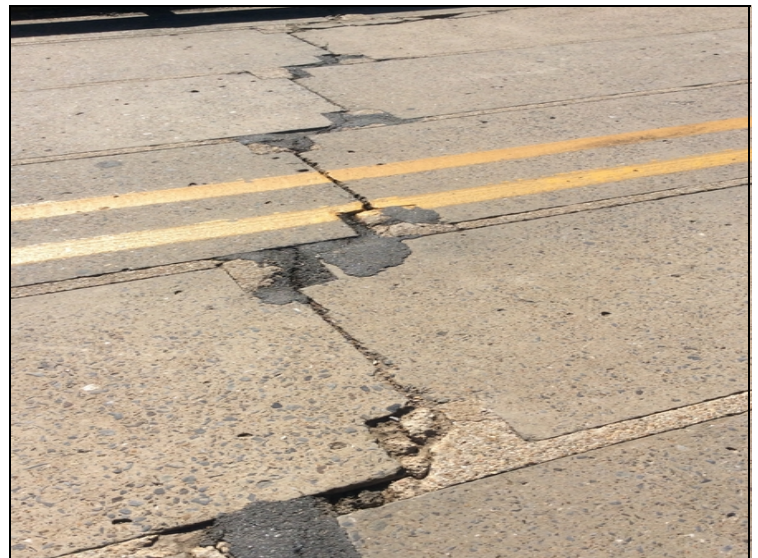
Deck - all spans: Some deterioration and spalling of grout in key-ways at ends of spans in various locations.

Span 1 Unit 2, Span 2 Unit 6, Span 4 Units 2 & 6, Span 6 Units 2 & 6, and Span 7 Unit 6 have some delaminations and cracking along sides of units close to ends of spans.

Deck - Bent 3: Spalls

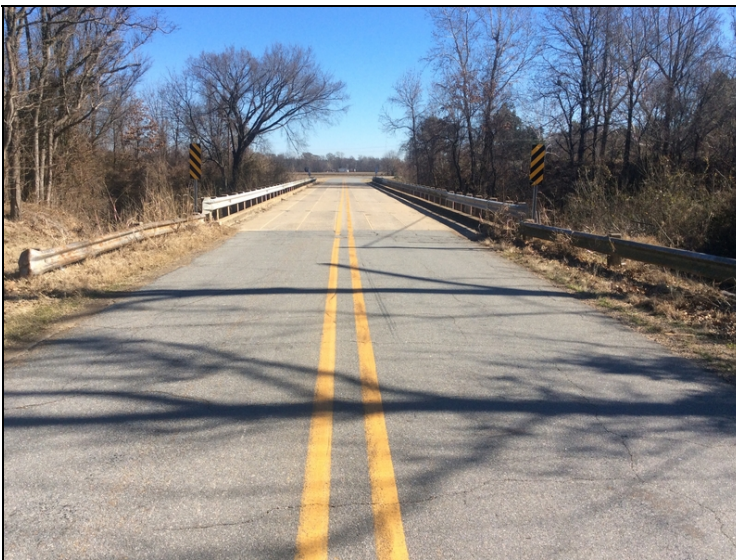
Roadway view

Sign - Bent 1 right: Log mile sign missing - object marker and post in place.

repair, advise when complete

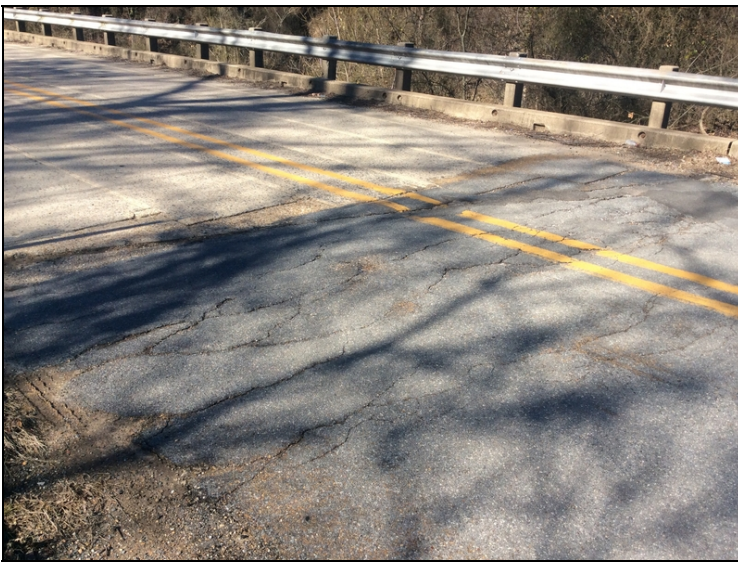
Approach roadway - Bent 8: Wearing surface is deteriorating with several moderate- to large-sized cracks and some settlement (1-1.5") in right lane.

Approach roadway - Bent 8: Drop off

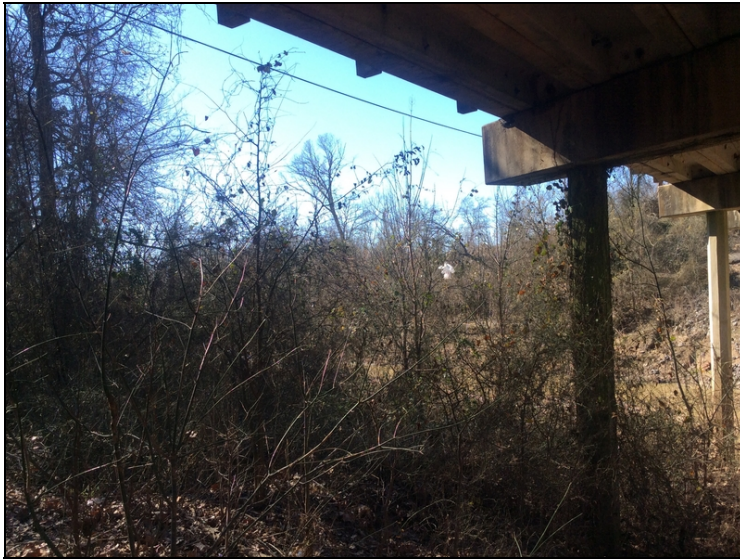
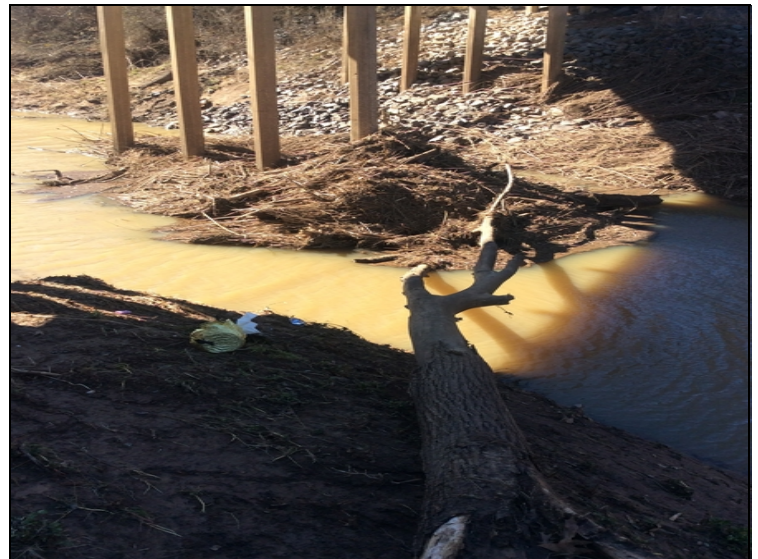
Endslopes - Bent 6-8: Small trees, bushes, and other vegetation growing underneath bridge.
Vines growing up pile at Bent 6 right.

Bent 6 - Trees and vines

Some trees at abutment have been removed but other trees remain and need to be removed.

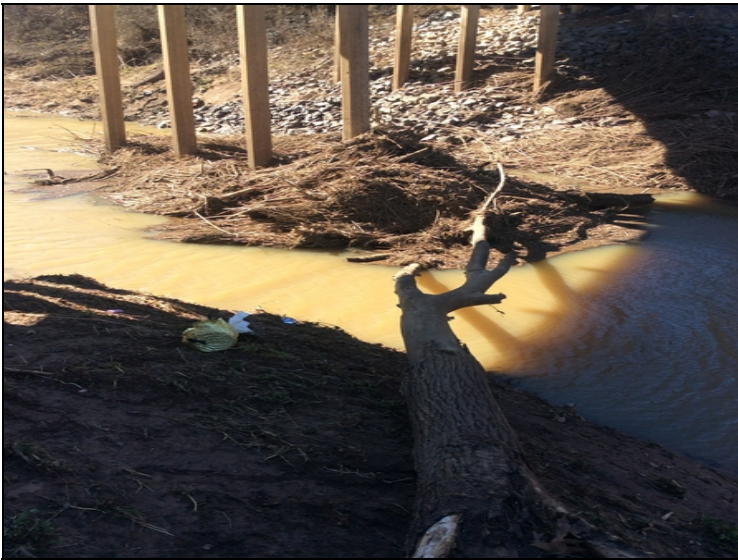
Channel - Bent 4: Some build-up of logs, limbs, and other debris against pile on left side.

Channel - Bent 4: Debris

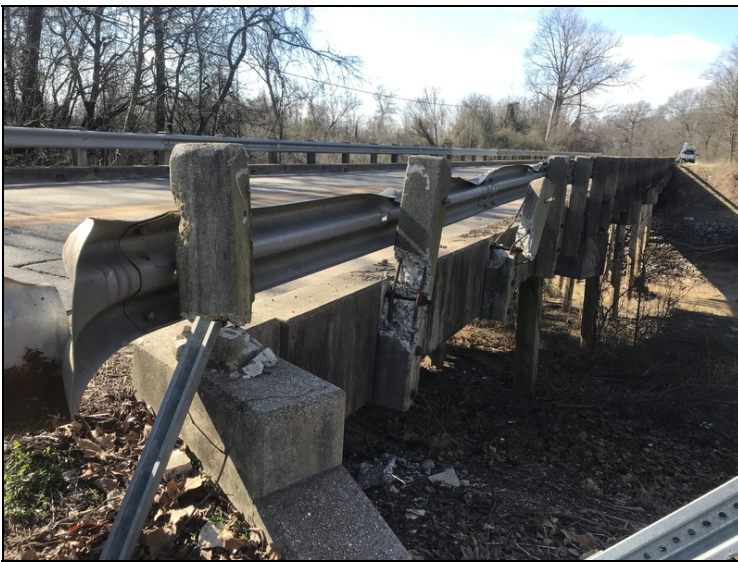
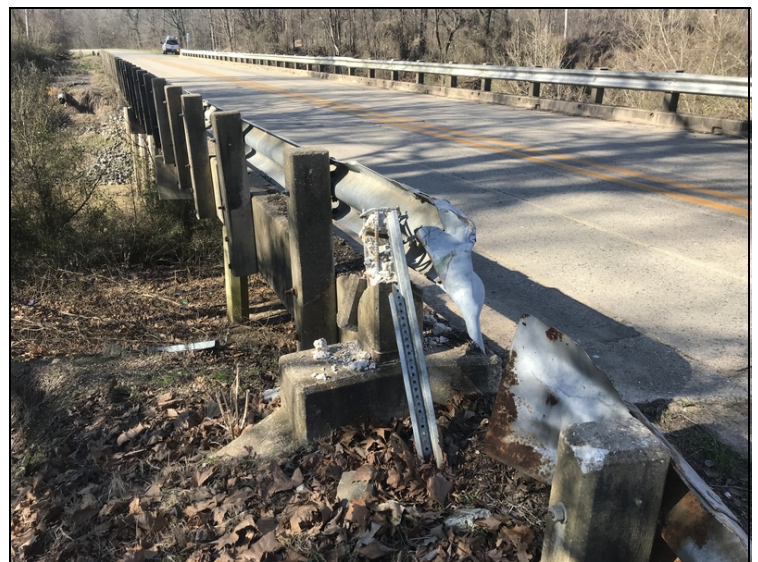
Concrete posting and metal post damage near bent 9 both sides.

Concrete post and railing damage.

Date Reported: 01/21/2020
Priority: C - Important
Type of Work: Repair
Status: Open
Component: Bridge
