Bridge #02890(Routine)

US 165-05 LM 30.42 over Hurricane Bayou

Team Lead: Greg Loomis Inspection Date: September 27, 2021

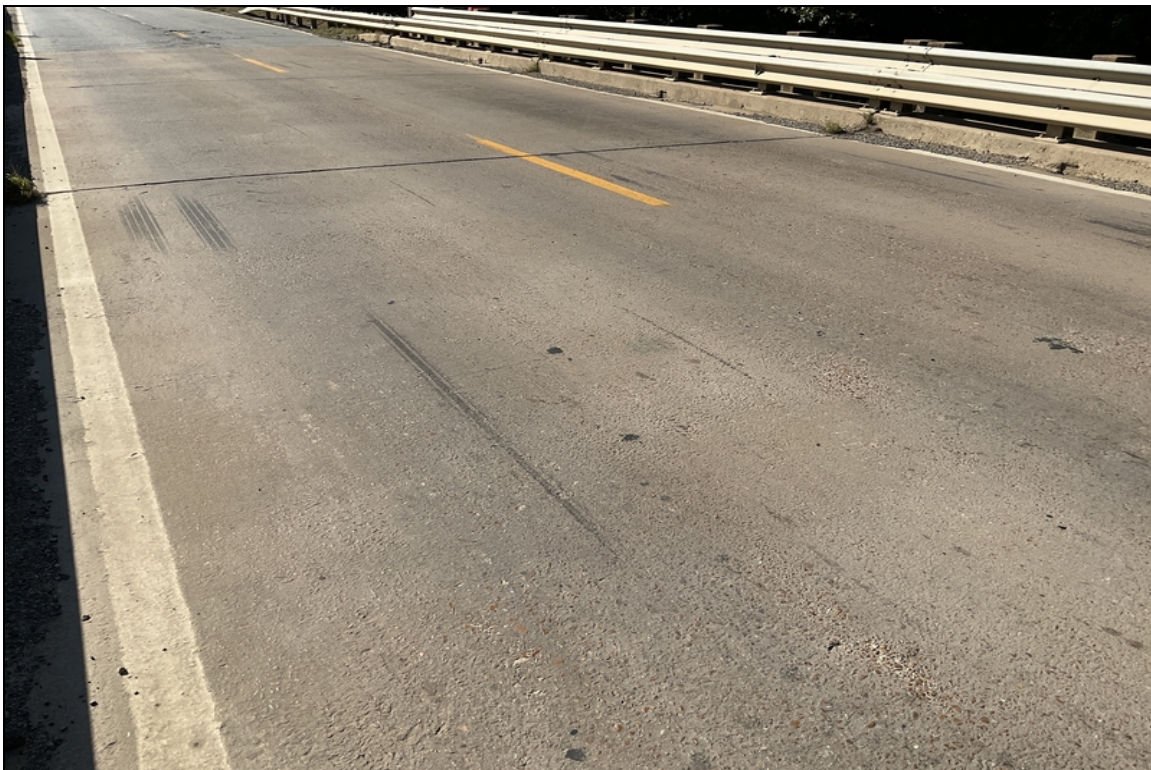
(38)							
Deck: 29'-6" wide (NOT including railing posts) x 75' long = 2212 sqft.							
NOTE: Healer sealer applied to deck surface in mid-2019. (Cracks have been sealed - CS2.)							
Healer-sealer: Larger cracks appear to be opening back up - scattered breaks in seal - 2021 inspection.							
Spans 1 & 3: A couple unsealed, moderate-sized, transverse or longitudinal cracks.							
Soffit -							
Span 1: Longitudinal crack with efflorescence along center-line / spalling with exposed rebar near mid-span.							
Spans 1-3: Some spalling/delamination around drains with rebar exposed (14 sqft).							
215	Reinforced Concrete Abutment	LF	76	46	10	20	0
1080	Delamination/Spall/Patched Area	LF	10	0	10	0	0
6000	Scour	LF	20	0	0	20	0

Deck - Spans 1-3: Typical

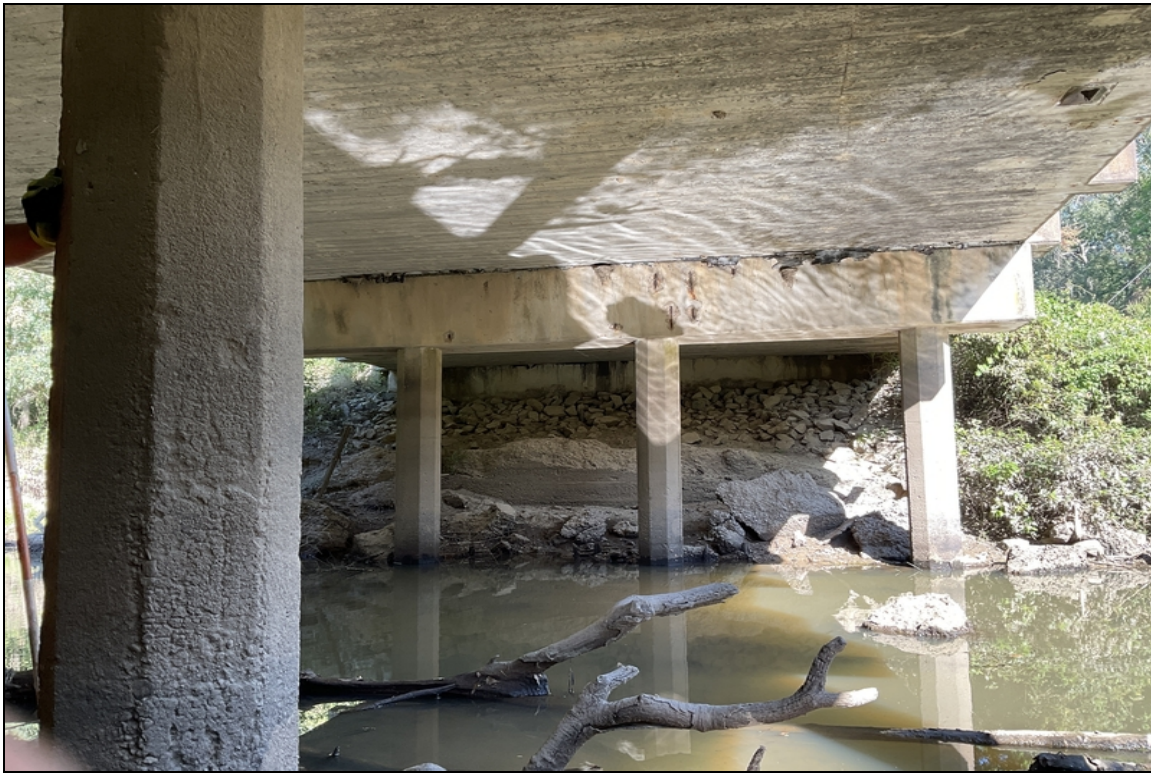
Soffit - Span 2: Typical

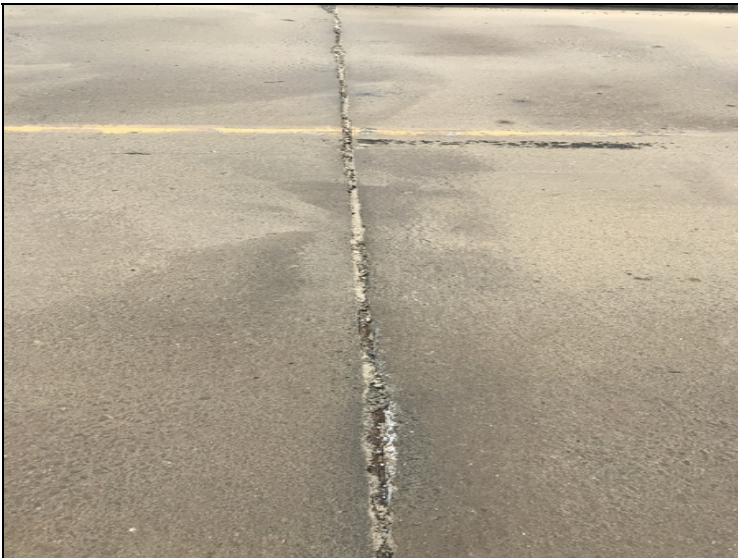
Joints – Bents 2 & 3:
No pourable joint material in place – joints are filled with dirt and debris.

09-27-2021 GGL-PRD: Changed priority from "D" to "C".

Joint - Bent 2 : Impacted

Clean joint, and replace pourable joint material

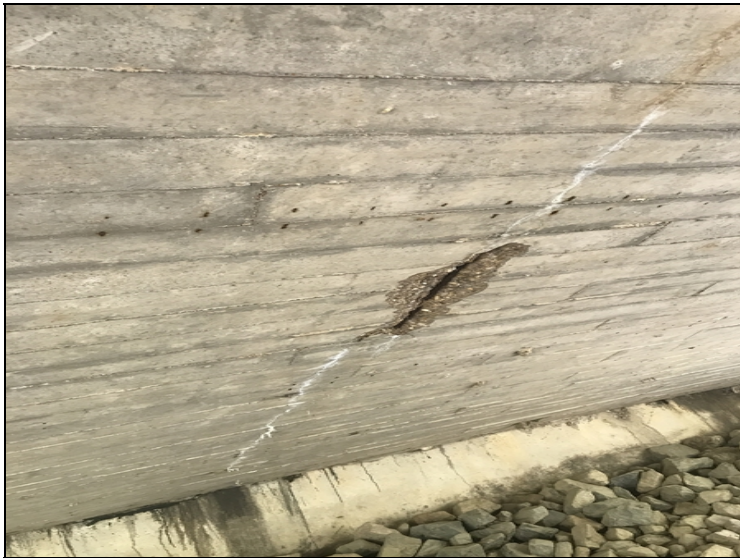
Span 1: Longitudinal crack with efflorescence along center-line / spalling with exposed rebar near mid-span.

Soffit - Span 1 : Efflorescence and Exposed Rebar

Remove de-lam areas, patch back and cover exposed steel

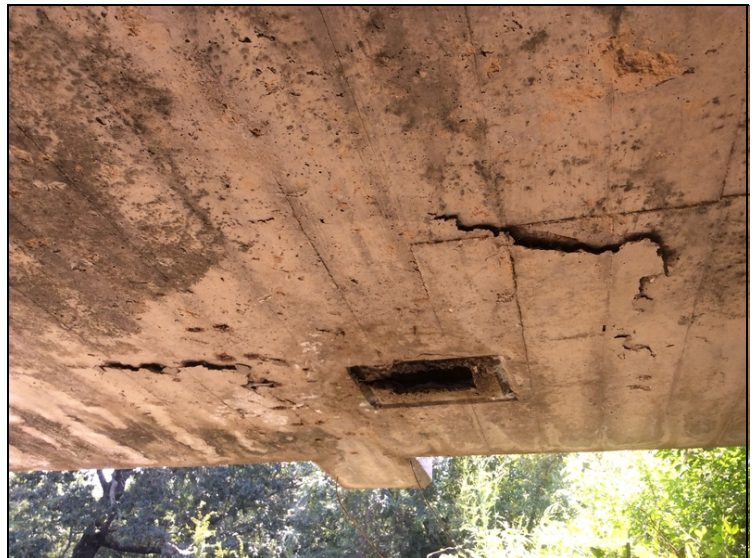
Soffit - Span 3 left

Spans 1-3: Some spalling/delamination around drains with rebar exposed (14 sqft).

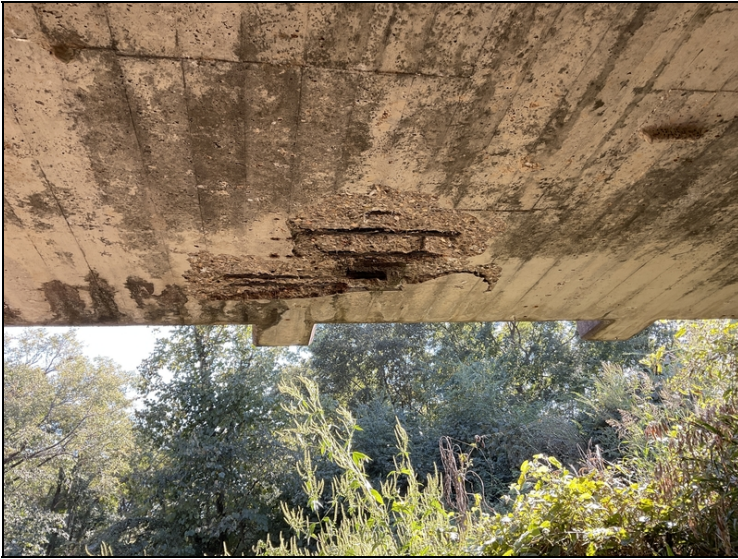
Soffit - Span 3 left: Rebar exposed at drain

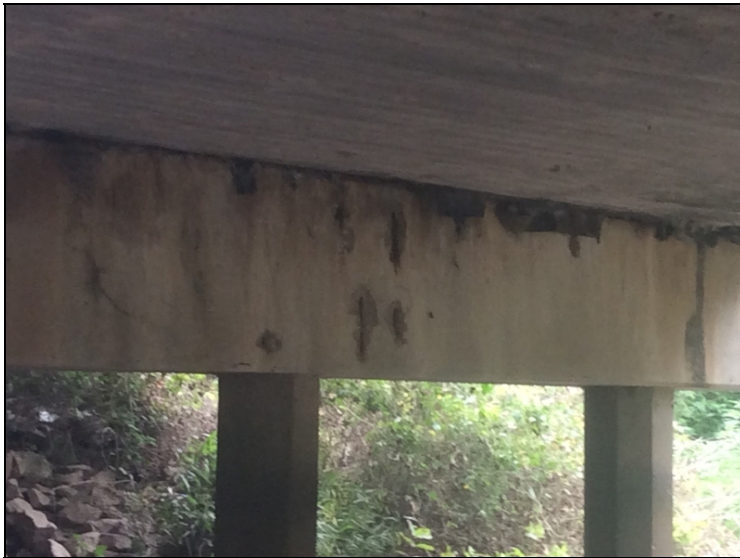
Bent 2 & 3: Small spalls with some light exposed rebar on ahead side at Pile 2.

Spalls with exposed rebar on bent 2 cap ahead near mid span .

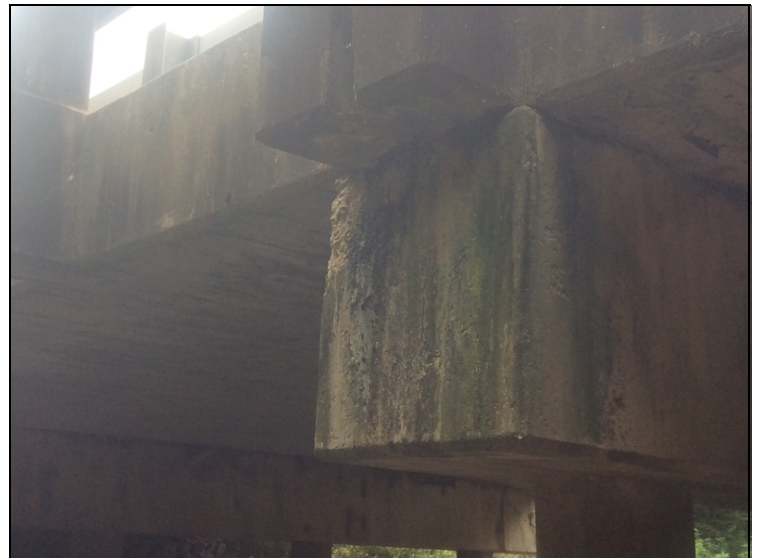
Bent 3: Scalling on left and right end (1.5" deep).

Bent 3 cap right end has small spall .

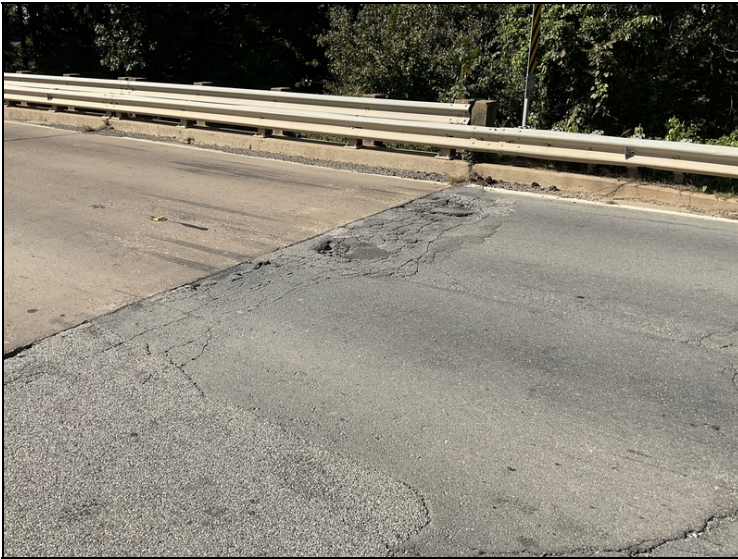
Approach roadway - Bents 1 & 4: Significant deterioration of asphalt wearing surface - cracking, delaminations, and spalls (potholes) on each end of bridge.

Approach roadway - Bent 1: Deterioration of asphalt wearing surface

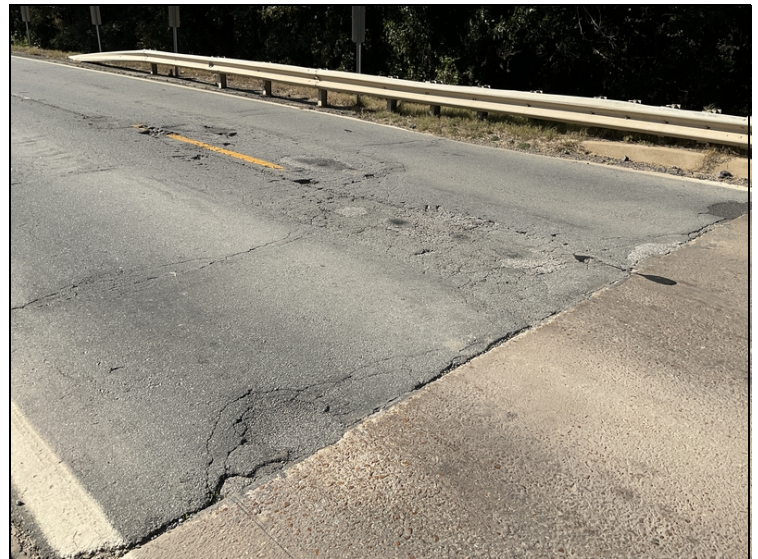
Approach roadway - Bent 4: Deterioration of asphalt wearing surface
