Bridge #02891(Routine)

US 165-05 LM 28.39 over Mill Bayou

Team Lead: Greg Loomis Inspection Date: September 27, 2021

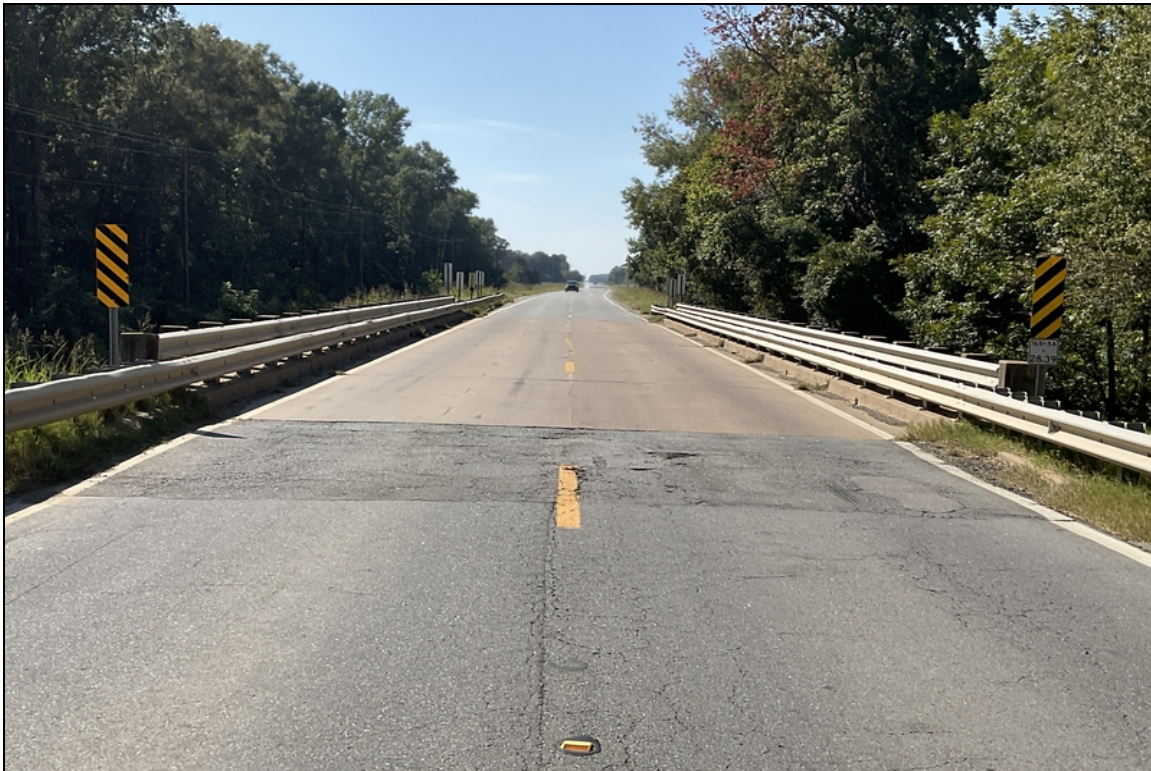
Roadway view

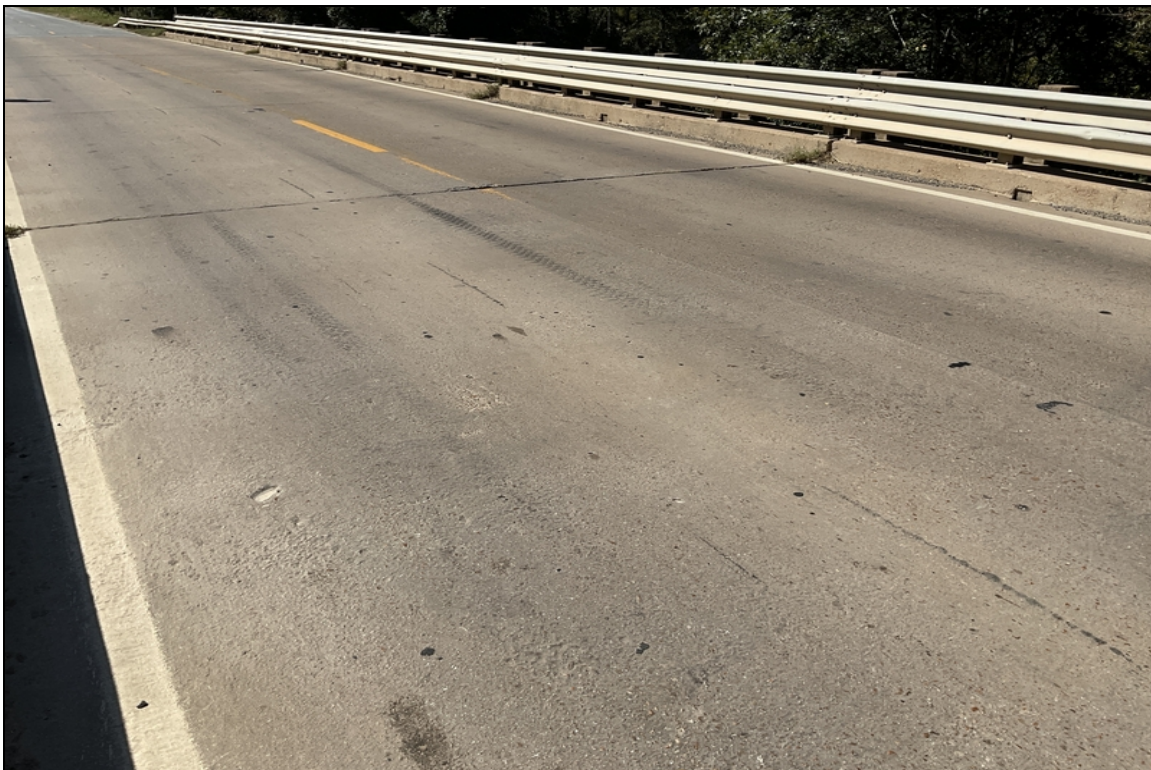
Deck - Spans 1-6: Typical

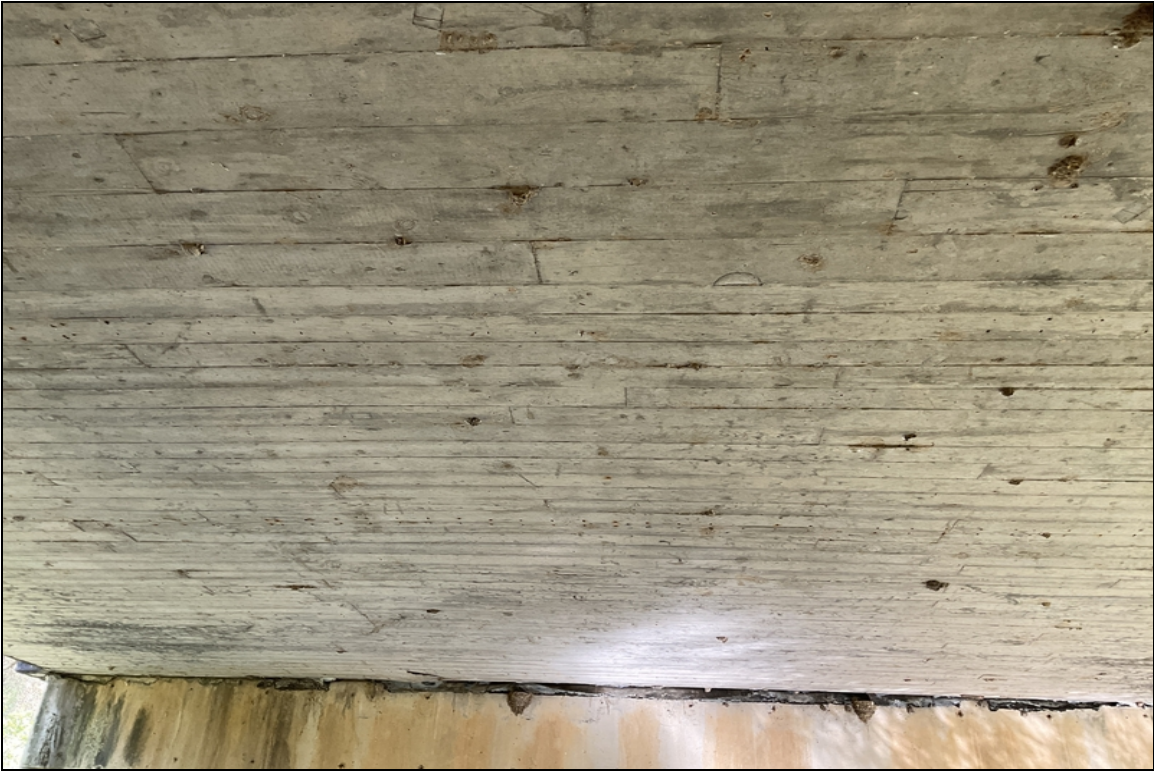
Soffit - Span 5: Typical

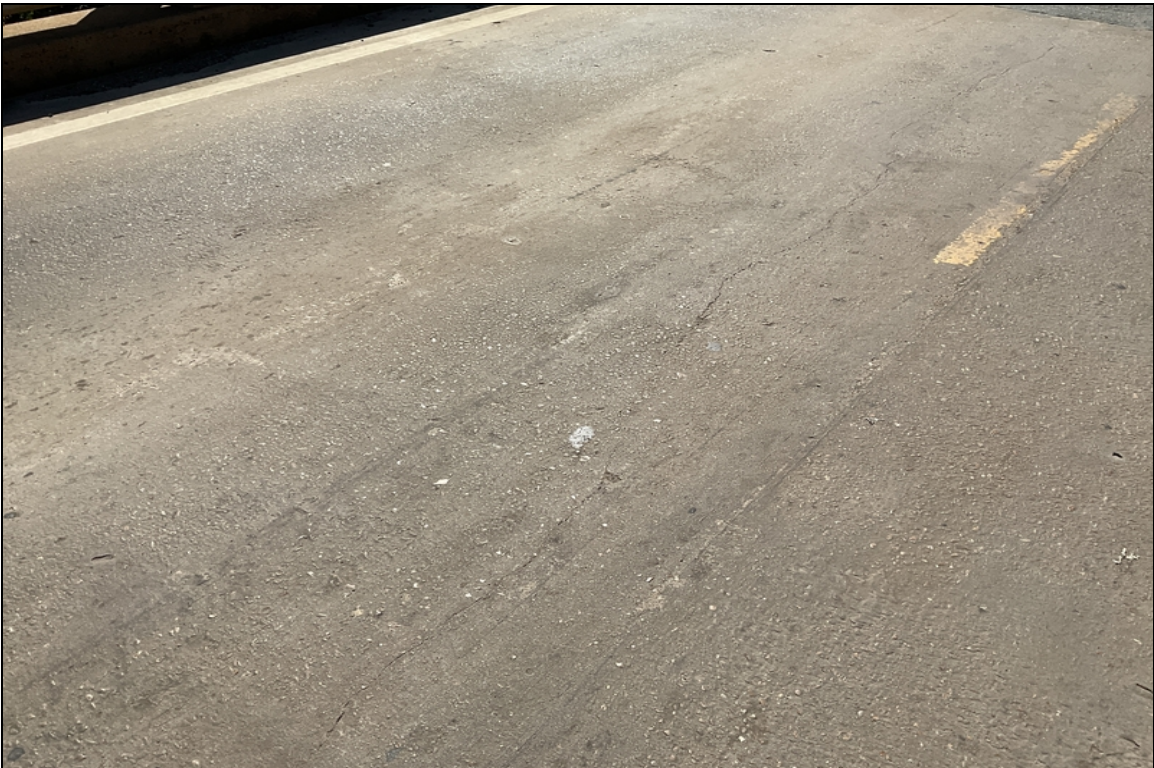
Deck - Span 6 left: Longitudinal crack

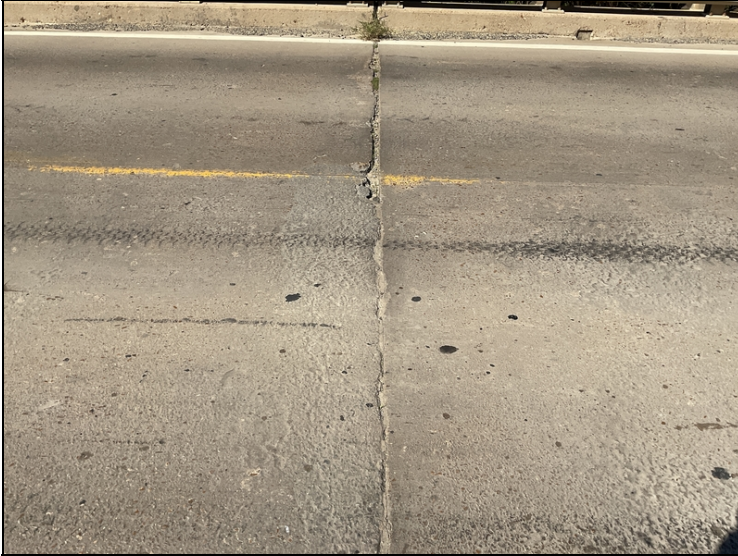
Joints – Bents 2-6:
No pourable joint material in place – joints are filled with dirt and debris.
Bents 2, 4, & 5: Spalling of adjacent concrete with some repairs.

Joint - Bent 2: Spalling of adjacent deck

clean joint, replace material

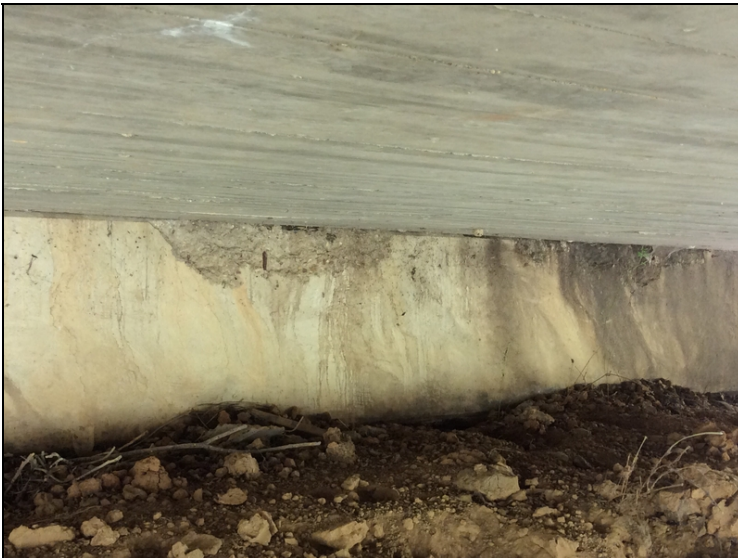
Abutment - Bent 7

Bent 7: Shallow spall with minor exposed rebar.

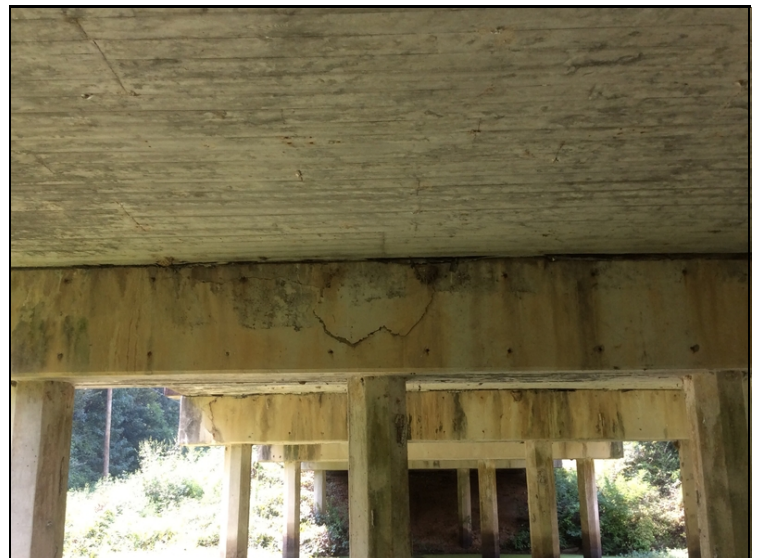
Cap - Bent 3 back face

Caps: Some minor cracking, shallow delaminations, and minor spalling on front and back faces of caps, mostly near ends under curbs and gutterlines.

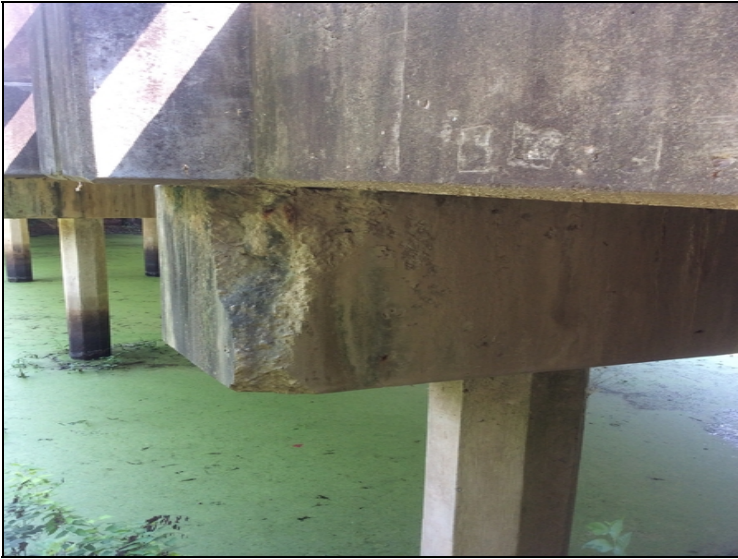
Cap - Bent 6 right

Bent 6 both ends: Scalling with some exposed rebar.

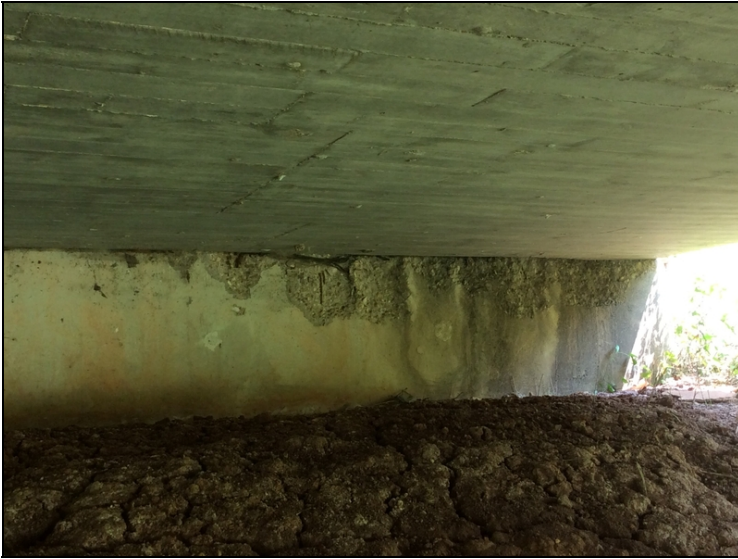
Abutment - Bent 1 left

Bent 1: Shallow spall on left side with some steel exposed.

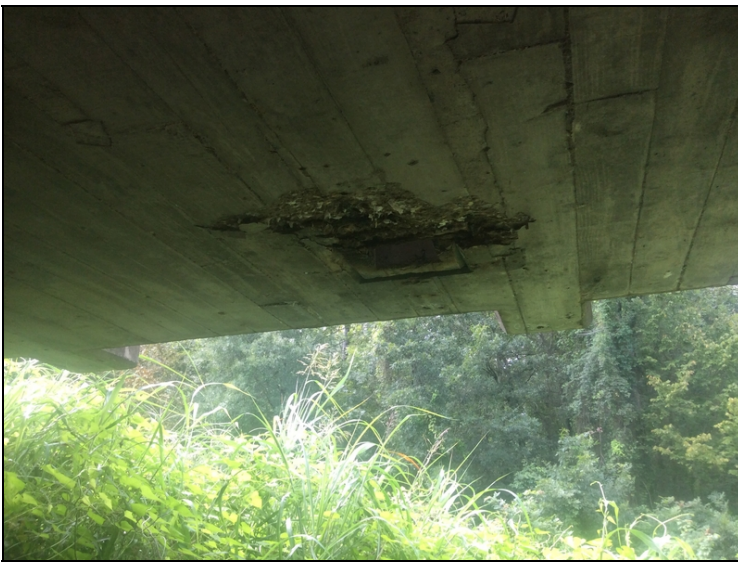
Soffit - Span 1 left: Delamination/spalling with exposed rebar at drain

Spall with exposed rebar at soffit drain opening span 1 left side .

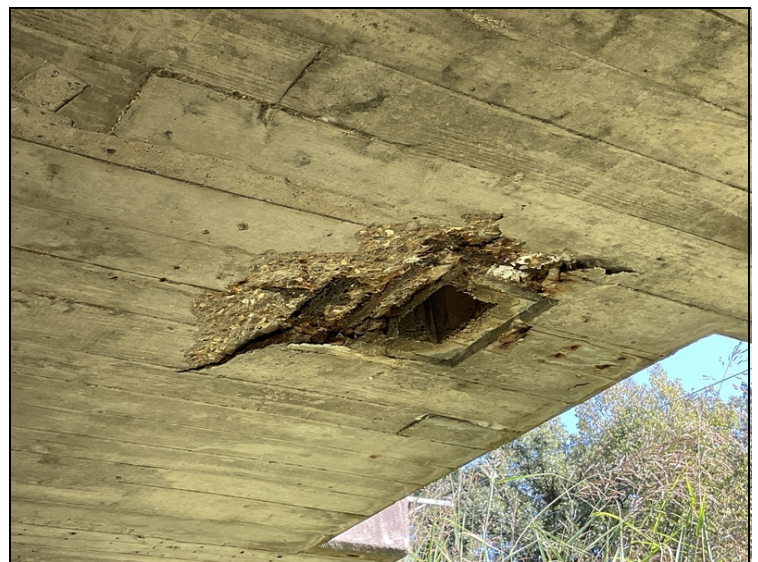
Soffit - Span 1 left: Rebar exposed
