Asset #02162(Routine)

SH 4-17 LM 5.34 over Bayou Macon

Location: 5.34 Mi E US 65-McGehee

Team Lead: Greg Loomis, Inspection Date: 03/31/2021

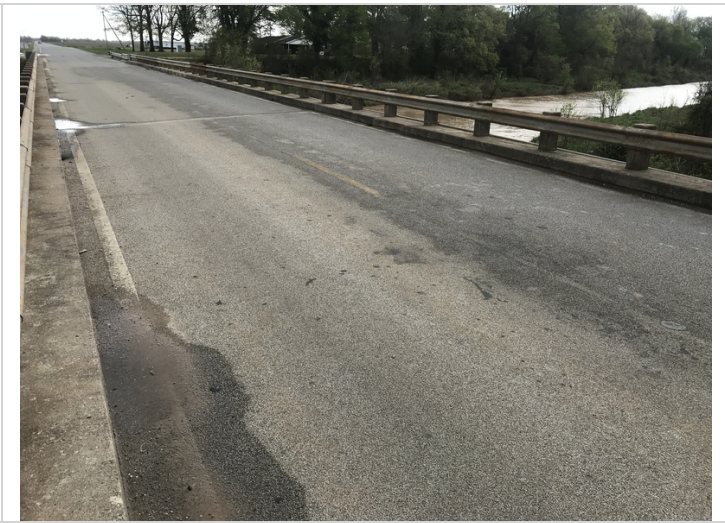
Deck - Spans 1-4: Typical

(12) Deck: 25'-4" wide (1'-7" STEP-UP each side) x 200' long = 5067 sqft. Wearing surface (polymer overlay): 24' wide x 200' long = 4800 sqft.  NOTE: Asphalt wearing surface was milled off deck surface, spalls and delaminations were patched, and a polymer overlay placed on deck.  Soffit - Several scattered locations where contractor broke through deck while making repairs - resulting in spalls with exposed rebar, mainly along gutter-lines (outside of outer girder). Span 2 Bay 4 @ Bent 3: A couple transverse lines of efflorescence. Span 4 Bay 4 @ Bent 5: Area of transverse lines of efflorescence.							
107	Steel Open Girder/Beam	LF	1000	872	96	32	0
1000	Corrosion	LF	128	0	96	32	0
515	Steel Protective Coating	SF	7410	0	6572	718	120
3410	Chalking (Steel Protective Coatings)	LF	6572	0	6572	0	0
3440	Effectiveness (Steel Protective Coatings)	LF	838	0	0	718	120

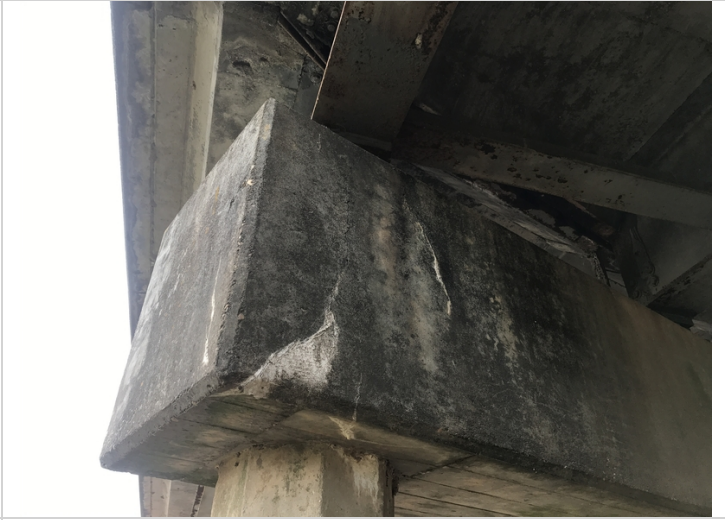
ELEMENTS	DESCRIPTION	UNITS	TOTAL	CS1	CS2	CS3	CS4
(234) Caps: 28'-2" = 29' each / Bents 2-4. Bents 2-4: Some cracking with efflorescence, mainly on front and back faces left end and at center-line.							
305	Assembly Joint without Seal	LF	125	3	12	110	0
2350	Debris Impaction	LF	100	0	0	100	0
2360	Adjacent Deck or Header	LF	12	0	12	0	0
2370	Metal Deterioration or Damage	LF	10	0	0	10	0

Cap - Bent 2 back left: Cracking with efflorescence

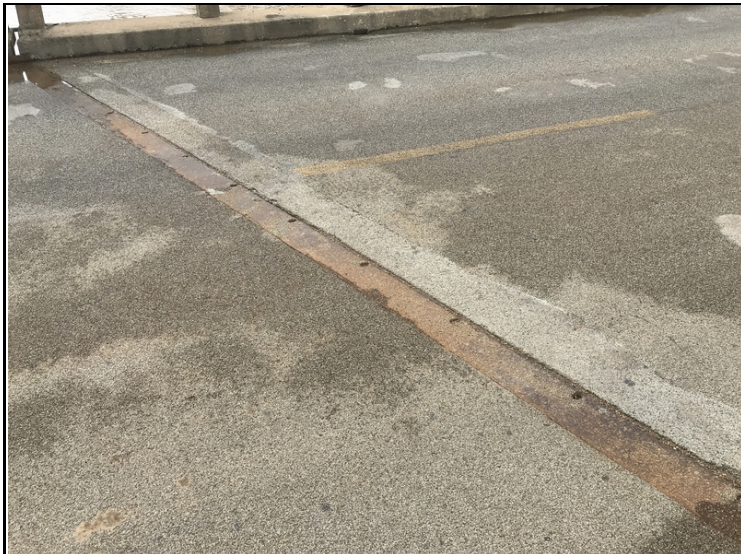
CORRECTED - Bent 4 deck has potholes at joint armor.

CORRECTED - Joint - Bent 4: Deck  
repaired/polymer sealed

03-31-2021 GGL-PRD: Deck has been repaired/polymer sealed.

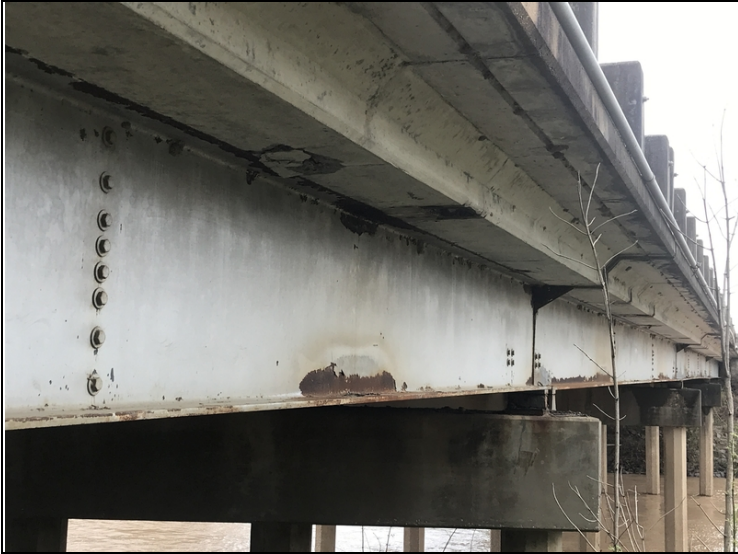
Ends of girders have been cleaned and spot-painted by state forces; however, corrosion is beginning to reform - especially on outer girders at haunches.

Some section loss at bearings on outer girders.

Exterior of outer girders is rusting at drains and on top of bottom flange.

Spans 1-2 Girder 5 right: Corrosion

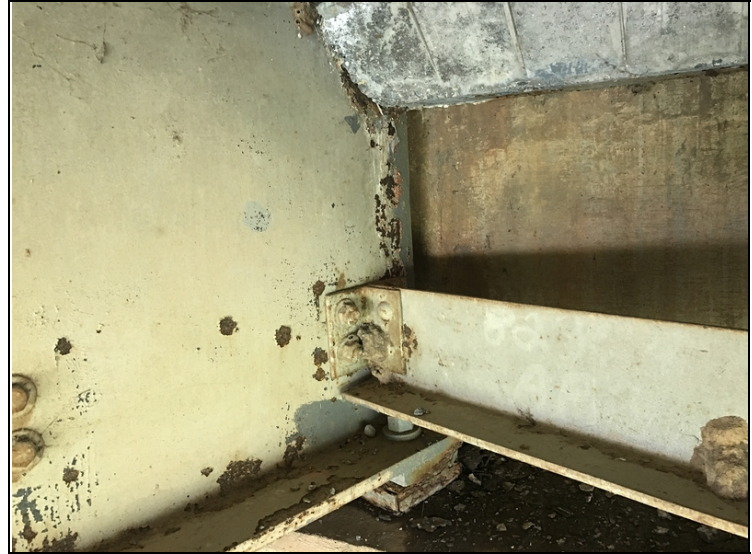
Span 1 Girder 2 left @ Bent 1: Corrosion

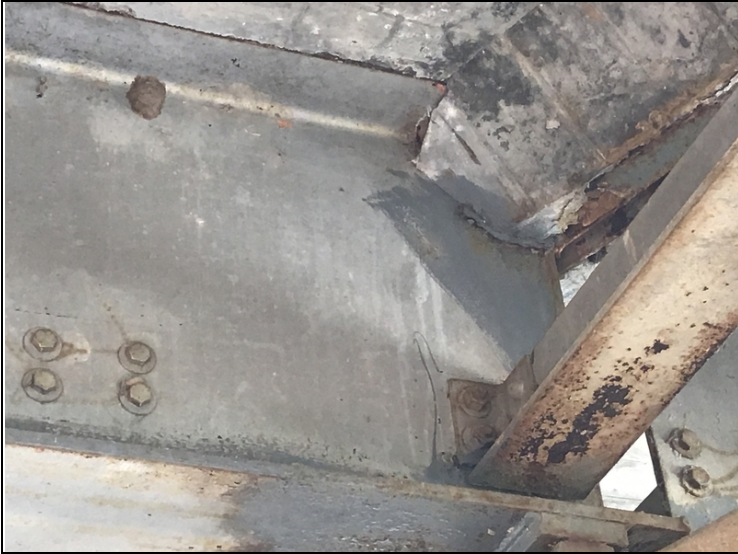
Span 1 Bent 2 girder 4 has some rust with flaking in hunch area. Common most hunch areas this bridge.

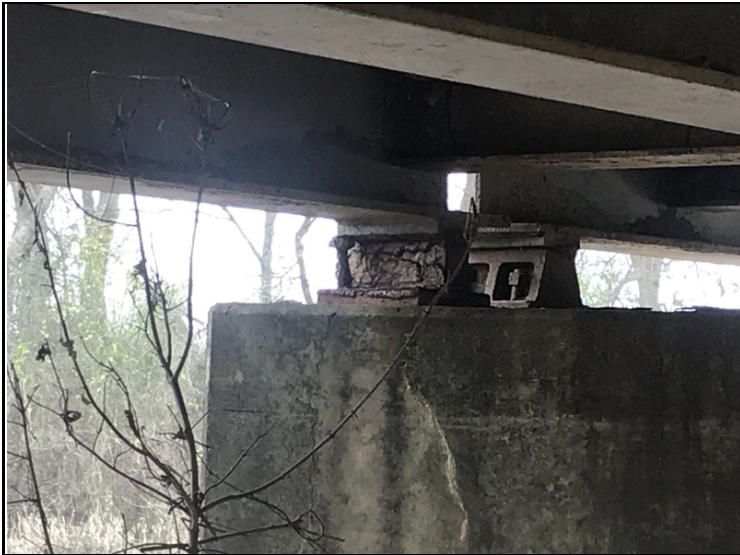
Bearings - all bents:  
Bearings 1 & 5 @ Bents 2-4 have heavy corrosion/flaking.  
Remaining bearings have some corrosion forming.

Bent 2 bearing 1 back has heavy flaking rust.  
Common bearing 5 this bent and on bearings 1 & 5  
Bent 3.

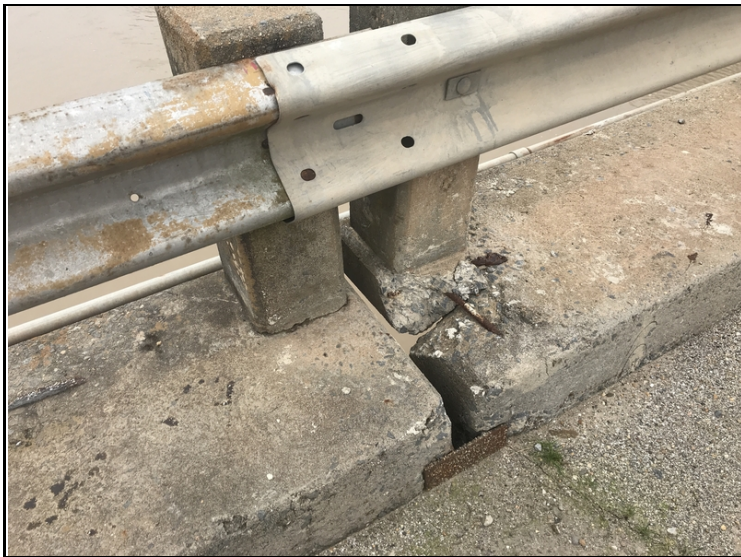
Railing - Span 3 right near Bent 4: Minor post damage.

Span 3 near bent 4 has some rail post damage right side.

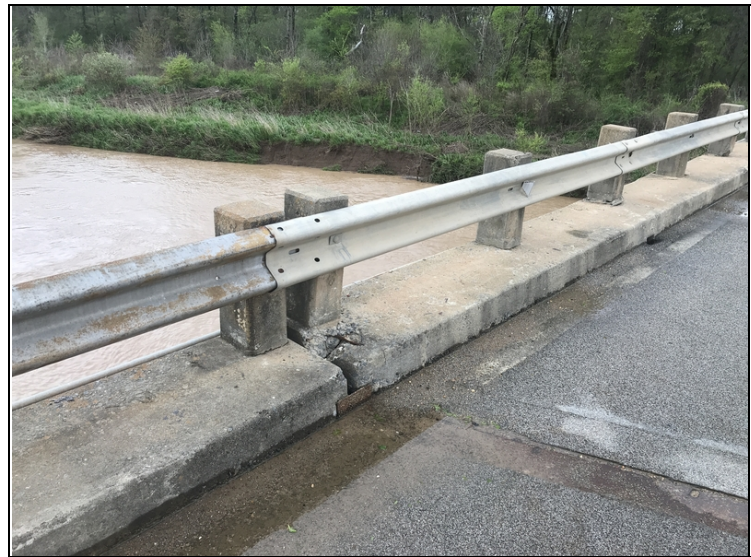
Railing - Bent 4 right: Post damaged

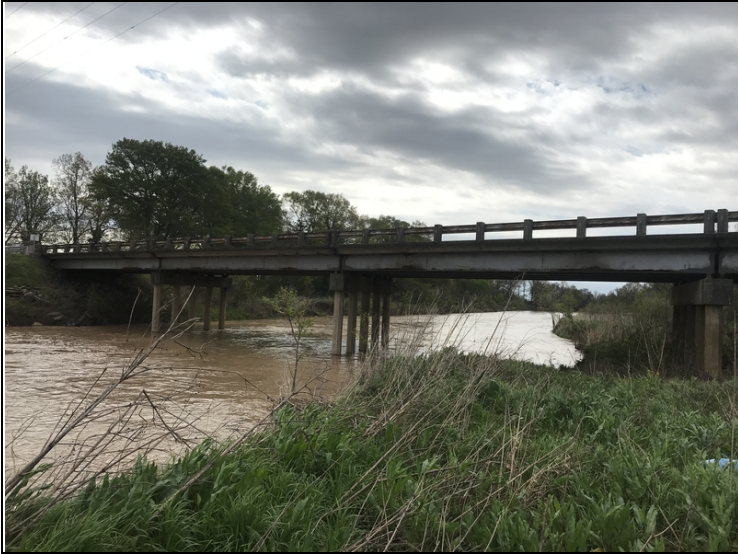
03-31-2021 GGL-PRD: No debris build-up visible this inspection - moderate water height.

**CORRECTED - Channel - left side: No debris build-up visible**

Removed by State Forces.

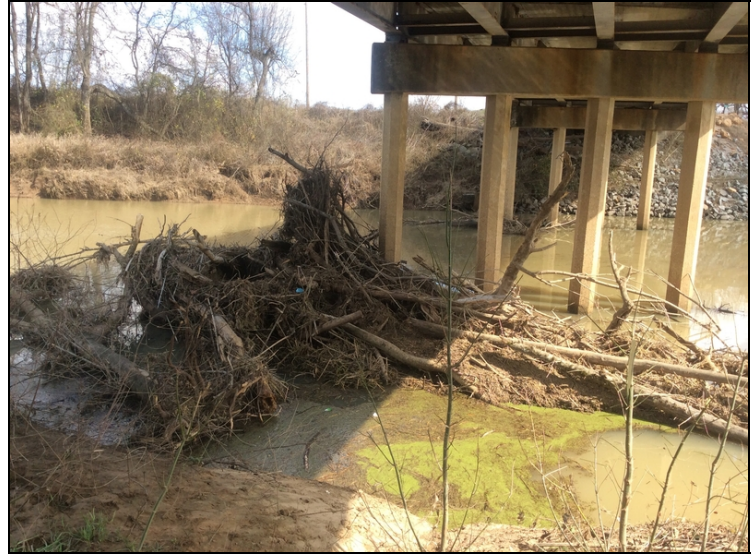
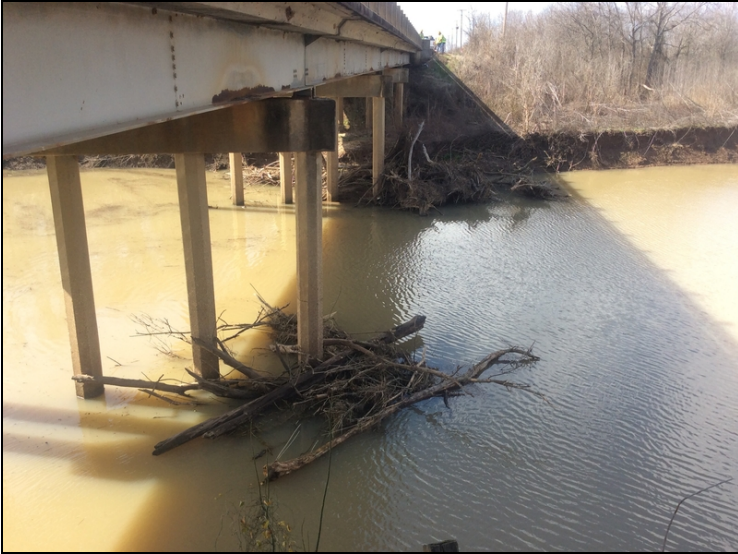
Channel - Bents 3-4 left : Minor build-up of logs, limbs, and other debris against piling.

**Channel - Bents 3-4 left (debris build-up)**

Desha: remove debris

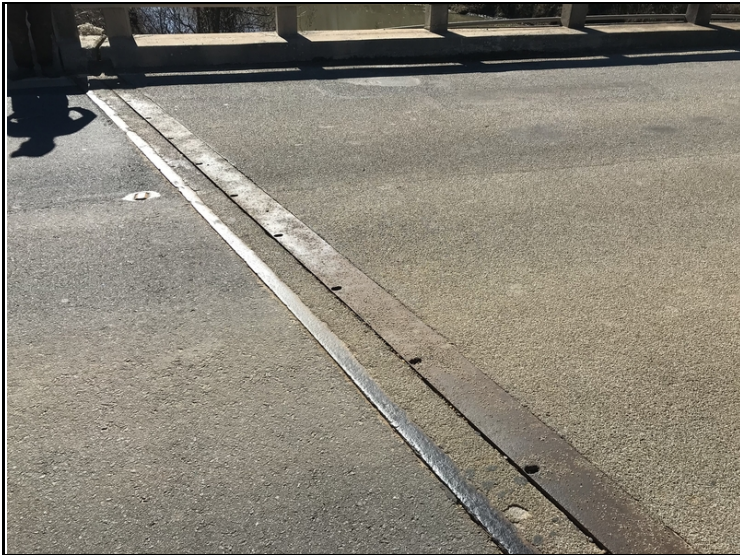
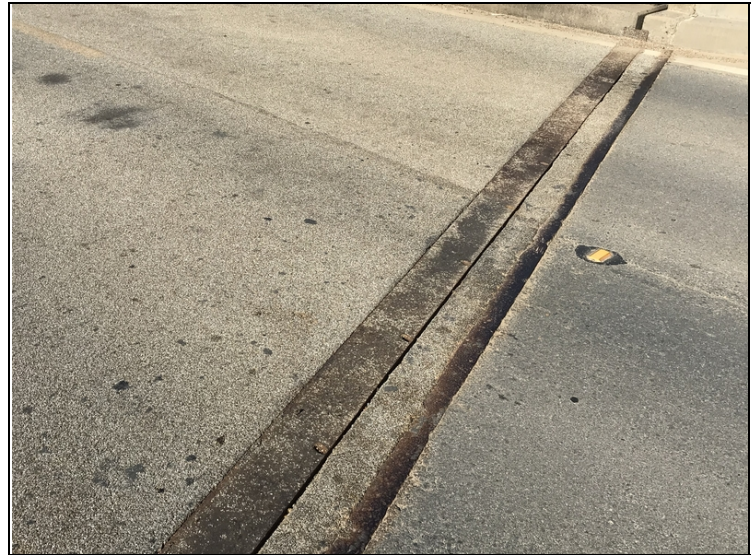
12-09-2020 GGL-PRD: Drive-by of structure showed sliding plate on Bent 5 joint making considerable noise. Situation was investigated and documented.

Center section (10') of sliding plate is loose and is flexing/making a considerable amount of noise when ran over by traffic in either direction (also able to flex under foot). No evidence of cracking of plate at this time (03-31-2021).

Joint - Bent 5: Sliding plate loose

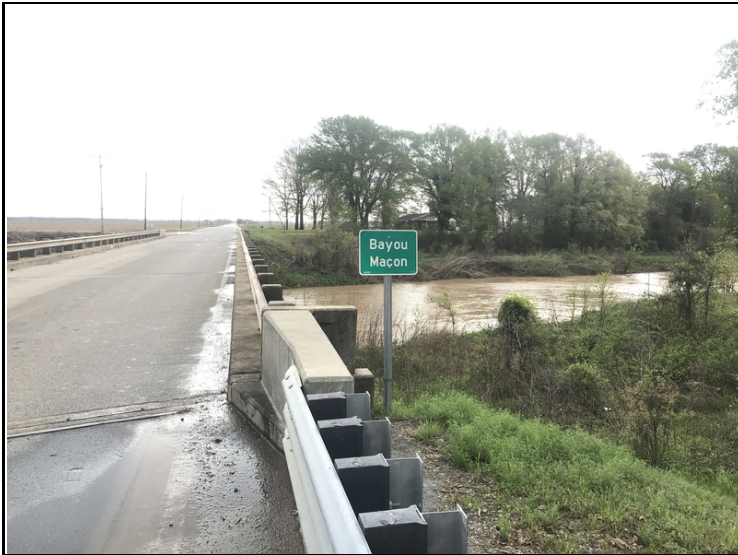
Signs - both sides/ends: No log mile signs, object markers, or posts.  
Signs should read "4-17  
5.34"

Sign - Bent 1 right: Log mile sign missing
