Asset #03592(Underwater type 2)

SH 4-17 LM 6.41 over Canal No. 43

Team Lead: Sharon Hooks, Inspection Date: 03/10/2022

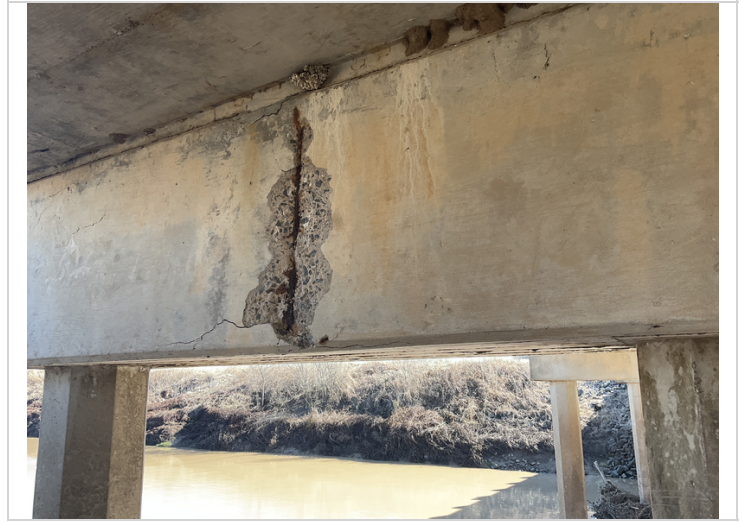
(234) Caps: 24' each \ Bents 2-5. Bent 2 has small spall with exposed rebar on back face between pile 1-2. Bent 2 very small spall with exposed rebar on bottom. Bent 5 cap between piles 1&2 cracking and delams on ahead face. Most spalls have been repaired by State Forces.							
301	Pourable Joint Seal	LF	96	0	0	96	0
2350	Debris Impaction	LF	96	0	0	96	0

Bent 2 back has spall with exposed rebar and cracking.

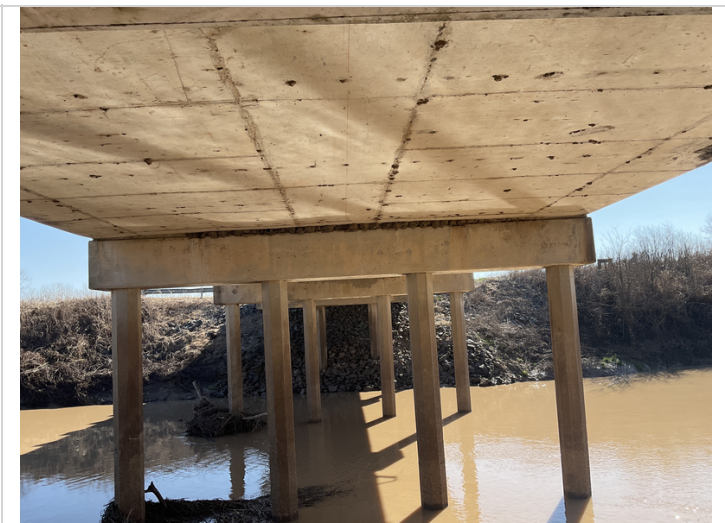
Overview of soffit.

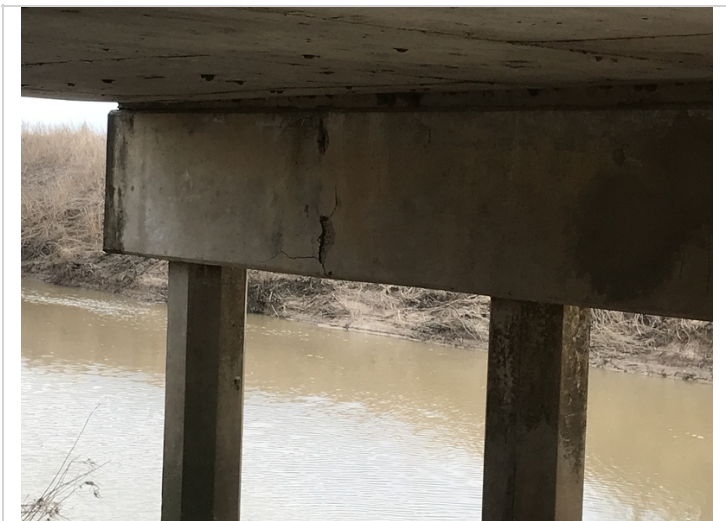
Bent 2 cap left behind cracking with delams.

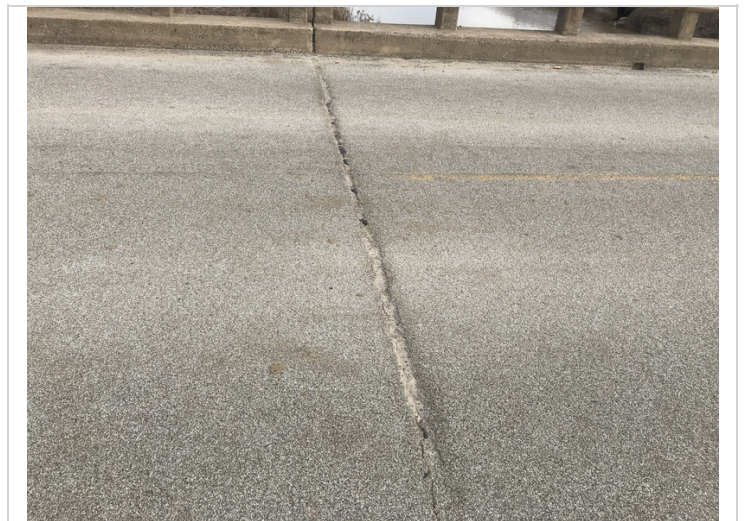
(301) Pourable Joint Seals : 24' each bents 2-4. All joint seals have debris impaction due to epoxy overlay of deck.							
330	Metal Bridge Railing	LF	270	270	0	0	0
515	Steel Protective Coating	SF	675	0	0	675	0
3410	Chalking (Steel Protective Coatings)	LF	675	0	0	675	0

Bent 2 joint seal has debris impactation due to epoxy overlay.

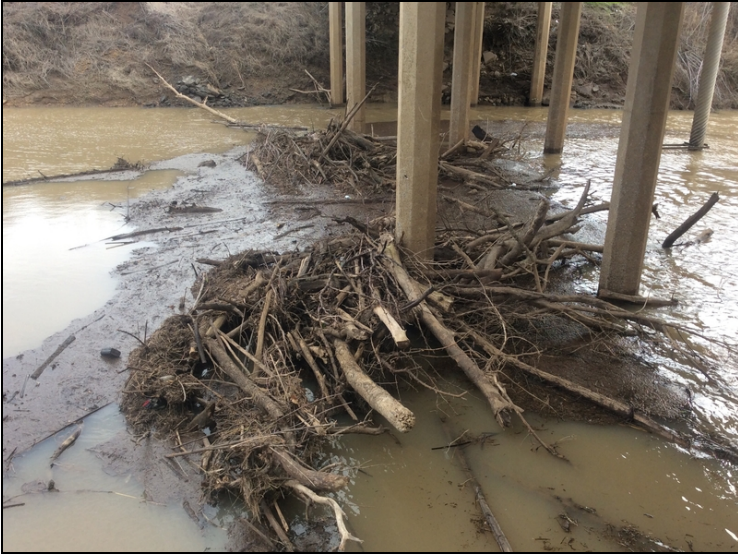
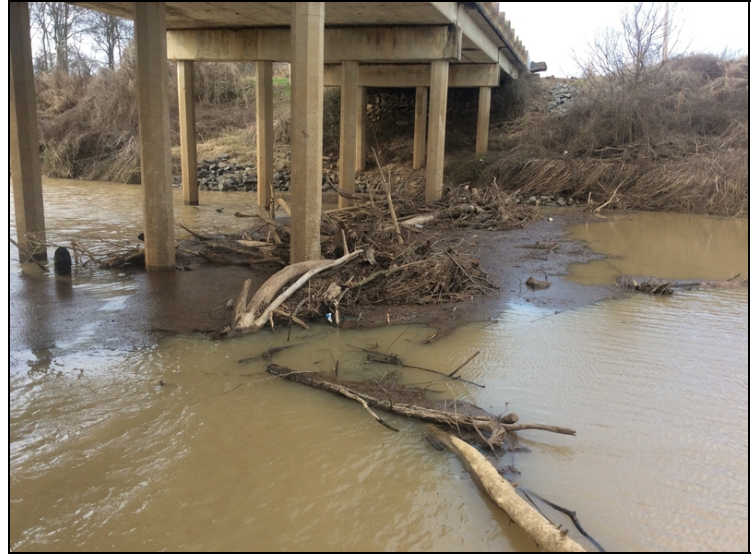
Channel - Bents 3-4 left : Minor build-up of small logs, limbs, and other debris against piling.
Note debris was removed by State Forces 2019 but debris is present this inspection 2021 SDH

Channel - Bents 3-4 left (debris build-up)

Cleaned by State Forces.

Desha: remove debris 2019

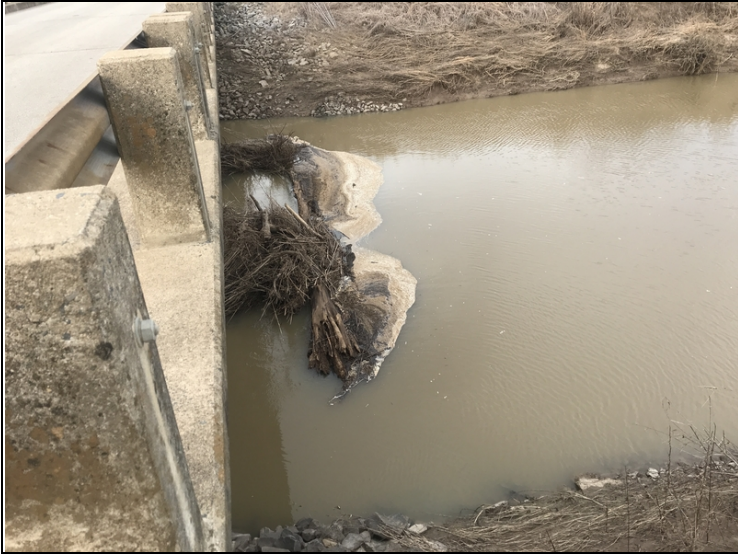
Drift and debris restricting water flow at bents 3&4.

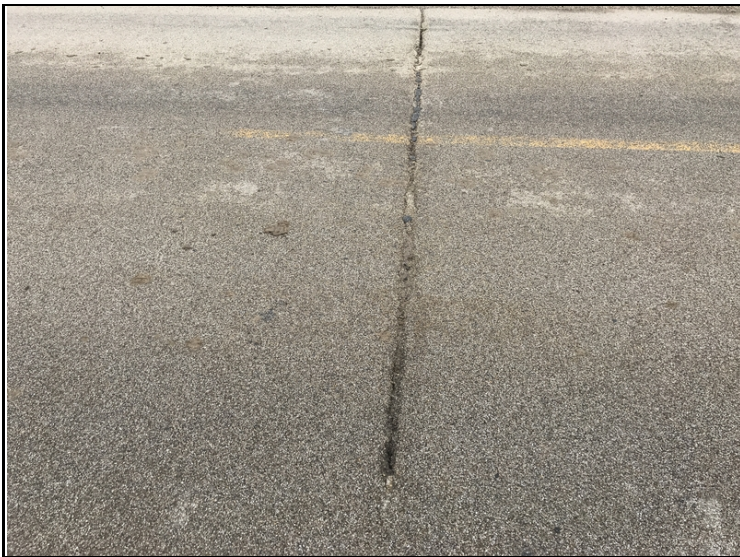
Pourable Joint Seals bents 2-5 have debris impaction from epoxy overlay of deck.

Pourable Joint Seals have debris impaction from epoxy overlay.
