Asset #03593(Routine, Underwater type 2)

SH 4-17 LM 7.44 over Boggy Bayou

Location: 7.44 Mi E US 65-McGehee

Team Lead: Sharon Hooks, Inspection Date: 03/09/2021

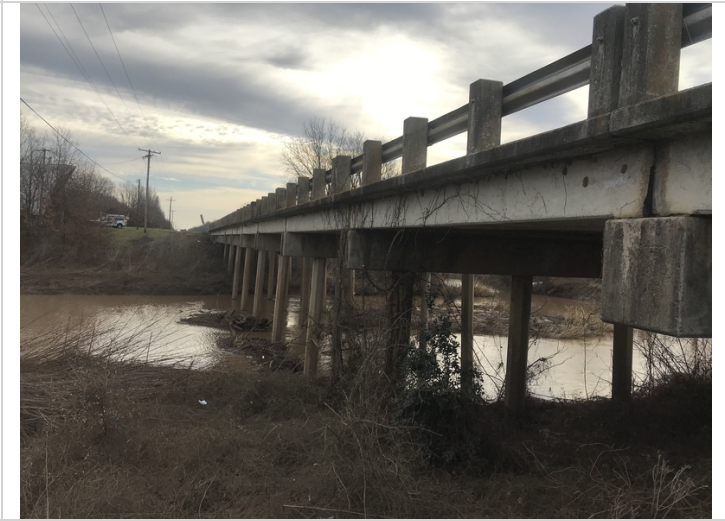
Elevation.

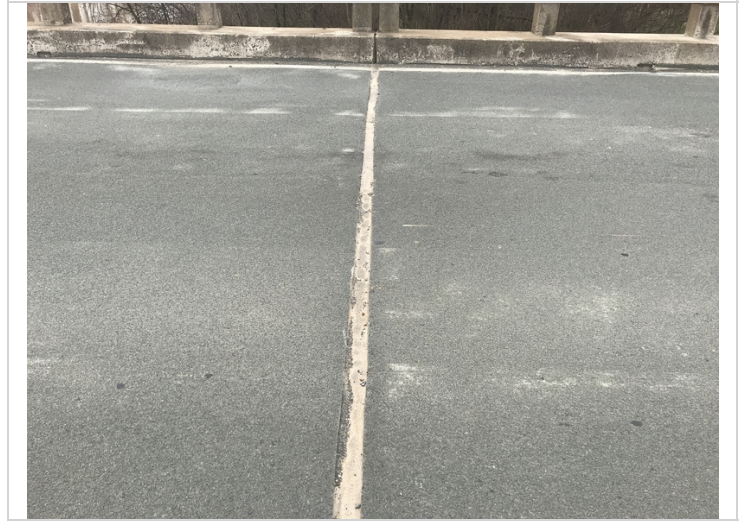
Bent 1 joint seals.

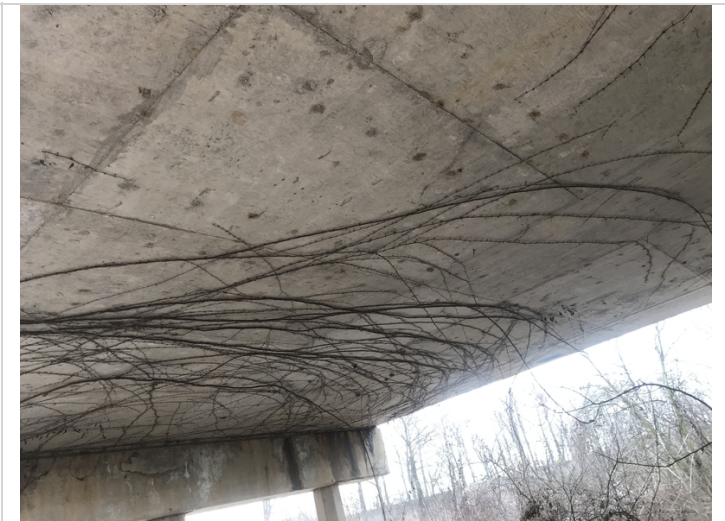
Under view of deck.

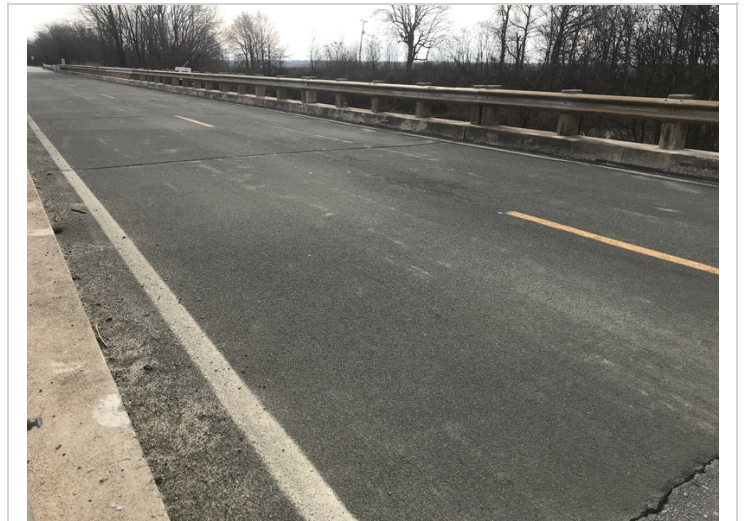
Deck over view.

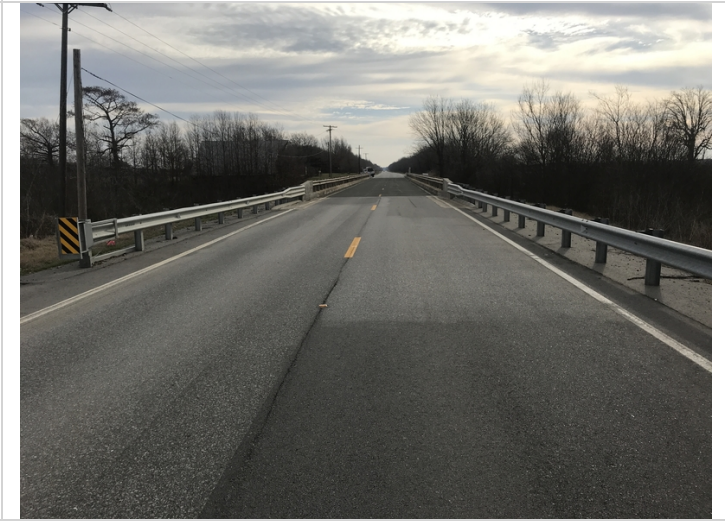
Approach.

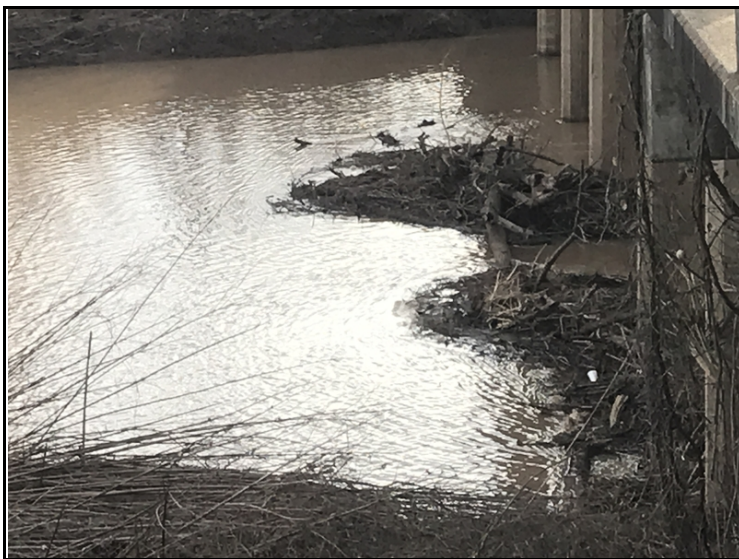
Channel - Bents 5, 6, & 7: Minor build-up of drift and debris against pile.

Drift and debris at bent 4-6 impeding waters flow.

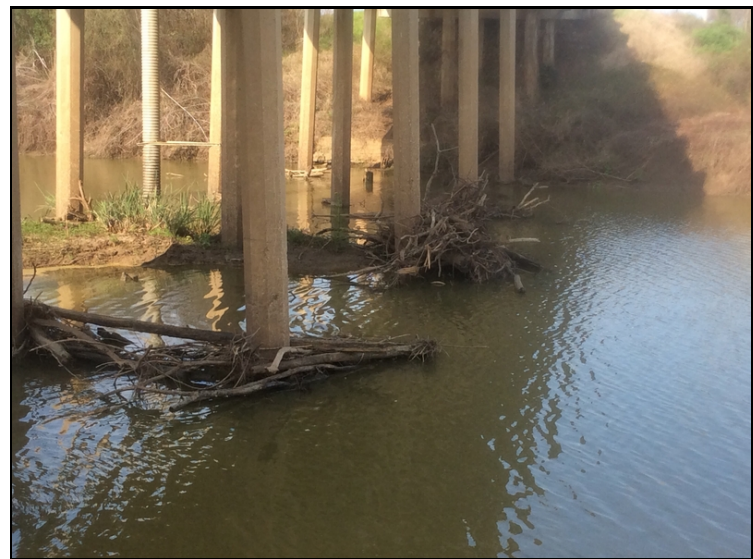
Channel - Bents 5-7: Debris build-up

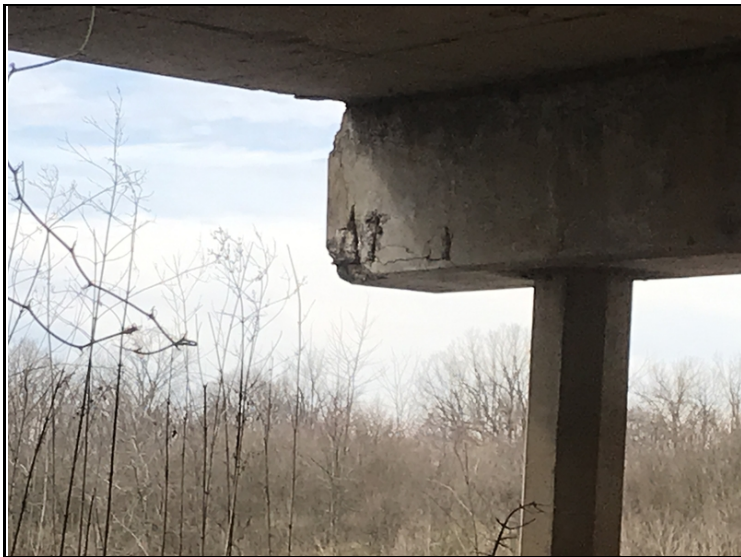
Caps - Bents 2, 3, 5, 8, 9, & 11: Scattered small, shallow delaminations and spalls with exposed rebar.

Bent 9 cap right ahead has spalls with exposed rebar.

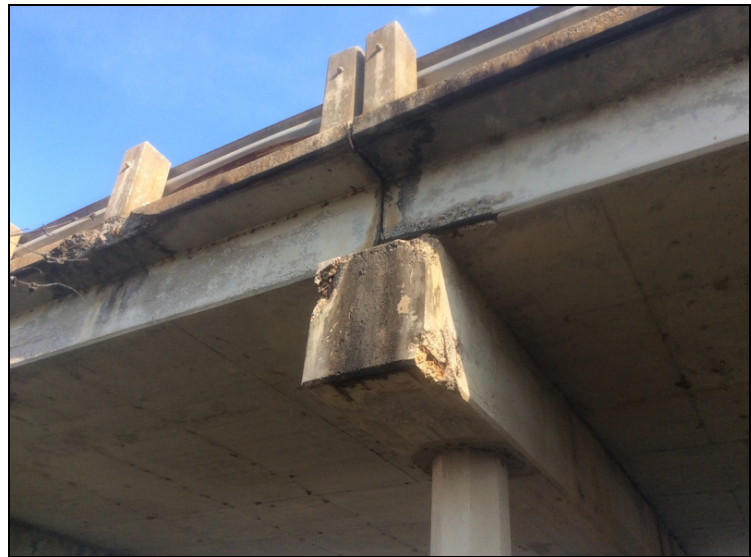
Cap - Bent 9 right end: Rebar exposed

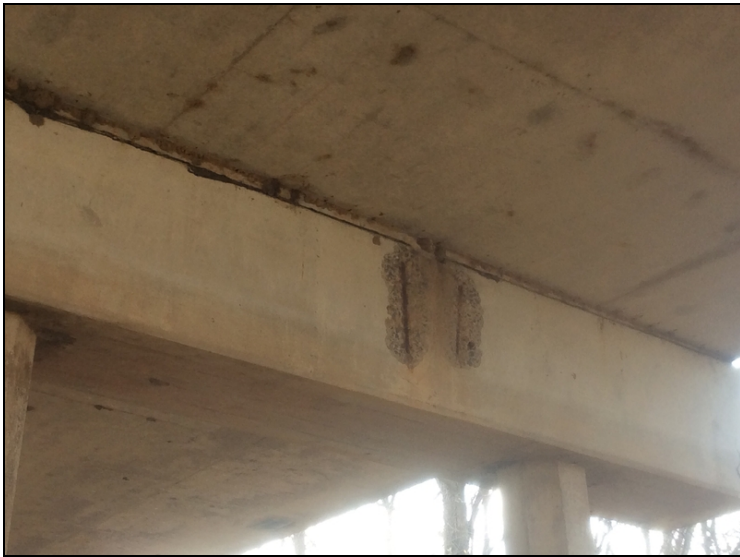
Caps - Bent 10 back: Rebar exposed

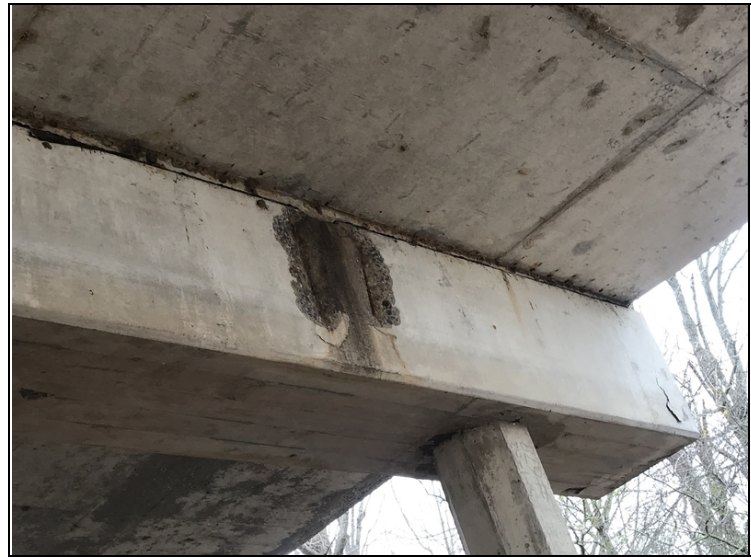
Bent 10 cap right has spall with exposed rebar.

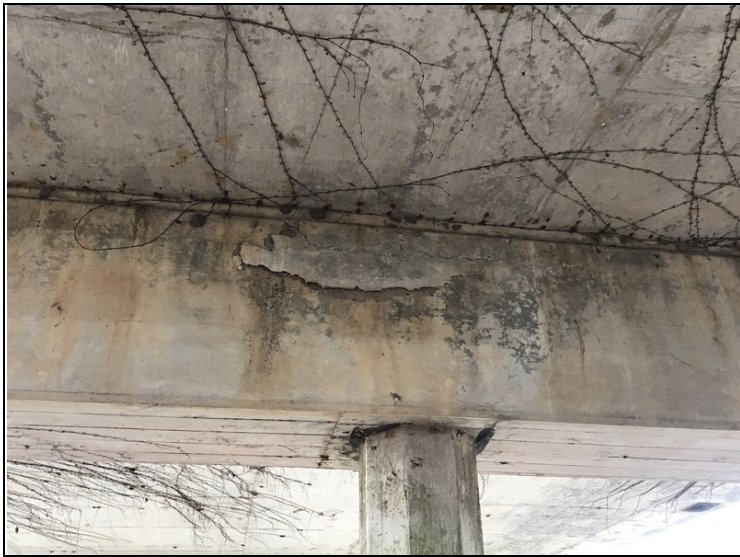
Bent 3 cap back has delams.

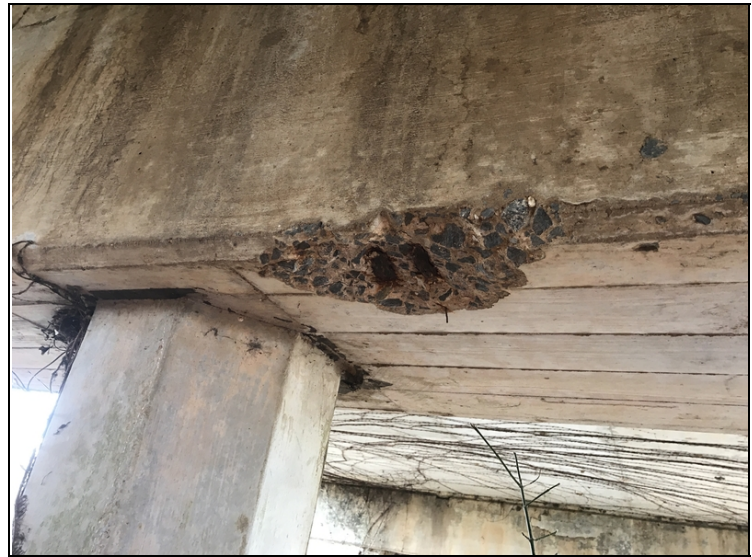
Spall with exposed rebar at bent 2 under cap near pile 2.

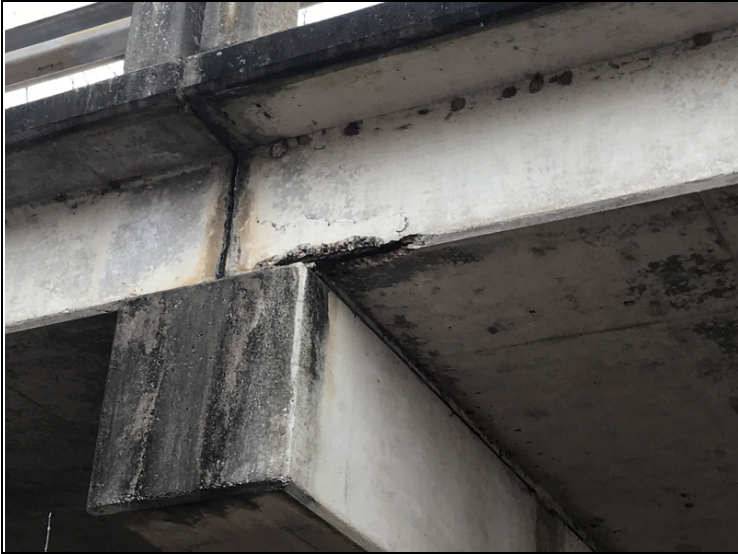
Span 9 at Bent 10 left behind under side of deck near cap has delam and spall with exposed rebar.

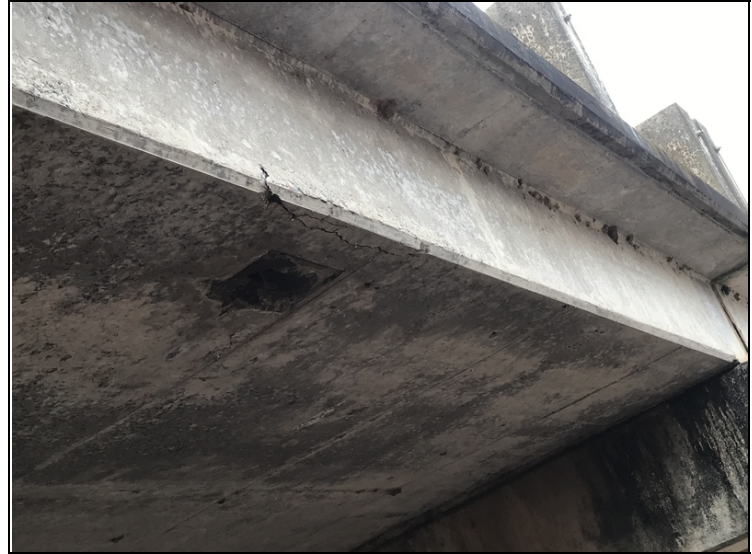
Span 10 under side of deck at soffit area at drain opening has cracking with delams.

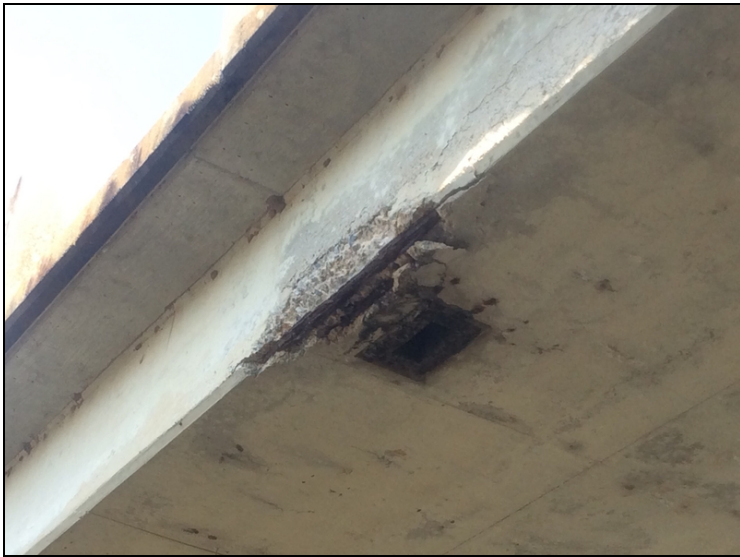
Soffit - Spans 7 & 8: Spalling with some rebar exposed on bottom corners of deck, mainly at drains and caps.

Soffit - Span 8 right: Rebar exposed

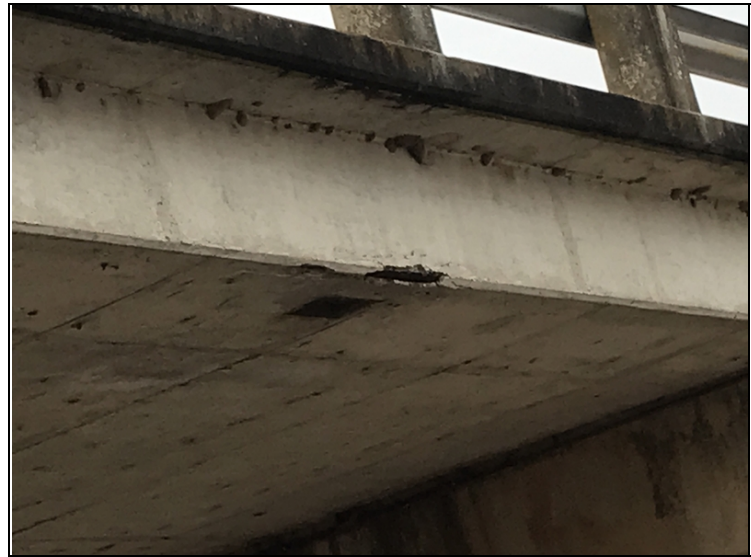
Span 7 left has spall with exposed rebar near drain opening on under side of deck.

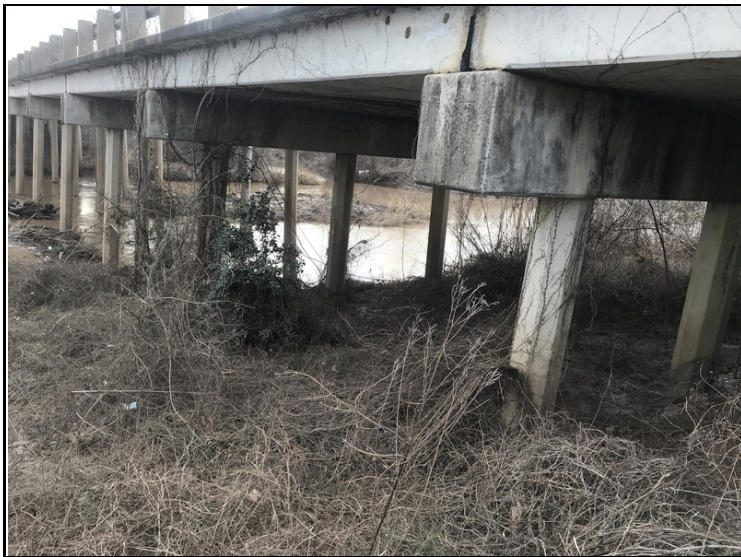
Trees vines and vegetation impeding inspection process.

Trees, vines and vegetation impeding inspections.
