**Asset #03594**(Routine, Underwater type 2)

**SH 4-17 LM 8.32 over Little Boggy Bayou**

**Location: 1.6 Mi W limits-Ark City**

**Team Lead: Greg Loomis, Inspection Date: 02/16/2022**

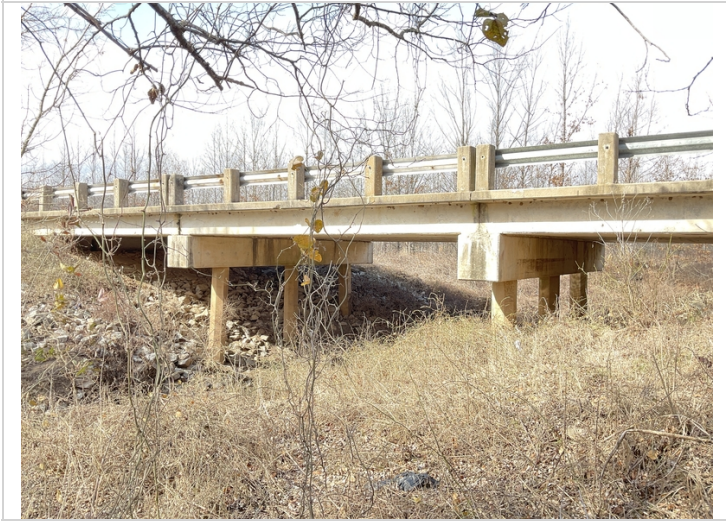
Right side view

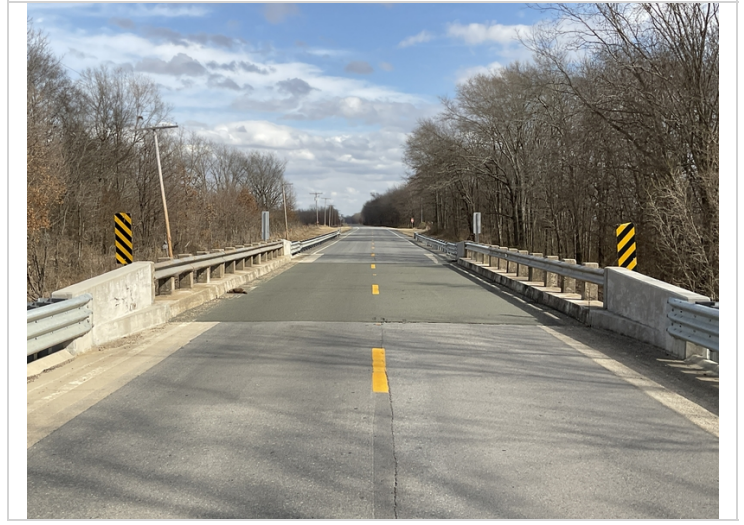
Roadway view

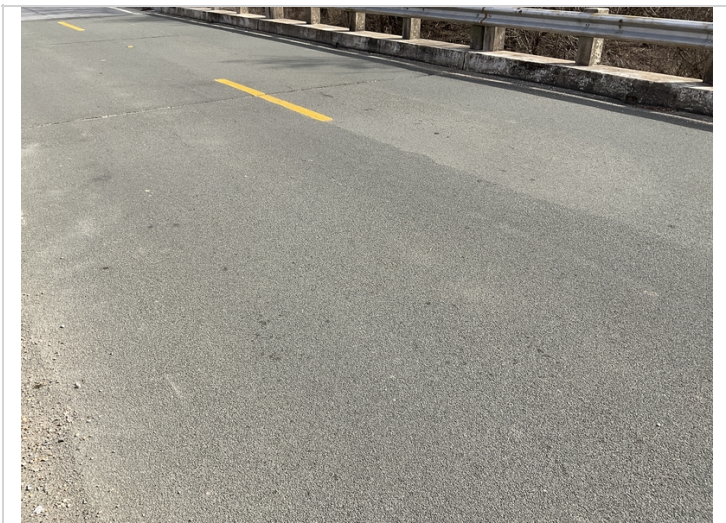
Deck - Spans 1-3: Typical

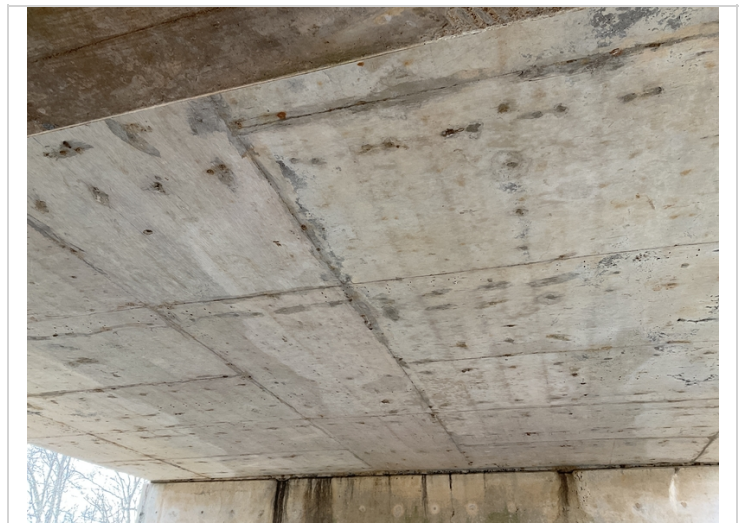
Soffit - Span 2: Typical

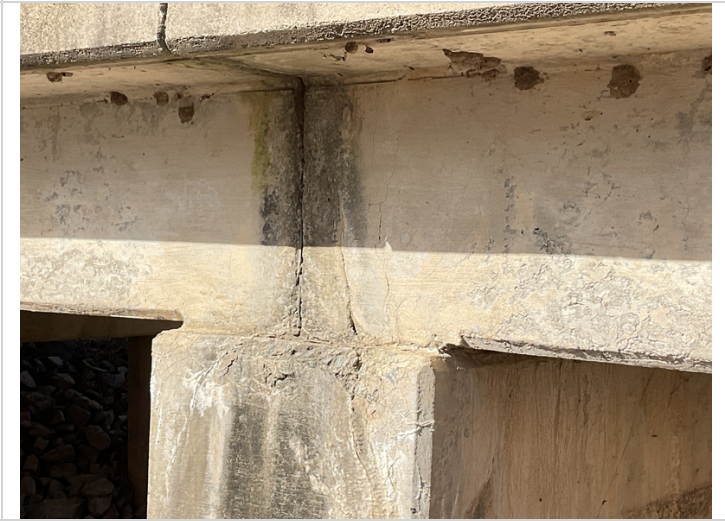
(38) Deck (sonovoid tubes in deck): 26' wide (1'-3" STEP-UP each side) x 75' long = 1950 sqft. Wearing surface (polymer overlay added prior to 2020 inspection): 24' wide x 75' long = 1800 sqft.  Sides of slab - Span 2 left & Span 3 left @ Bent 3: Vertical cracking over cap - 2 sqft CS2 cracking, Span 3 right @ Bent 3: Vertical cracking over cap - 1 sqft CS3 cracking.  Soffit: Some small cracks in various locations, especially along center-line.  *OLD NOTE (prior to polymer overlay): Wearing surface: Moderate-sized transverse cracks at bents and bridge ends (96 sqft). Some minor cracking in wheel ruts, mainly on Spans 2-3 (84 sqft).							
215	Reinforced Concrete Abutment	LF	66	66	0	0	0

Deck - side of slab - Span 3 right @ Bent 3: Cracking
