Asset #03799(Routine, Underwater type 2)

SH 4-17 LM 4.34 over Canal No. 18

Location: 4.34 Mi E US 65-McGehee

Team Lead: Sharon Hooks, Inspection Date: 03/09/2021

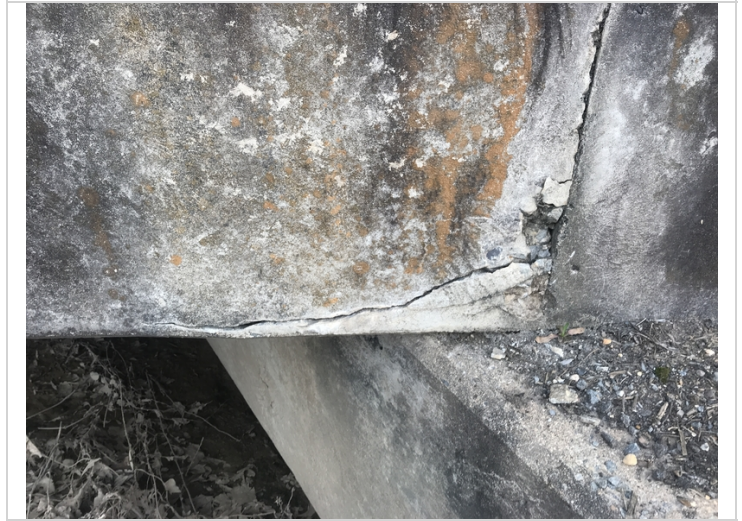
Span 6 near bent 7 girder 7 has cracking and delams.

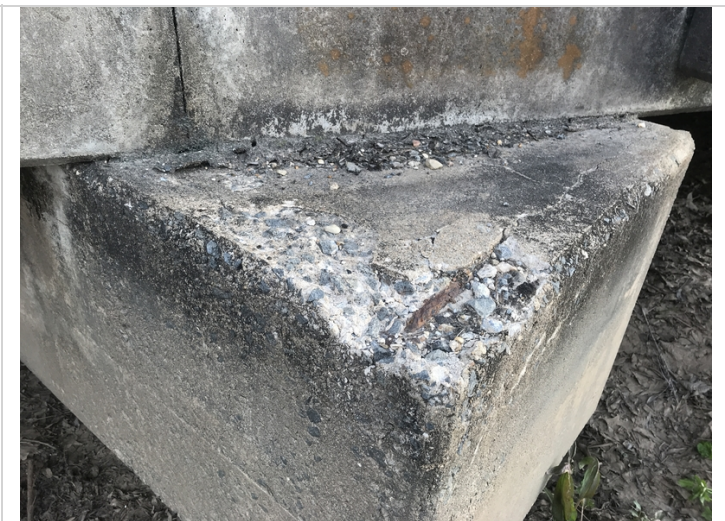
Cap at bent 6 has spall with exposed rebar.

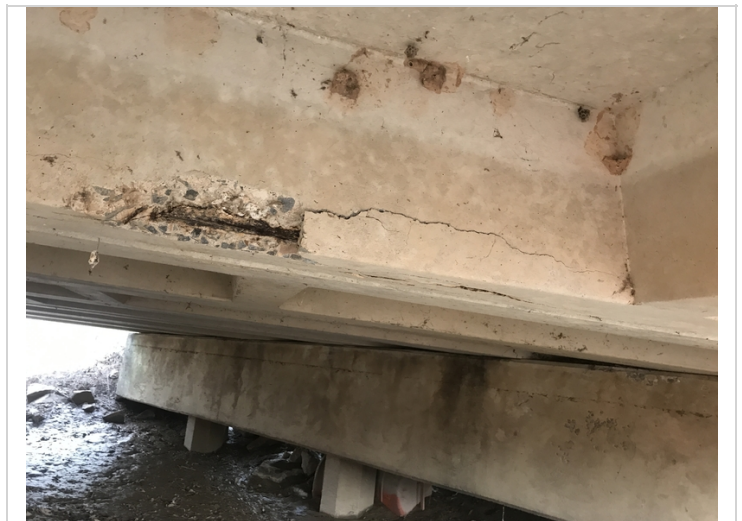
(110) Girders: 7 precast units per span \ 145' total span. Units are bolted transversely and longitudinally - no noted missing or loose bolts. Scattered hairline vertical cracks and very small spalls in channel legs. Span 3 unit 7 left leg has small spall at mid span. Span 6 Unit 7: Exposed Rebar 1'							
215	Reinforced Concrete Abutment	LF	72	71	1	0	0
6000	Scour	LF	1	0	1	0	0

Span6 unit 7 has spall with exposed rebar.

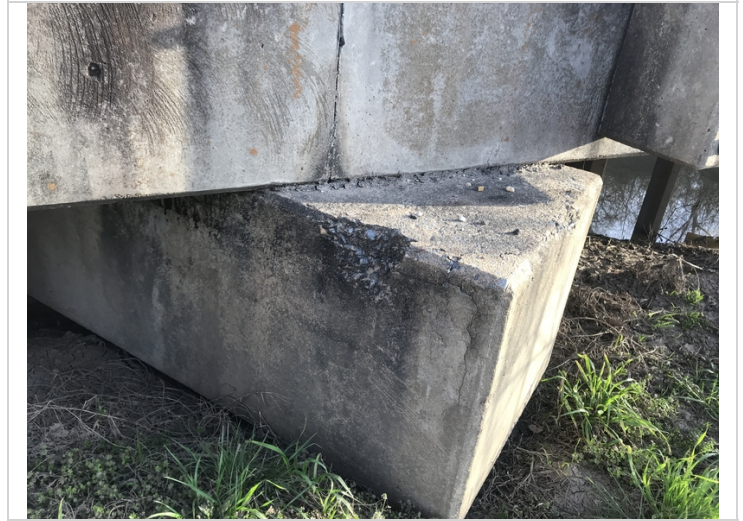
Bent 2 cap right has spall and delam.

Caps Bents 2,3,5 & 6 have small spalls and cracks.

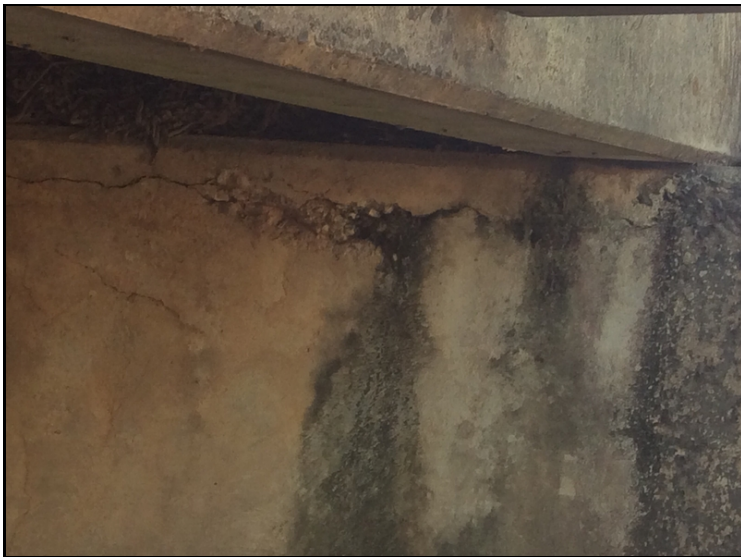
Bent 6 back cap has cracking with some exposed rebar
