Asset #M3278(Routine)

SH 54-10 LM 1.20 over Nevins Creek

Location: 1.20 Mi W US79-WatsonChpl

Team Lead: Greg Loomis, Inspection Date: 12/02/2021

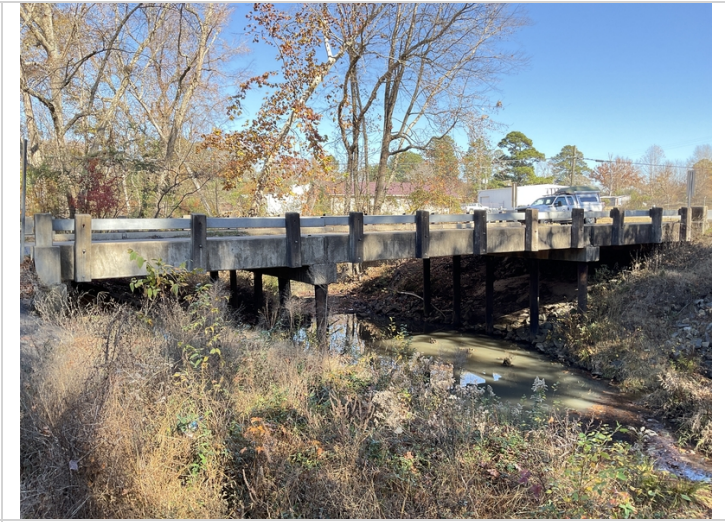
Left side view

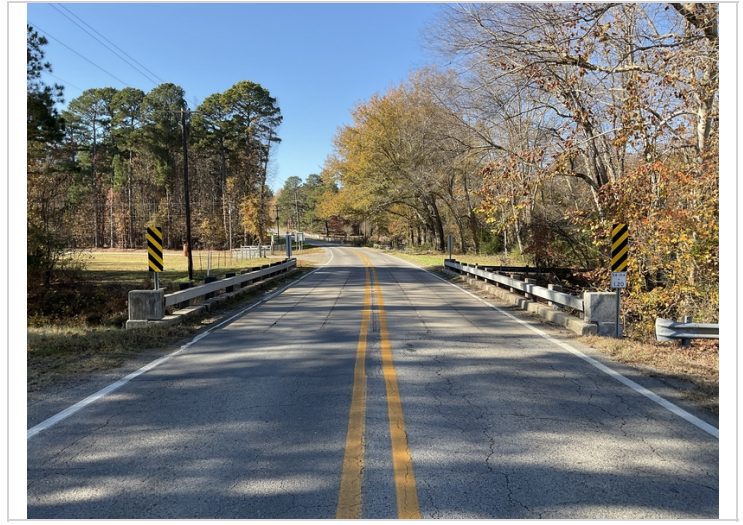
Roadway view

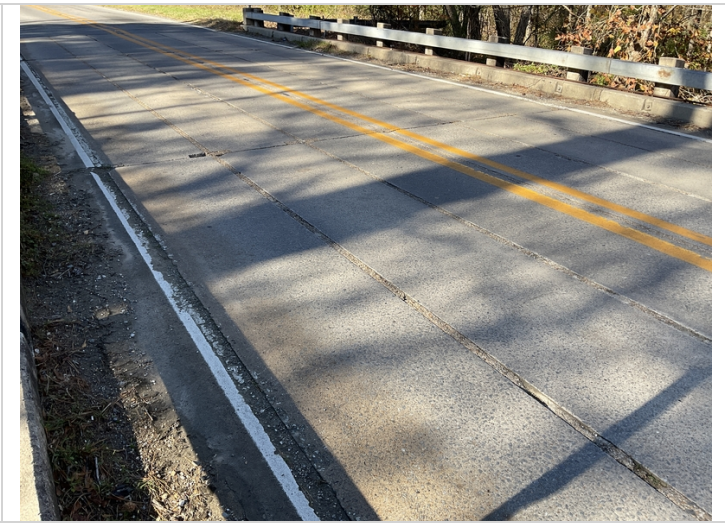
ELEMENTS	DESCRIPTION	UNITS	TOTAL	CS1	CS2	CS3	CS4
16	Reinforced Concrete Top Flange	SF	1943	1875	68	0	0
1130	Cracking (RC and Other)	SF	68	0	68	0	0
<p>(16) Deck: 28'-2" wide x 69' long = 1943 sqft.</p> <p>Joints are grouted and grout is in good condition - grout has come out of a few key-ways along bents.</p> <p>Some scattered minor- to moderate-sized cracks on decks of a few units.</p>

Deck - Spans 1-3: Typical

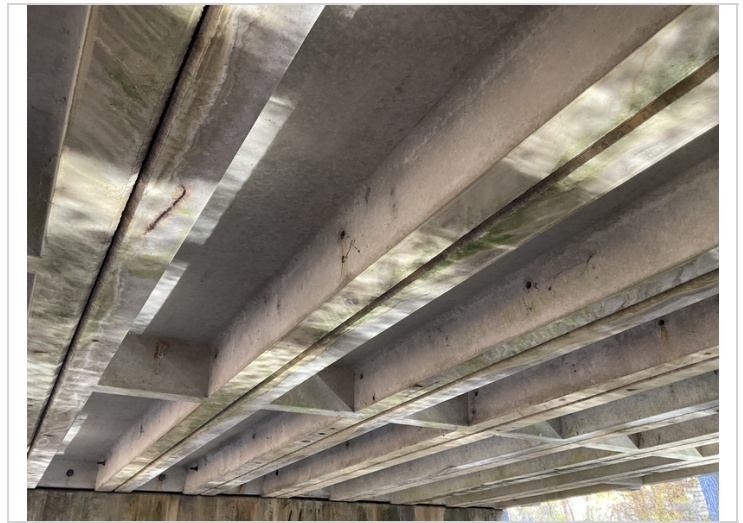
Soffit - Span 2: Typical

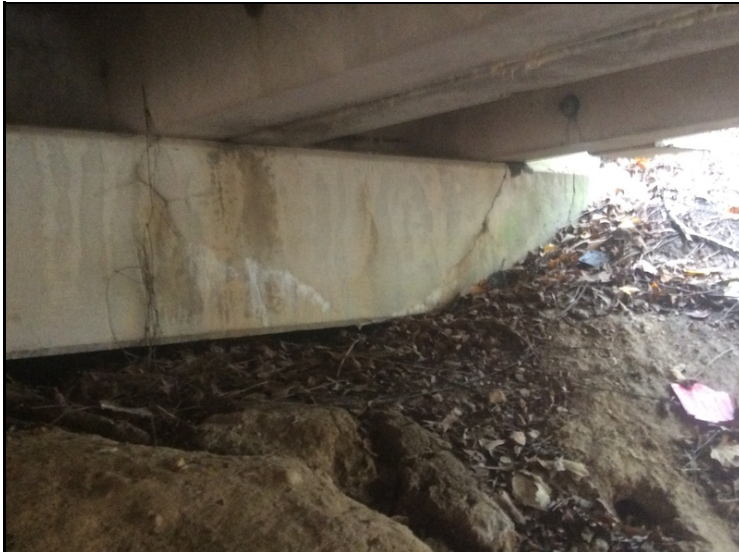
(234) Caps: 28' each / Bents 1-4. Bent 1: Two vertical cracks Bent 2: Spall with exposed rebar - 4'. Bent 3: Spall to right corner and small contact spalls under channel legs. Bent 4: Small spalls, delaminations, and large cracks with efflorescence.

Caps -  
Bent 2: Spall with exposed rebar.  
Bent 3: Spall to right corner and small contact spalls under channel legs.  
Bent 4: Small spalls, delaminations, and large cracks with efflorescence.

Bent 4 abutment right has cracking with efflorescence and delambs

**Date Reported:** 11/07/2017  
**Priority:** D- Routine  
**Type of Work:** Repair (General)  
**Status:** Monitor  
**Component:** Element

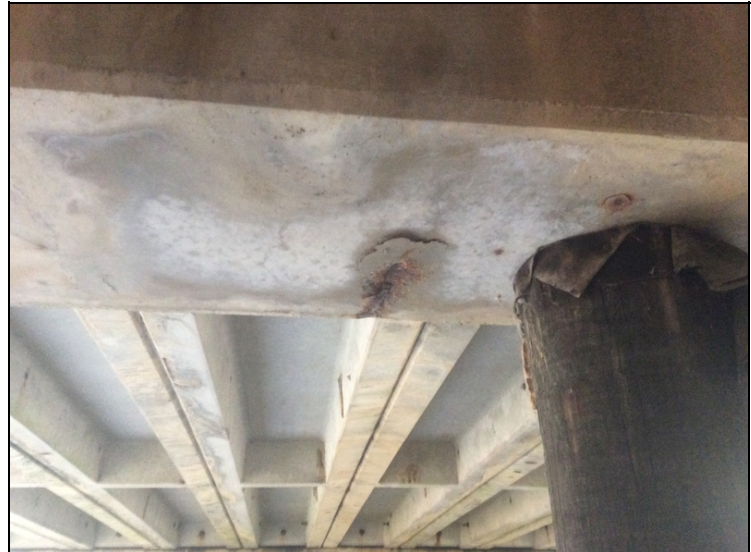
Bent 2 cap near pile 3 has spall with exposed rebar .

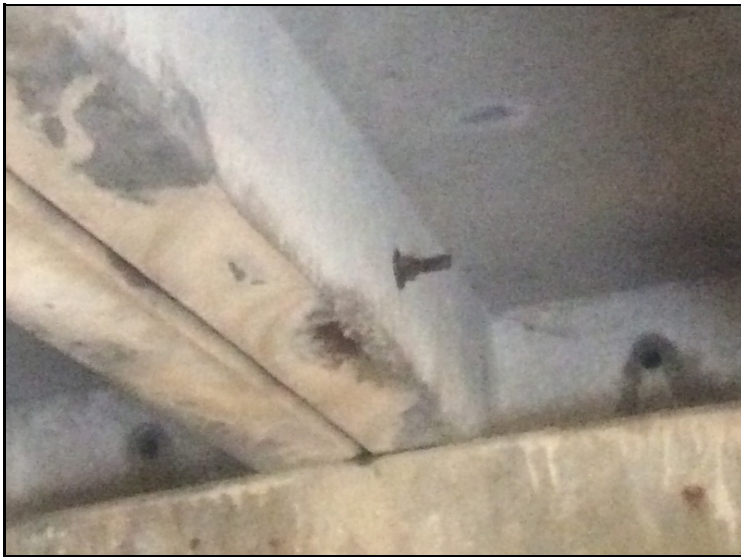
ELEMENTS	DESCRIPTION	UNITS	TOTAL	CS1	CS2	CS3	CS4
110	Reinforced Concrete Open Girder/Beam	LF	552	515	27	10	0
1080	Delamination/Spall/Patched Area	LF	27	0	27	0	0
1090	Exposed Rebar	LF	10	0	0	10	0
<p>(110) Girders: 8 precast units per span / Spans 1-3 (19' - 31' - 19' = 69' total span).            Units are bolted transversely and longitudinally - no noted missing or loose bolts.            NOTE: State forces have removed delaminated concrete, cleaned steel, and applied concrete patches to legs of units in various locations. (Repaired areas = 25' in State 2.)</p> <p>Spalling along bottom of legs (some rebar exposed) at locations indicated:            Span 1 Girders 3,4 &amp; 5: Spalling with exposed rebar - 5' total.</p>

Girders - Span 1 Units 1, 4, 5, 6, & 7: Scattered spalling with exposed rebar (minor corrosion/section loss) on bottom of legs of units

Spall with exposed rebar at span 1 girder 4 left leg  
but common on right leg also.

**Date Reported:** 11/07/2017  
**Priority:** (Inactive) (Inactive) G - General/ Preventive maintenance  
**Type of Work:** Repair (General)  
**Status:** Monitor  
**Component:** Element
