Asset #03384(Routine, Underwater type 2)

SH 1-04 LM 1.57 over Prices Branch

Location: 1.57 Mi NE US 165-DeWitt

Team Lead: Greg Loomis, Inspection Date: 07/21/2021

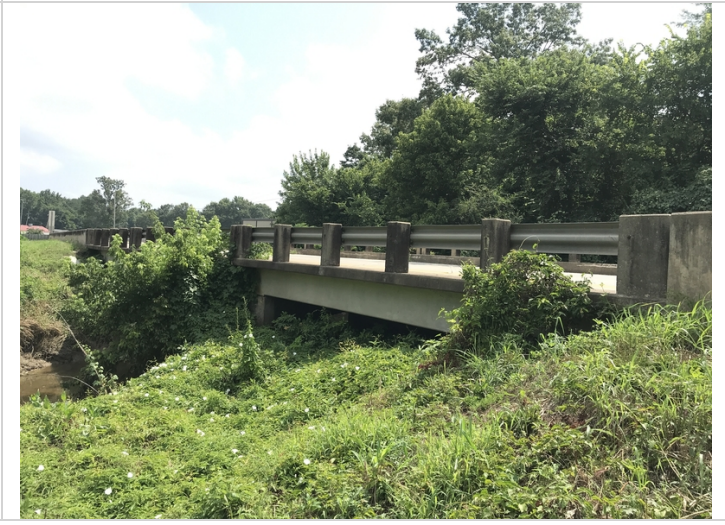
Left side view

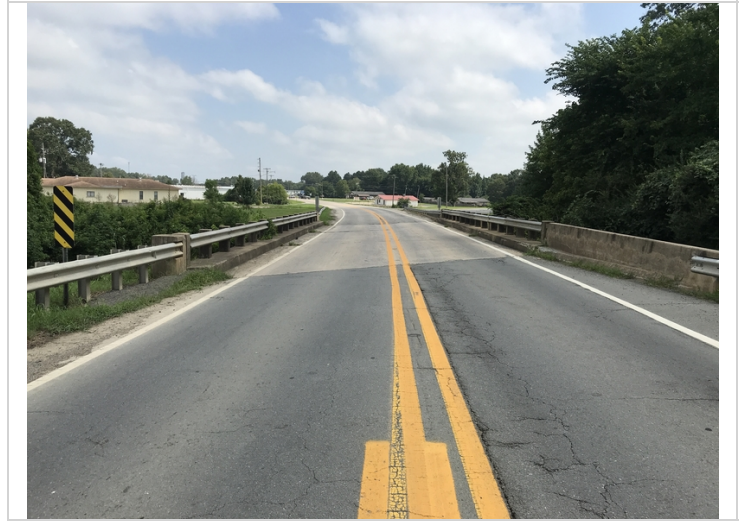
Roadway view

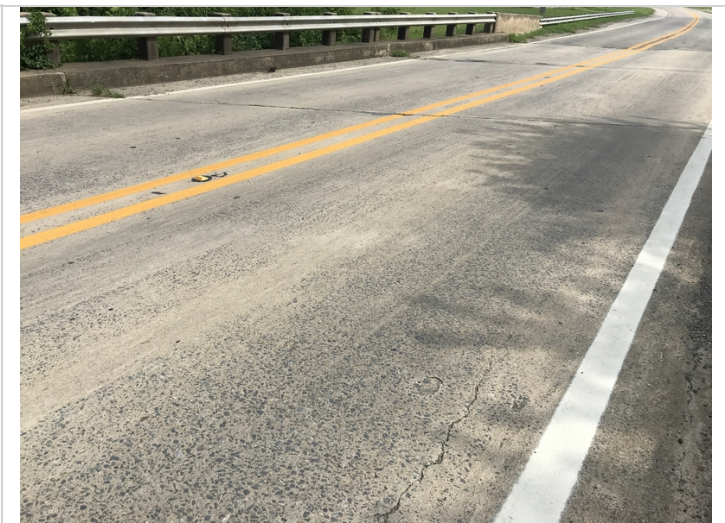
Deck - Spans 1-3: Typical

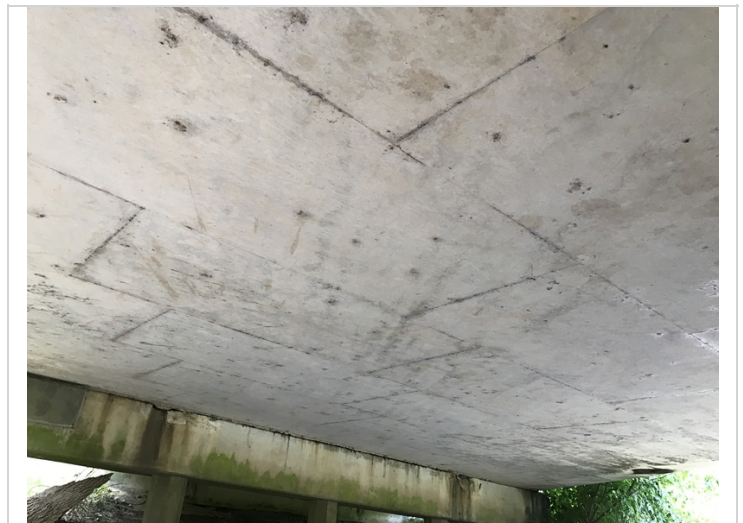
Soffit - Span 2: Typical

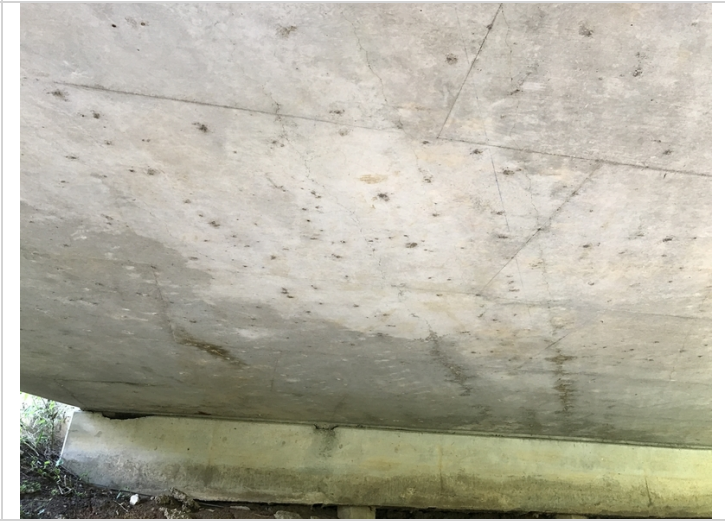
Soffit - Span 3: Cracking/rust-staining

Span 3 left: Several moderate-sized longitudinal cracks with rust staining.  
Some cracking around drains on left side.

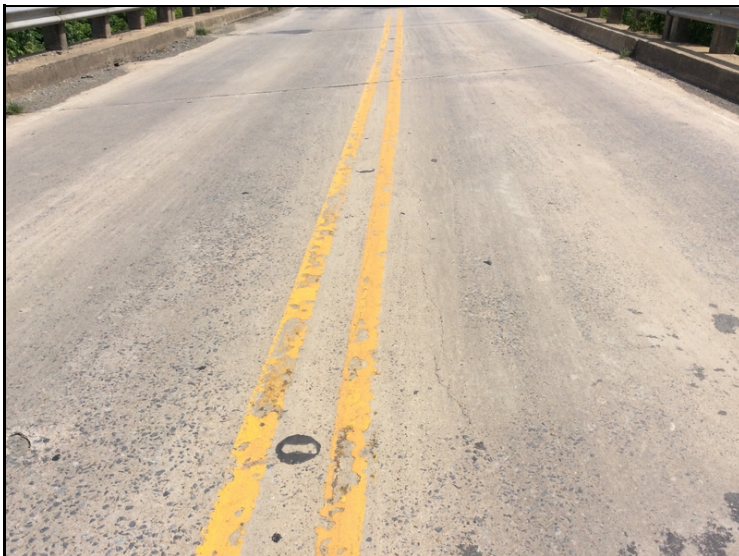
Deck - Span 1

Deck - all spans: Unsealed, minor- to large-sized longitudinal and diagonal cracks in various locations throughout deck.

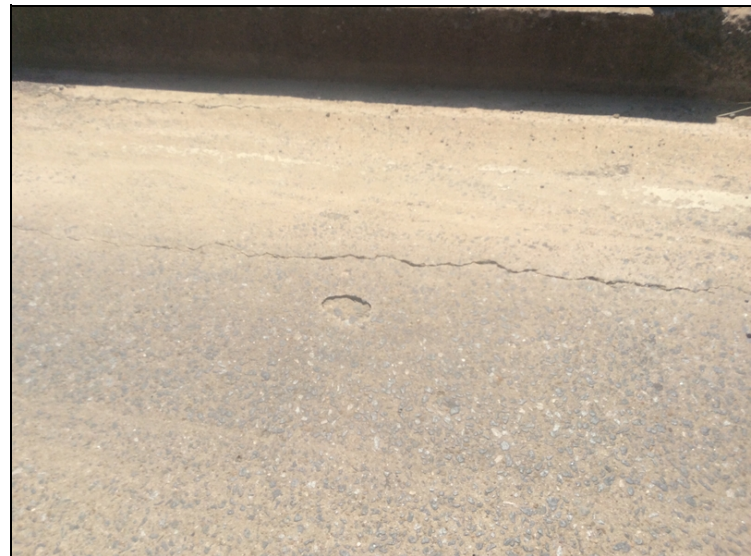
Span 1 near bent 1 right side has large unsealed longitudinal crack.

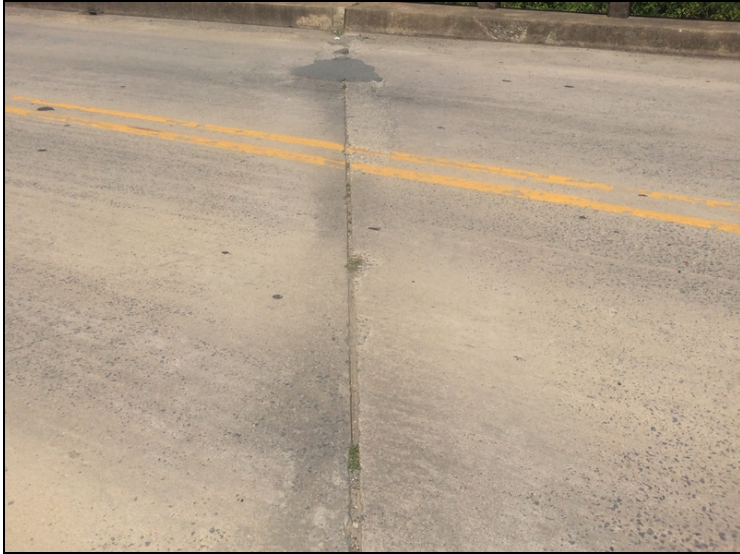
Joints – Bents 2 & 3: Poured joint material missing from joints. Joints filled with dirt and debris.

Bent 3 joint seal filled with dirt and debris. Common all bents.

Clean joints out, and re-pour material into joints

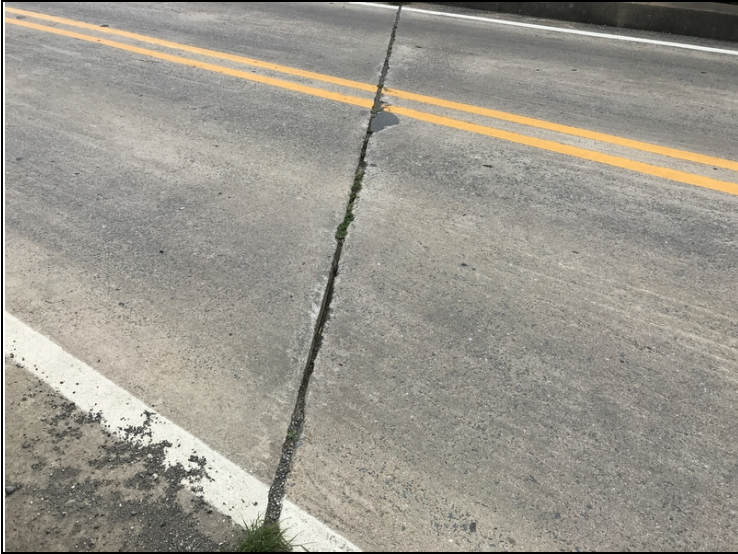
Joint - Bent 2: Material missing/debris filled

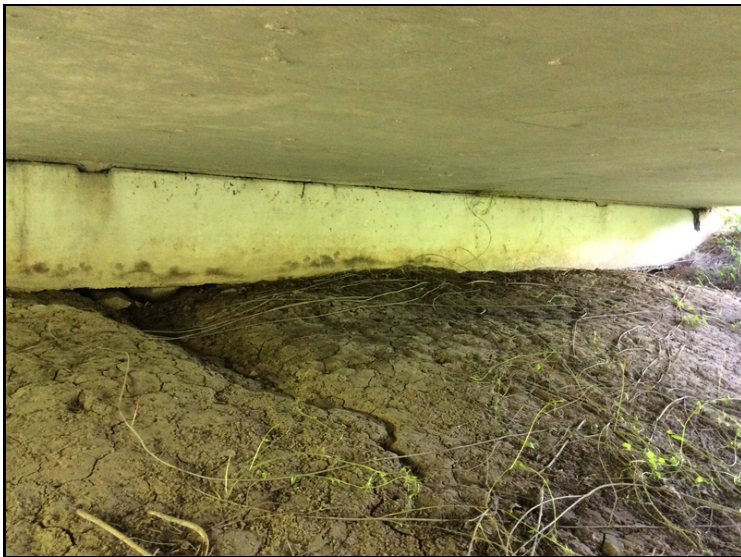
End slope -Bent 1

End slope – Bent 1: Small areas of erosion beginning near keyways, especially on right side.

No action at this time. Continue to monitor and advise if erosion worsens.

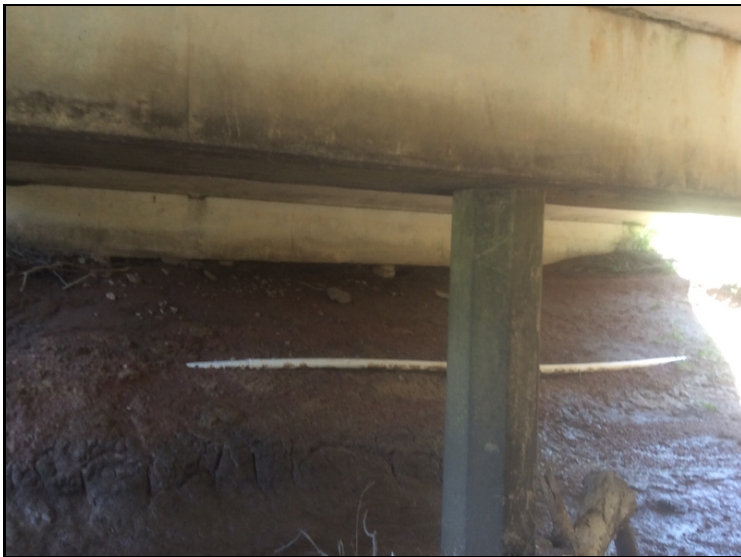
End-slope - Span 3: Moderate erosion exposing bottom of cap with some undermining and exposing utilities line(water).

End Slope erosion area under bottom of cap on bent 4 .

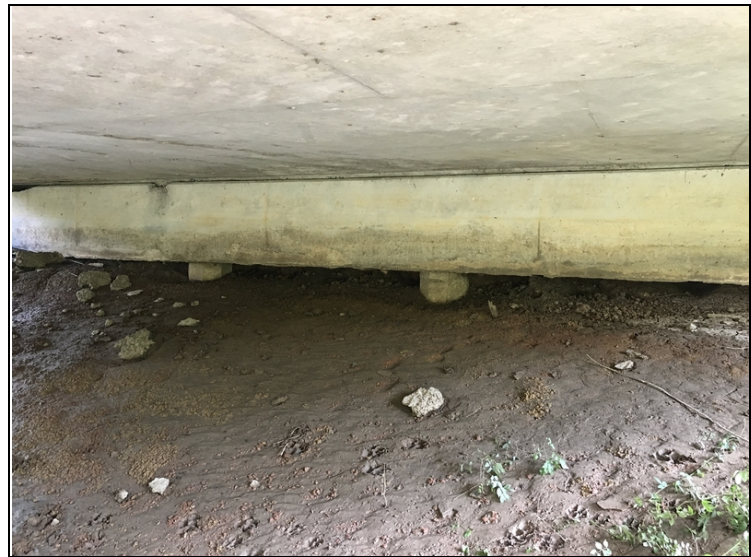
End-slope - Bent 4: Settlement/piling exposed

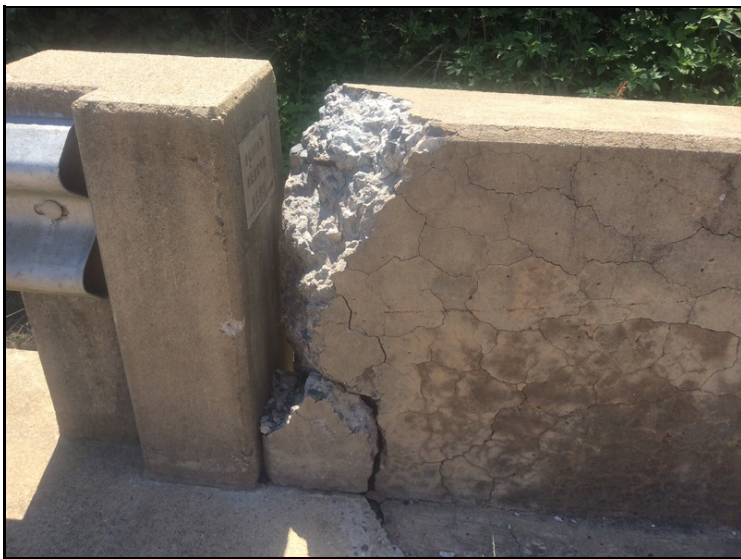
Railing - Bents 1 & 4 left & right (all 4 corners): Concrete transition post/railing is deteriorating with spalling/scaling of the surface of the post.

Southeast corner of bridge , guard rail end post has spalls with chloride contamination.

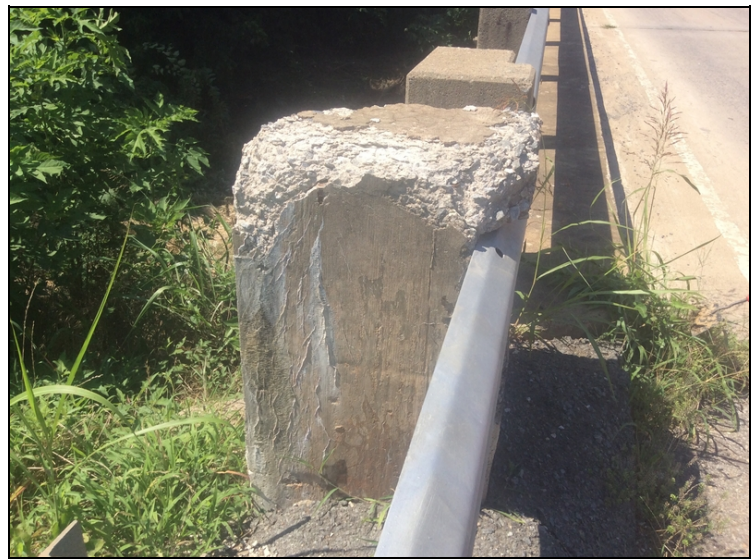
Southeast corner of bridge, guard rail end post has spalling with heavy chloride contamination..

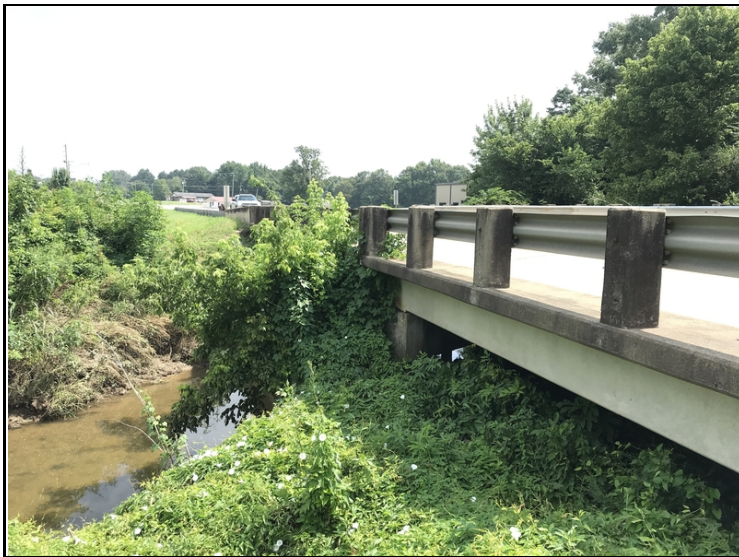
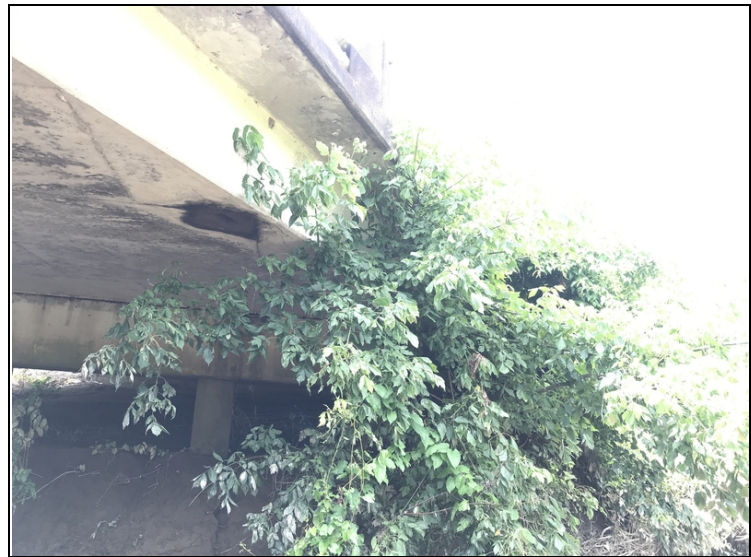
Channel - Bent 2: Small tree/bush and other vegetation growing up along side and under bridge.

Channel - Bent 2 left: Vegetation

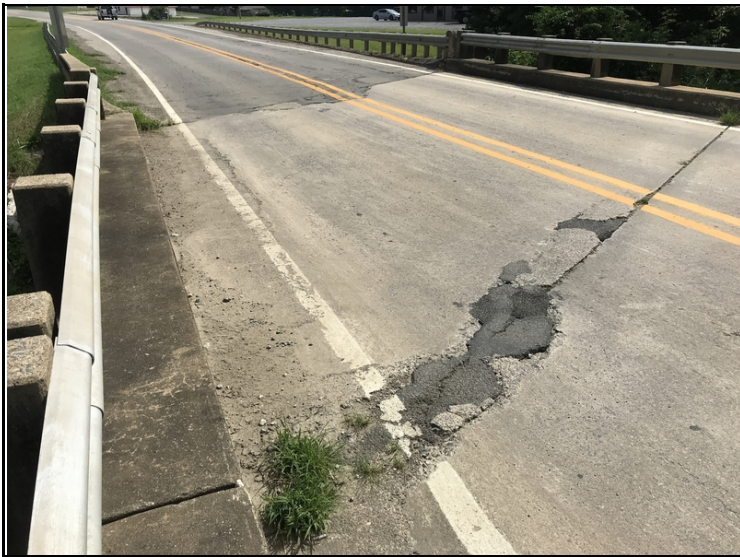
Deck - Bents 3 & 4 left sides: Some significant spalling along joints (most of spalls have been filled/patched with asphalt material).

Deck @ Bents 3-4: Spalling/patches
