Asset #02962(Routine)

SH 8-15 LM 4.67 over Fleshman Bayou

Location: 4.68 Mi E US 165-Parkdale

Team Lead: Sharon Hooks, Inspection Date: 10/03/2022

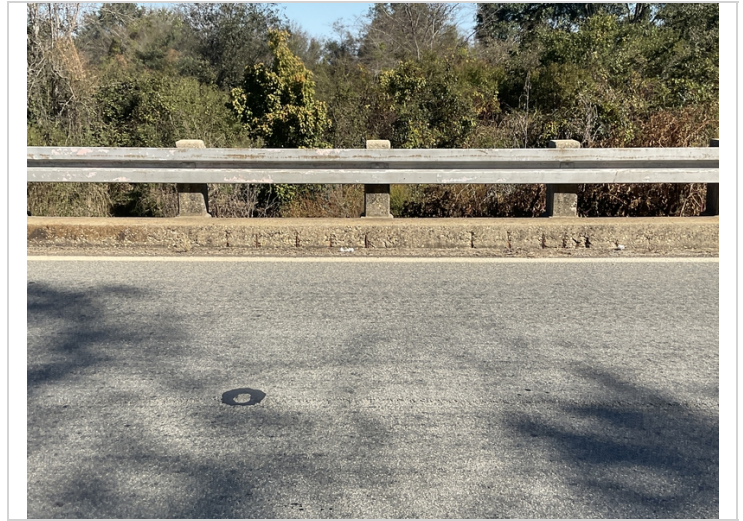
| ELEMENTS | DESCRIPTION | UNITS | TOTAL | CS1 | CS2 | CS3 | CS4 |
|---|---|---|---|---|---|---|---|
| Curbs: Rebar exposed on face of curbs in various locations. | | | | | | | |

Span 5 right concrete curb has exposed rebar.

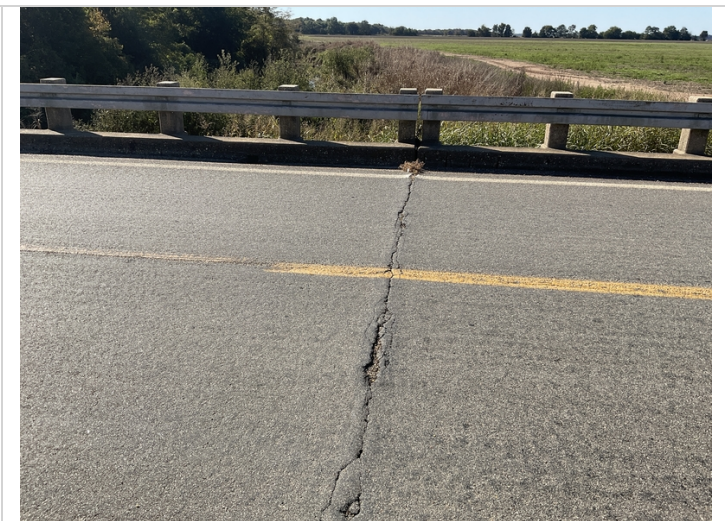
| ELEMENTS | DESCRIPTION | UNITS | TOTAL | CS1 | CS2 | CS3 | CS4 |
|---|---|---|---|---|---|---|---|
| (301) Joints: 24" each / Bents 2-5.<br>All joint seals are CS3 impacted due to asphalt overlay. | | | | | | | |

Bent 2 joint seal has debris impactation due to asphalt overlay.  
Common on all joint seals.

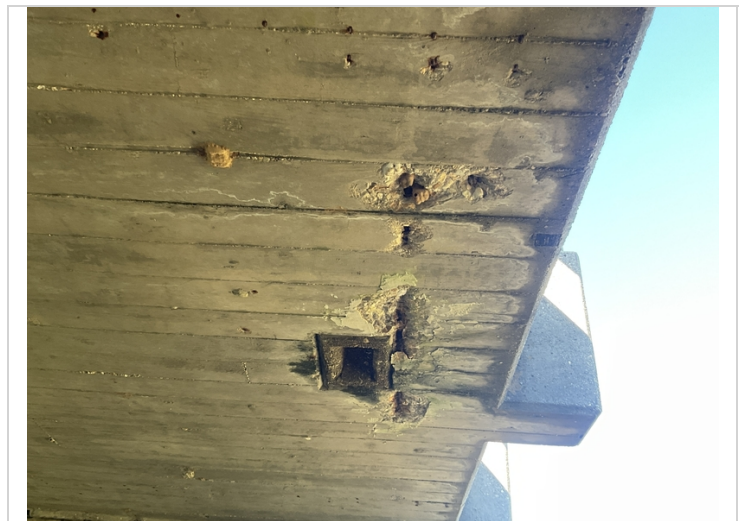
| ELEMENTS | DESCRIPTION | UNITS | TOTAL | CS1 | CS2 | CS3 | CS4 |
|---|---|---|---|---|---|---|---|
| Soffit:<br>Some very small cracks near center-line.<br>Areas around drains have been rubbed or patched in the past - some small spalls with exposed rebar at drain openings on left side. | | | | | | | |

Bent 2 left soffit at drain opening has minor spalling with  
exposed rebar.

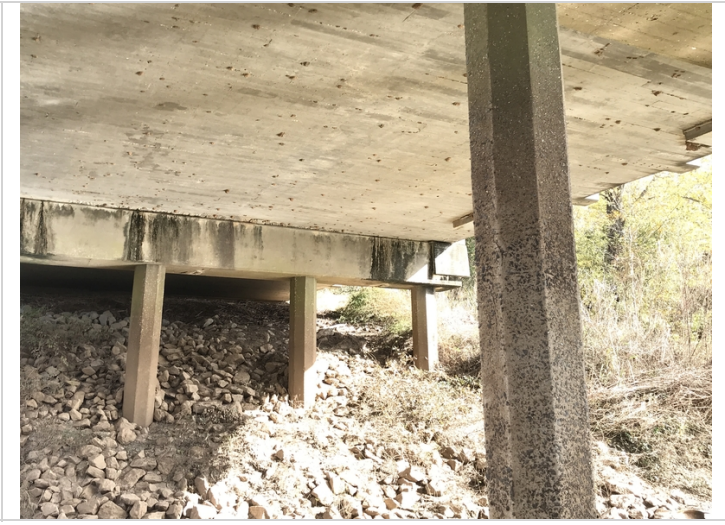
| ELEMENTS | DESCRIPTION | UNITS | TOTAL | CS1 | CS2 | CS3 | CS4 |
|---|---|---|---|---|---|---|---|
| Bent 4 Pile 2 left: Vertical crack 8-10' down from cap. | | | | | | | |

Bent 4 Pile 2: Cracking

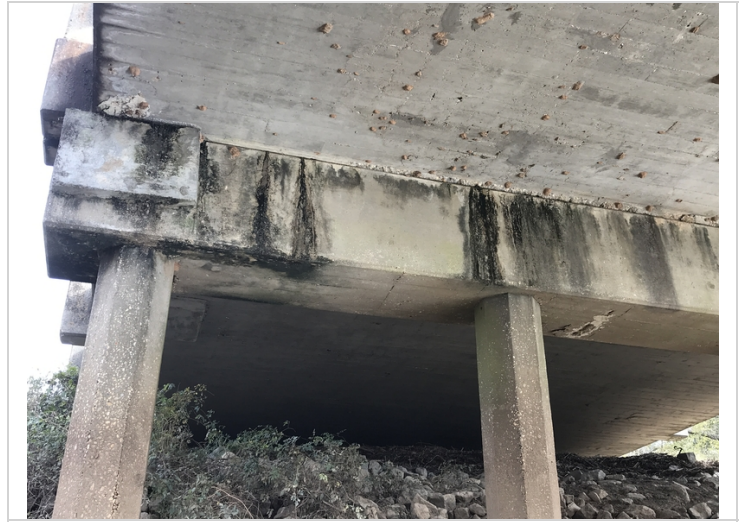
| ELEMENTS | DESCRIPTION | UNITS | TOTAL | CS1 | CS2 | CS3 | CS4 |
|---|---|---|---|---|---|---|---|
| Bents 4-5: Spalling with some rebar exposed - 5'. | | | | | | | |
| Bents 2, 4, & 5: Spalling with rebar exposed has been patched/repared by state forces - 13'. | | | | | | | |

Cap - Bent 5 back: Patched/rebar exposed

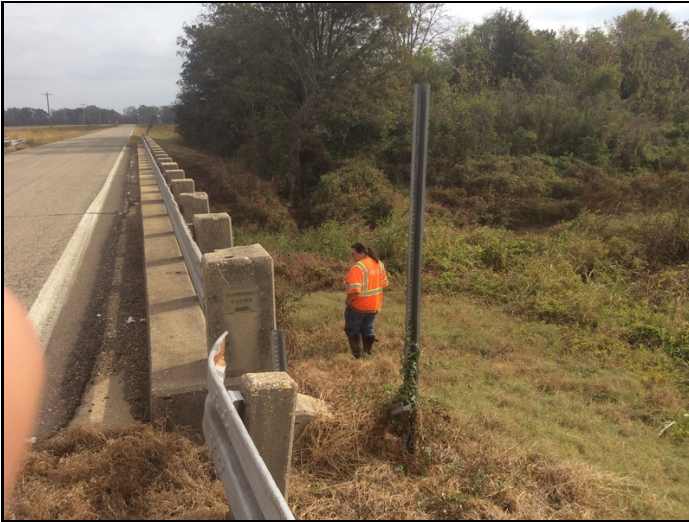
Log mile signs - both ends: Log mile signs, object markers, and posts are missing/knocked down.

Object marker and logged mile signs missing on both ends of bridge

**Type of Work:** Replace (General)

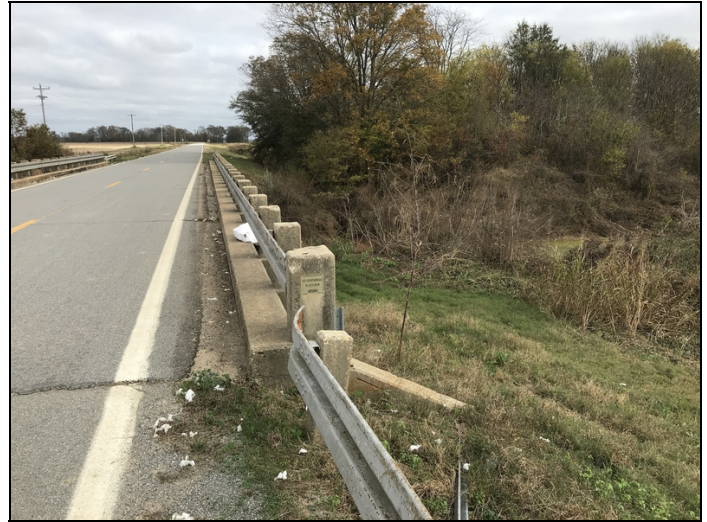
Log mile sign - Bent 1 right: Sign missing

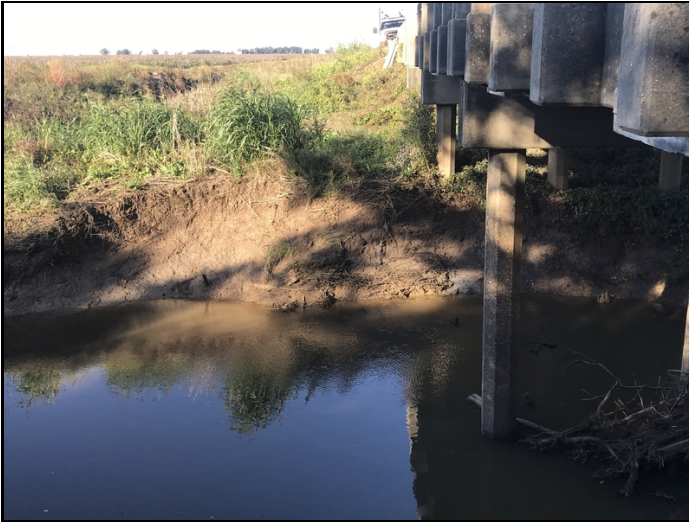
Channel - Span 3 near Bent 3: Slope erosion with vertical bank

Span 3 near bent 3 has slope erosion with vertical bank.
