Asset #02963(Routine, Underwater type 2)

SH 8-16 LM 6.87 over Boeuf River

Location: 5.7 Mi W US 65-Eudora

Team Lead: Greg Loomis, Inspection Date: 06/01/2022

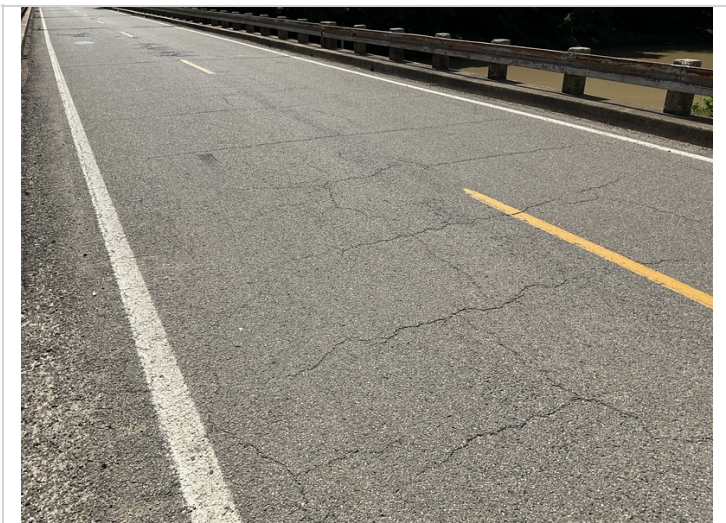
All spans: Minor- to moderate-sized transverse cracking in asphalt wearing surface with some potholing beginning, mainly on Spans 2 & 3.

Deck - Spans 1-6: Typical

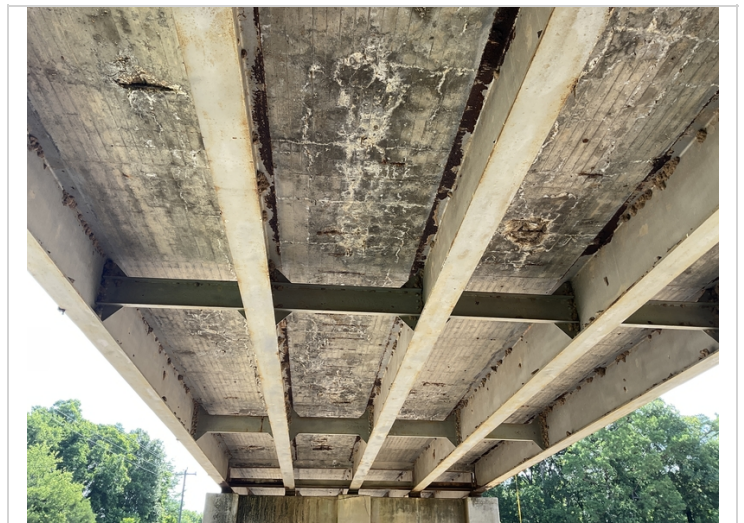
Spans 1-6: Numerous areas cracking with efflorescence and rust staining. A few areas of spalling with reinforcing steel exposed.

Soffit - Span 2: Typical

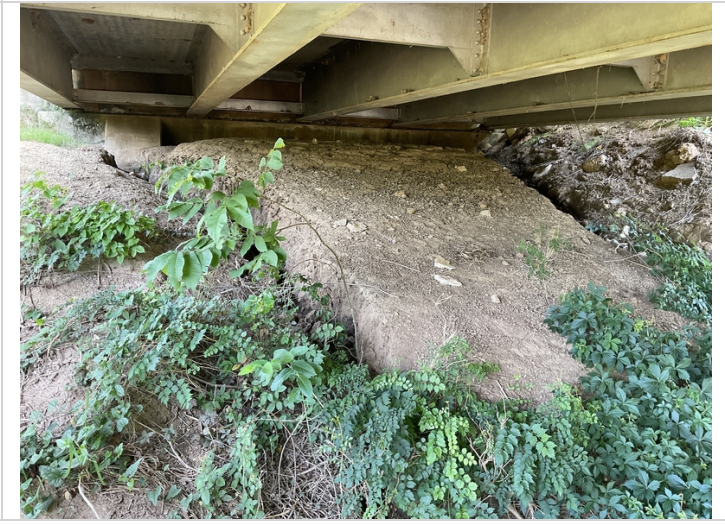
End-slope - Bent 1: Erosion

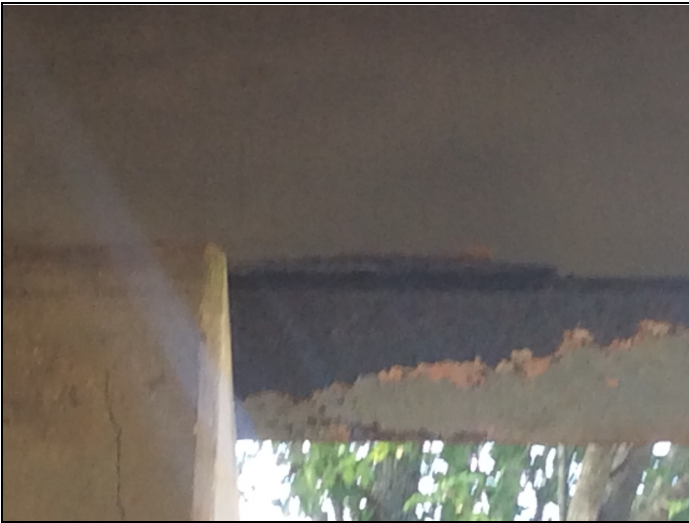
Some light surface rust beginning throughout, with rust with some flaking and section loss at ends of girders, mainly at haunches and on top of bottom flanges. (6' each end of each girder = 180' total)

Span 5 at bent 6 at girder 5 has heavy flaking rust .

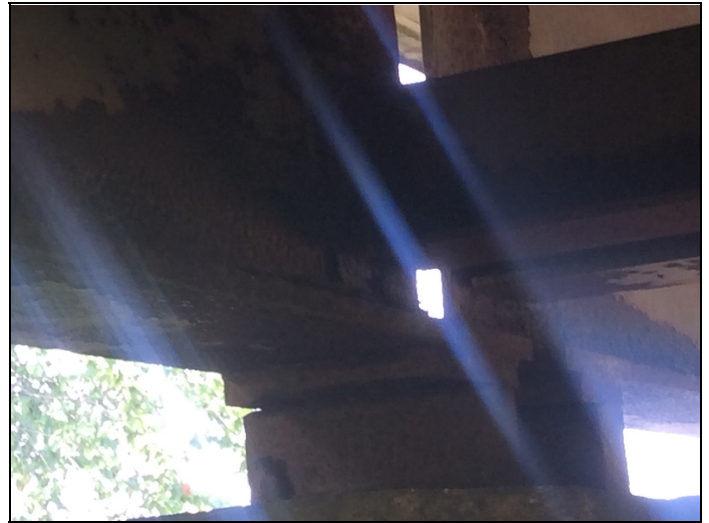
Span 6 at bent 6 girder 5 has flaking rust at bearing area 5'. Common several girder ends this bridge.

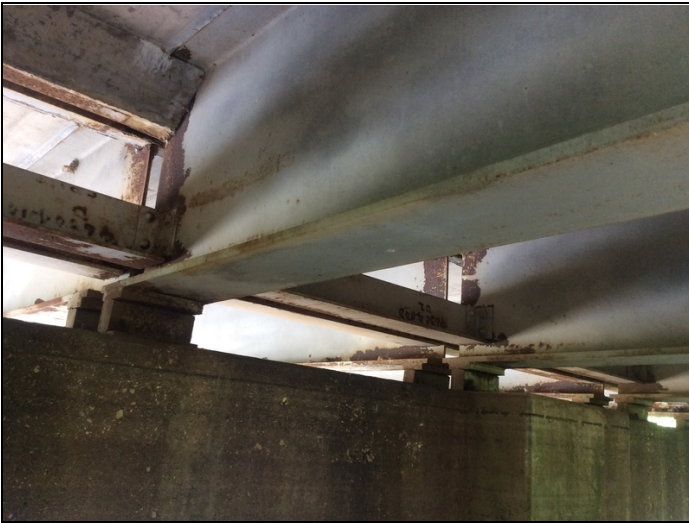
Girders 2-4 @ Bent 6 (corrosion)

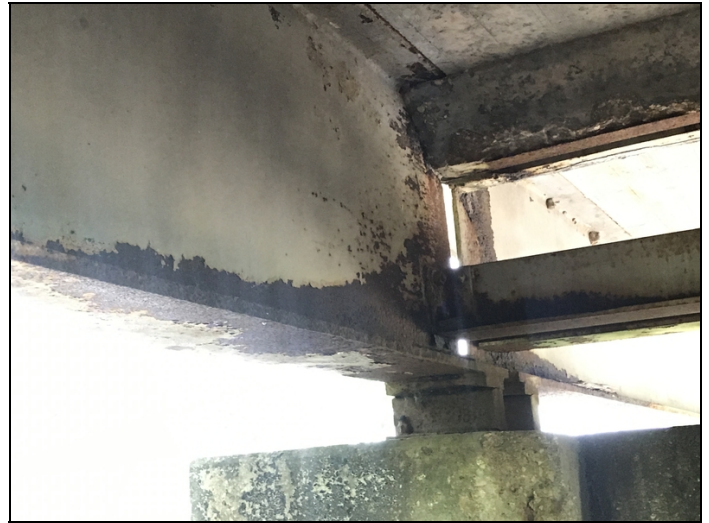
Bent 6 back and ahead, girders hav rust and rus its flaking areas.

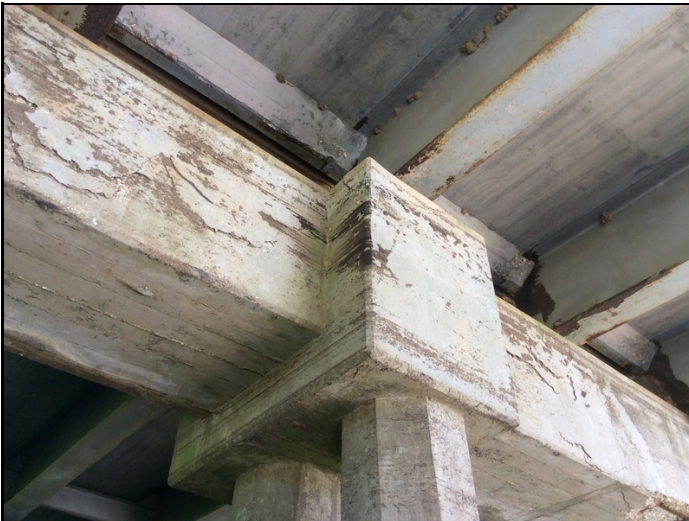
Cracking/delaminating/spalling in various locations. Reinforcing steel is rusting with some minor section loss to reinforcing steel in these locations.

Cap - Bent 6 back (delamination)

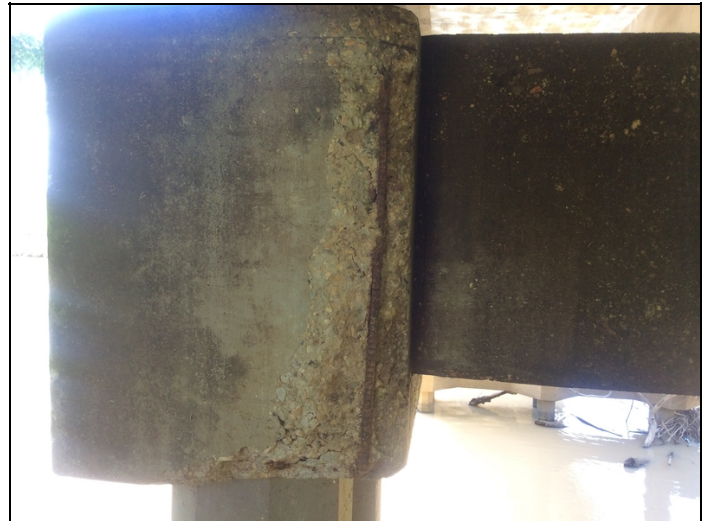
Cap - Bent 6 right ahead (rebar exposed)

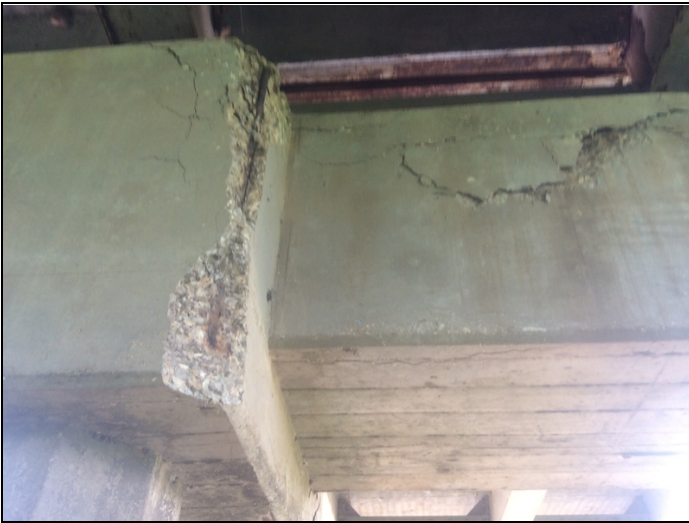
Bent 2 cap under girder 3 has spalls, delambs and exposed rebar .

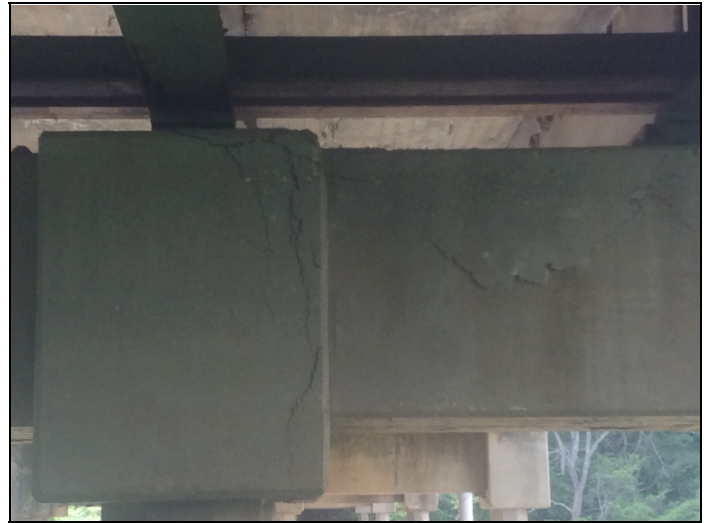
Bent 2 cap back has spalls ,spalls with exposed rebar and delaminations. Common ahead face and bents 3,4, 5 & 6.

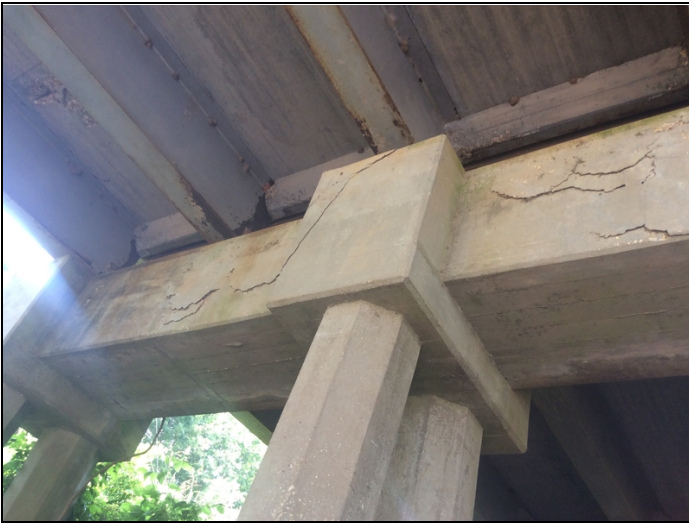
Bent 6 cap ahead face has heavy delambs .

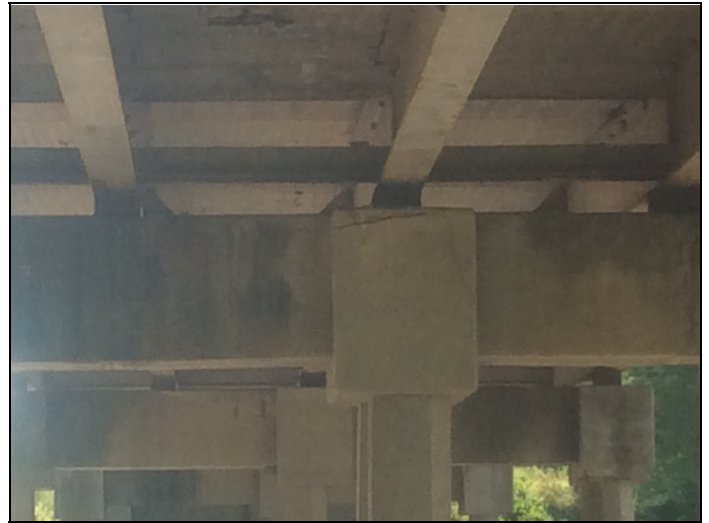
Bent 3 back cap cracking under bearing 3.

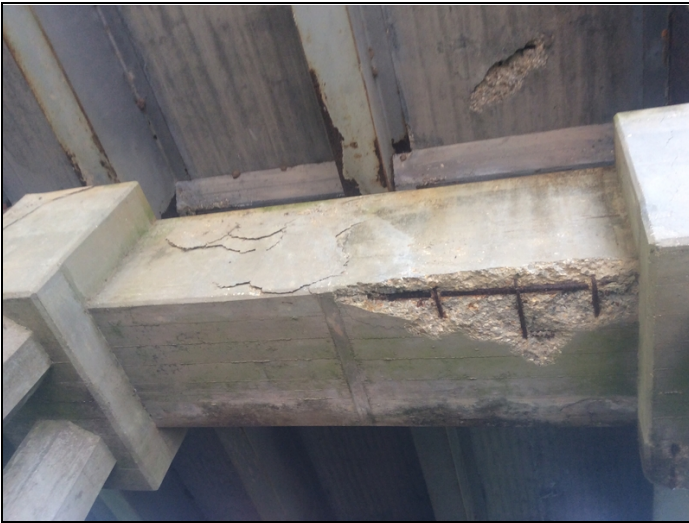
Bent 6 cap has spalls ,delambs and exposed rebar with minor section lose.

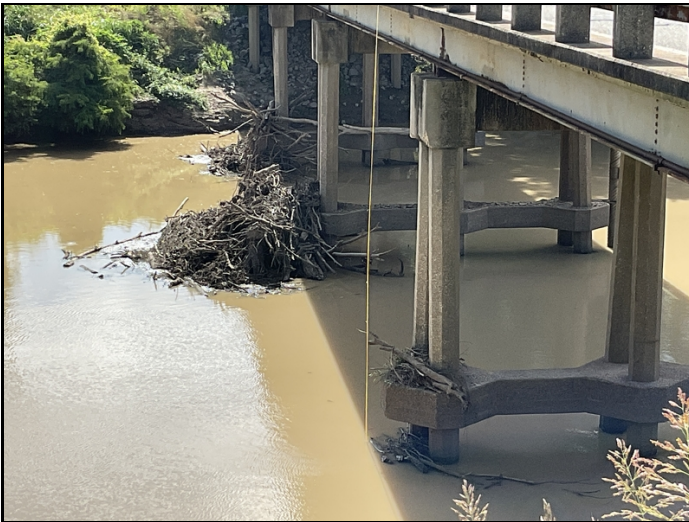
Channel - Bents 4-5 Some build-up of logs, limbs, and other debris against left side of piling.
"Note debris has been removed in the past but continues to be a maintance issue."

Channel - Bents 3-5: Debris build-up

bride / maintenance : remove debris and advise when complete

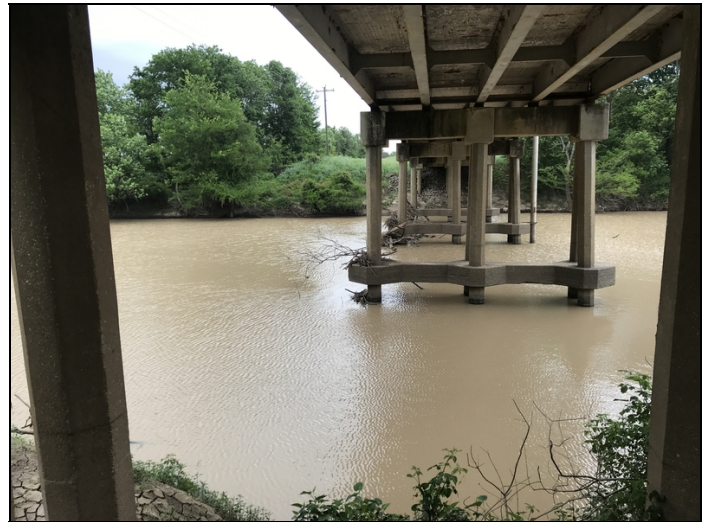
Bents 3-5 has one debris on pile.

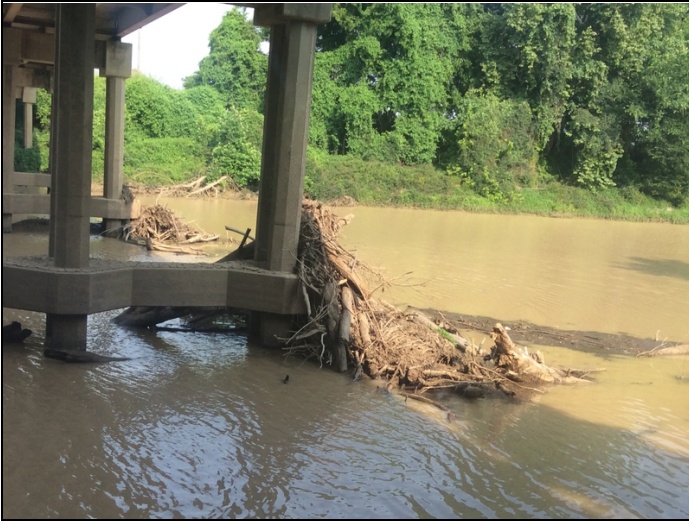
Drift and debris at bent 4&5 on piles 1&4 at each bent.

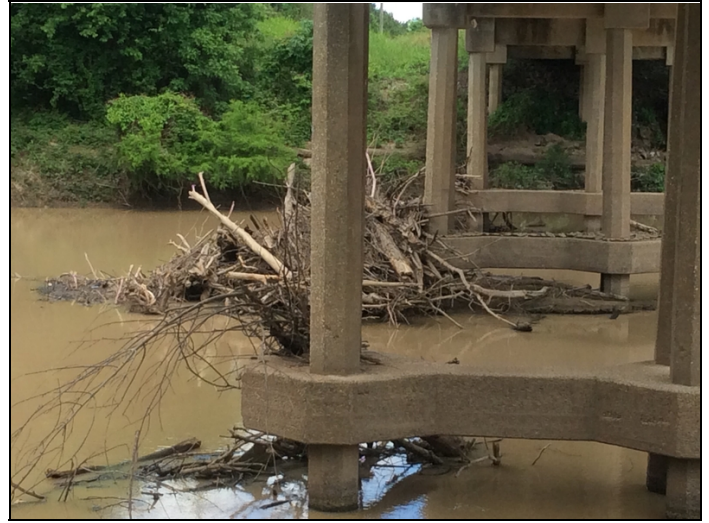
Channel - Bents 3-5 (debris built-up)

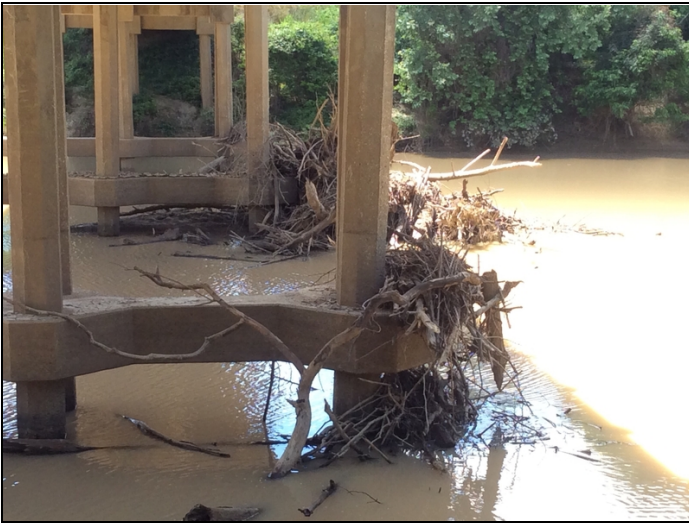
Channel - Bents 3-5 (debris built-up)

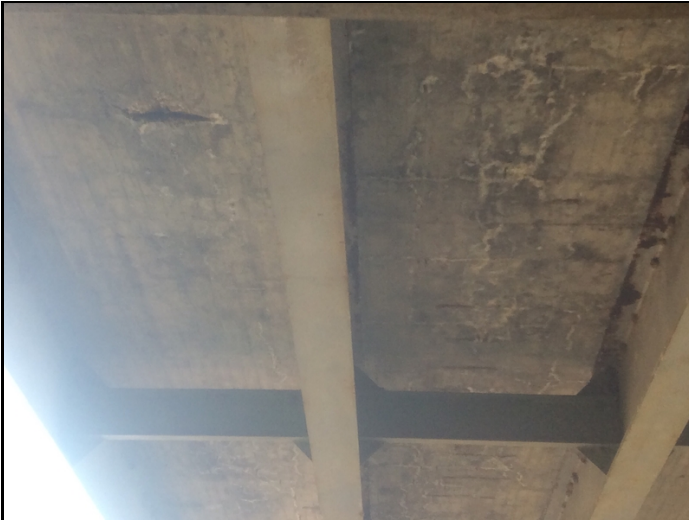
Span 2 soffit spalls with rebar exposed and cracking with efflorescence.

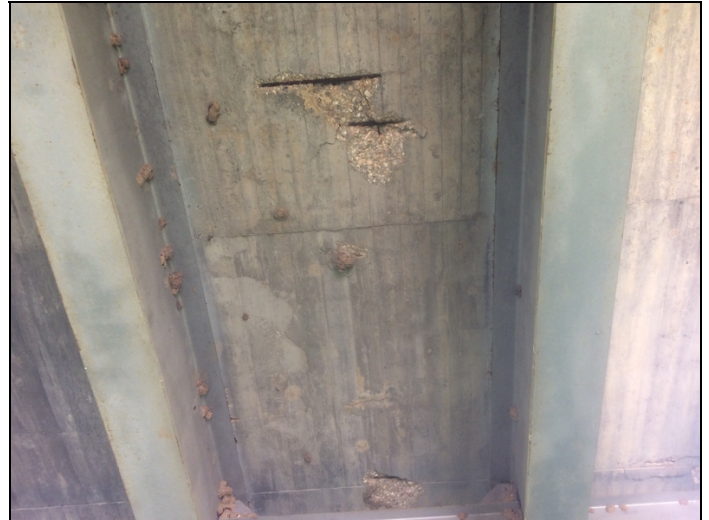
Soffit spalls with exposed rebar common most spans.

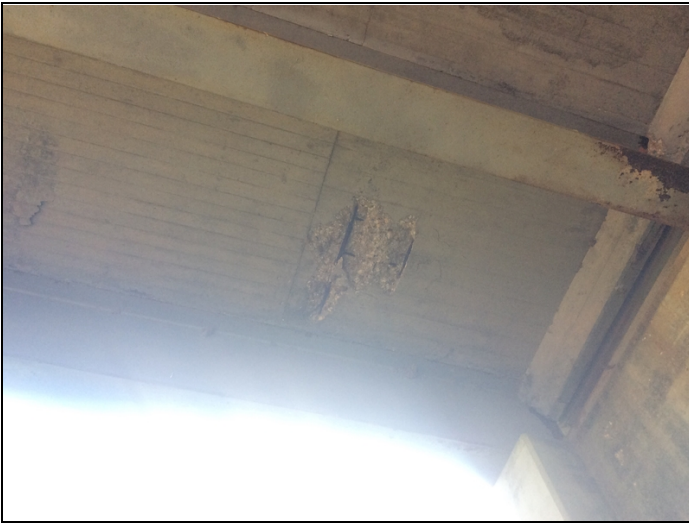
Span 5 under side of deck has spalls with exposed rebar
between girders 1&2 near bent 6 .

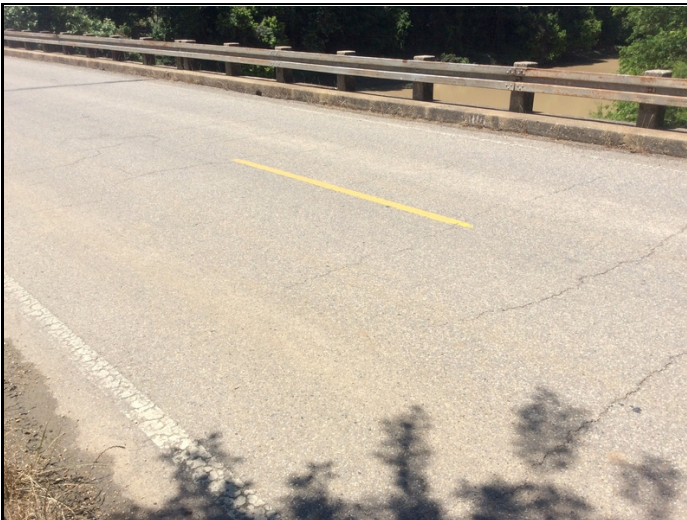
Wearing surface - Span 5 (cracking)

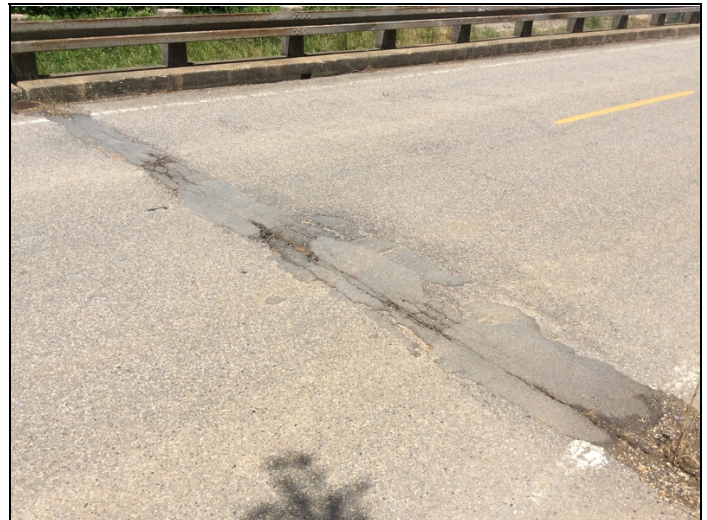
Wearing surface - Bent 6 (cracking)

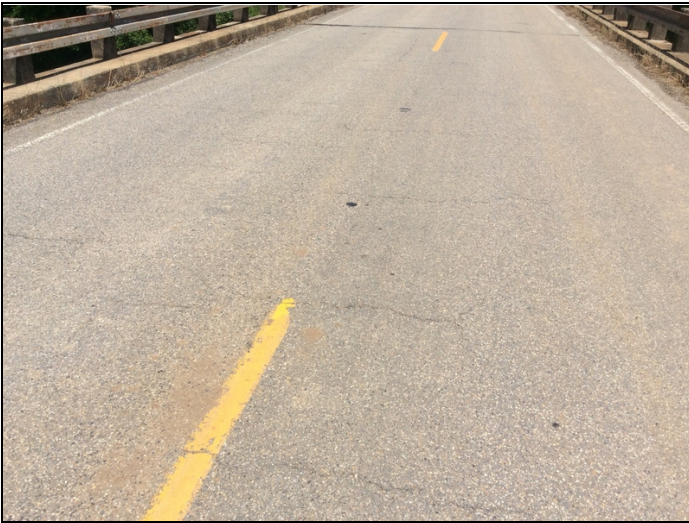
Wearing surface - Span 4 (cracking)

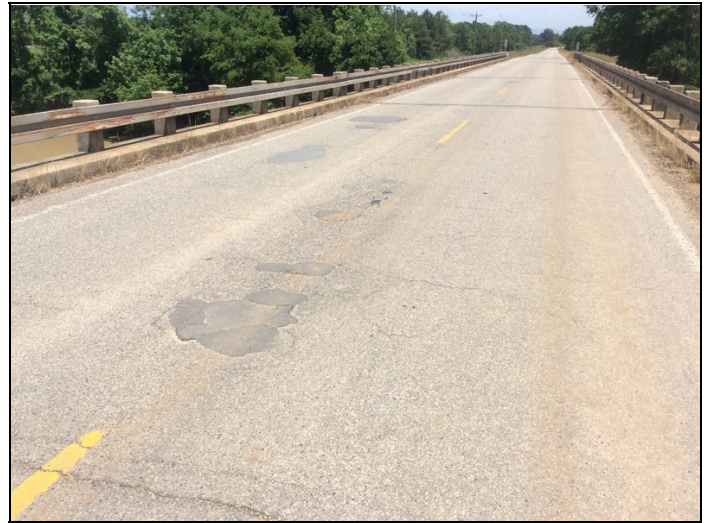
Wearing surface - Span 2 (patches)

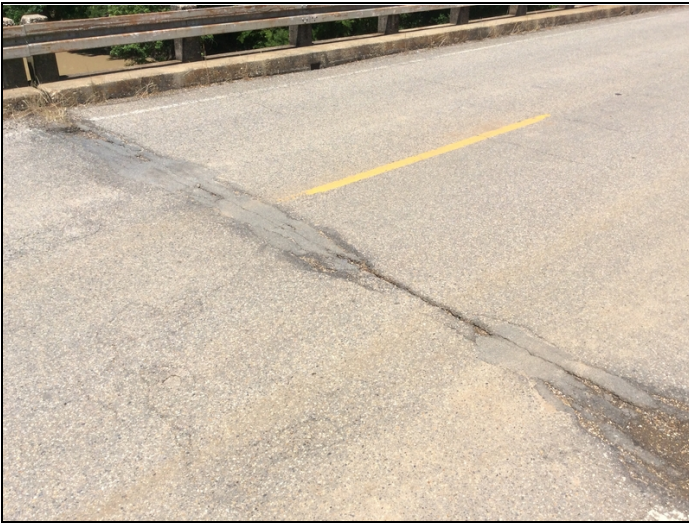
Wearing surface - Bent 4 (cracking)

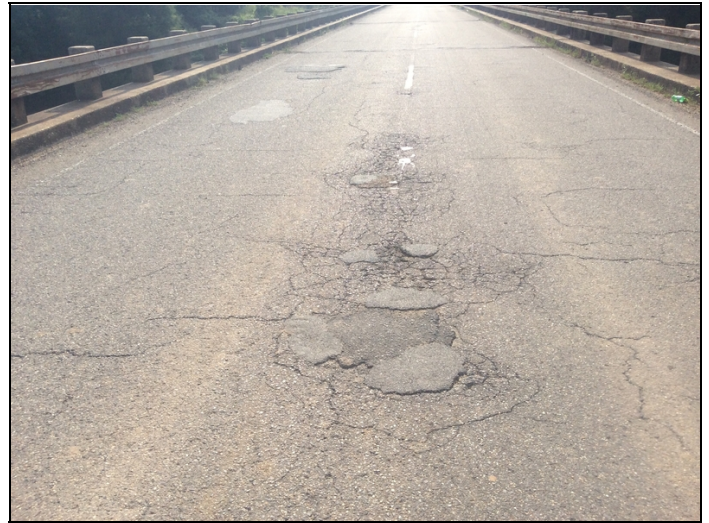
Span 2 wearing surface has patched areas. Common in span 3.

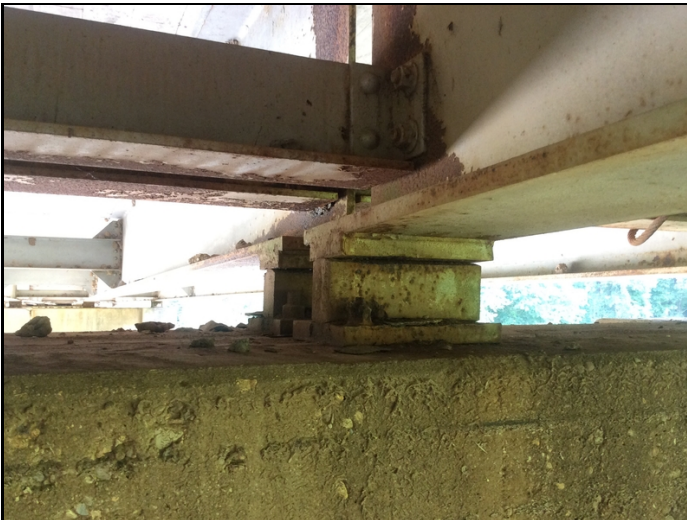
Bearings – all bents:
Some light surface rust covering most of bearings.

Bearings 2 @ Bent 6 (corrosion)

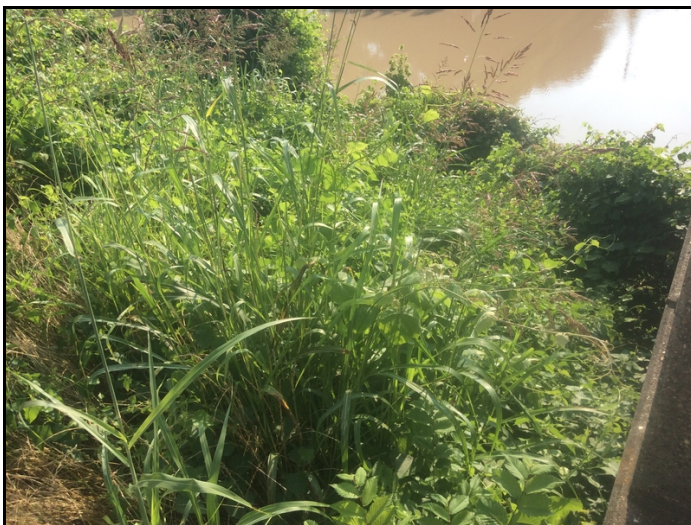
Trees , vines and vegetation growing on and under bridge at both ends.

Tall trees vines and vegetation impeding inspection .

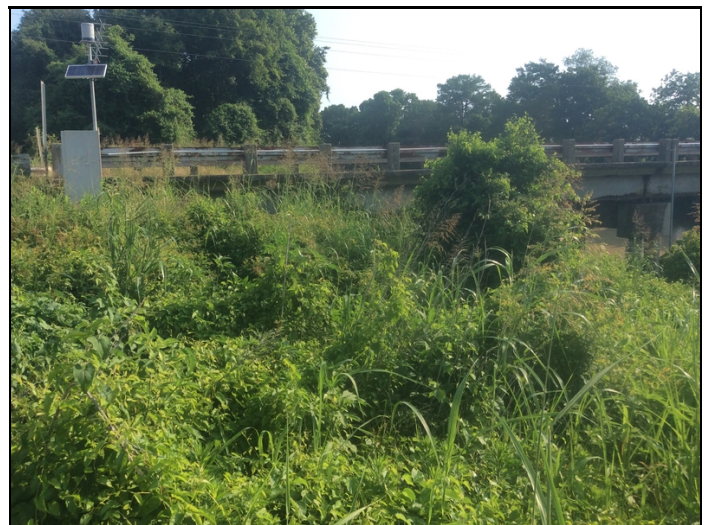
Trees vines and vegetation impeding inspection .

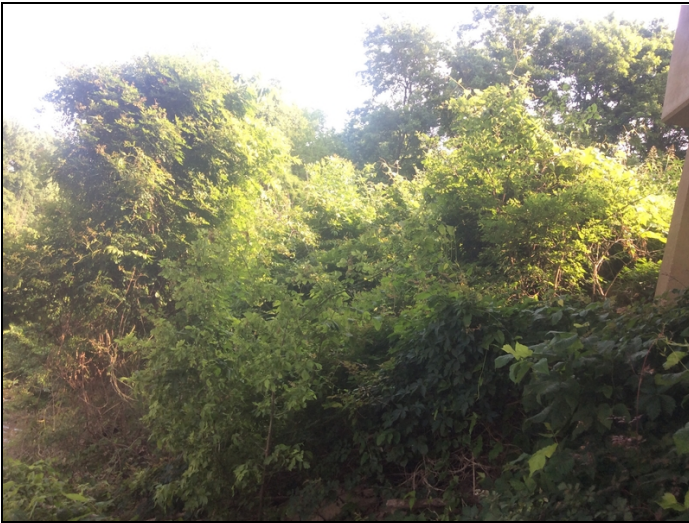
Large trees ,vines and vegetation on and under bridge.

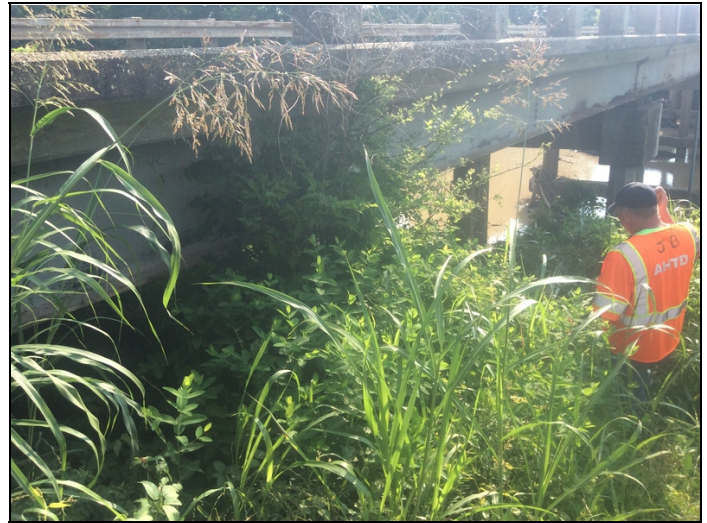
Trees and vegetation growing on and under bridge.

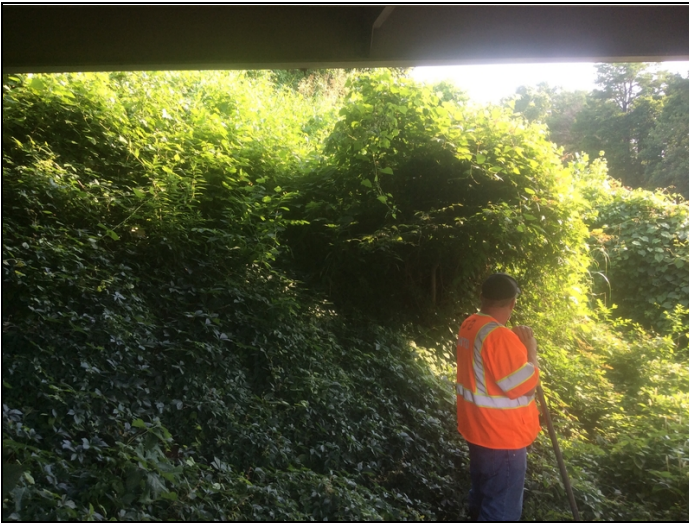
Span 1 vines, trees and vegetation.

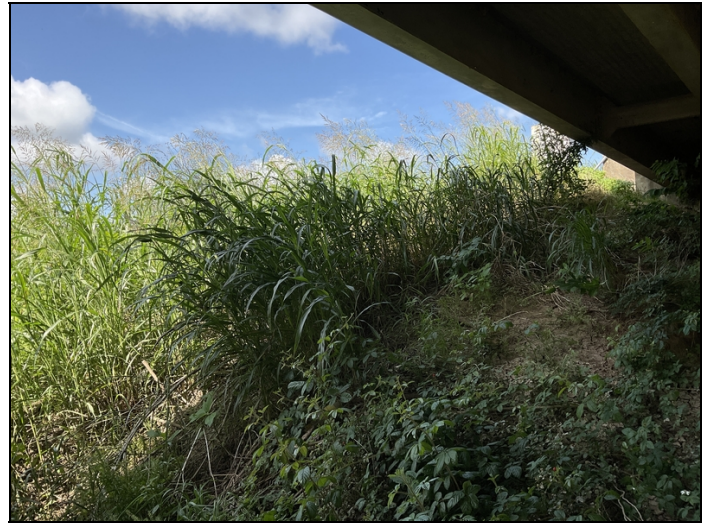
Channel - Span 1 right: Vegetation
