Asset #02964(Routine)

SH 8-16 LM 7.12 over Boeuf River Relief

Location: 4.5 Mi W US 65-Eudora

Team Lead: Greg Loomis, Inspection Date: 06/01/2022

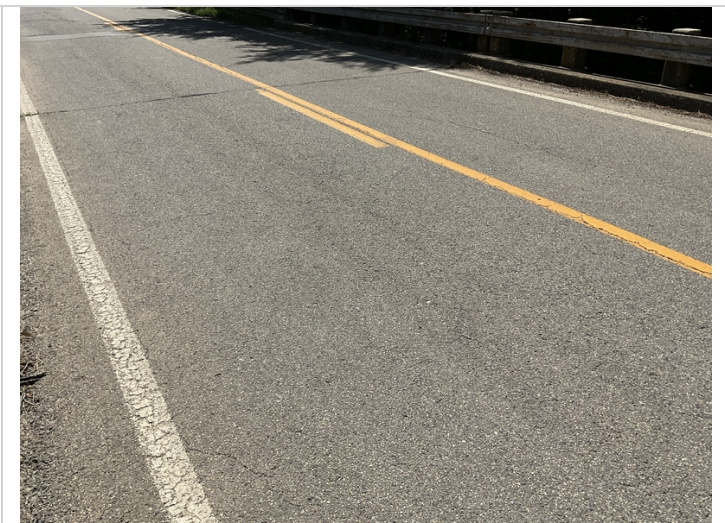
Deck - Spans 1-2: Typical

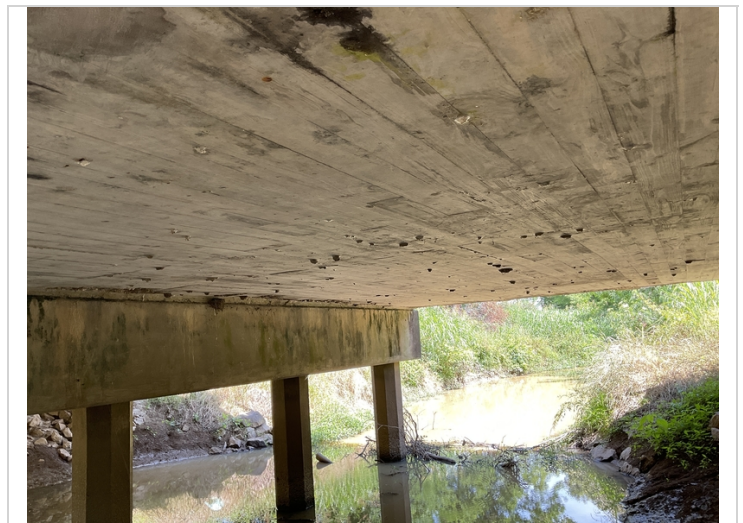
Soffit -Span 2 :Typical

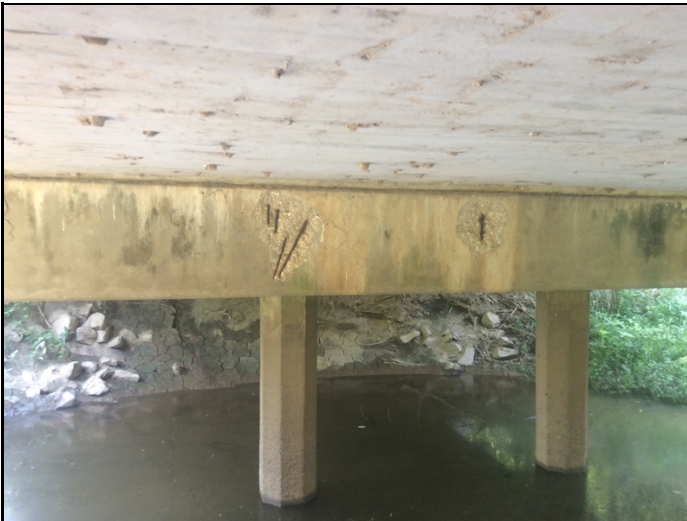
(234) Cap: 27'-6" = 28' each / Bent 2. Some small delaminations and one area of spalling (rebar exposure with light section loss) on back face of cap - 4' CS2 exposed rebar. Some light deterioration beginning on end corners - 4' CS2 spalling.

Some small delaminations and one area of spalling (rebar exposure with light section loss) on back face of cap.
Some light deterioration beginning on end corners.

Bent 2 cap back has spalls with exposed rebar.

Type of Work: Repair (General)

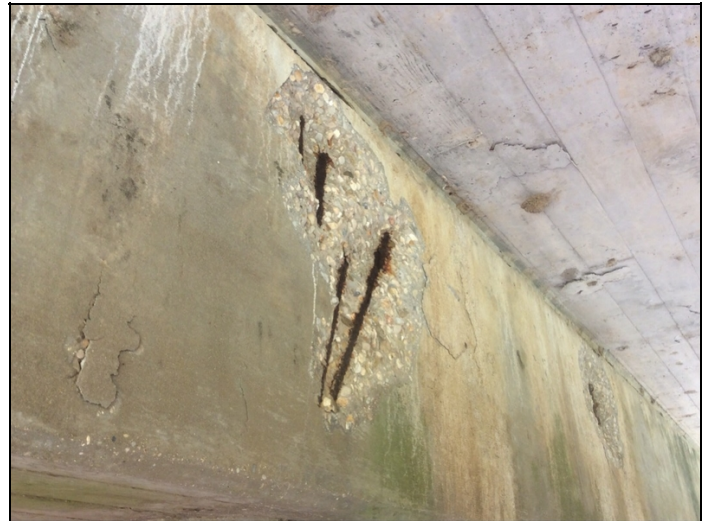
Cap - Bent 2 back (rebar exposed)

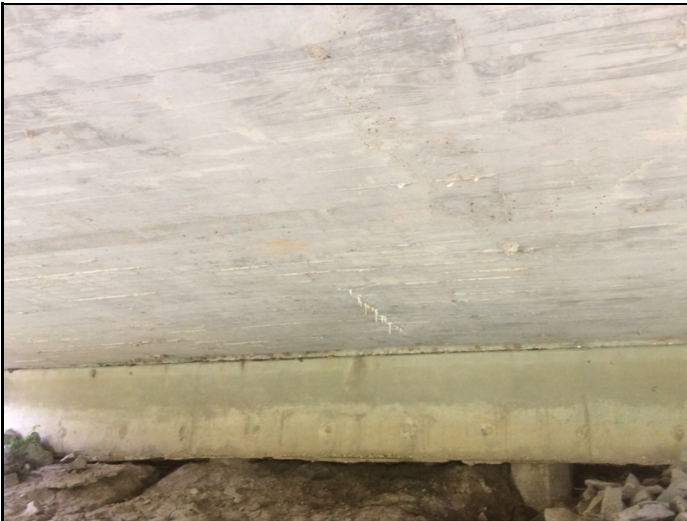
Some minor spalling/delaminations with some rebar exposure (light section loss), especially on outside of spans under gutter-lines and on Span 2 along edge of Bent 2 cap.

Soffit - Span 2 @ Bent 3 (efflorescence)

Type of Work: Repair (General)

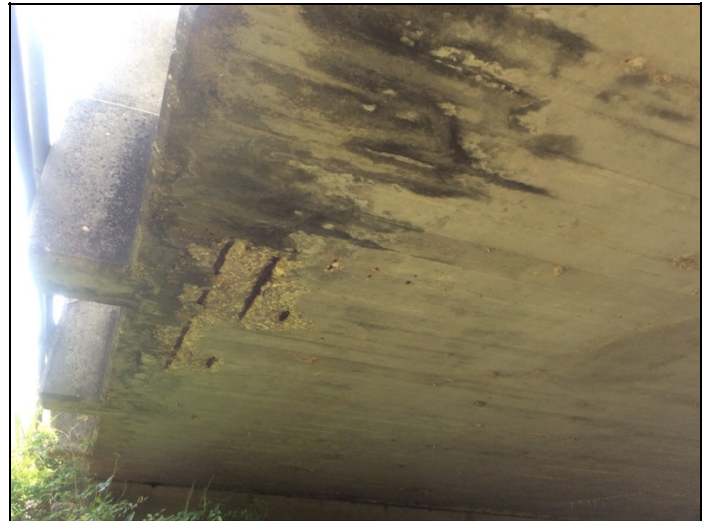
Soffit - Span 2 left (rebar exposed)

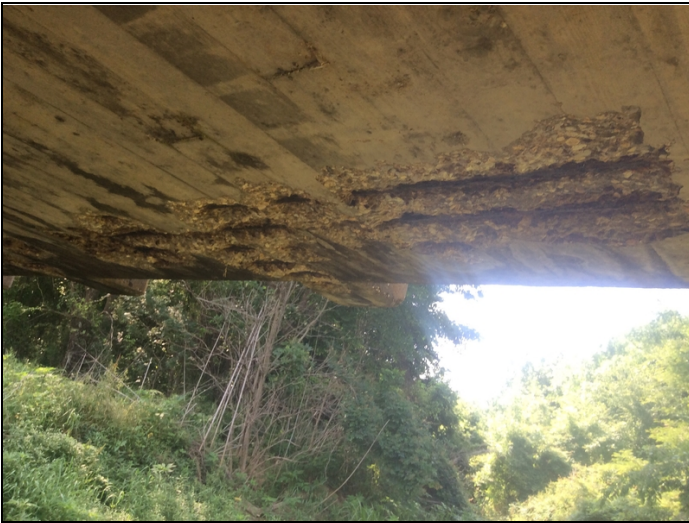
Spalls with exposed rebar at span 1 right side of soffit area near midspan towards bent 2 .

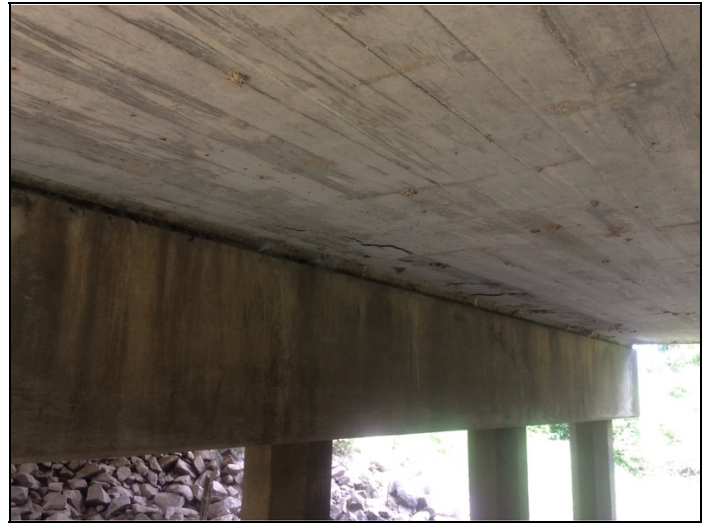
Soffit - Span 2 @ Bent 2 (delaminations)

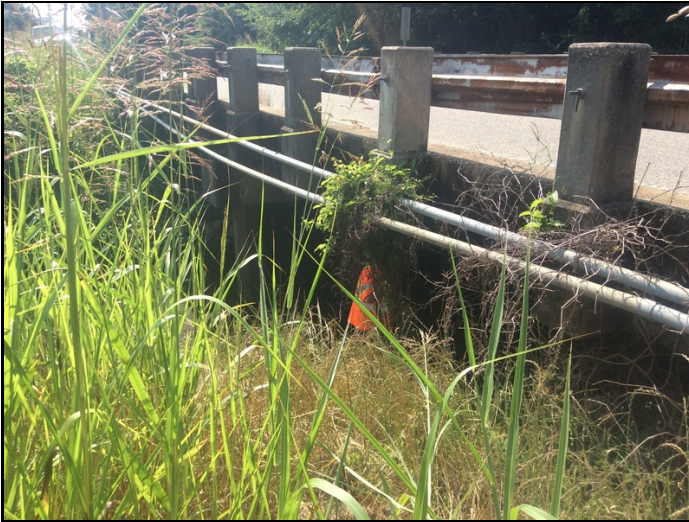
Elevation.

Channel - Spans 1-2: Significant vegetation growth (grasses/weeds) on both sides of bridge.

Type of Work: (Inactive) (Inactive) 1 - Clean

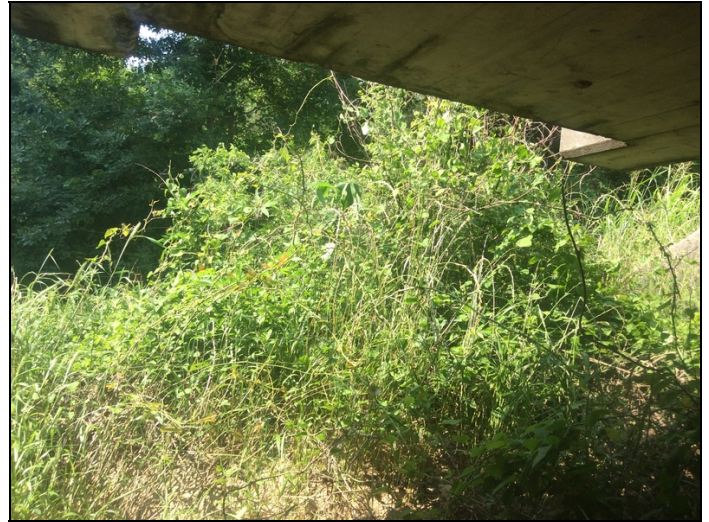
Large vines and vegetation .
