Asset #02069(Routine, Underwater type 2)

US 65-20 LM 3.30 over Black Pond

Team Lead: Sharon Hooks, Inspection Date: 03/29/2021

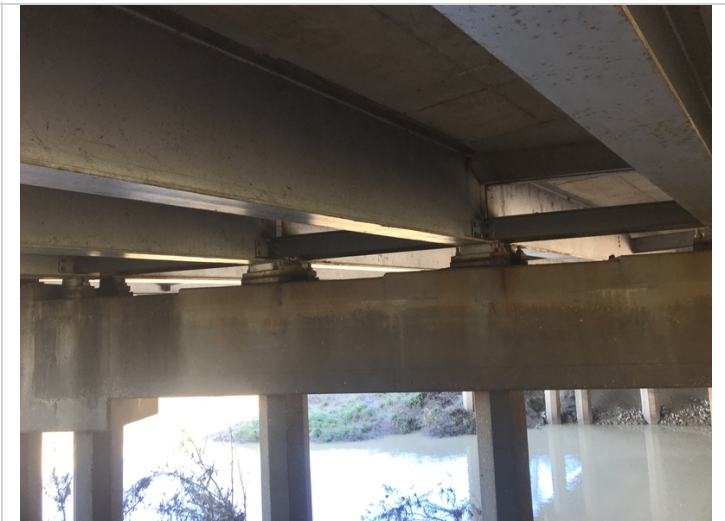
Bent 3 bearing has rust with flaking.

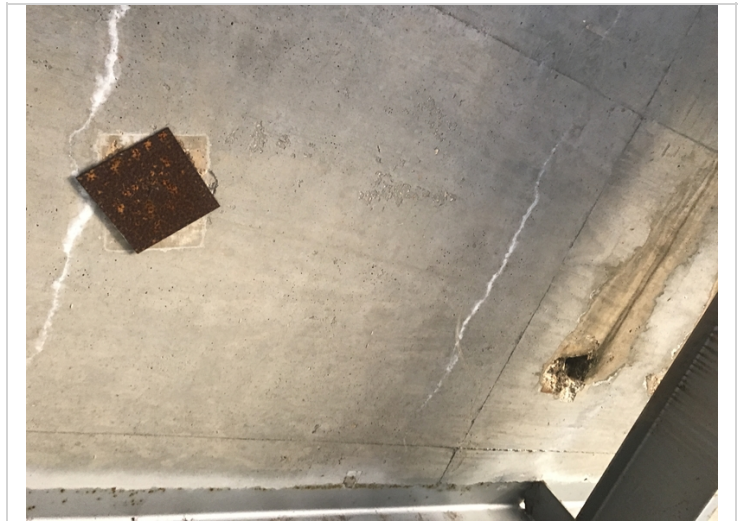
Soffit north bound lanes has spalls from screed placement.
As built.

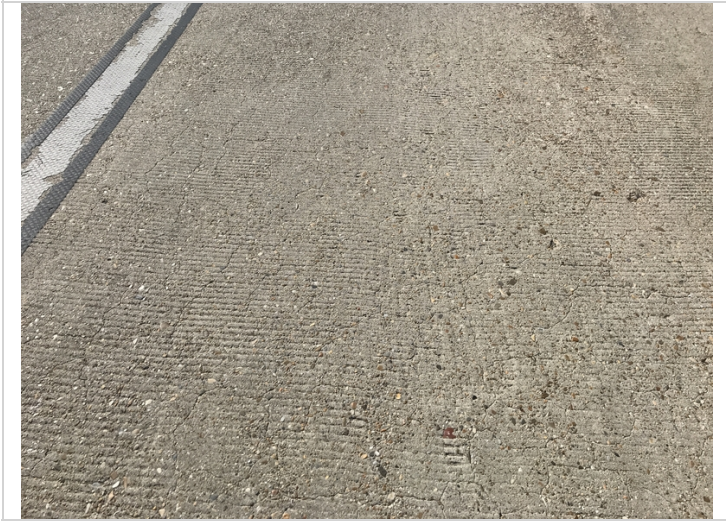
North bound span 2 map cracking in deck.

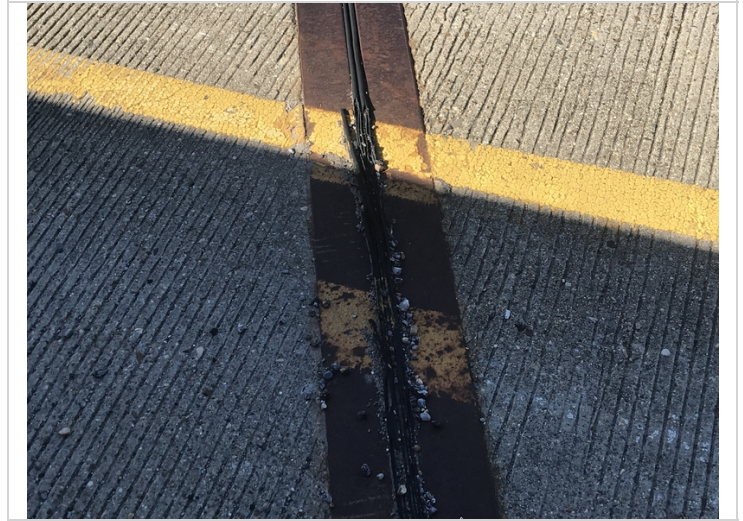
Bent 2 joint seals are torn and leaking near gutter line south bound.

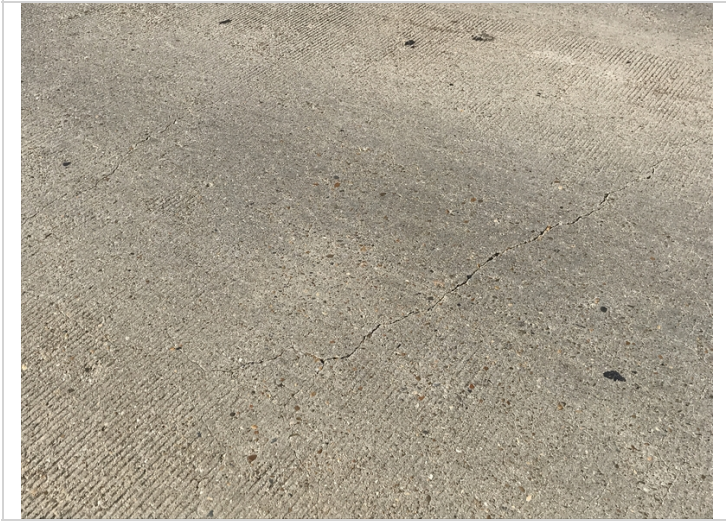
Unsealed transverse cracks.

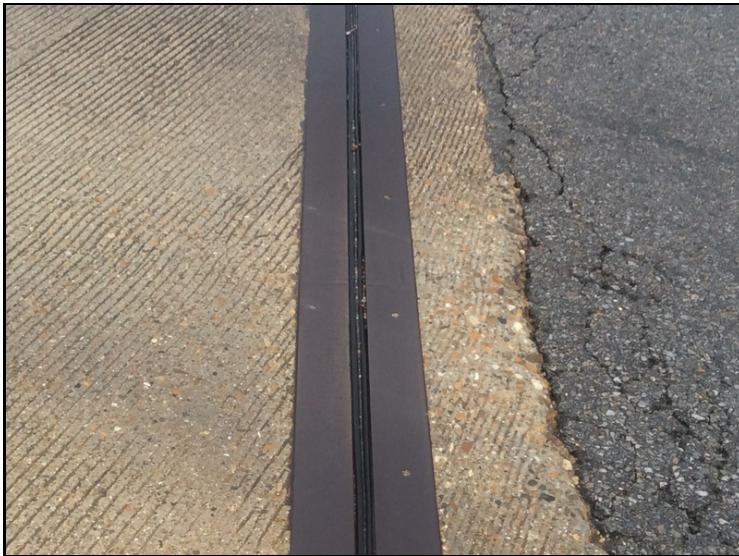
Some scattered areas of cracking and tattering of joint material, mainly in the northbound (left side) lanes, with scattered loss of adhesion and leaking.

Bent 1 as logged heading south expansion joint is leaking lose of adhesion

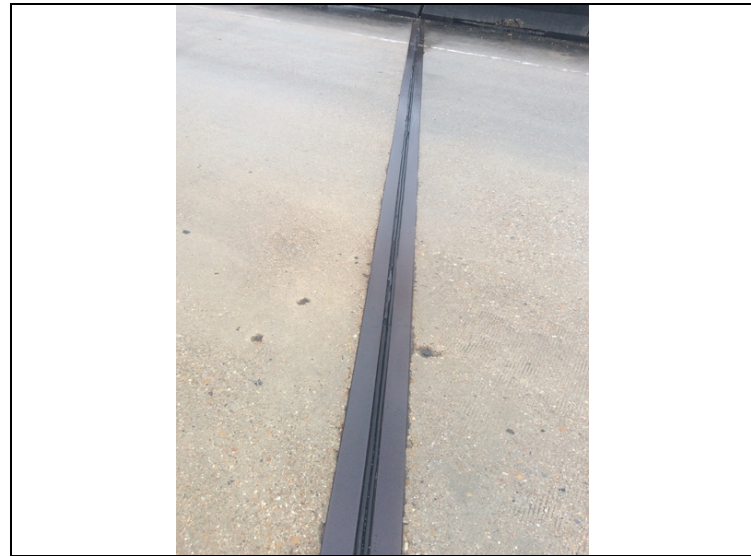
Bent 3 North Bound joint seal torn and leaking.

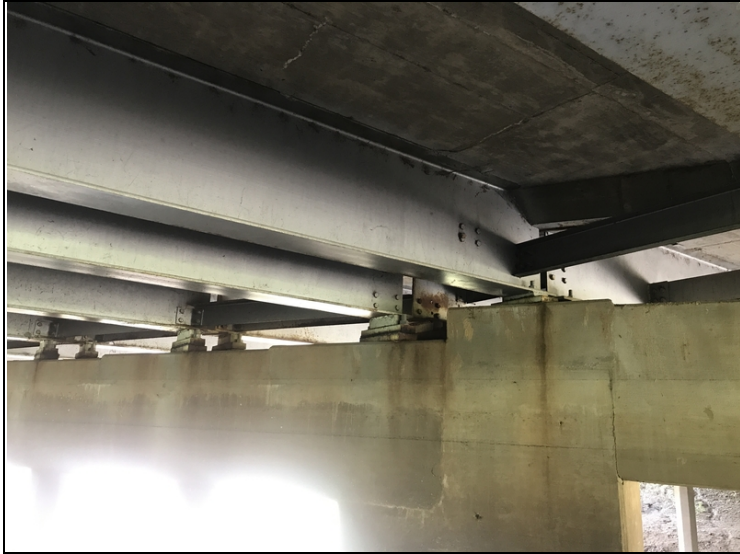
Bent 3 - Bearings

Some scattered surface corrosion with flaking and pack rust between bearing and masonry plate.

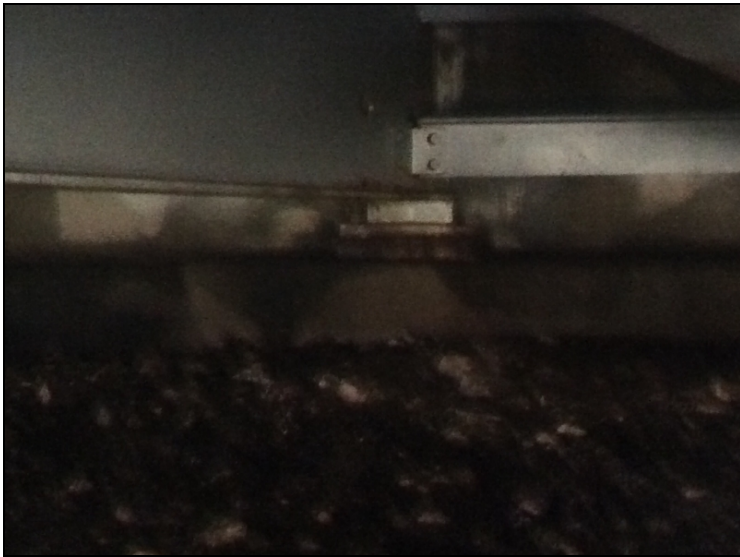
Bent 1 bearing 10 has moderate rust forming

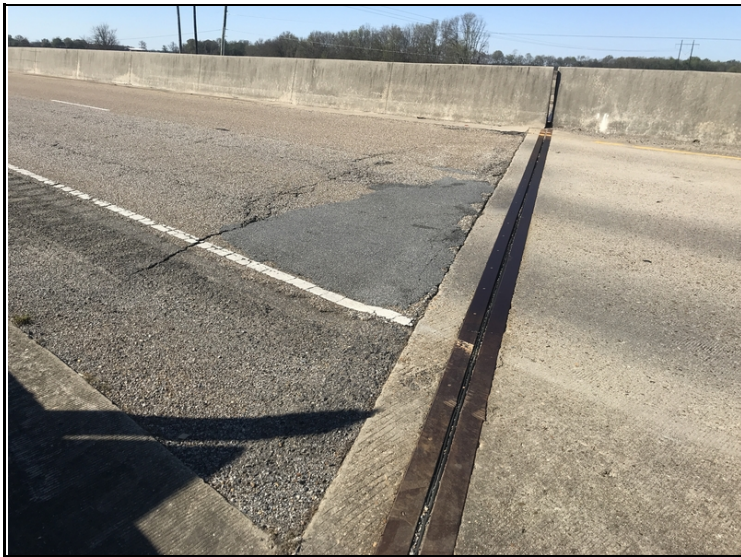
Approach roadway - both ends/sides: Some deterioration and settlement of asphalt surface, causing a bump going onto bridge.

North bound approach roadway has cracking and settlement at bridge end.

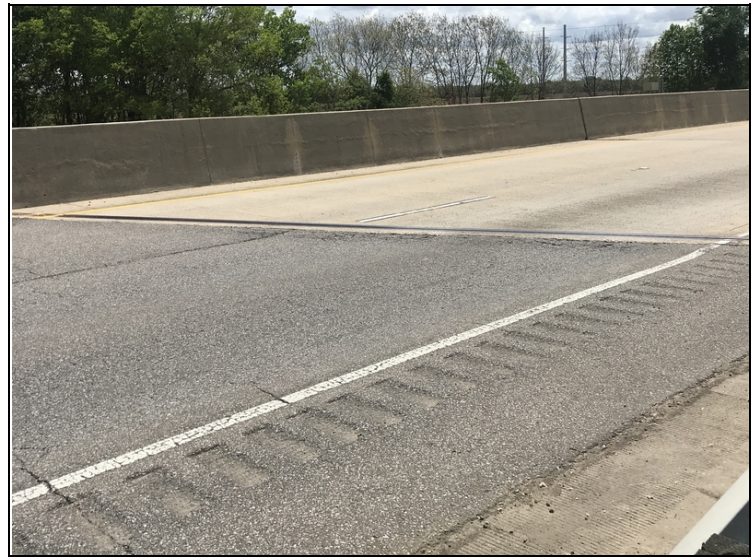
Approach roadway - Bent 1 SB: Settlement

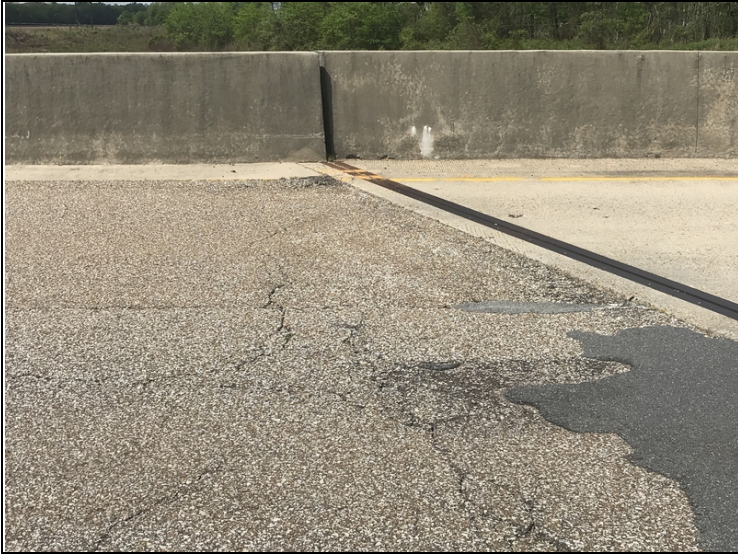
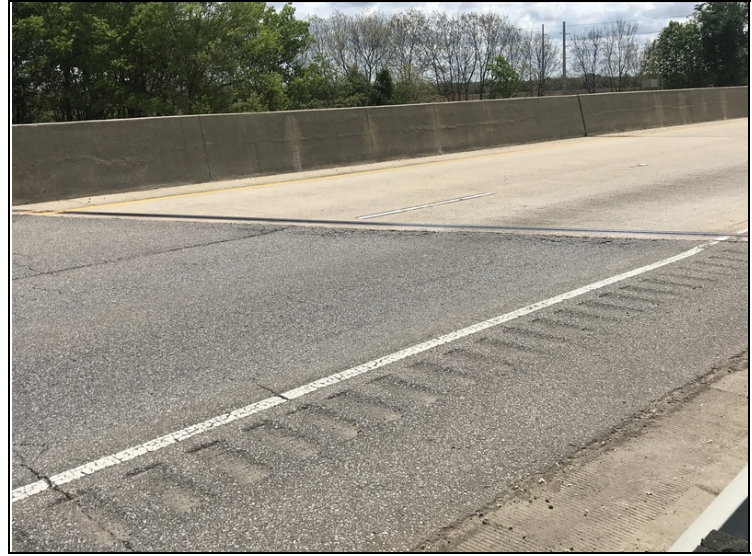
Approach roadway - Bent 4 left inside : Settlement
