Asset #02070(Routine)

US 65-20 LM 7.63 over Boeuf Canal

Team Lead: Greg Loomis, Inspection Date: 04/19/2021

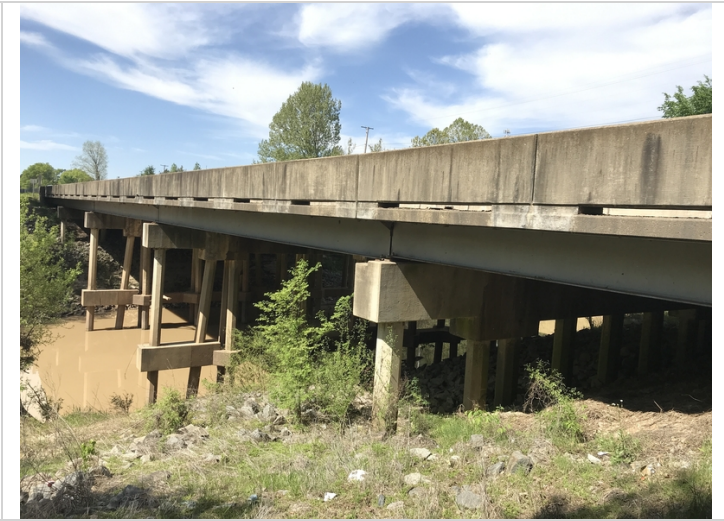
Right side view

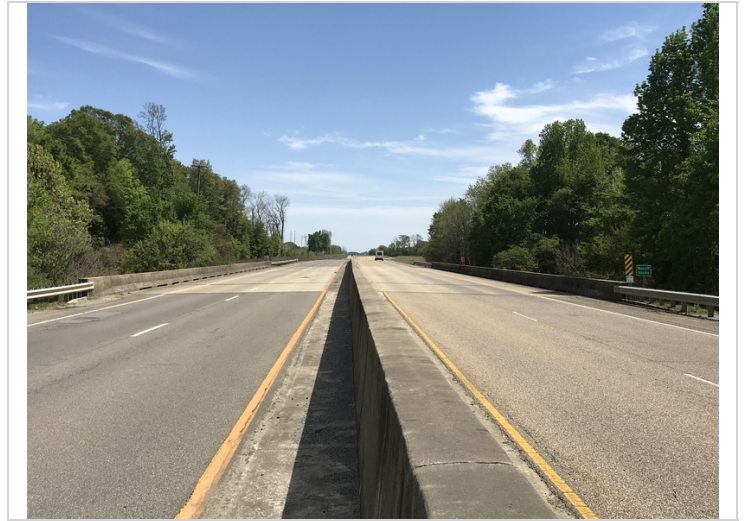
Roadway view

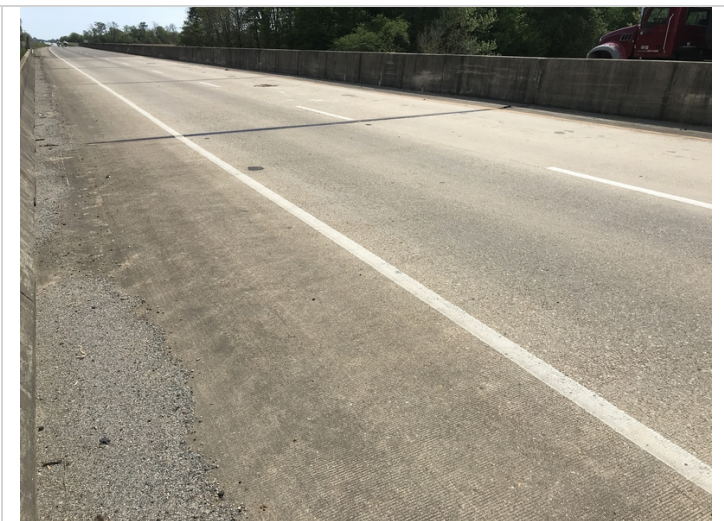
Deck - Spans 1-5 left: Typical

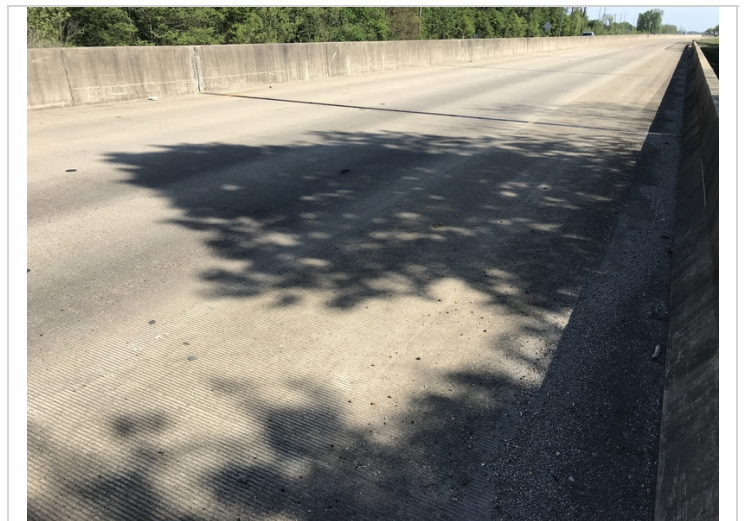
Deck - Spans 1-5 right: Typical

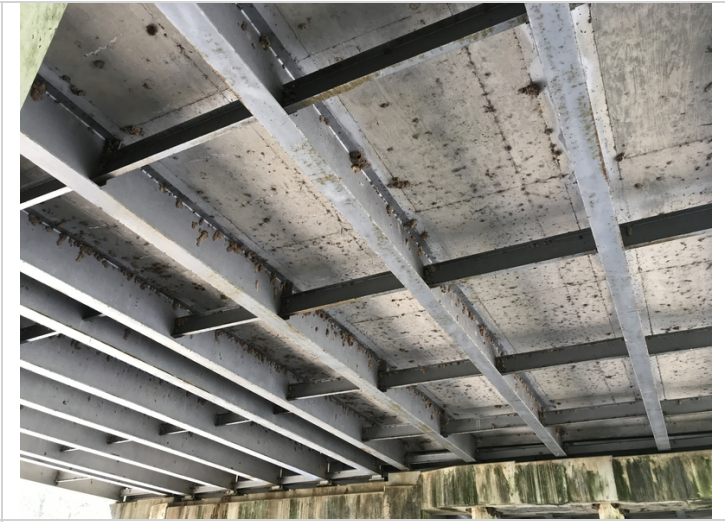
Soffit - Span 3: Typical

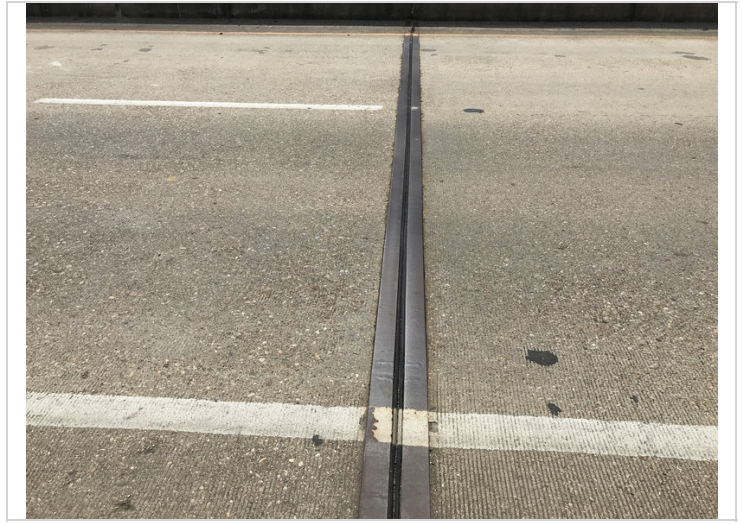
(302) Compression Joint Seal: 72' each / Bents 1-4 & 6. Bent 2 left (northbound) lanes: Small areas of loss of adhesion (6') with some adjacent deck spalling (18'). Bent 2 right (southbound) lanes: Torn and leaking (25'). Bent 4 left (northbound) lanes: Small torn and tattered areas. Bent 4 right (southbound) lanes: Torn and leaking (4').							
311	Movable Bearing	EA	65	0	45	20	0
1000	Corrosion	EA	65	0	45	20	0
515	Steel Protective Coating	SF	195	0	135	60	0
3440	Effectiveness (Steel Protective Coatings)	EA	195	0	135	60	0

Joint - Bent 2 left: Adjacent deck spalling

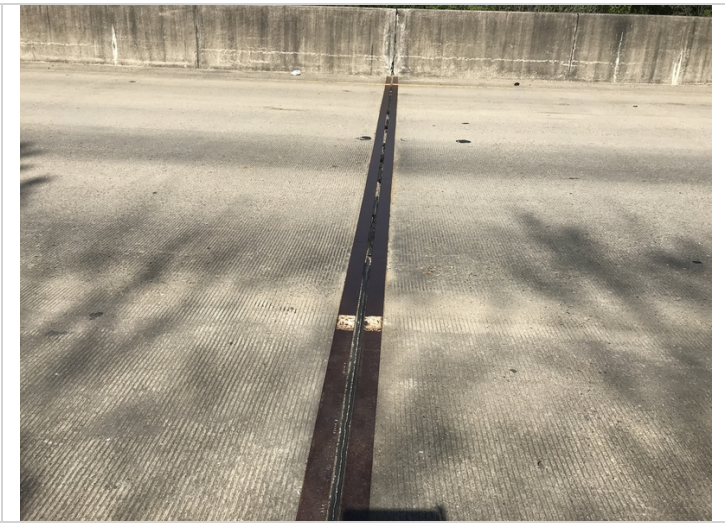
Joint - Bent 2 right: Damage

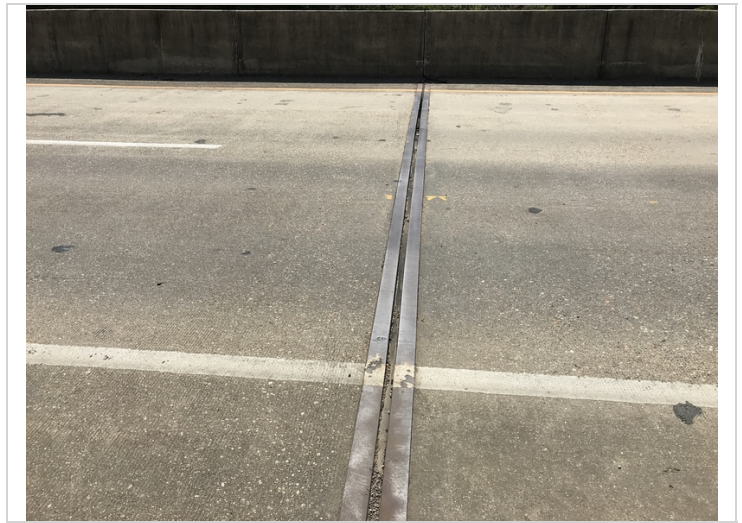
(301) Pourable Joint Seal: 72' each / Bent 5. Left (northbound) lanes: Missing/loss of adhesion across majority of right (inside) lane.							
302	Compression Joint Seal	LF	360	295	44	21	0
2320	Seal Adhesion	LF	6	0	6	0	0
2330	Seal Damage	LF	41	0	20	21	0
2360	Adjacent Deck or Header	LF	18	0	18	0	0

Joint - Bent 5 left: Loss of adhesion

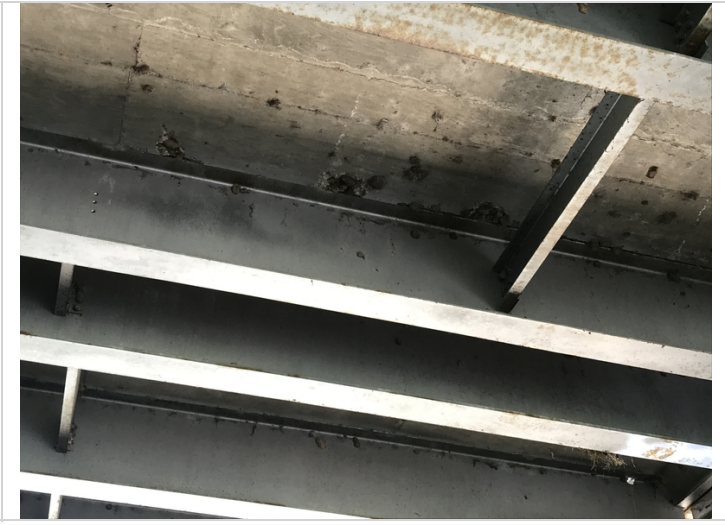
Soffit - Span 4 Bay 5: Rebar exposed

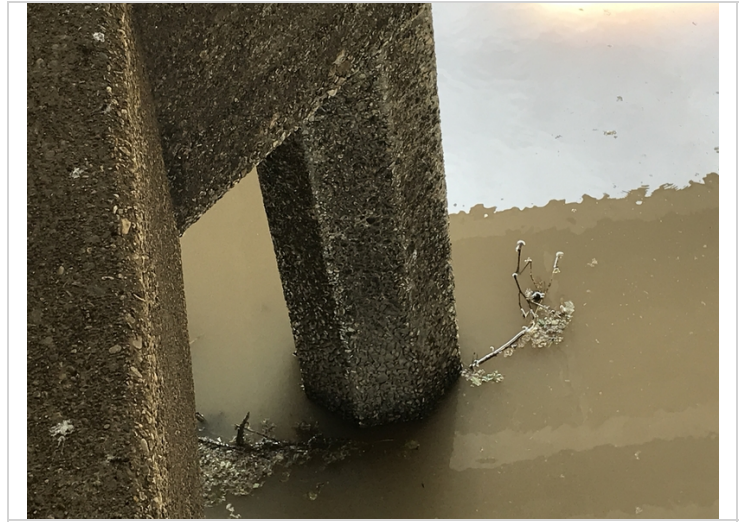
Bent 4 Pile 7: Abrasive wear

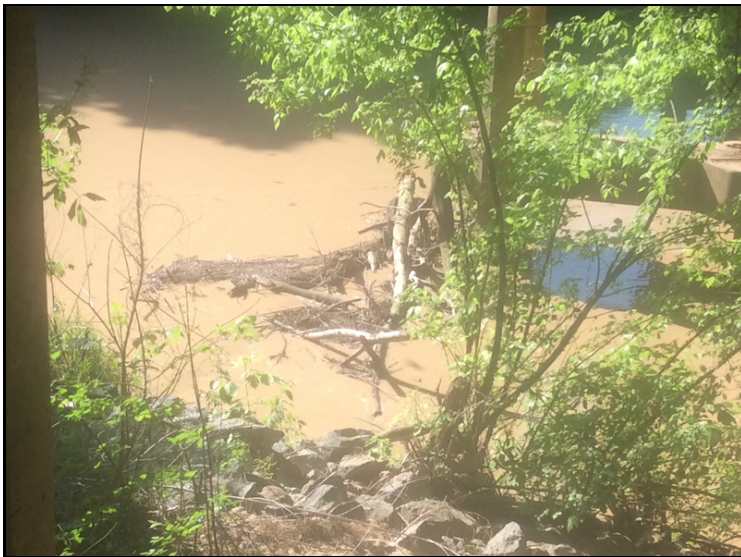
Channel - Bent 3 left: Build-up of some logs, limbs, and other debris against piling.

Bent 3 drift and debris against pile on upstream side.

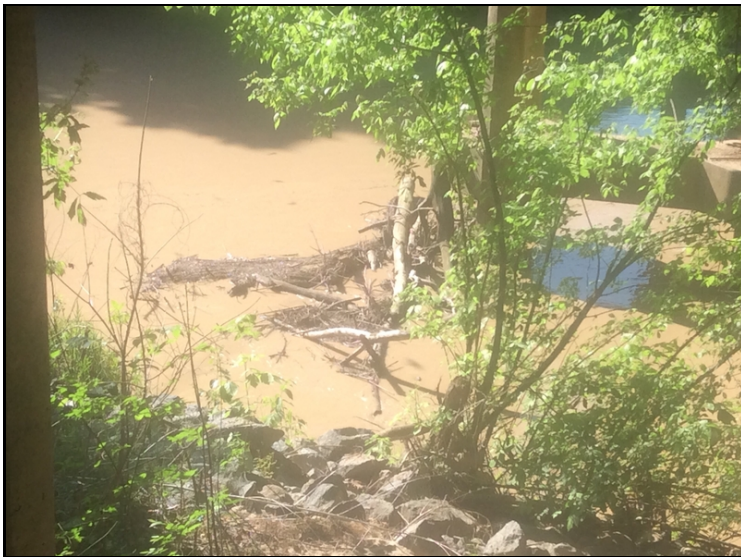
Bent 3 drift and debris against pile on upstream side.

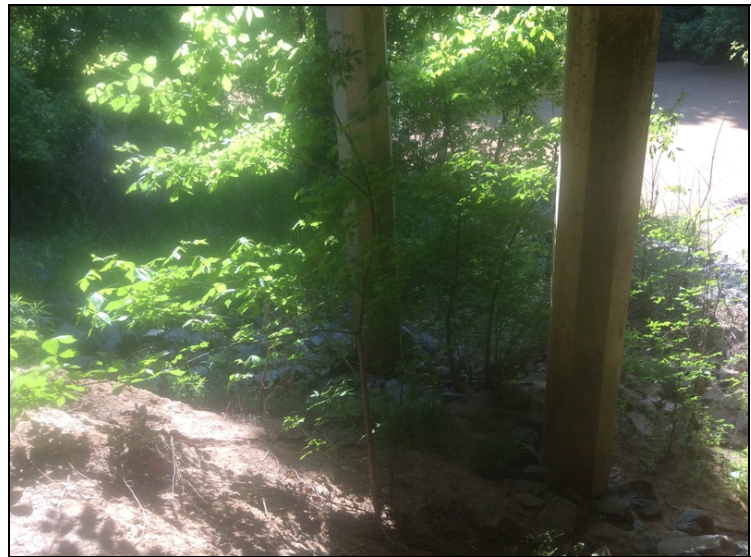
End-slopes/channel - all spans: Small trees and vegetation growing under bridge.

Span 1 & 2 small trees growing under bridge.

Chicot: remove and advise when complete
