Bridge M3479 Inspection Report

SH 83-01S LM 0.41 over US 425

Location: 1.2 Mi S US278-Monticello

Team Lead: Phillip Dowell Inspection Date: 08/05/2024

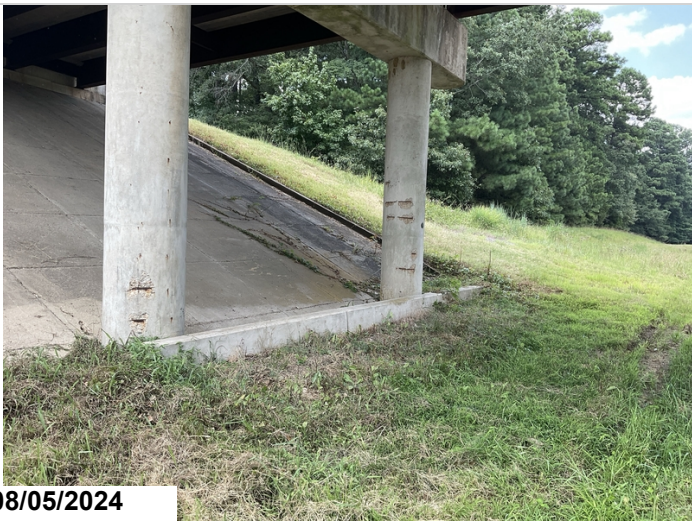
Bent 4, columns 1 & 3 - CS3 Exposed Rebar

Bent 4 Column 1 & 2: Some small spalls with exposed rebar (with minor corrosion) on left side face.

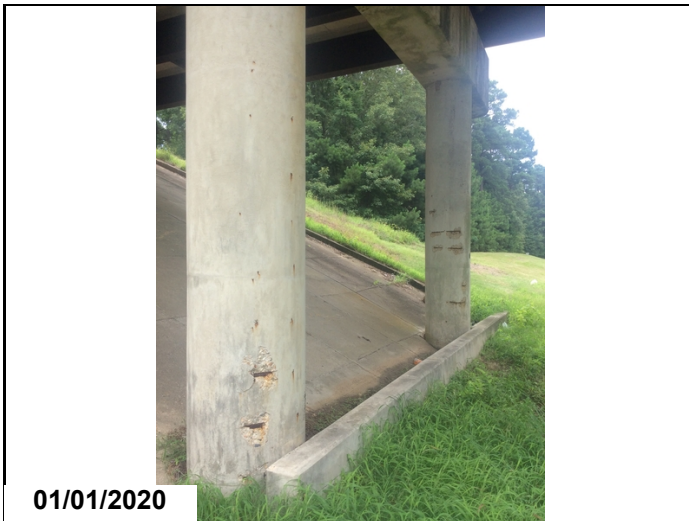
Some horizontal cracking/delaminations along top corners of caps in various locations, heaviest at Bent 2 left side and Bent 4 @ Column 2.

Some minor vertical cracking at step-ups.

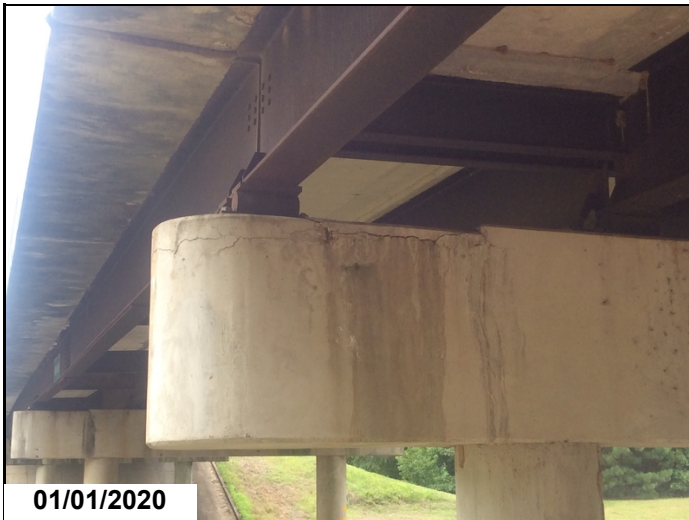
Cap - Bent 2 left : Delamination

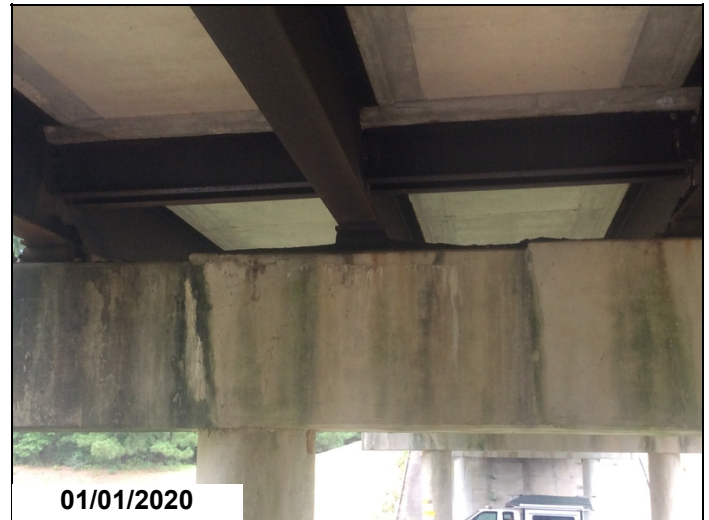
Cap - Bent 4: Delamination

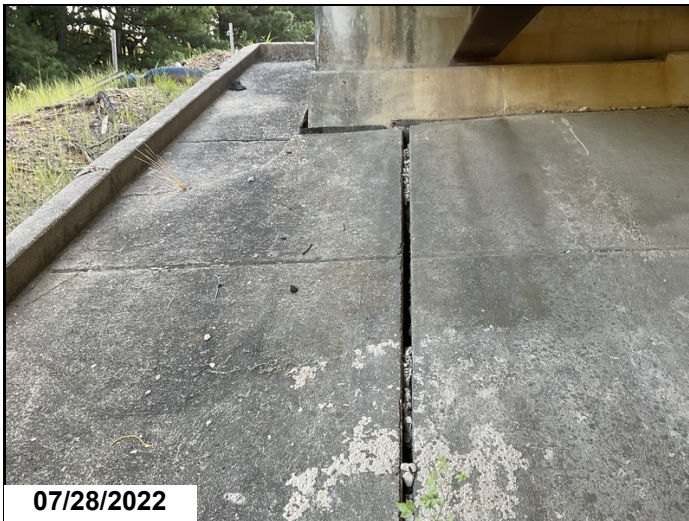
Bent 1 right erosion.

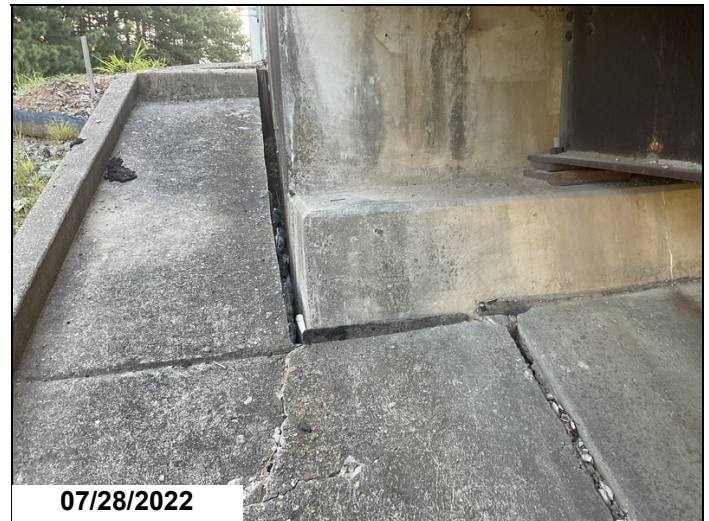
Some erosion starting at top of slope paving running along right side causing separation from end bent.

Bent 1 right slope paving separation due to erosion.

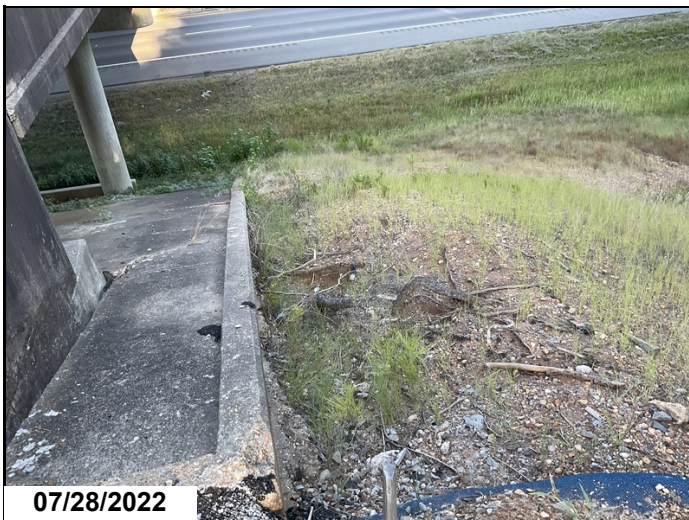
Bent 1 right has erosion at end slopes.

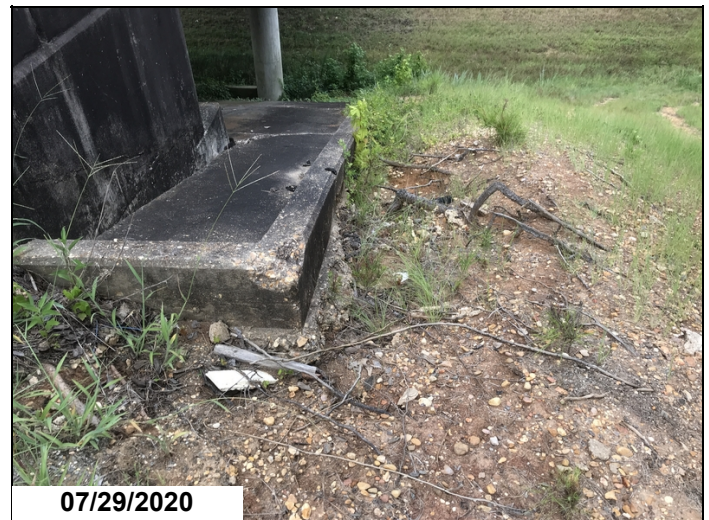
Bent 1 right enslope has erosion.

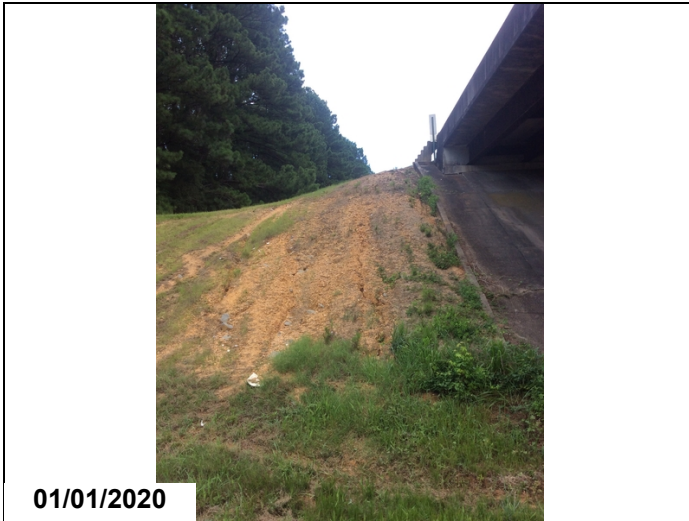
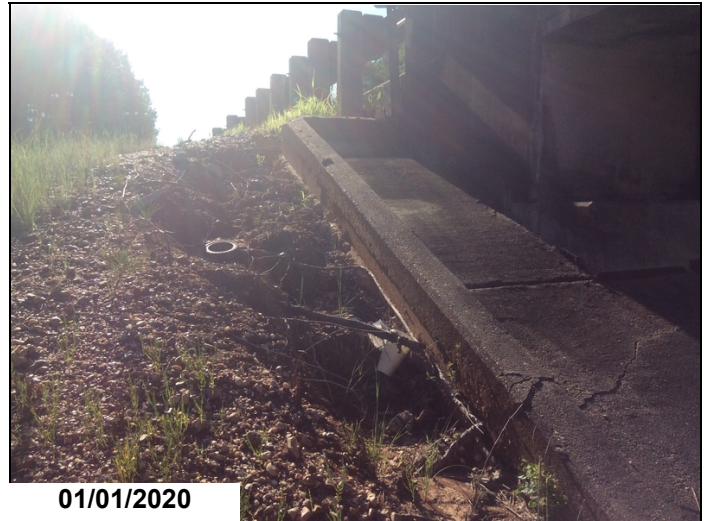
Erosion on slope on east side of slope closest to town

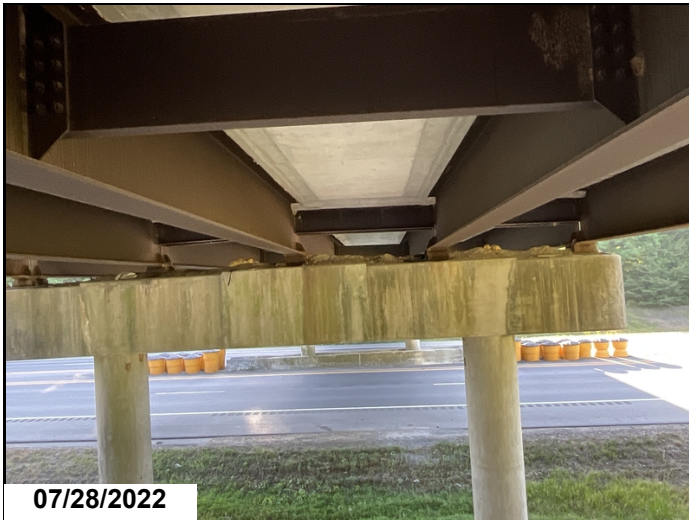
Caps - all bents: Some debris build-up on top of caps due to joint deterioration/leakage and bat defecation, allowing moisture to be retained around bearings, ends of girders, and on top of cap.

Bent 4 cap has debris on cap.

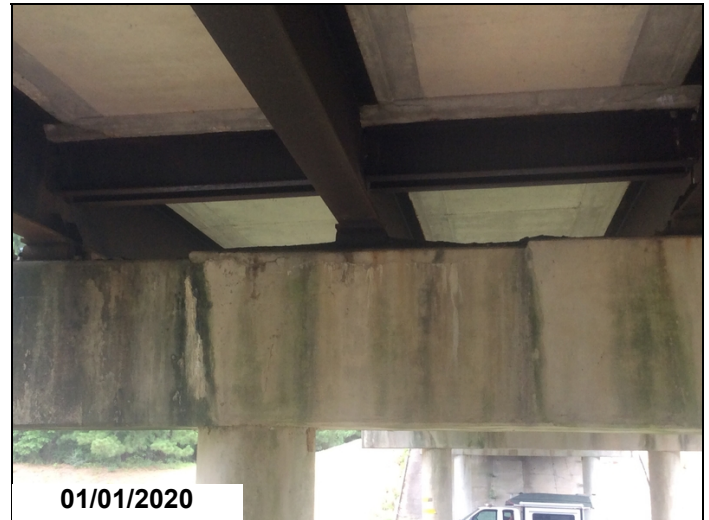
Cap - Bent 4: Delamination

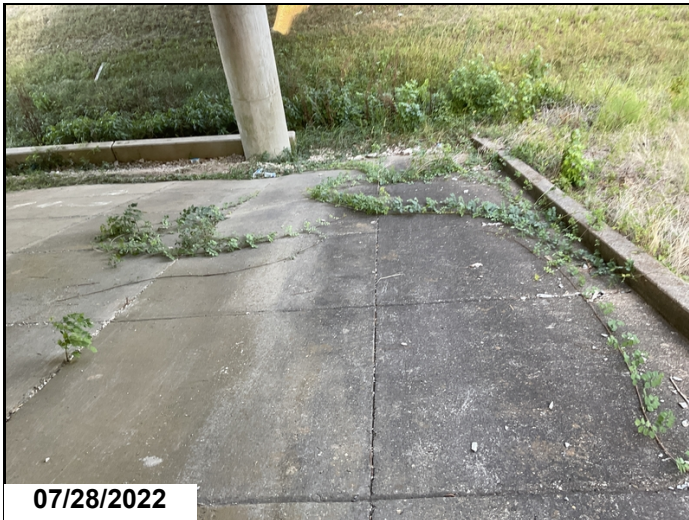
07/28/2022

Abutment 1 concrete riprap-
Vines are over taking slope and walls.

Bent 1 concrete slope paving has vines and vegetation.

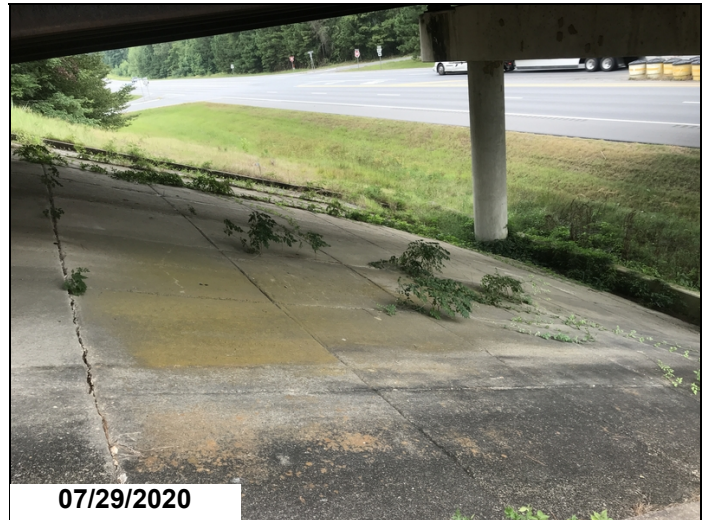
07/29/2020

Bent 1 concrete slope has vines and vegetation growing.
