Asset #05496(Routine)

SH 133-01 LM 13.58 over Beech Creek

Location: 13.58 Mi N US 82-Crossett

Team Lead: Sharon Hooks, Inspection Date: 04/25/2023

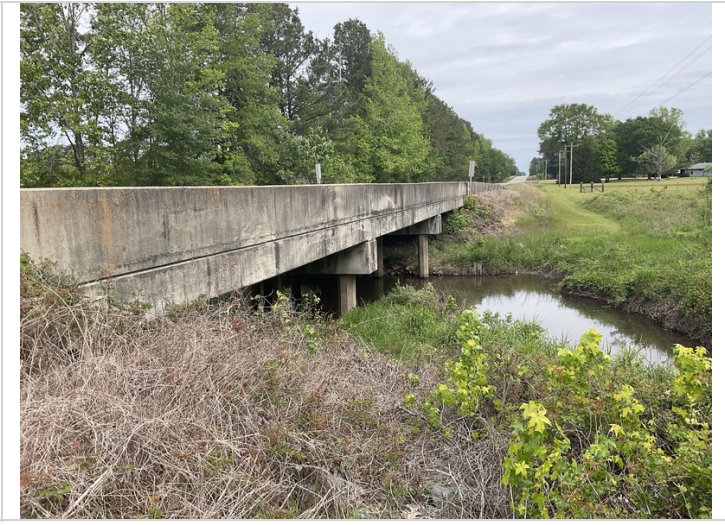
Elevation.

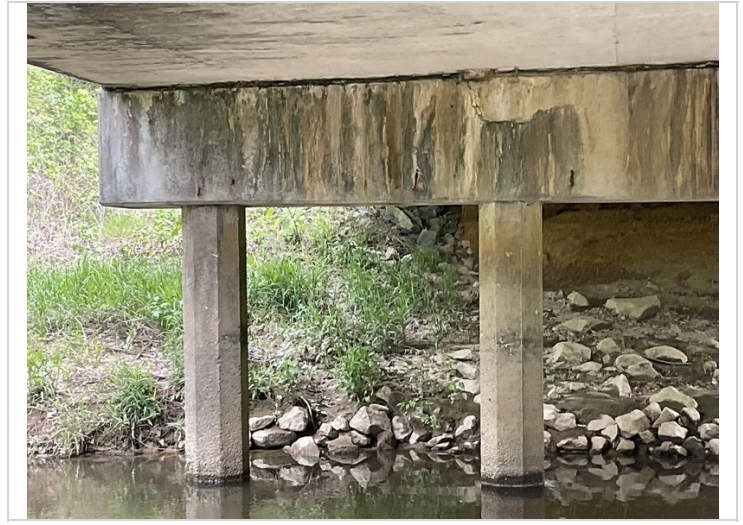
(234) Caps: 31' each /Bents 2-3 Bent 3 back: Near Pile 2.cap has crack with efflorescence .							
301	Pourable Joint Seal	LF	124	0	0	124	0
2350	Debris Impaction	LF	124	0	0	124	0

Bent 3 cap back has delams at keyways.

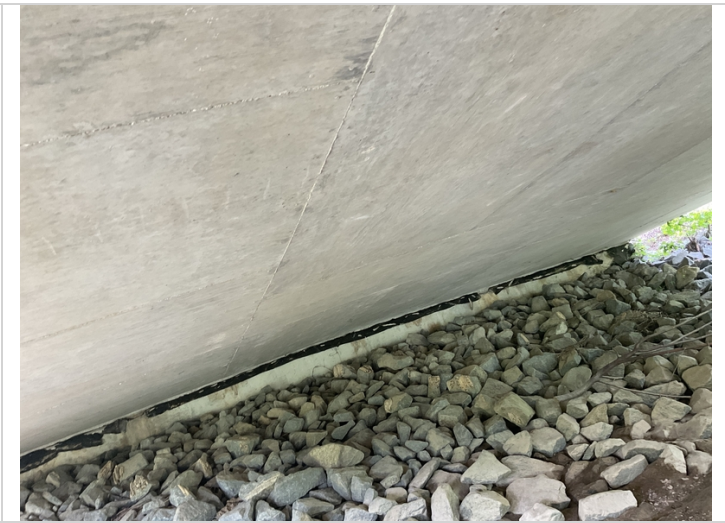
Under view of deck.

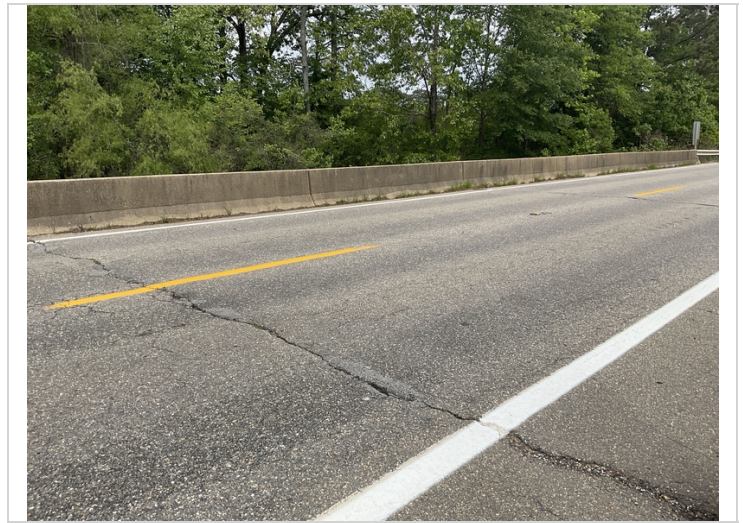
(38) Deck: 30.8' wide x 105' long. Wearing surface - 6" asphalt overlay: 28.4' wide x 105' long. Some rutting (less than 1" deep) and cracking in wearing surface.							
215	Reinforced Concrete Abutment	LF	92	92	0	0	0

Deck over view

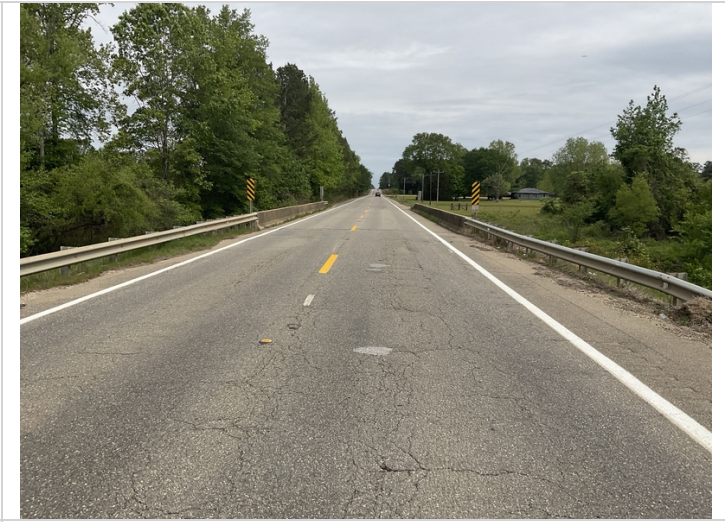
Approach.

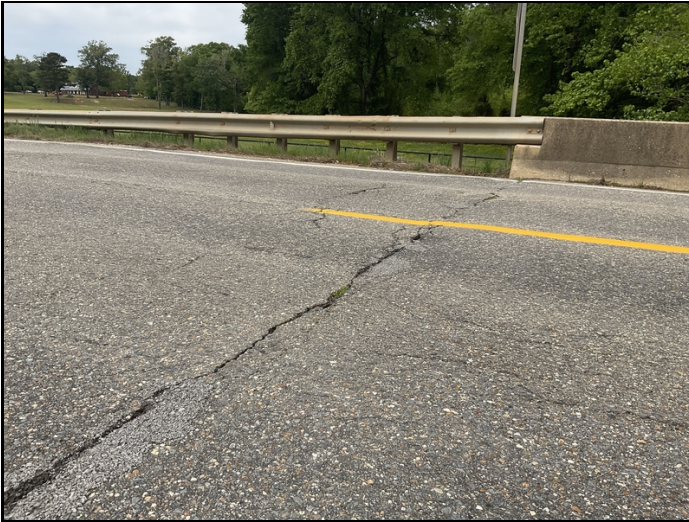
Approach roadway - Bents 1 & 4: Deterioration/cracks in wearing surface - becoming small pot-holes.

Approach roadway has settlement and rutting.

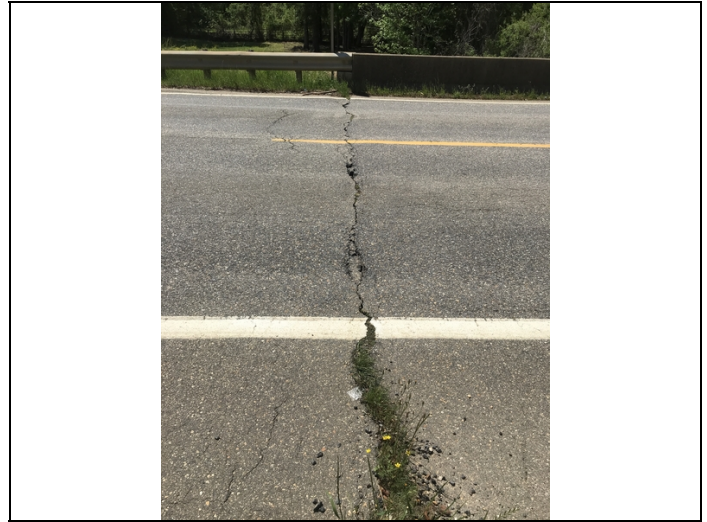
Approach roadway - Bent 1 : Pot holes

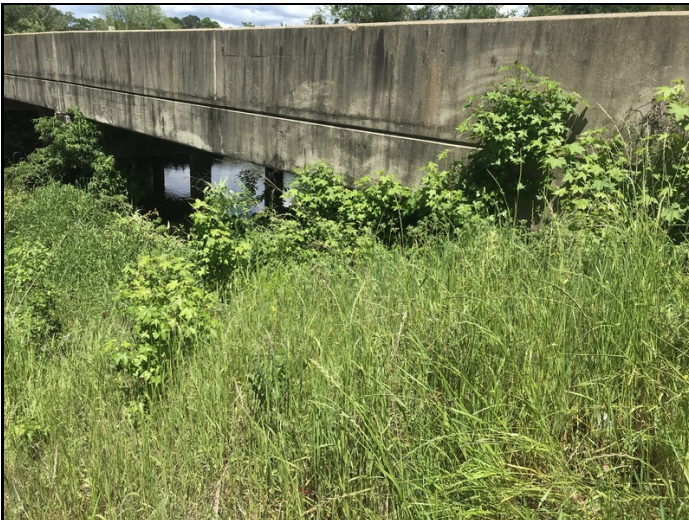
Channel/end-slope - Span 1: Several small trees, bushes, or other vegetation growing under bridge.

End-slope - Bent 1 left : Vegetation
