Asset #05497(Routine)

SH 133-01 LM 14.58 over Fountain Creek

Location: 14.58 Mi N US 82-Crossett

Team Lead: Sharon Hooks, Inspection Date: 04/25/2023

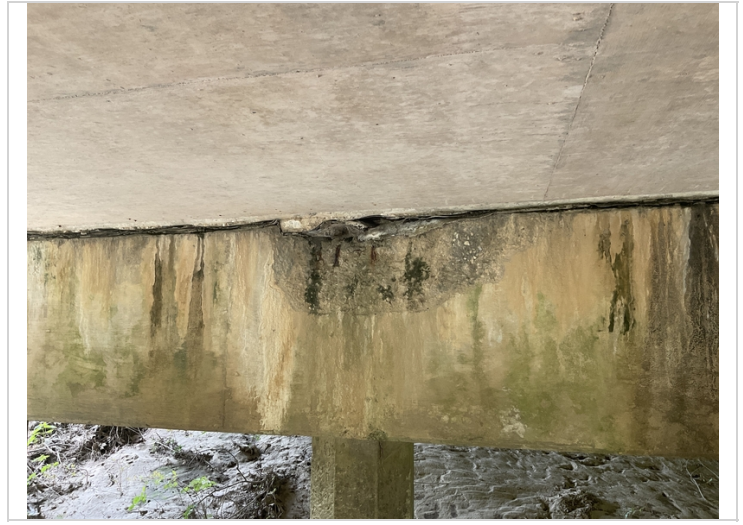
(234) Caps: 31' each /Bents 2-3 Bent 3 back: Spall with exposed rebar over Pile 2/delamination over Pile 4							
301	Pourable Joint Seal	LF	124	0	0	124	0
2350	Debris Impaction	LF	124	0	0	124	0

Bent 3 cap back left at key way has spall with exposed rebar.

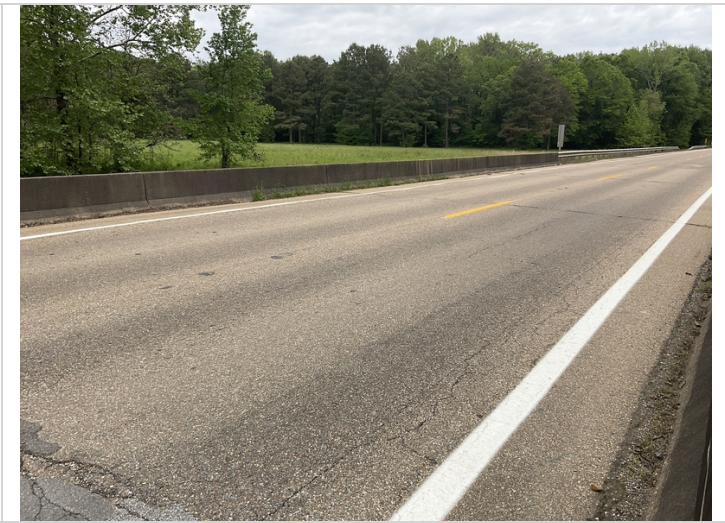
(38) Deck: 30.8' wide x 105' long. Wearing surface - 6" asphalt overlay: 28.4' wide x 105' long. Some rutting (less than 1" deep) and cracking in wearing surface.							
215	Reinforced Concrete Abutment	LF	92	84	8	0	0
6000	Scour	LF	8	0	8	0	0

Deck over view.

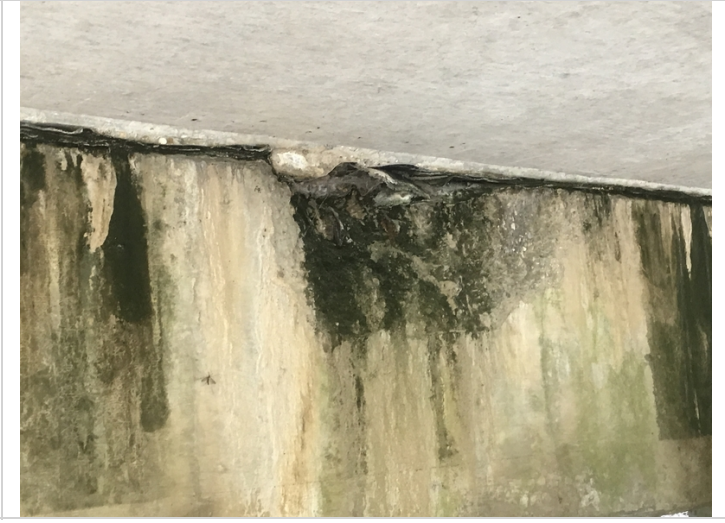
Bent 3 back face has spall with exposed rebar in left key way.

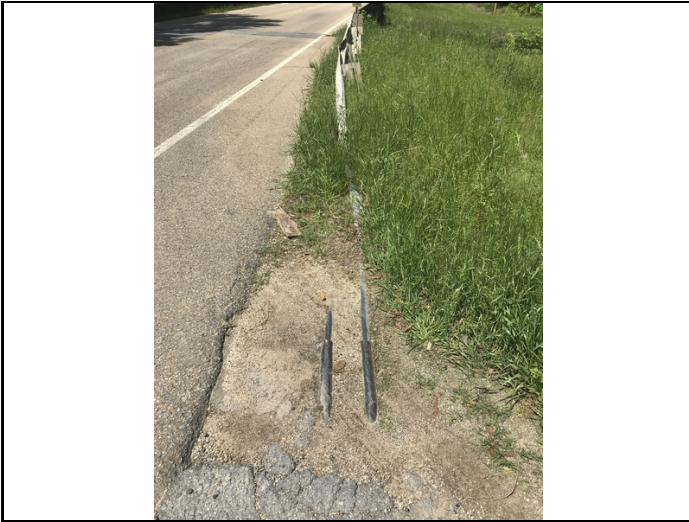
Approach railing - Bent 1 right: Some impact damage to approximately 35' of railing and posts.

Approach railing - Bent 1 right : Damage
