Asset #05498(Routine)

SH 133-01 LM 14.67 over Fountain Creek Relief

Location: 14.67 Mi N US 82-Crossett

Team Lead: Sharon Hooks, Inspection Date: 04/25/2023

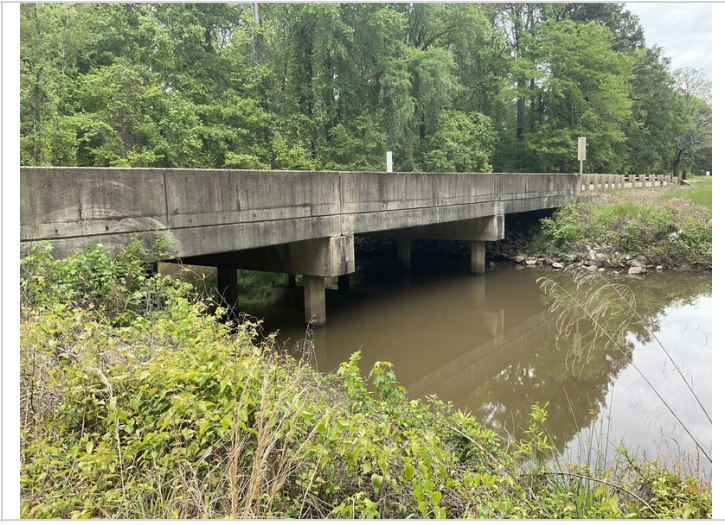
Elevation.

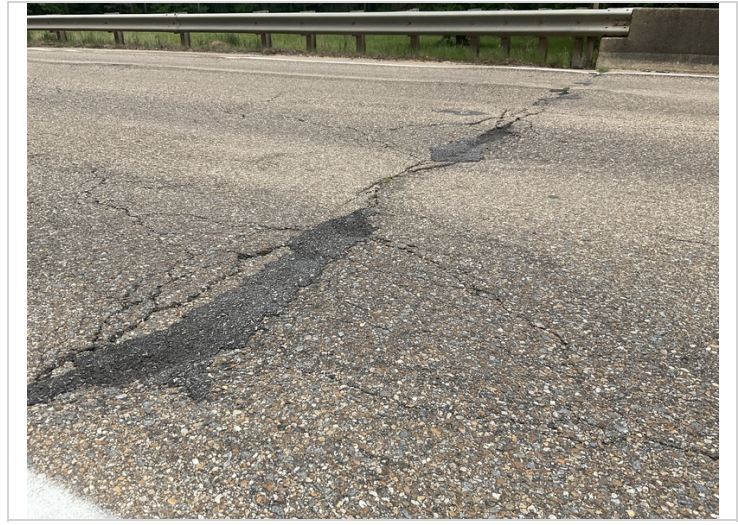
Heavy settlement and rutting on approaches.

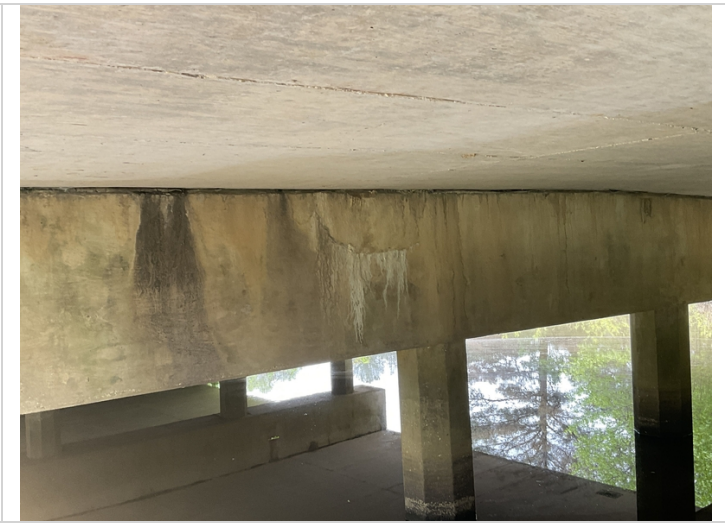
(234) Caps: 31' each /Bents 2-3 Bent 3: Vertical crack/large delamination near left key-way ahead face.							
301	Pourable Joint Seal	LF	124	0	0	124	0
2350	Debris Impaction	LF	124	0	0	124	0

Bent 3 cap right ahead has delam at key way.

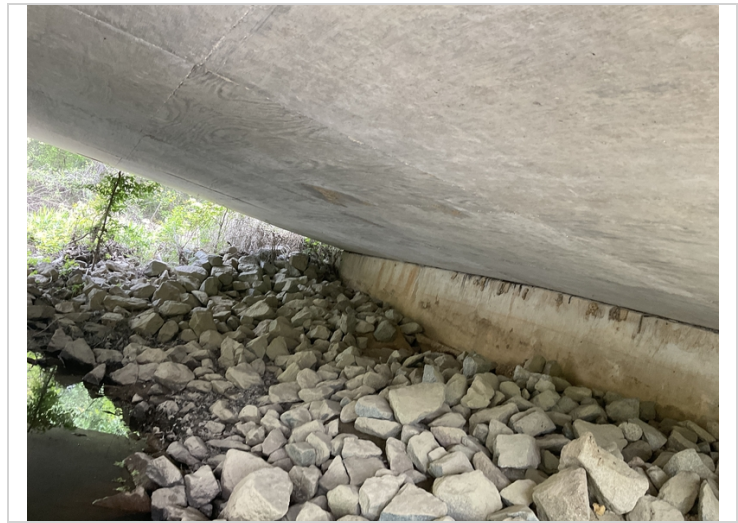
Under view.

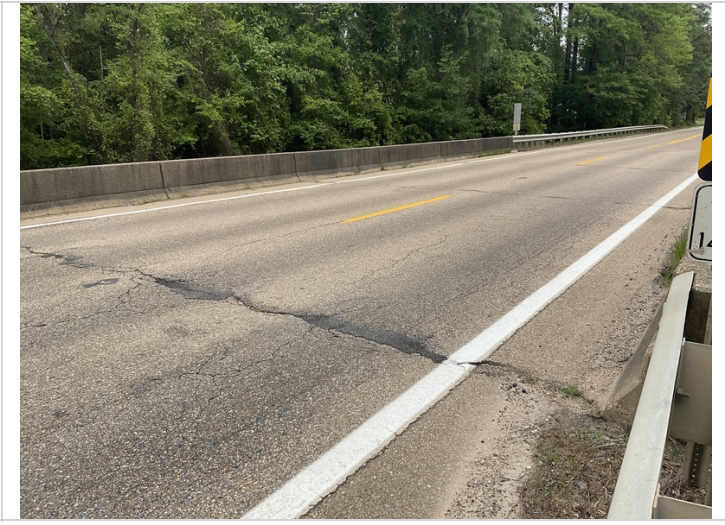
Deck over view.

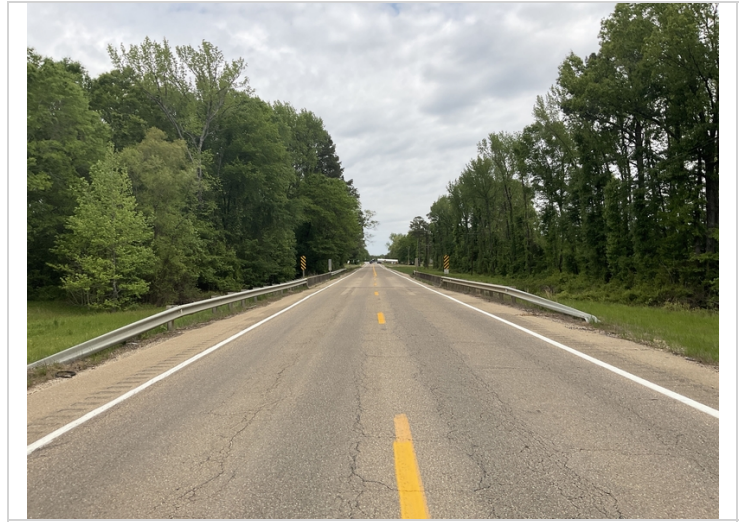
Approach.

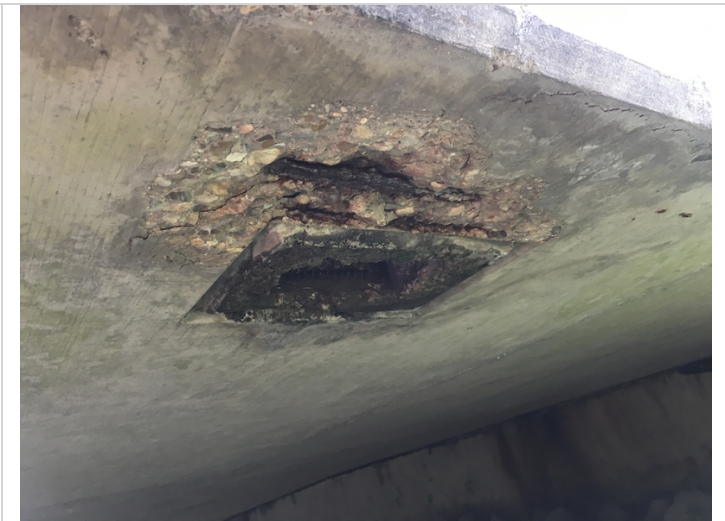
(38) Deck: 30.8' wide x 75' long. Wearing surface - 6" asphalt overlay: 27.9' wide x 75' long. Some rutting (less than 1" deep) and cracking in wearing surface. Soffit - Few hairline cracks on bottom of deck (no efflorescence visible). Span 1 left: Spall with exposed rebar at drain.							
215	Reinforced Concrete Abutment	LF	92	88	0	4	0
6000	Scour	LF	4	0	0	4	0

Span 1 left has small spall at drain opening.

Bent 1 left drain opening has spall with exposed rebar.

Type of Work: Repair (General)
