Asset #30666(Routine)

SH 133-01 LM 11.08 over North Fork Mill Creek

Team Lead: Sharon Hooks, Inspection Date: 04/19/2022

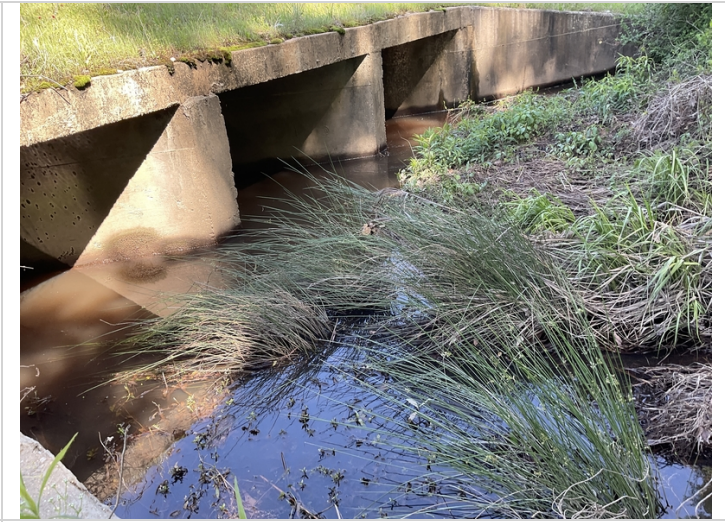
Elevation.

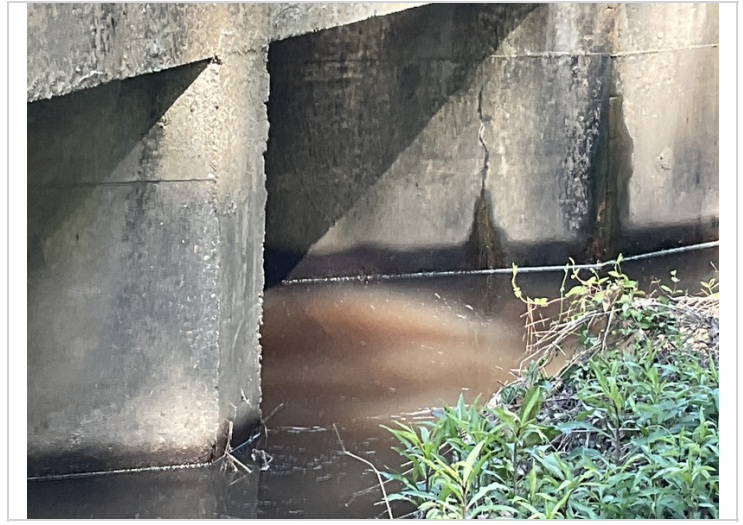
ELEMENTS	DESCRIPTION	UNITS	TOTAL	CS1	CS2	CS3	CS4
241	Reinforced Concrete Culvert	LF	402	398	4	0	0
1090	Exposed Rebar	LF	2	0	2	0	0
1130	Cracking (RC and Other)	LF	2	0	2	0	0
(241) Box culvert: 3 barrels @ 134' each (skewed) = 402' total. Barrel 3 - right: Some exposed rebar (as-built) on bottom of top slab - 2 CS2. Barrel 3 right has cracking on and near wing wall. CS2-2' Some leakage and efflorescence on bottom of top slab along extension points, especially on right side.

Barrel 3 right has cracking on wall and near wing wall..

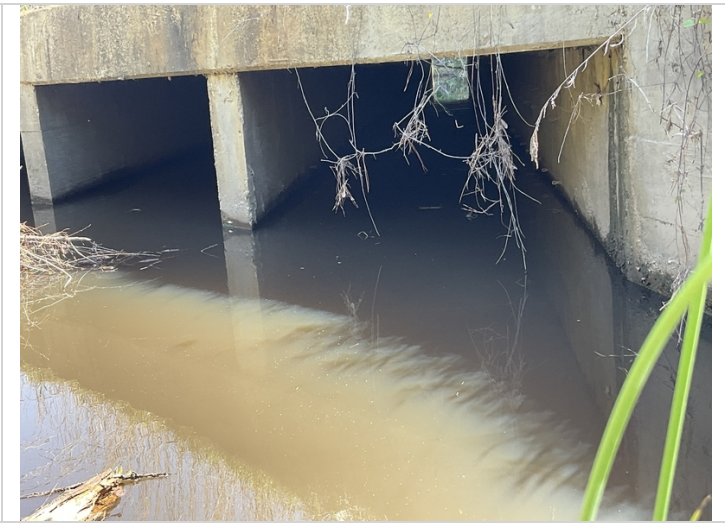
Barrel 1 view.

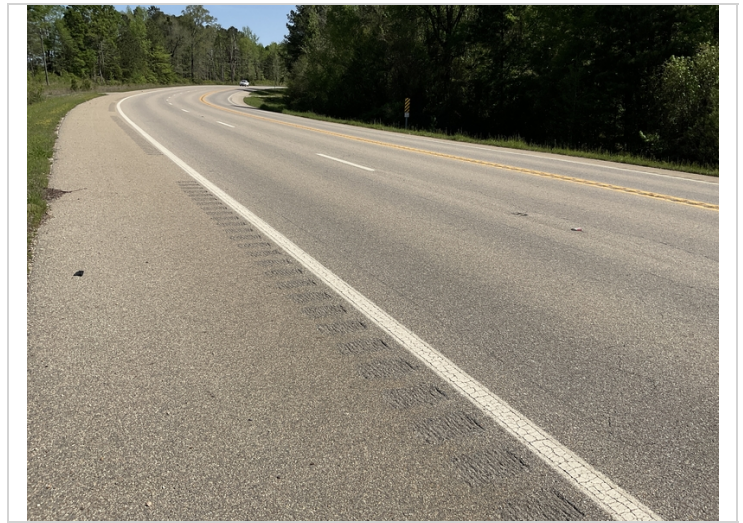
Deck overview.

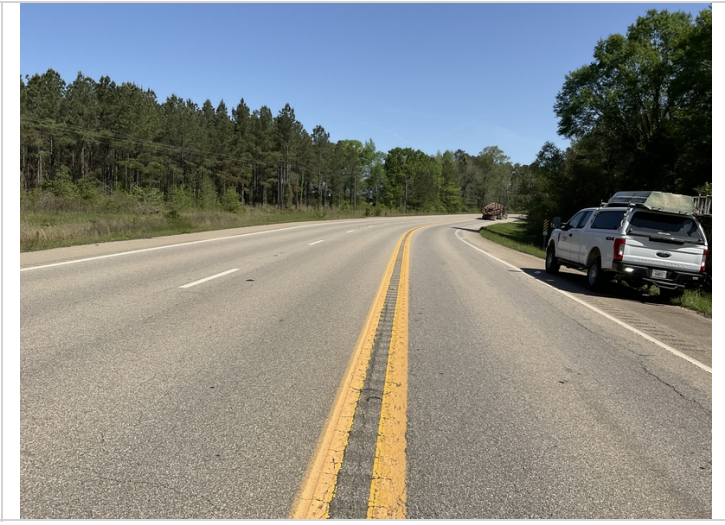
Approach.

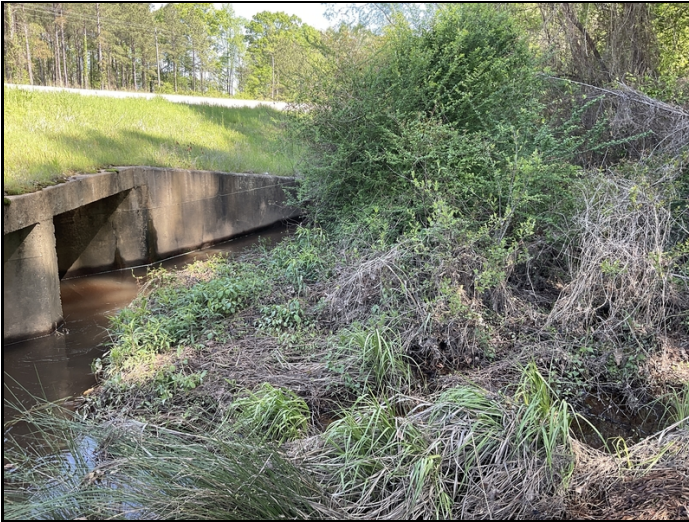
Right side (inlet end)of culvert has trees, vines and vegetation impeding water flow.

Trees, vines and vegetation on right side (inlet end) of culvert.

Type of Maintenance	Is recommended?
A-54 - Sealable Deck Cracks	
A-55 - Deck Washing Needed	
A-56 - Joint Cleaning/Flushing Needed	
A-57 - Beam End and Bearing Paint Needed	
A-58 - Cap Cleaning/Flushing Needed	
A-59 - Joint Repair Needed	
A-60 - Full Beam Painting Needed	
A-61 - Polymer Overlay Advised	
A-62 - Hydro and LMC Advised	
A-63 Missing/Incorrect Log Mile Signage	
A-64 - Vegetation Removal Requested
