Asset #X1218(Routine)

SH 133-01 LM 7.12 over Whiteoak Creek

Location: 7.12 Mi N US 82-Crossett

Team Lead: Greg Loomis, Inspection Date: 05/02/2023

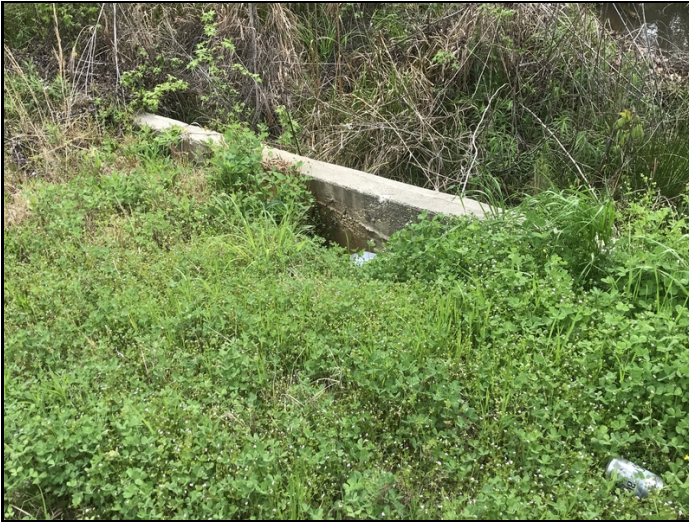
Barrel 1 left (southwest) & Barrel 4 right (northeast) wing-walls: Erosion exposing back face of wing.

Northeast wing wall has some erosion exposing back face of wing.

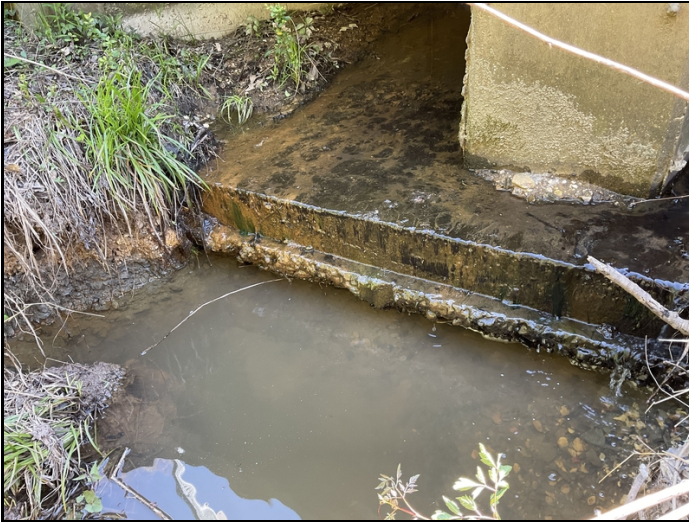
Channel - Barrels 3-4 left: Area of erosion (6" x 6" x 4' long) along face of bottom slab - beginning to undermine.

Channel - Barrels 3-4 left: Erosion

**Type of Work:** Channel Work/Drift Removal
