**Asset #M2572**(Routine, Underwater type 2)

**SH 256-01 LM 1.68 over Caney Creek**

**Location: 0.4 Mi E SH 365-WhiteHall**

**Team Lead: Greg Loomis, Inspection Date: 10/06/2022**

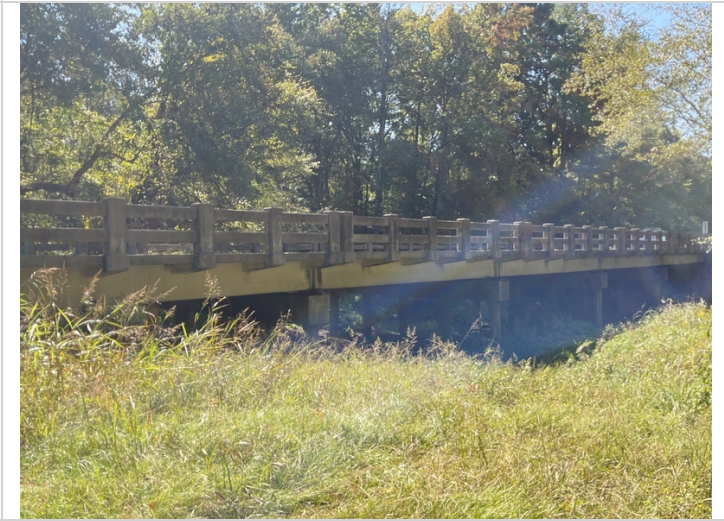
Left side view

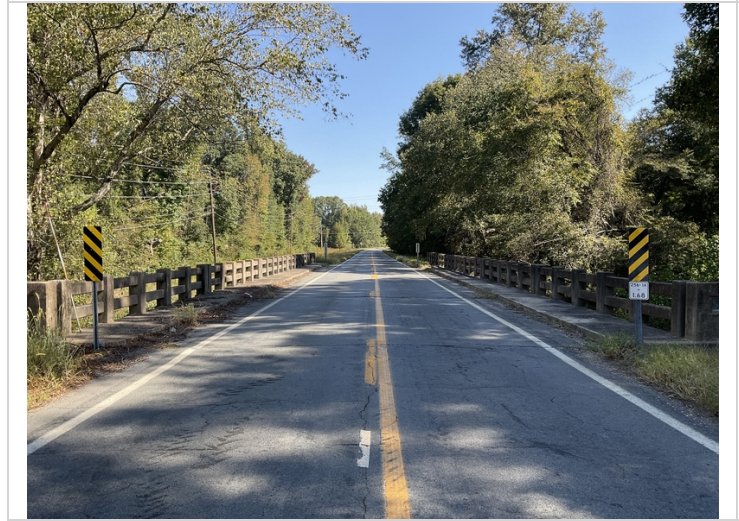
Roadway view

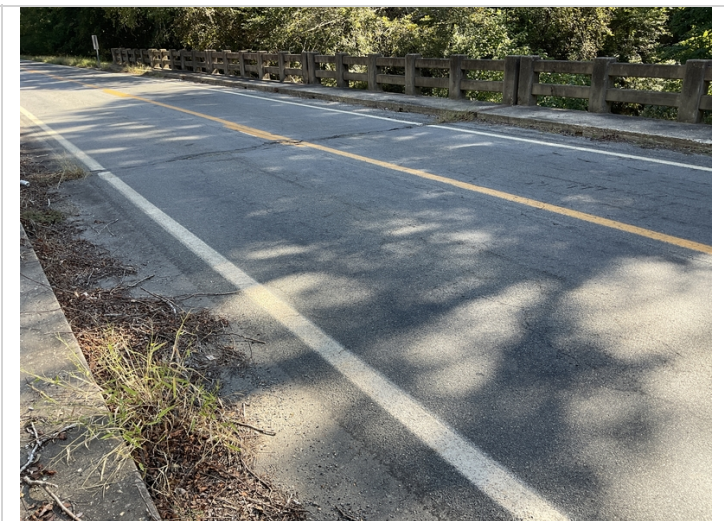
Deck - Spans 1-5: Typical

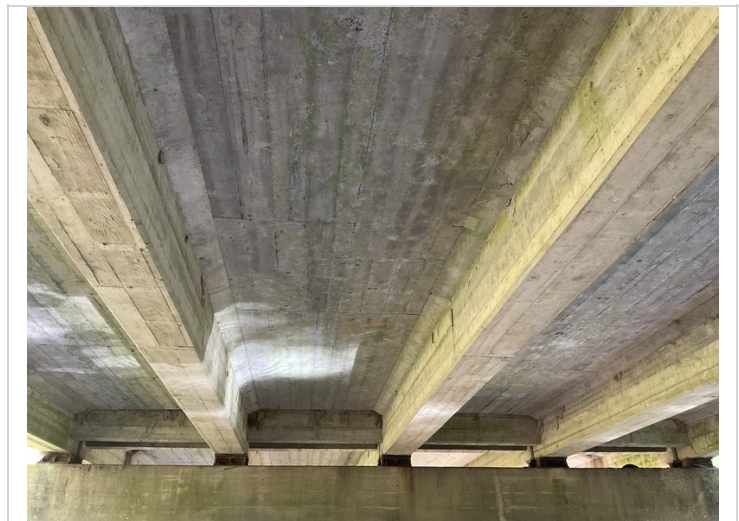
Soffit - Span 2: Typical

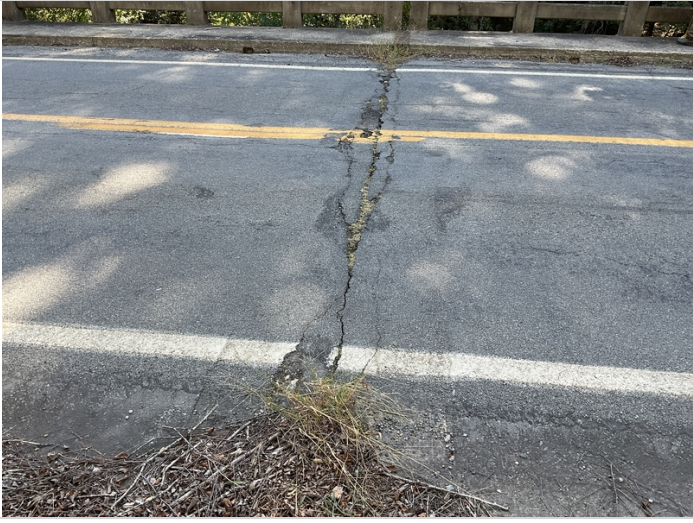
(16) Deck: 30'-6" wide (3'-9 1/2" STEP-UP each side) x 150' long = 4575 sqft. Wearing surface: 28' wide x 150' long = 4200 sqft.  Wearing surface: Some cracking/deterioration/spalling(potholes at bents, especially Bent 2 - 84 sqft CS4 spalling; 140 sqft CS3 cracking. Scattered large-scale map cracking across most of travel lanes - 1530 sqft CS3 cracking.							
110	Reinforced Concrete Open Girder/Beam	LF	750	706	0	44	0
1080	Delamination/Spall/Patched Area	LF	20	0	0	20	0
1090	Exposed Rebar	LF	20	0	0	20	0
1130	Cracking (RC and Other)	LF	4	0	0	4	0

Wearing surface - Bent 2: Spalling

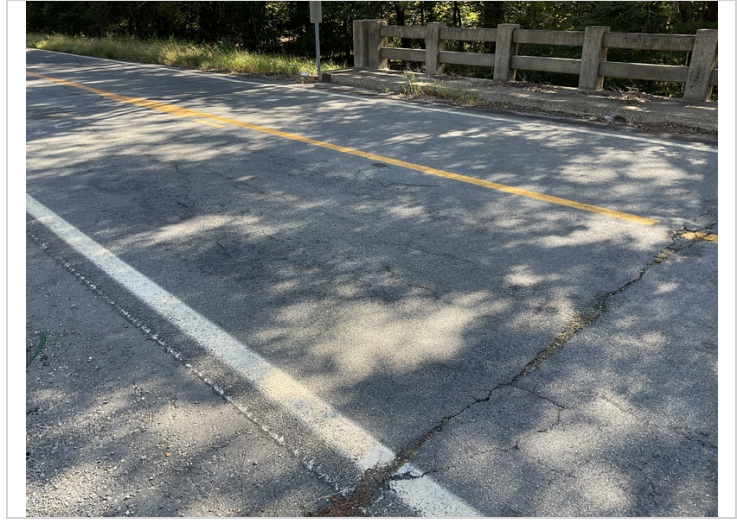
Wearing surface - Span 5: Cracking

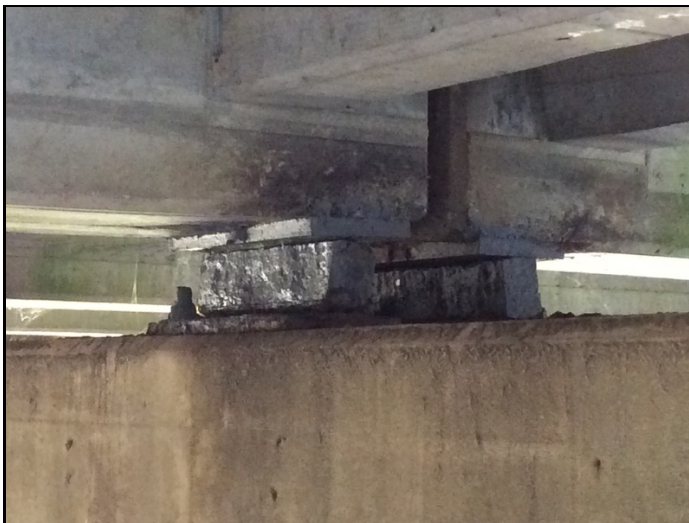
Moveable bearings – Bents 2 back & ahead and Bents 3-5 ahead: Corrosion with pack rust between rockers and masonry plate - making movement of bearing difficult.

Fixed bearings – all bents: Corrosion with minor section loss (pitting & flaking).

Bent 2 Bearings 4 (corrosion)

Clean - repaint bearings- re-establish at the correct angle

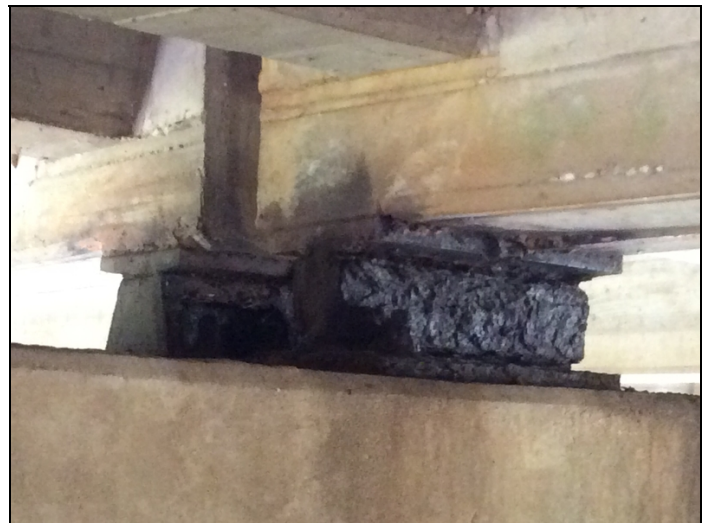
Bent 5 Bearings 3 (corrosion)

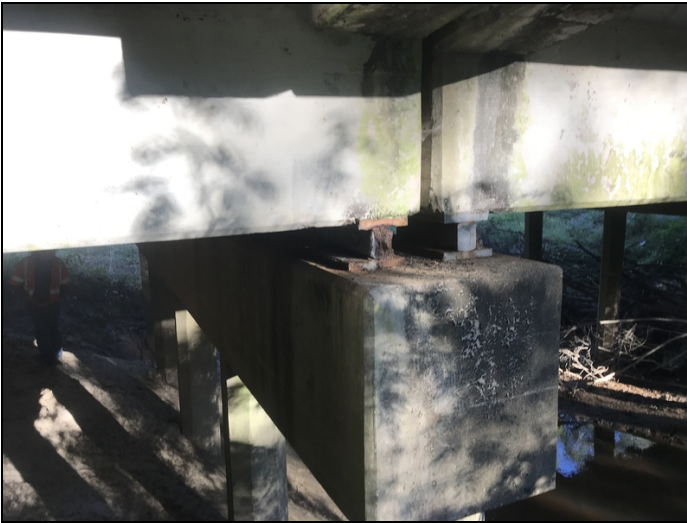
Bent 2 bearing 5 has heavy flaking rust.

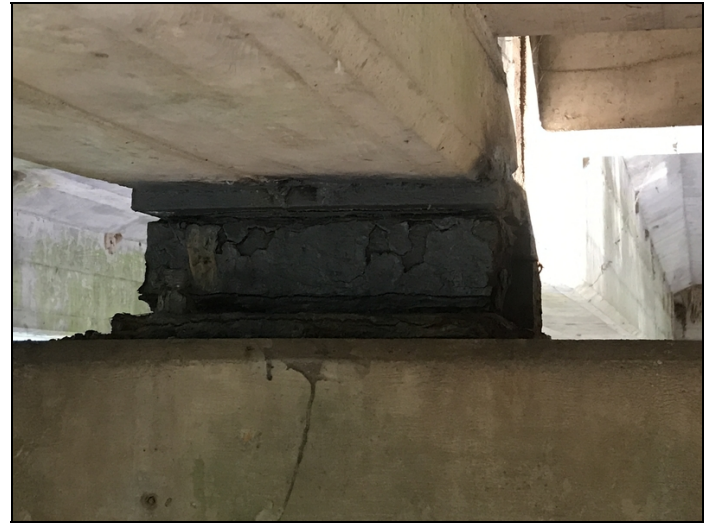
Bent 2 bearing 2 has has heavy flaking corrosion .

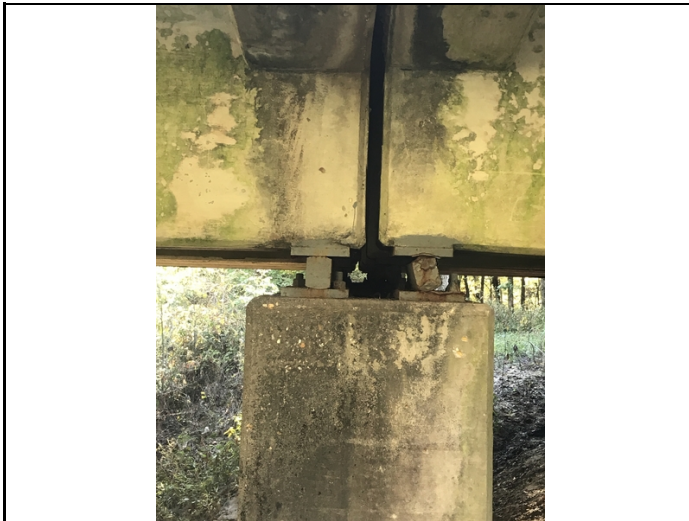
Bent 2 Bearings 1-5 back: Bearings are leaned ahead right near limits.

Bent 2 - Bearing 1 left: Corrosion and leaning

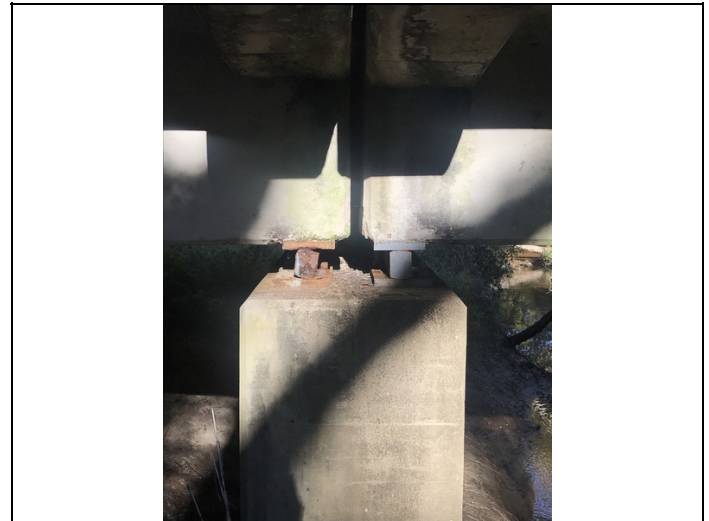
Bent 2 - Bearing 5 right: Corrosion and leaning

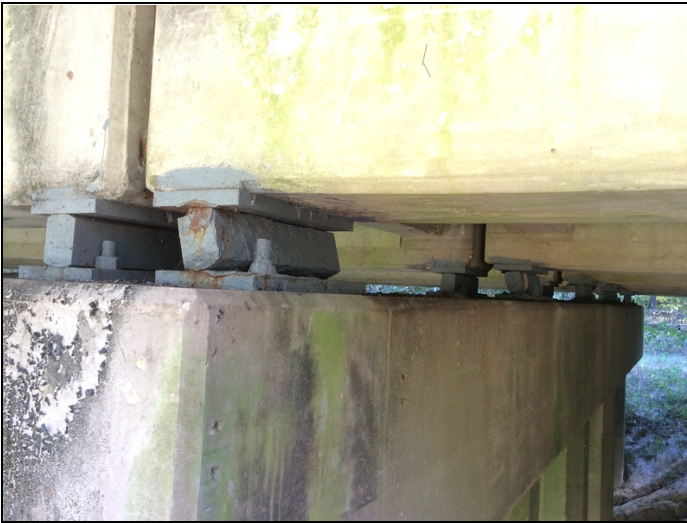
Bent 2 back side bearings (leaning ahead)

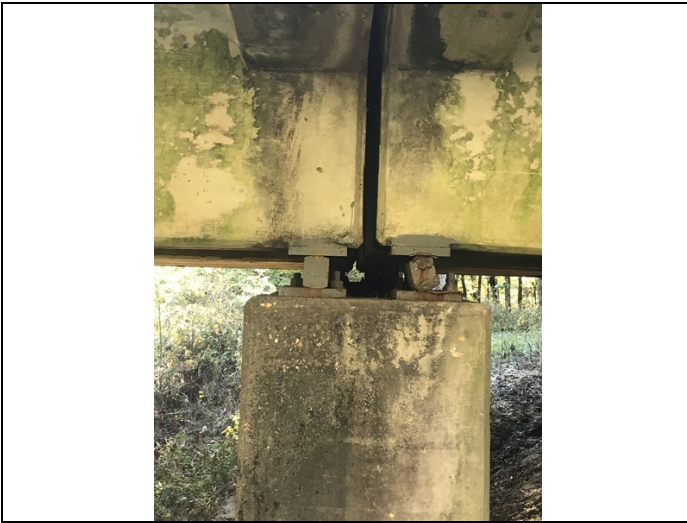
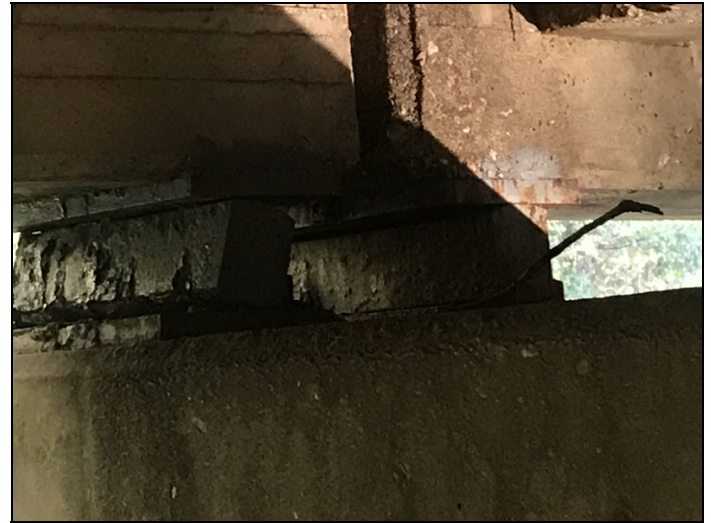
Bent 2 bearing 1 is leaning extremely.

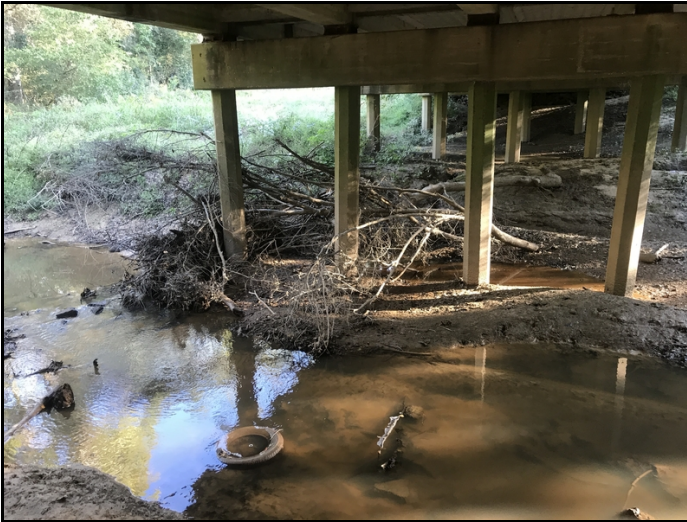
Channel - Bent/Span 3: Build-up of logs, limbs, and other debris against pile and under span, restricting water flow.

Tree and debris at bent 3 piles .

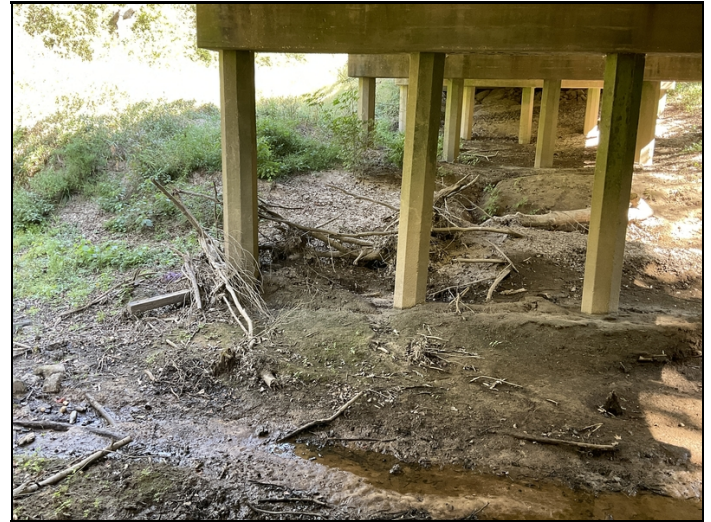
Channel - Bent 3: Debris build-up

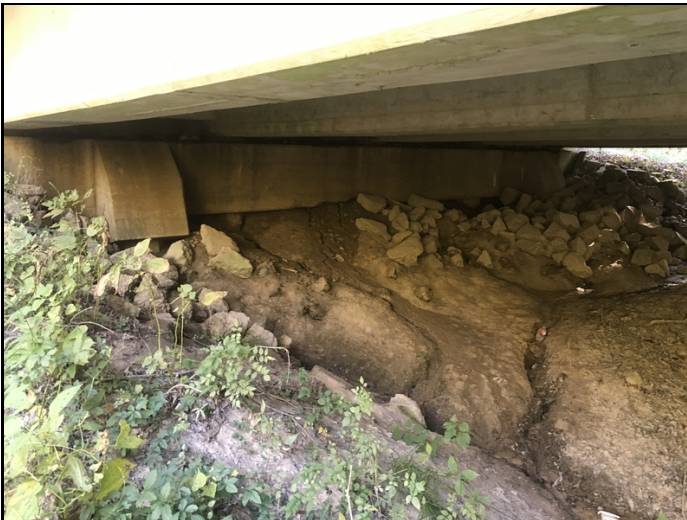
Channel/end-slope - Span 5: Some erosion of slope material in various locations (exposure of underside of abutment & piling on right side)

Abutment - Bent 5 : Erosion

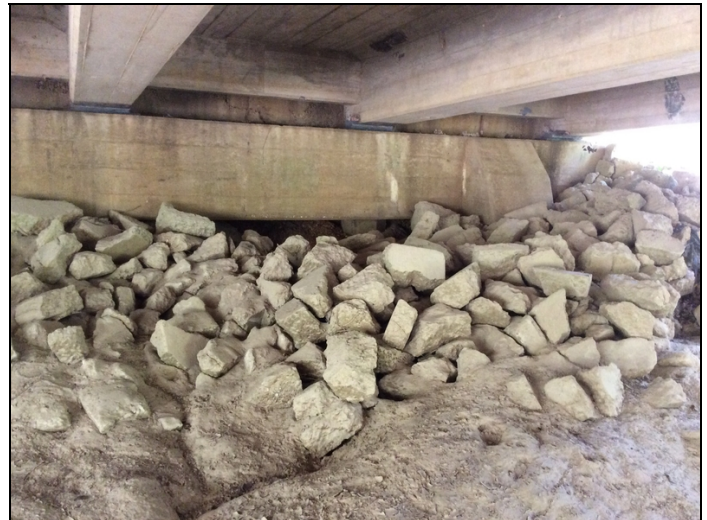
Endslope - Bent 5 right (erosion/settlement)
