Asset #00832(Routine)

US 425-06 LM 0.86 over Cane Creek

Team Lead: Sharon Hooks, Inspection Date: 10/20/2022

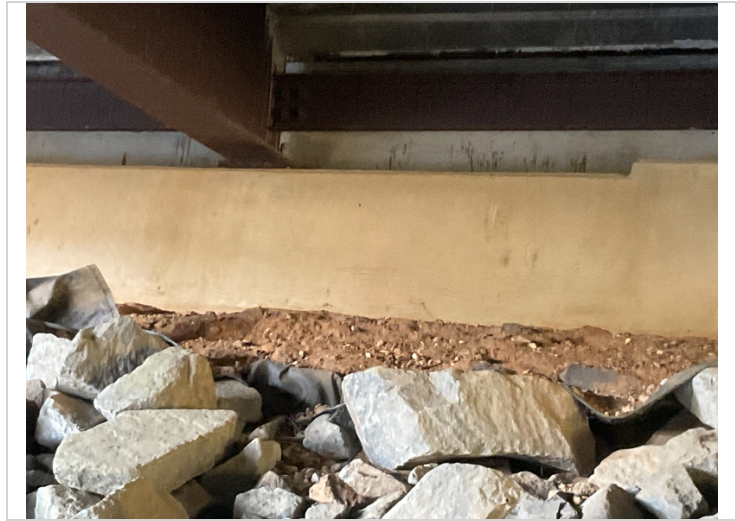
(215) Abutments: 80' each / Bents 1 & 4. Both abutments have hairline vertical cracks. Top of back walls map cracking is moderate. Bent 1 abutment has horizontal cracks in face of cap. Abutment - Bent 4 left: Map cracking							
227	Reinforced Concrete Pile	EA	18	18	0	0	0

Bent 1 abutment has cracking.

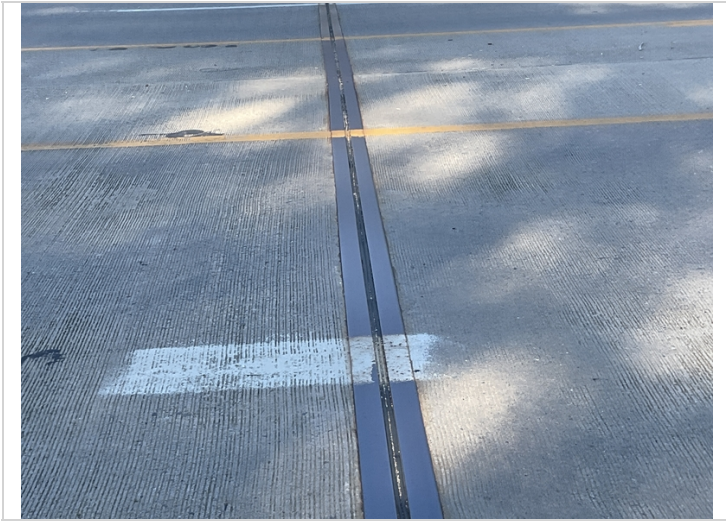
(302) Joints: 70' each / Bents 1-4. Adhesive starting to loosen at various locations on preformed joint seals. Minor cracking in joint material Bent 1.							
311	Movable Bearing	EA	24	24	0	0	0
515	Steel Protective Coating	SF	24	24	0	0	0

Bent 3 joint seal has some loss of adhesion.

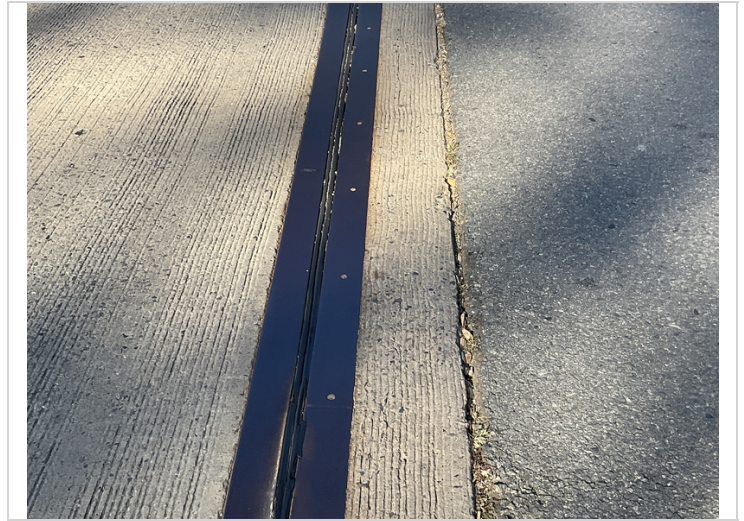
Bent 4 concrete header has cracking right lane northbound.

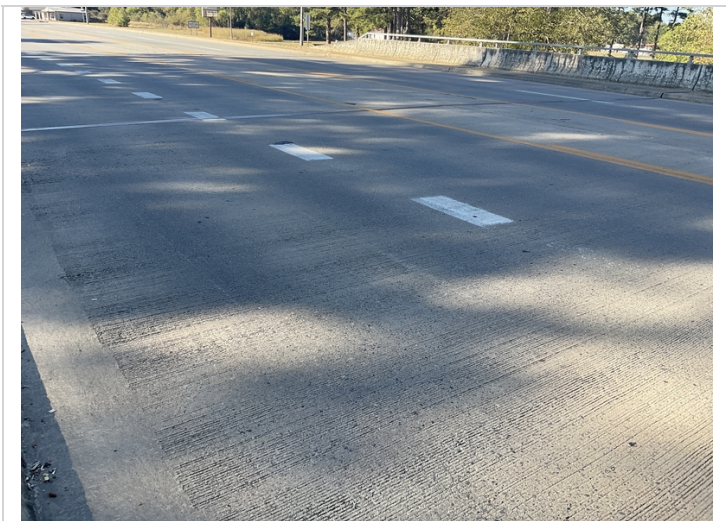
(12) Deck: 73.3' wide x 92' long. Some map cracking in curbs around deck joints. Spans 1-3: 2 longitudinal cracks with scattered hairline map cracking. Soffit- Left side : Light Cracking with efflorescence on overhang.							
107	Steel Open Girder/Beam	LF	720	720	0	0	0
515	Steel Protective Coating	SF	4363	3543	820	0	0
3430	Oxide Film Degradation Color/Texture Adherence(Steel Protective Coatings)	LF	820	0	820	0	0

Deck over view.

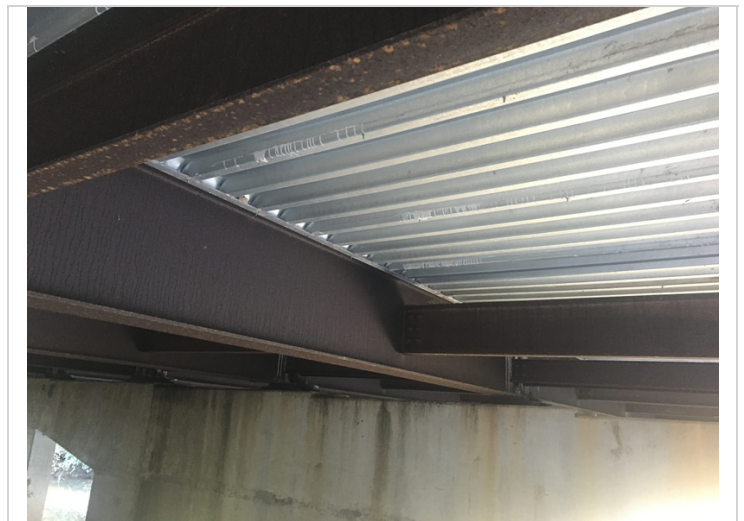
(107) Girders 8 per span / Spans 1-3 (90' total span). Coating: W24x68 = 6.06 square feet per linear feet of girders. Outsides of outer 2 girders are brown with a granular texture with all girders showing early signs of aging.							
215	Reinforced Concrete Abutment	LF	160	64	72	24	0
1130	Cracking (RC and Other)	LF	96	0	72	24	0

Overview of soffit and girders.

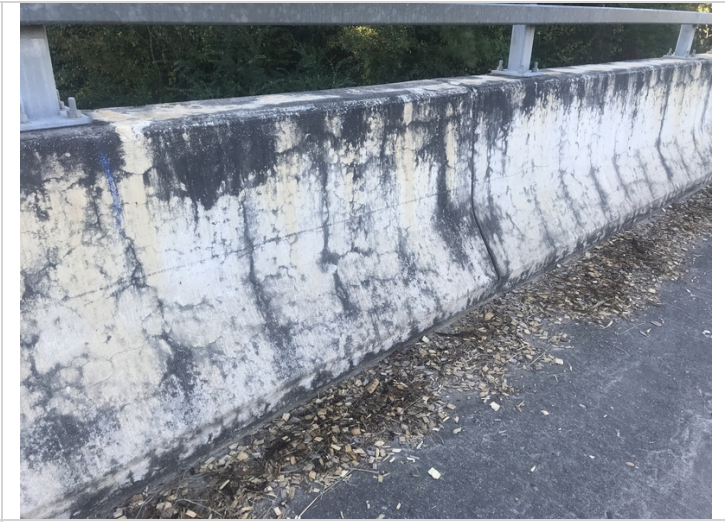
Bridge rail right side has map cracking. Common left.

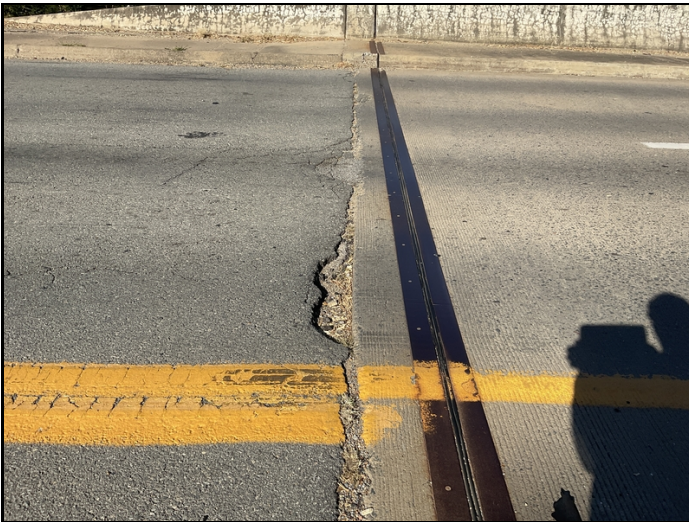
Approach Bent 1 asphalt has spalled away leaving pot hole on South end of bridge.
(Common on bent 4 right lane southbound lane.)

Asphalt approach on South end of bridge at Bent 1 has some potholes in both lanes.

Type of Work: Repair (General)

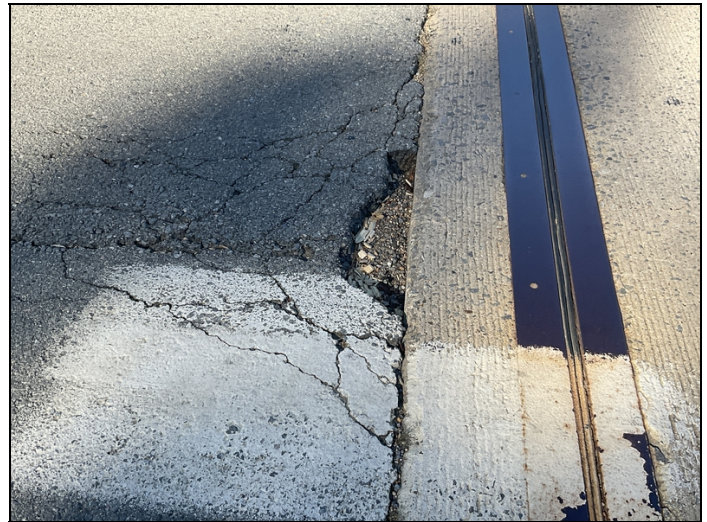
Bent 1 asphalt approach has spalling and a few potholes.
(common on bent 4 right lane headed south .)
