Asset #A6681 (Routine)

US 425 SB LM 5.83 over Bayou Bartholomew

Location: 4.3 Mi S SH 199-Yorktown

Team Lead: Greg Loomis, Inspection Date: 10/27/2022

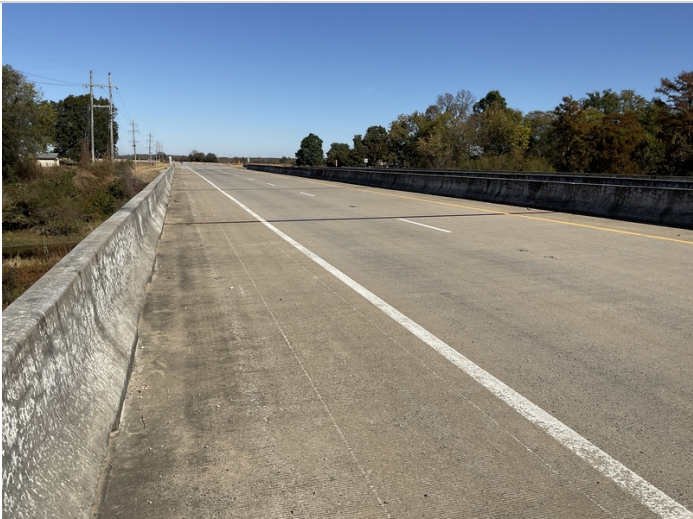
ELEMENTS	DESCRIPTION	UNITS	TOTAL	CS1	CS2	CS3	CS4
12	Reinforced Concrete Deck	SF	13475	13400	75	0	0
1130	Cracking (RC and Other)	SF	75	0	75	0	0
<p>(12) Deck: 40'-10" wide x 330' long = 13, 475 sqft. Very light abrasive wear with very light map cracking in scattered areas, especially in wheel ruts. A few small longitudinal cracks per span.</p>

Deck - Spans 1-3: Typical

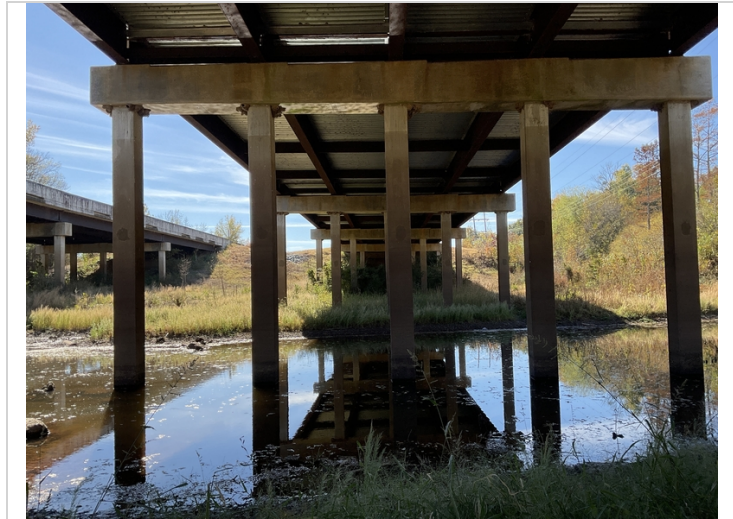
Soffit - Span 4: Typical

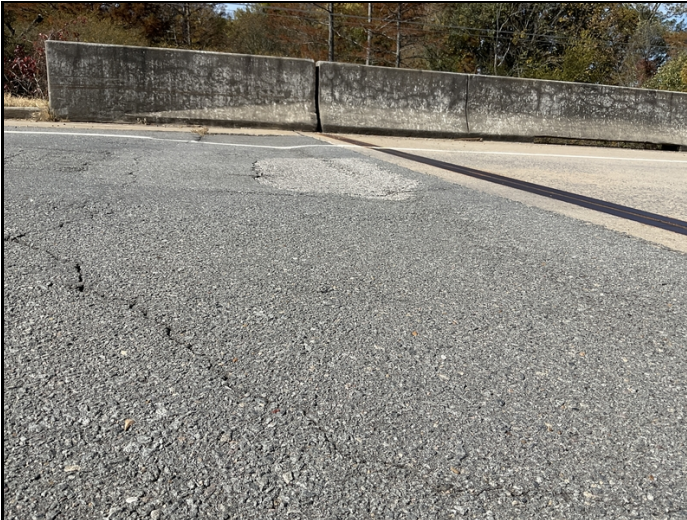
Approach roadway - Bent 1 left: Significant settlement of roadway - right at bridge end.

Approach roadway - Bent 1 left: Settlement

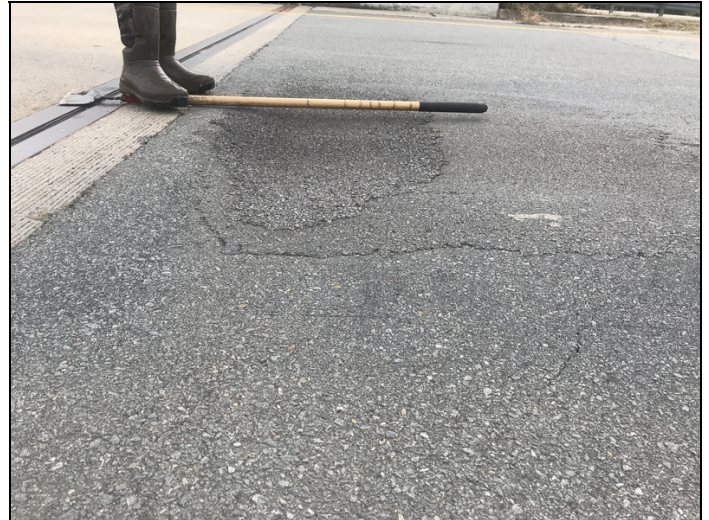
Right lane south bound, approach road way has settlement due to erosion under cap at abutment at bent 1.

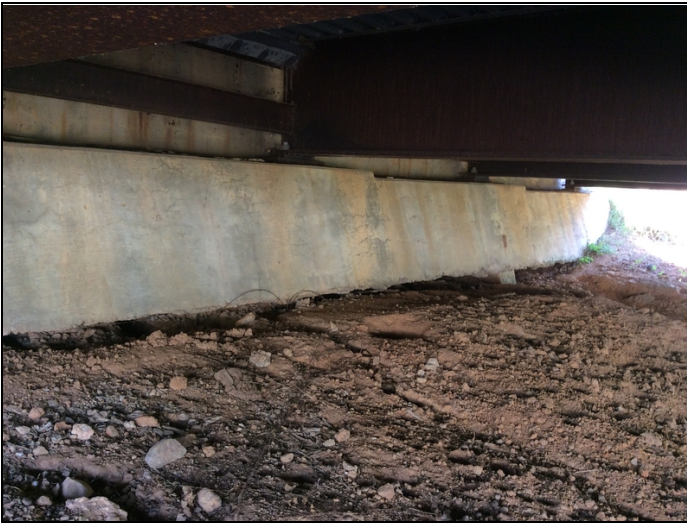
End-slope - Bent 1: Some erosion/scour with undermining under and behind abutment cap and settlement of roadway.

End slope - Bent 1 (settlement/scour)

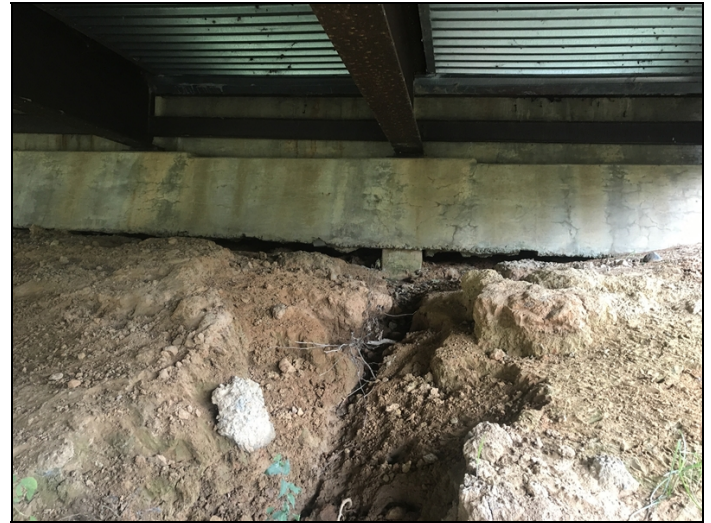
Bent 1 abutment has erosion on left side under cap.

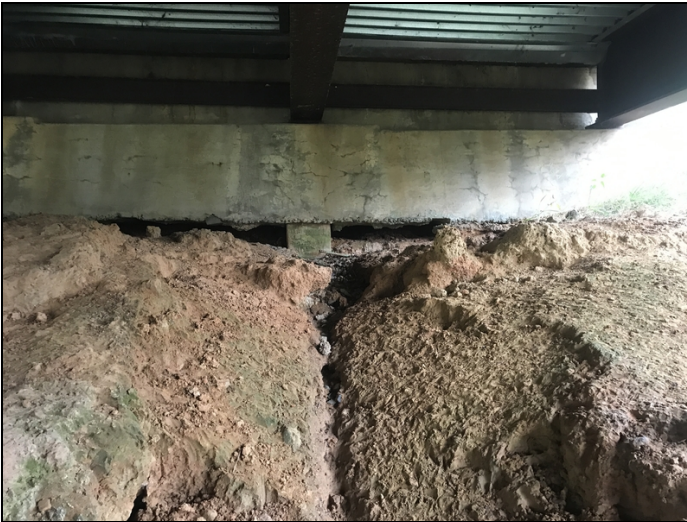
Bent 1 abutment has erosion exposing bottom of cap and pile.

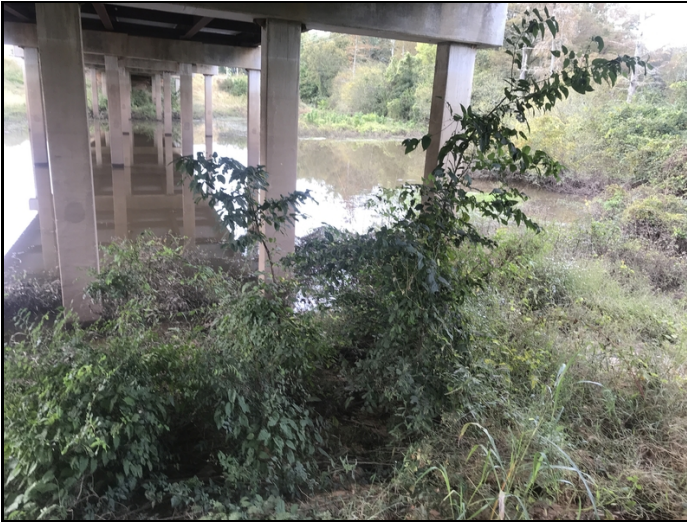
Span 7 trees and vegetation growing under bridge.

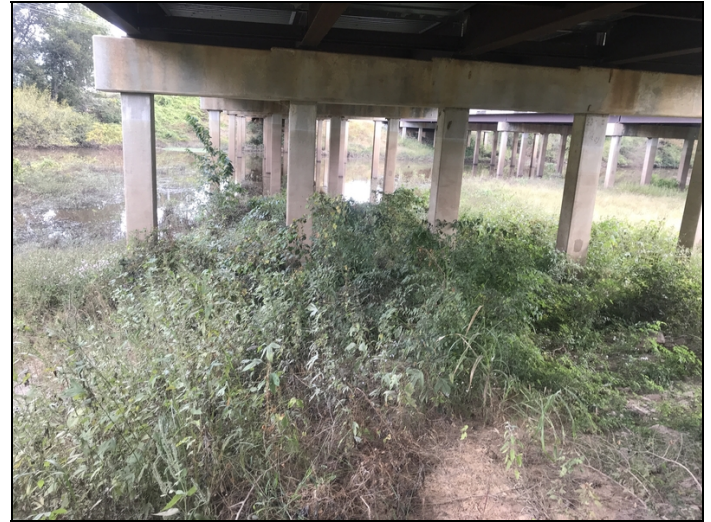
Trees and vegetation growing under bridge.

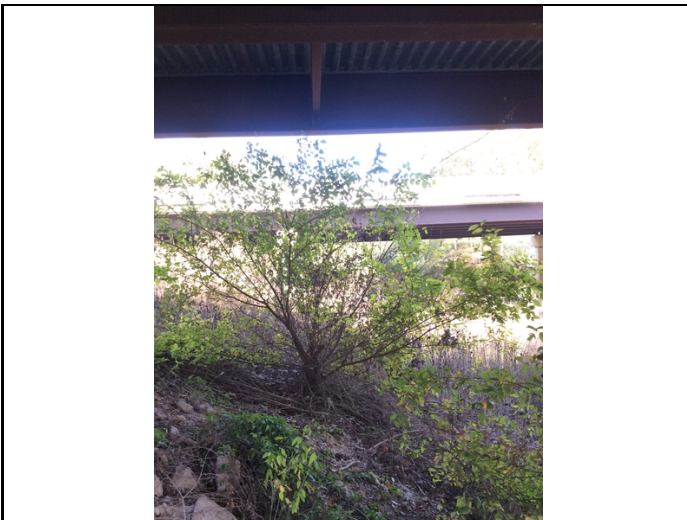
Channel - Spans 1-3 & Span 6: Numerous small trees, bushes, and other vegetation growing up under bridge.

Channel - Span 6 (vegetation)

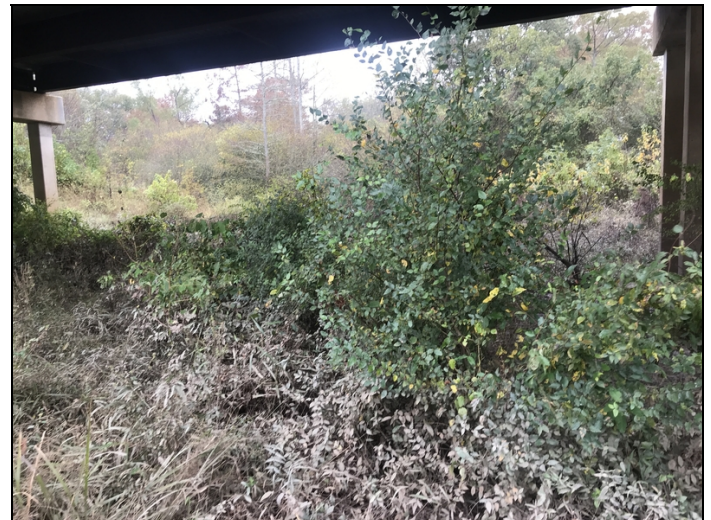
Span 2 trees under bridge.

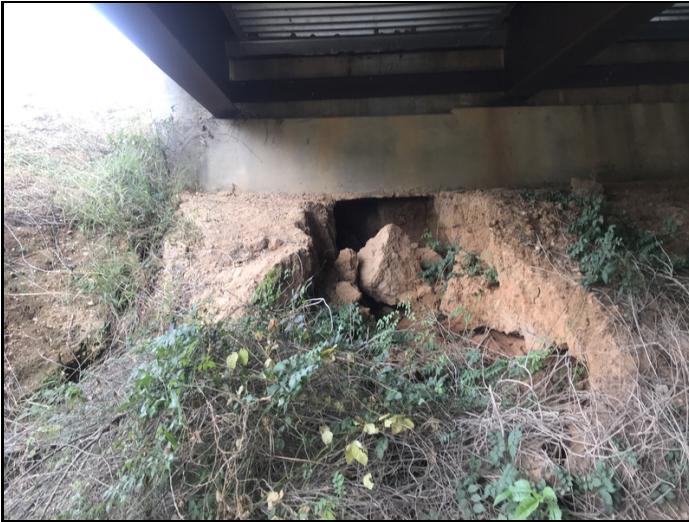
End-slope - Bent 7: Some erosion/scour with undermining under and behind abutment cap.

Bent 7 left side has erosion under approaching towards roadway.

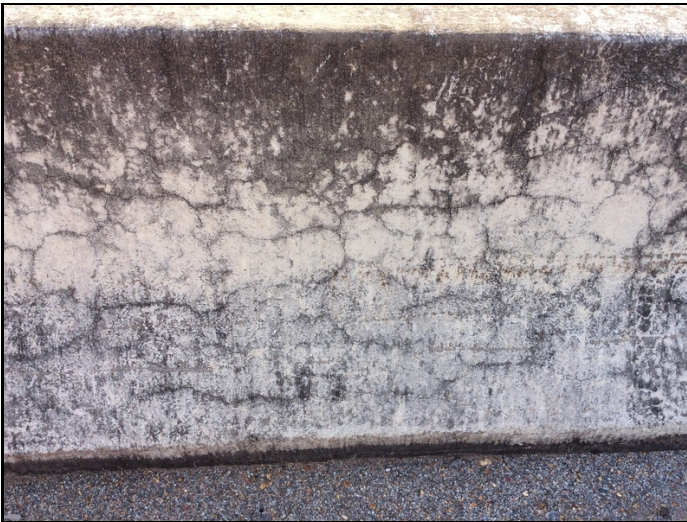
Railing - all spans: Numerous map cracks.

Railing - all spans (map cracking)

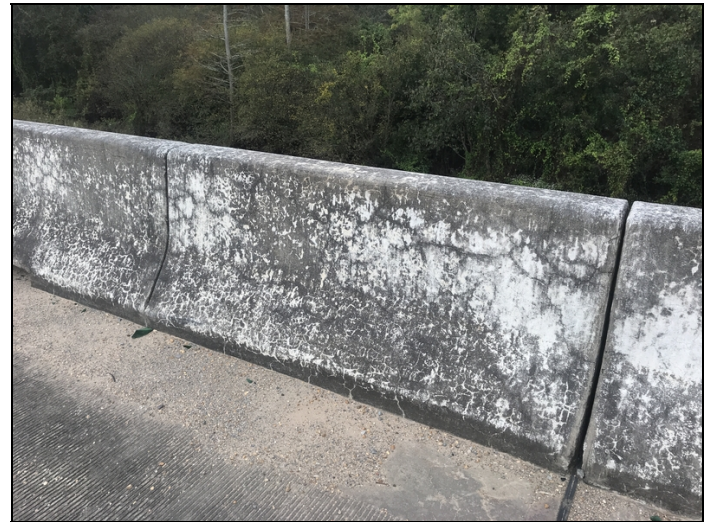
Bridge railing has moderate to heavy map cracking on all spans.

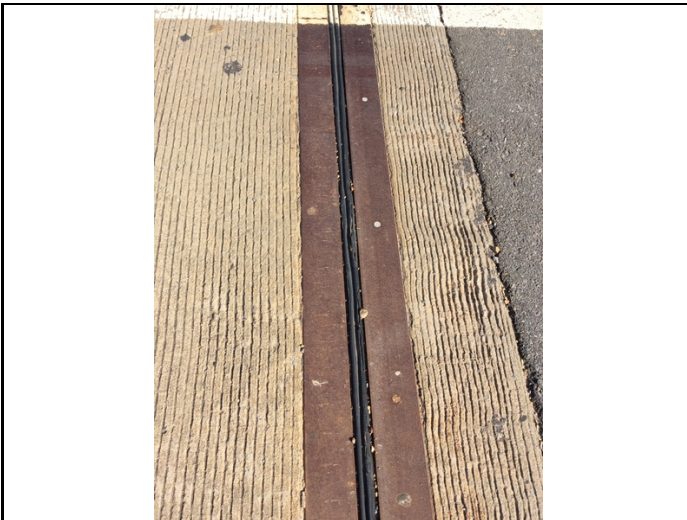
Joints - all bents: Preformed joint material is beginning to deteriorate and crack with a few areas of wear/tattering.

Joint - Bent 1 (damage)

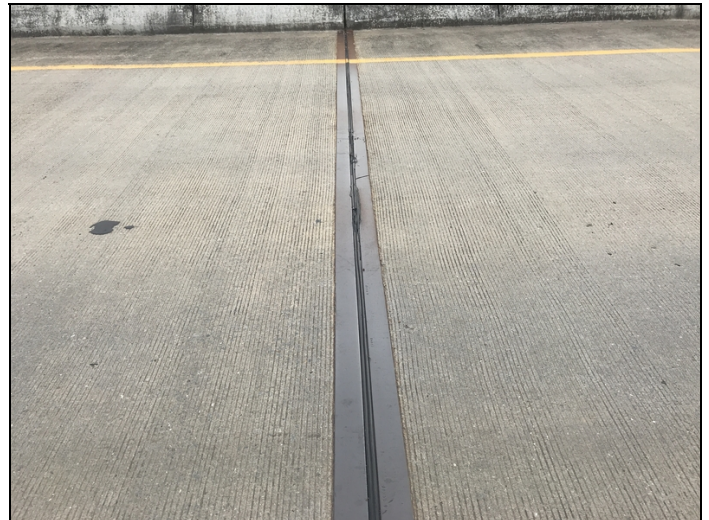
Bent 5 expansion is torn and tattered.

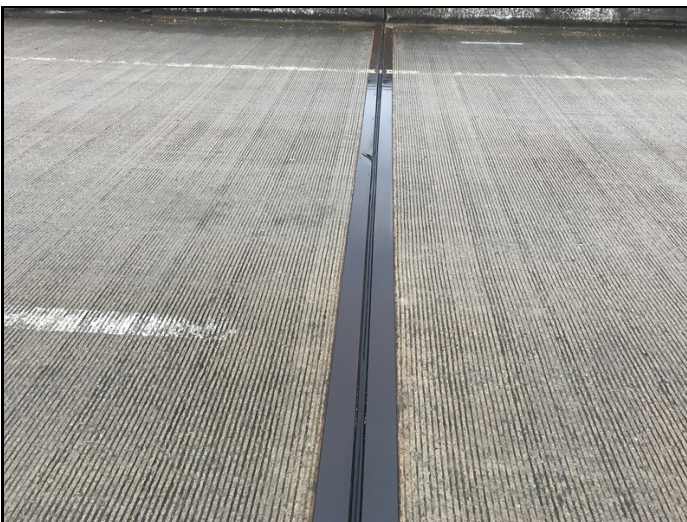
Bent 2 joint seal is torn and leaking.
