Asset #B6681 (Routine)

US 425 NB LM 5.83 over Bayou Bartholomew

Location: 4.3 Mi S SH 199-Yorktown

Team Lead: Greg Loomis, Inspection Date: 10/27/2022

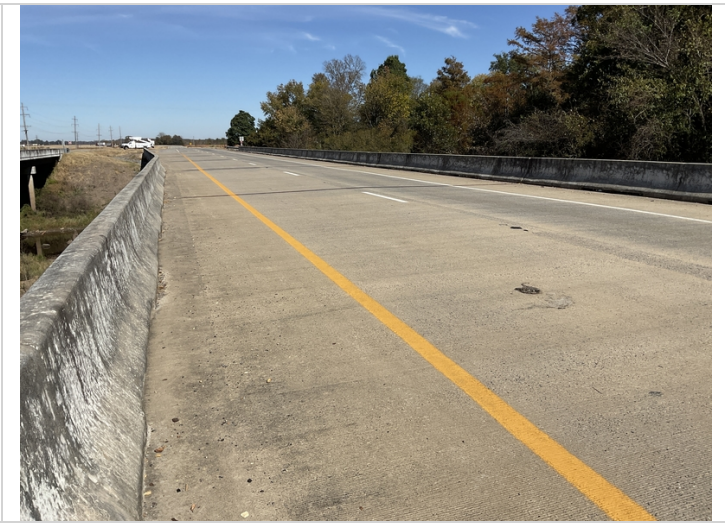
Deck - Spans 1-3: Typical

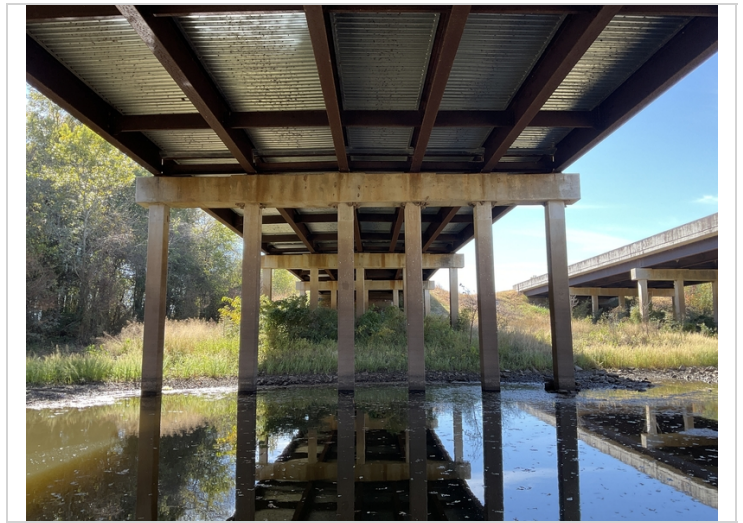
Soffit - Spans 3-4: Typical

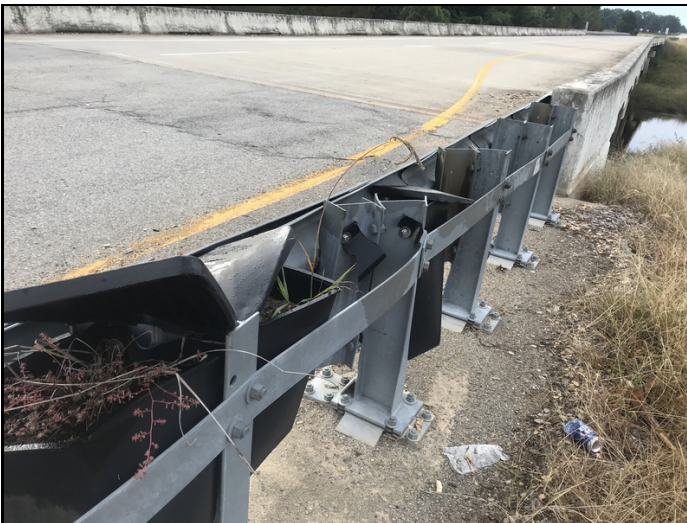
Approach railing - Bent 7 left: Several posts have been damaged (bent) by traffic impact - sliding railing also appears to be out of place.

Bent 7 bridge railing and post damage.

Type of Work: Repair (General)

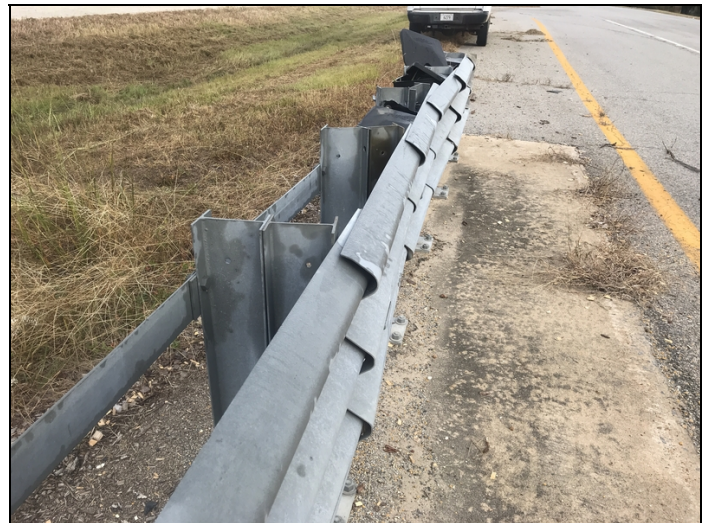
Bent 7 bridge guard rail damage.

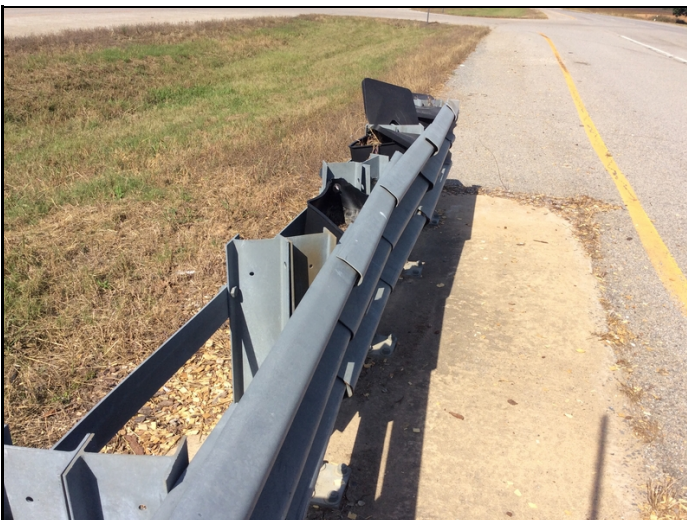
Approach railing - Bent 7 left (damage)

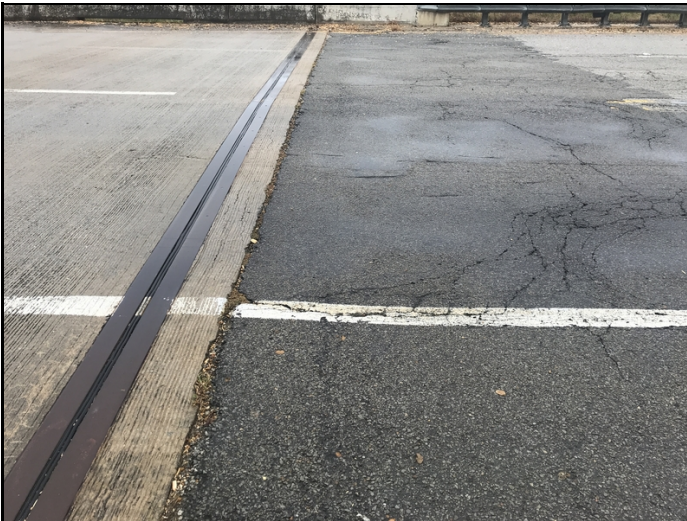
Bent 7 (north end) has settlement (approximate 1/2-1") causing a drop leaving bridge.

North approach has 1/2" to 1" drop leaving bridge.

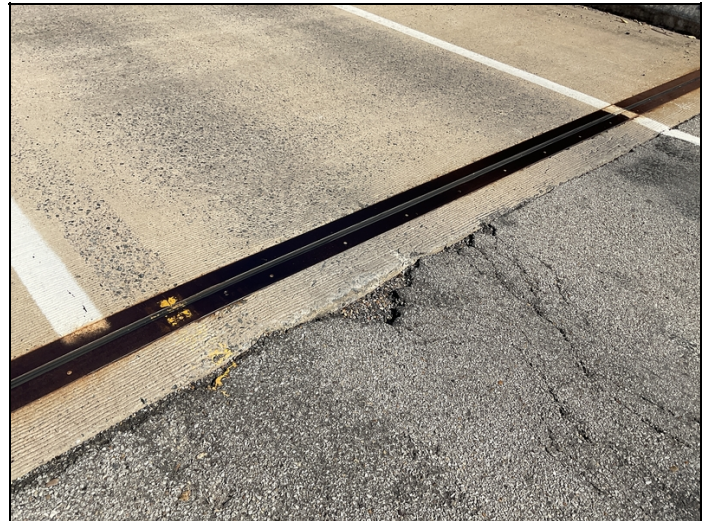
Bent 1 (south end) has a 1' x 2' pothole in inside wheel rut of right lane with settlement causing a bump going onto bridge.

Approach roadway - Bent 1 right: Deterioration/pothole

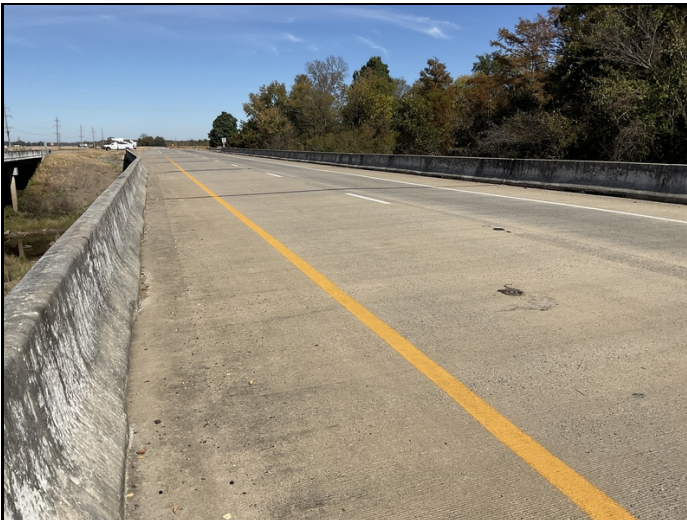
10-27-2022 GGL-PRD: No debris build-up in gutter-line needing removal this inspection.

CORRECTED - Gutter-line - left side: No debris needing removal

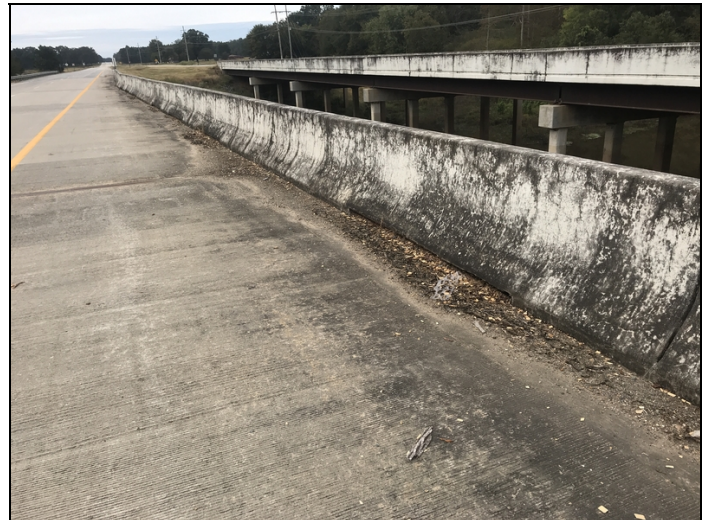
Gutter lines and drains both sides of deck have sediment and debris impeding drainage off of deck.

Gutter lines and drains full sediment and debris impeding drainage.

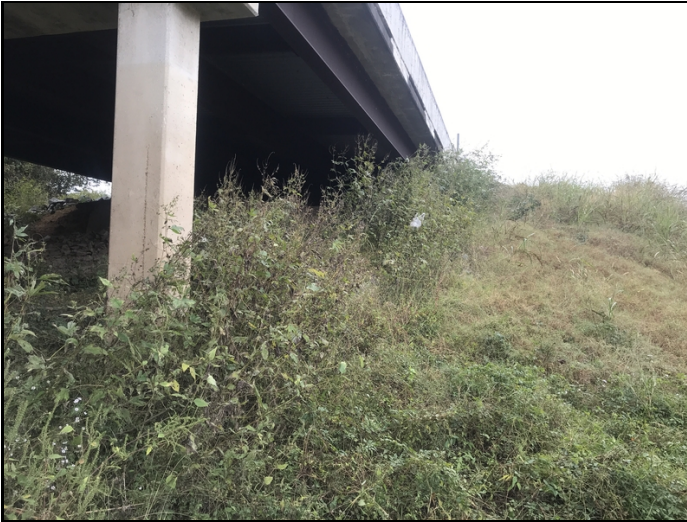
Channel - Spans 1-3 & Span 5: Numerous small trees, bushes, and other vegetation growing up under bridge.

Vegetation on both ends of bridge.

A-64 - Vegetation Removal Requested

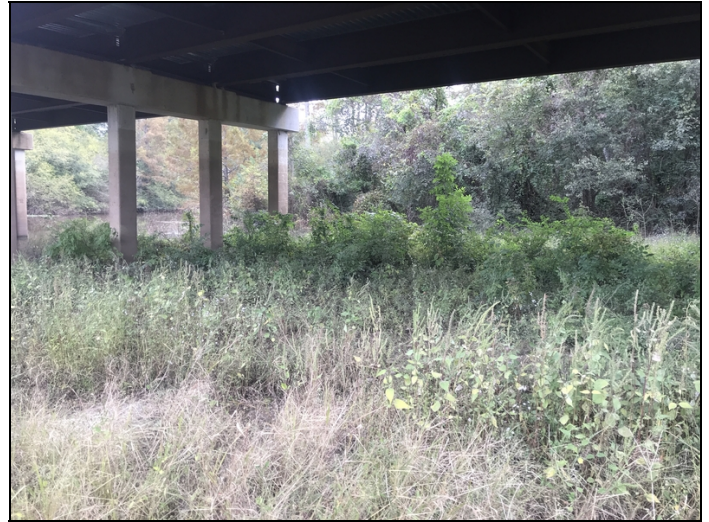
Small trees and vegetation growing under bridge.

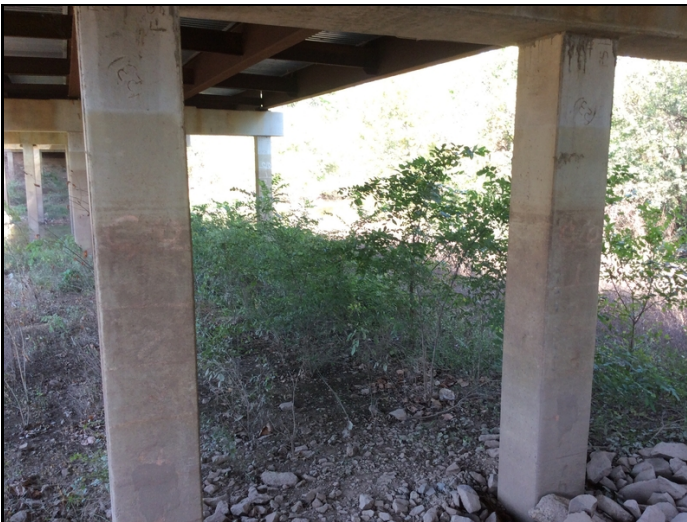
Channel - Span 2 (vegetation)

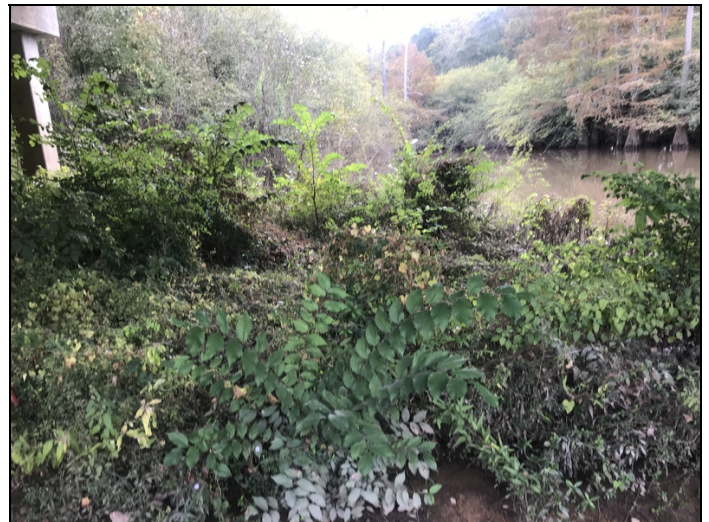
Spans 5&6 have trees and vegetation growing under bridge.

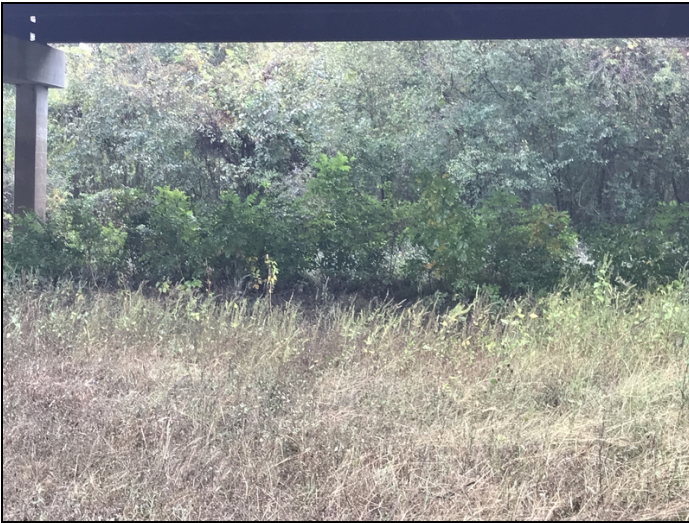
Trees growing under bridge.

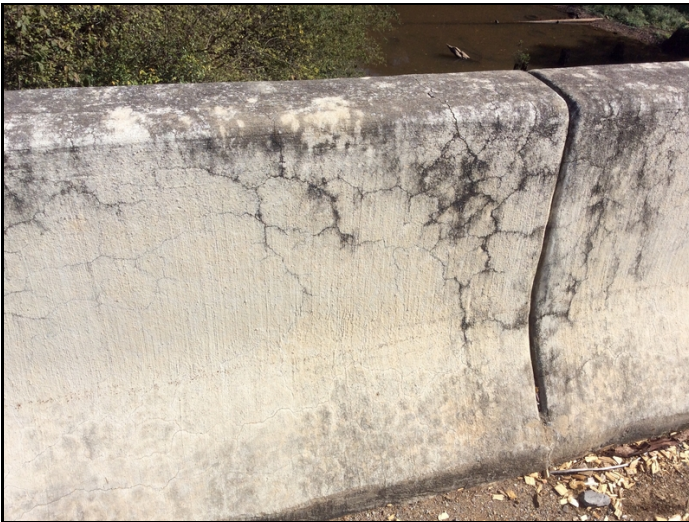
(331) Railing 332' each side. Heavy map-cracking throughout on inside and outside of walls.

Railing - all spans: Numerous map cracks.

Railing - Span 7 left (typical map cracking)

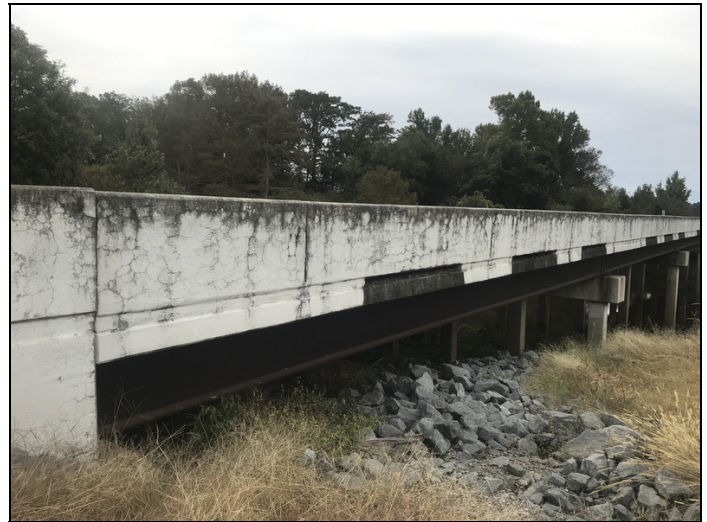
Span 6 map cracking (common on all concrete bridge railing).

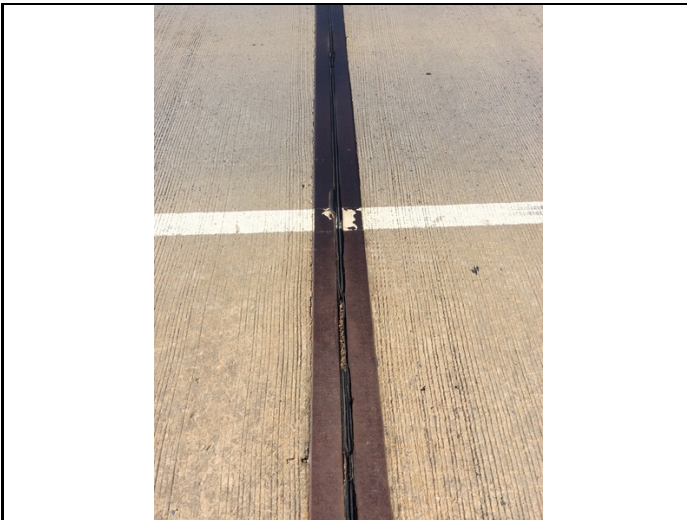
(302) Joints: 38' each / Bents 1-3; 40'-6" = 41' each / Bent 4; 43' each / Bent 5; 45'-6" = 46' each / Bent 6; 48' each / Bent 7. Bents 2-6: Various locations have adhesive failing and cracking on one side or the other with some damage/leakage. Bent 5: Transverse cracking across deck adjacent to joint.							
311	Movable Bearing	EA	34	24	10	0	0

Joints - all bents: Preformed joint material is beginning to deteriorate and crack with a few areas of wear/tattering.

Joint - Bent 4 (damaged)

A-59 - Joint Repair Needed

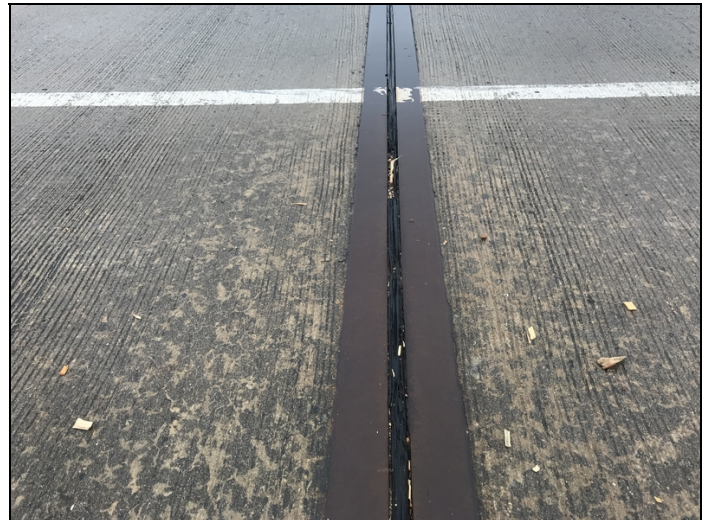
Bent 4 joint seals are torn and leaking.
