Asset #M1497(Routine)

US 425-06 LM 4.43 over Flat Creek

Location: 4.43 Mi N SH 11-Star City

Team Lead: Sharon Hooks, Inspection Date: 08/08/2022

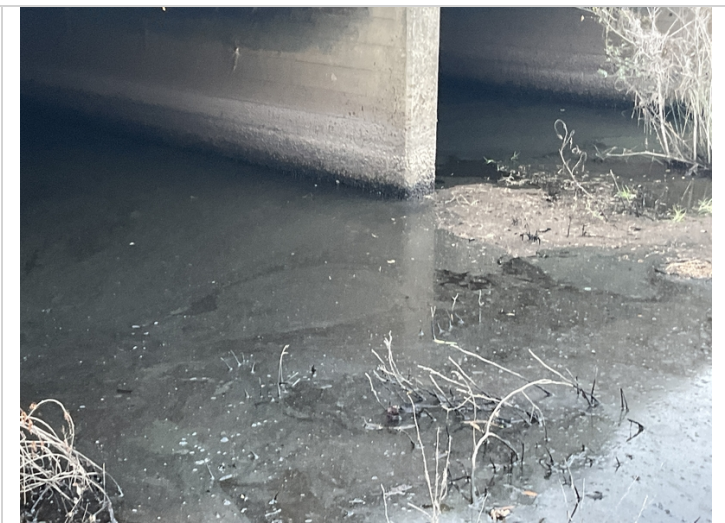
ELEMENTS	DESCRIPTION	UNITS	TOTAL	CS1	CS2	CS3	CS4
241	Reinforced Concrete Culvert	LF	132	62	69	1	0
1130	Cracking (RC and Other)	LF	4	0	4	0	0
1190	Abrasion/Wear (PSC/RC)	LF	66	0	65	1	0
(241) Box culvert: 44' each / Barrels 1-3. Barrels 1-3: Abrasive wear on bottom 24" of walls - heaviest from center to right side. Hairline vertical cracks at corners of box walls and wing walls. Channel - Barrels 1 & 3: Some minor erosion at end of bottom slab.

Barrel 3 wall abrasion common on all divider walls.

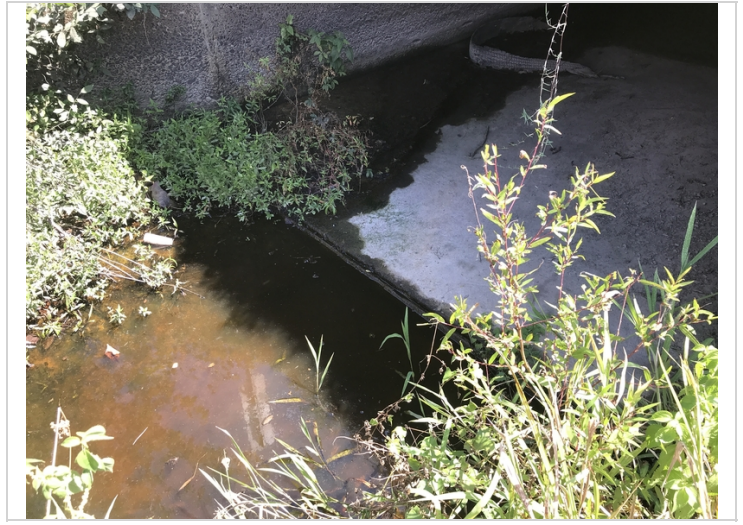
Channel - Barrel 3 left: Erosion @ bottom slab

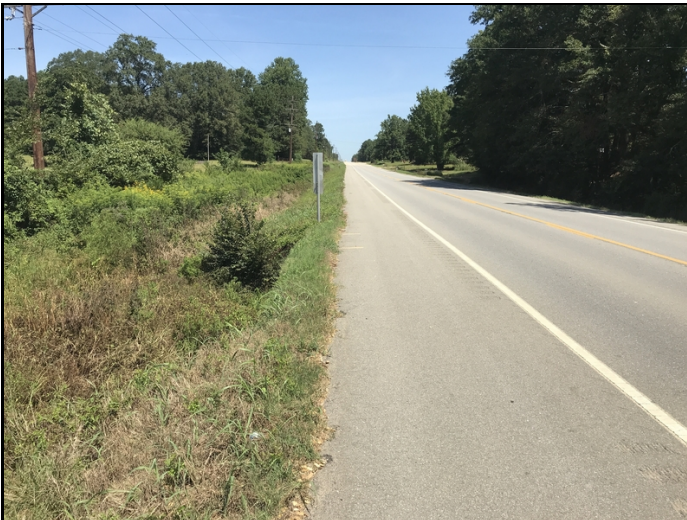
Signs - Barrel 1 left: No object marker or post in place.
Signs are in place. 8/8/2022 JRB

Barrel 1 left: No object marker

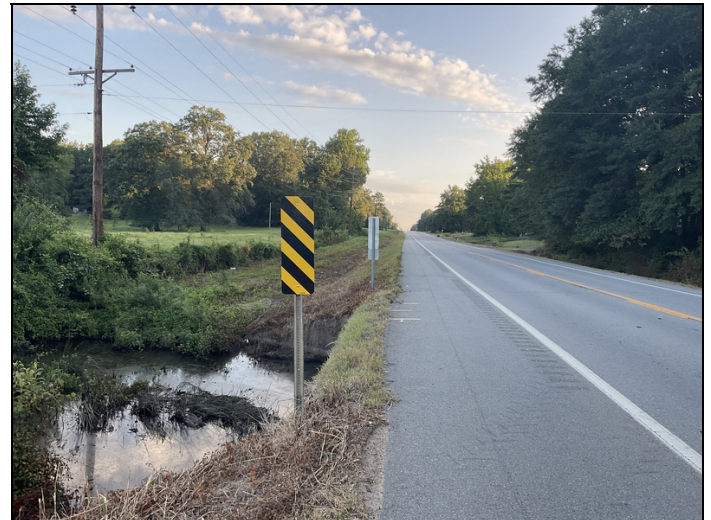
Signs in place. 8/8/2022 JRB
