Asset #02380(Routine)

US 270-10 LM 10.84 over Derriseaux Creek

Location: 0.2 Mi W JeffCo-ClearLake

Team Lead: Greg Loomis Inspection Date: 10/10/2023

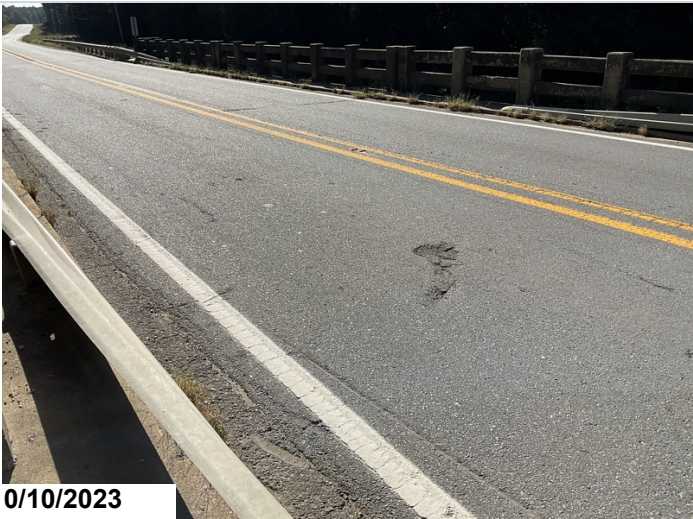
Deck is in good condition with some minor efflorescence and cracking in wearing surface.

Deck - Spans 1-3: Typical

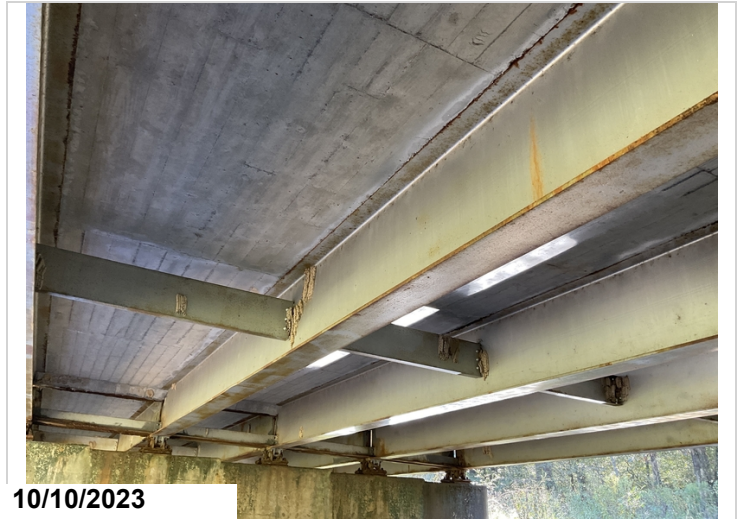
Soffit - Span 2: Typical

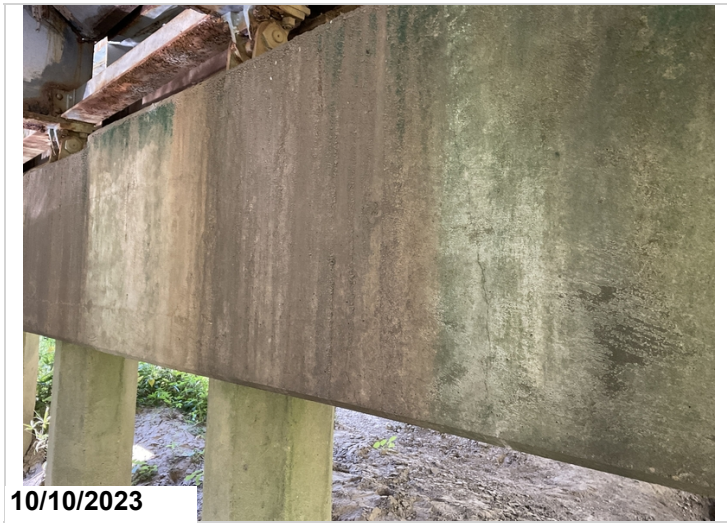
(234) Caps: 27' each / Bents 2 & 3. Bent 2: Several minor- to moderate-sized vertical cracks on back and ahead sides (with continuation across bottom face) between Piles 2-4 - 22' CS3 cracking. Bent 2: Very small spall with exposed rebar back face right side - 1' CS2 exposed rebar. Bent 3: A couple moderate- to large-sized crack (wider at the top of cap) on back and ahead faces (under Girder 2 and between Piles 2 & 3) - 5' CS2 cracking; 1' CS3 cracking. Bent 3: Minor spalling with exposed rebar on bottom face between Piles 1 & 2 - 1' CS2 exposed rebar.							
305	Assembly Joint without Seal	LF	120	0	0	120	0
2350	Debris Impaction	LF	120	0	0	120	0

Cap - Bent 2 ahead: Cracking

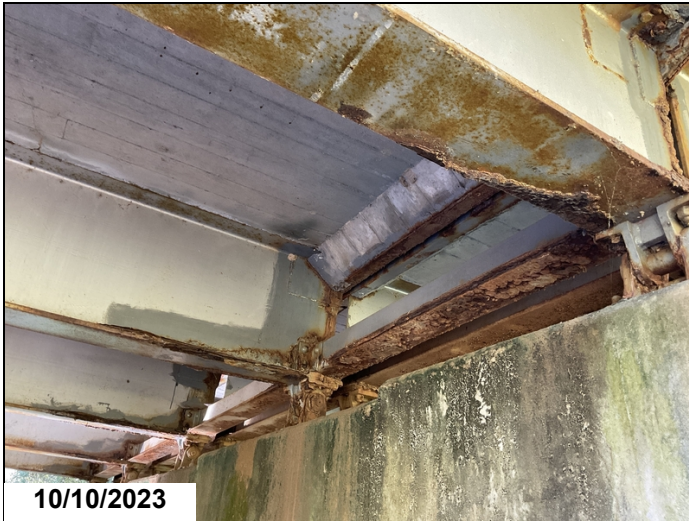
Remaining girders @ Bent 2 ahead: Significant corrosion of webs and bottom flanges (and diaphragms).

Span 2 Girders 1-3 @ Bent 2: Corrosion

NOTE: State forces welded some patches over holes in webs at haunches on Span 2 Girders 1-4 @ Bent 2 after 2011 inspection. Ends of girders and diaphragms have also been cleaned and spot-painted.

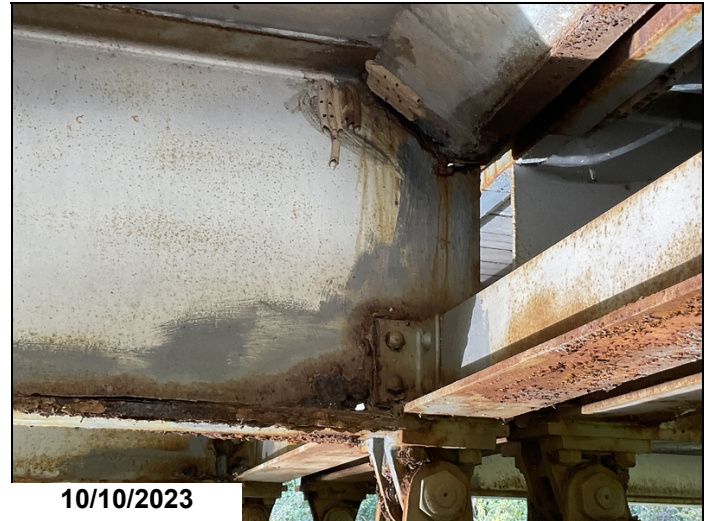
\*Span 2 Girder 4 @ Bent 2: Corroded through at haunch (1/2" diameter hole) / corroded through at bottom of web (2" diameter hole with smaller holes ahead - see photo).

Span 2 Girder 4 @ Bent 2: Corrosion (holes)

**Type of Work:** T-Splice

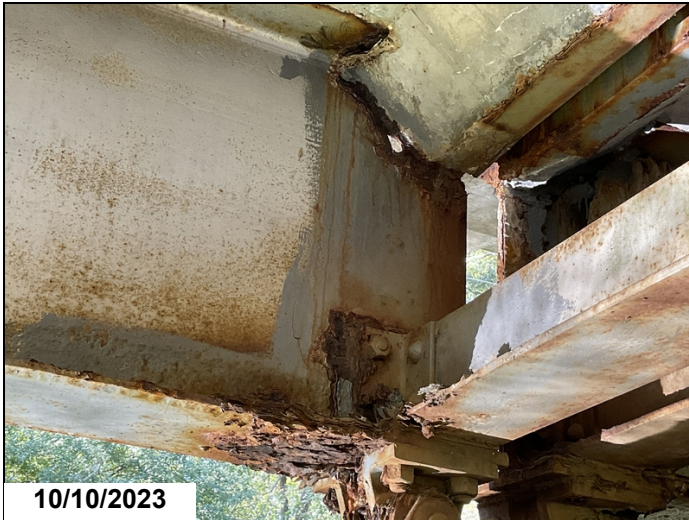
\*Span 2 Girder 5 @ Bent 2: Corroded through at haunch (1" x 1/2" hole) / significant section loss in web and bottom flange (see photo).

Span 2 Girder 5 @ Bent 2: Corrosion (hole)

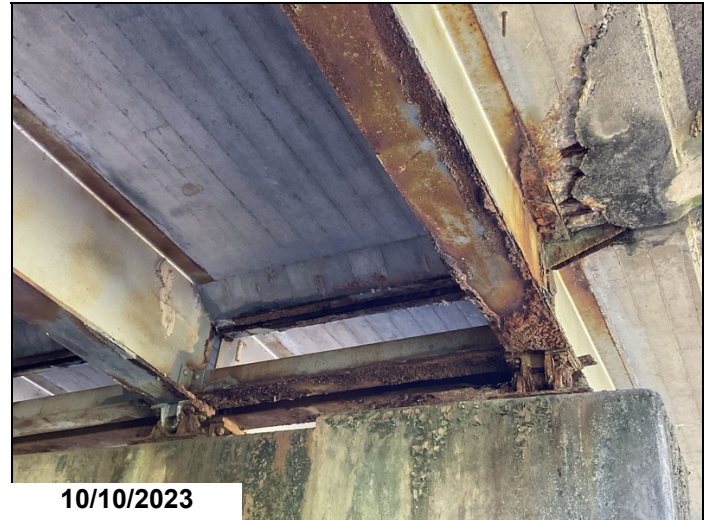
Span 3 Girders 1-2 @ Bent 3: Corrosion

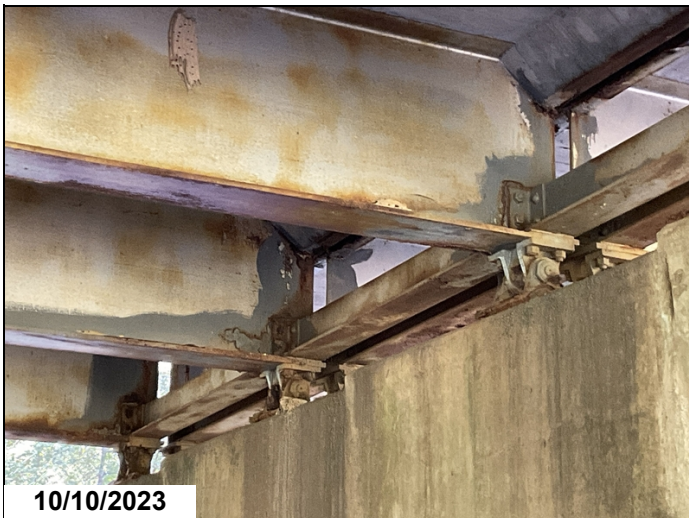
Span 3 Girders 3-5 @ Bent 3: Corrosion

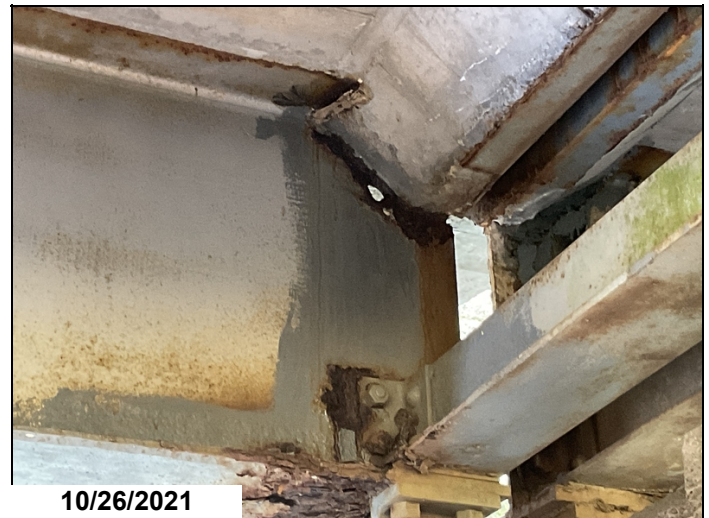
Span 2 Girder 5 @ Bent 2: Corrosion (hole)

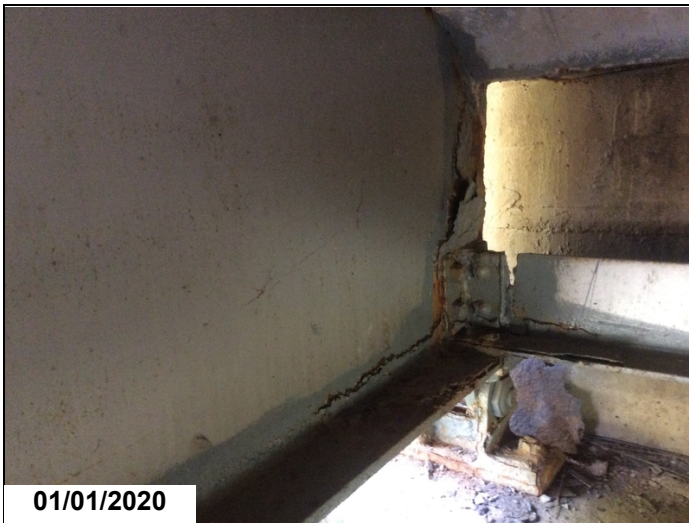
Span 1 Girder 5 left @ Bent 1: Corrosion

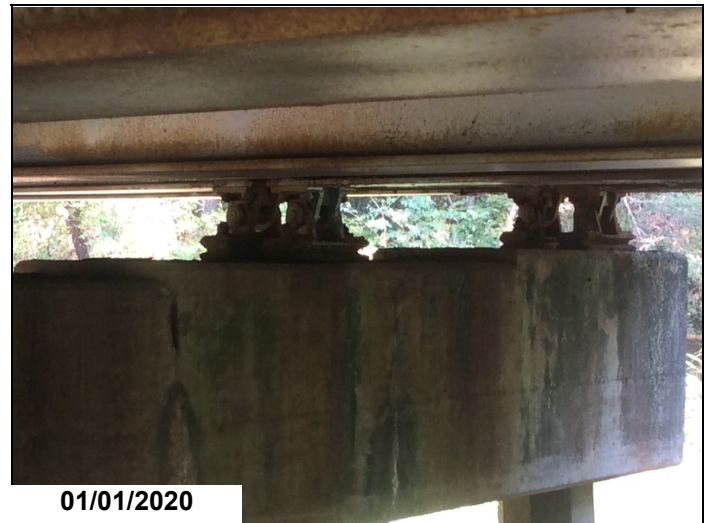
Corrosion is reappearing on bearings that had been previously cleaned and repainted. Bearings are showing some measurable section loss (flaking and pack rust between parts and under rockers).

Current and past corrosion has resulted in some significant section loss to several anchor bolts/nuts and to some portions of the bearing.

Bearings 1-2 @ Bent 3: Corrosion

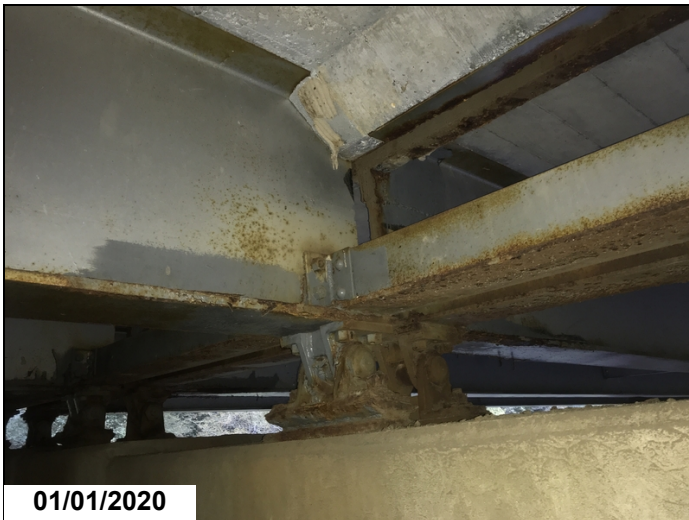
Bent 2 girder 3 beam ends have heavy flaking rust .  
Common on most beam ends .

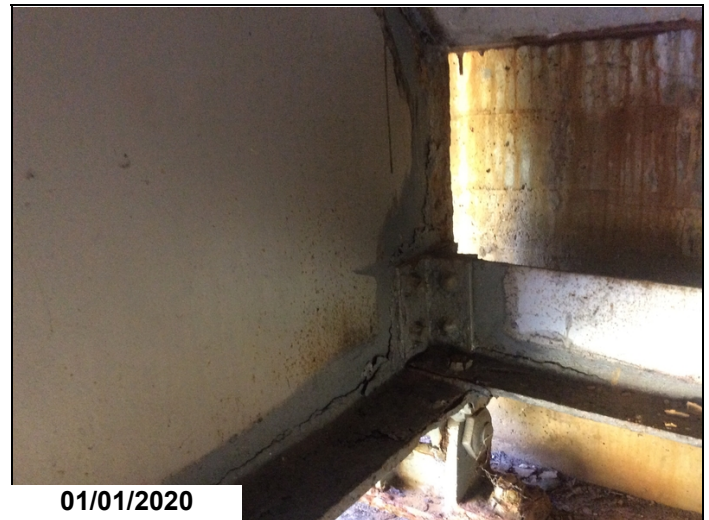
Span 3 Girder 1 right @ Bent 4: Corrosion

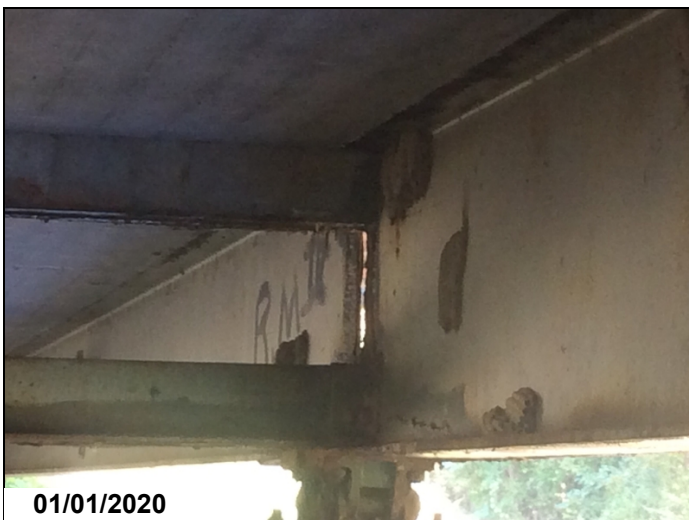
Girders 1 @ Bent 3: Corrosion

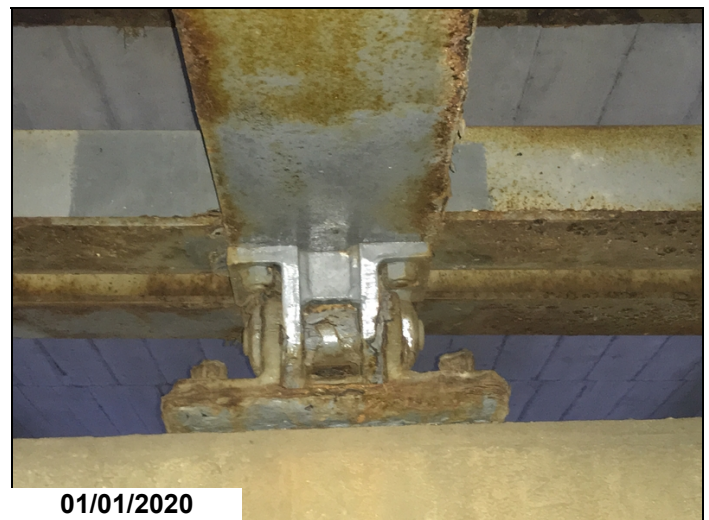
Bent 2 girder 3 bearing 3 has heavy corrosion.

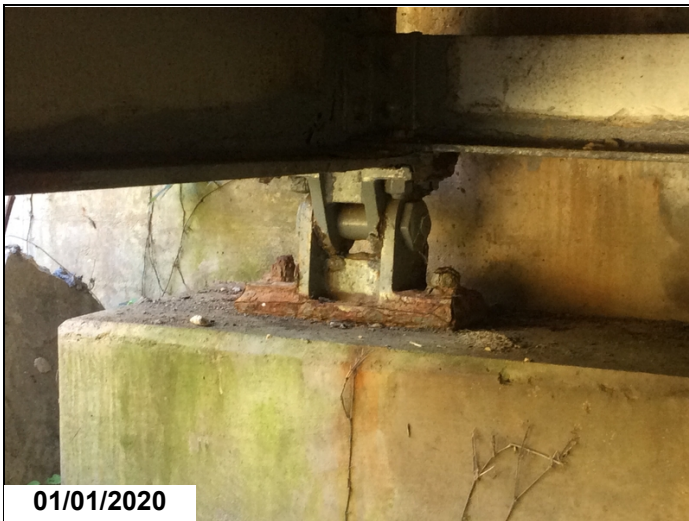
Bent 4 Bearing 1: Corrosion

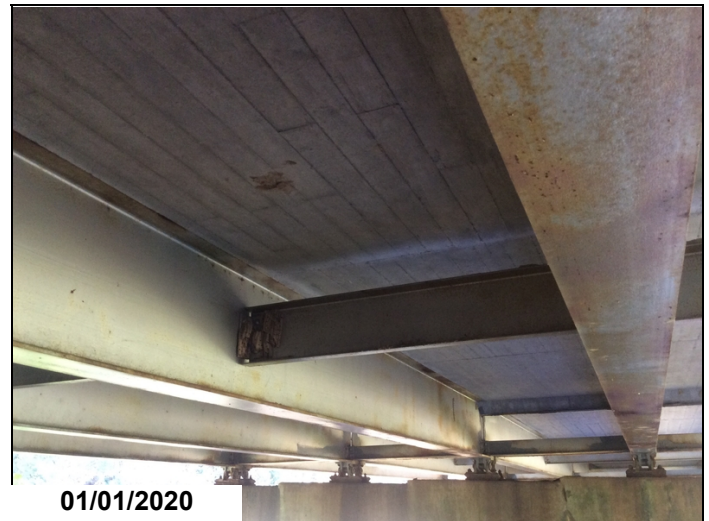
Span 3 Girders 2-3: Corrosion

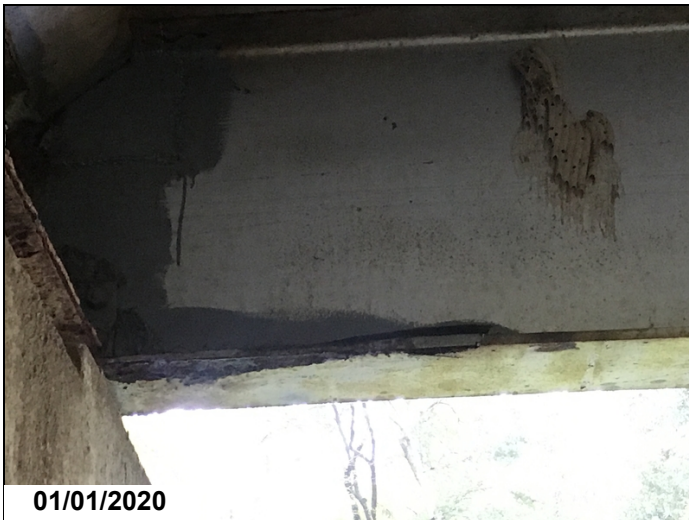
Span 2 at bent 2 girder 1 has flaking rust from end of girder ahead 4'. Common most girders this bridge.

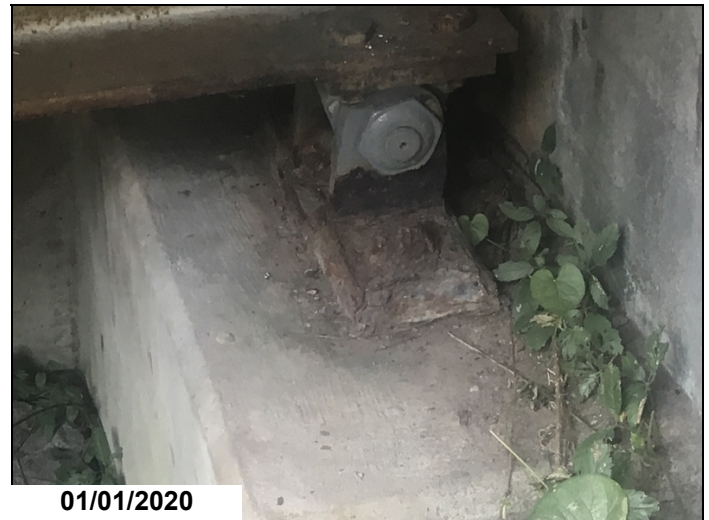
Bent 1 bearing 1 has heavy flaking rust.

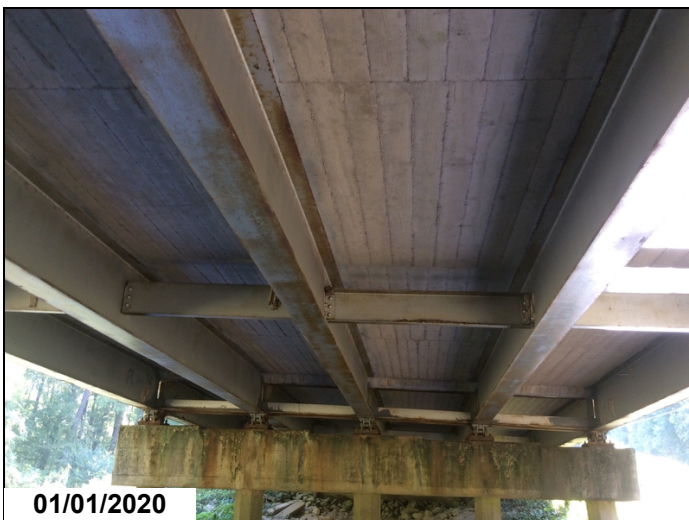
Girders - Span 2: Corrosion

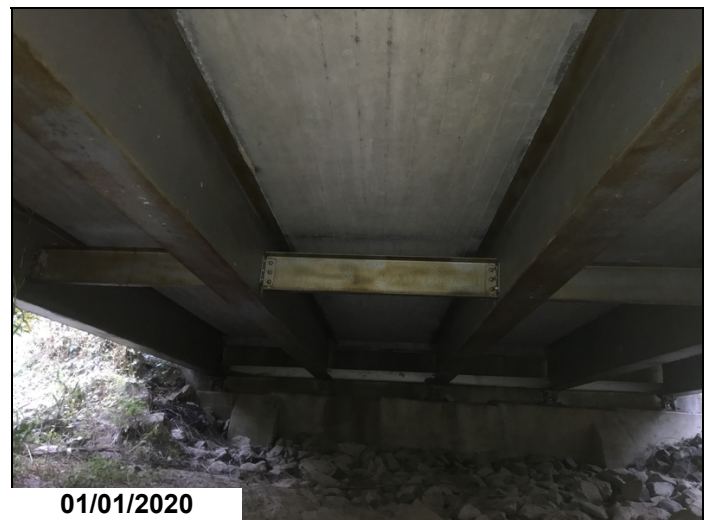
Span 1 under view of paint system.

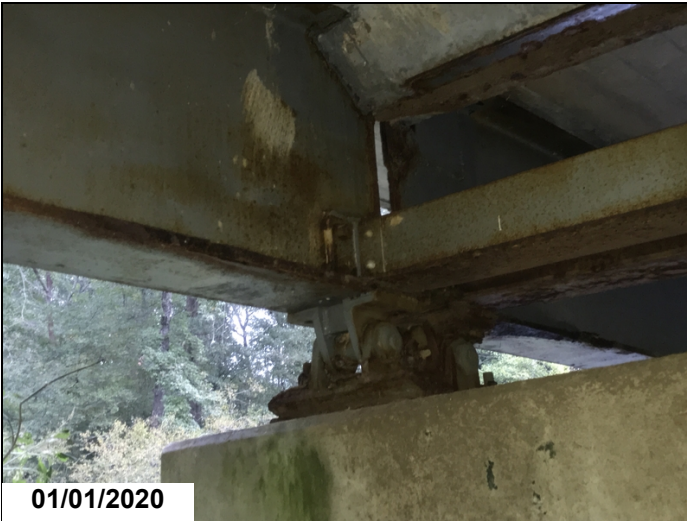
Bent 2 girder 2 beam end has heavy flaking rust.

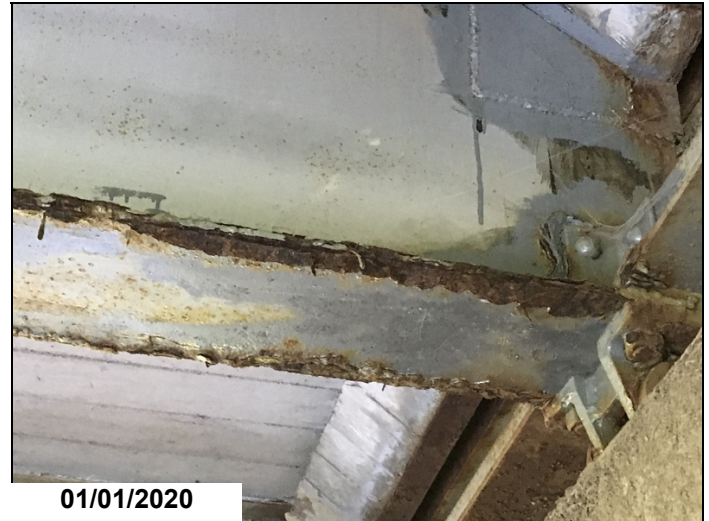
Span 2 at bent 2 girder 3 has heavy flaking rust near bearing area.

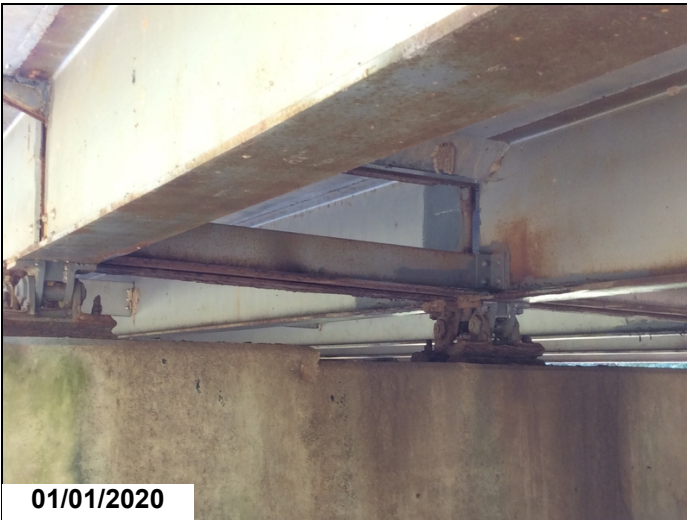
Span 1 Girders 1-2: Corrosion

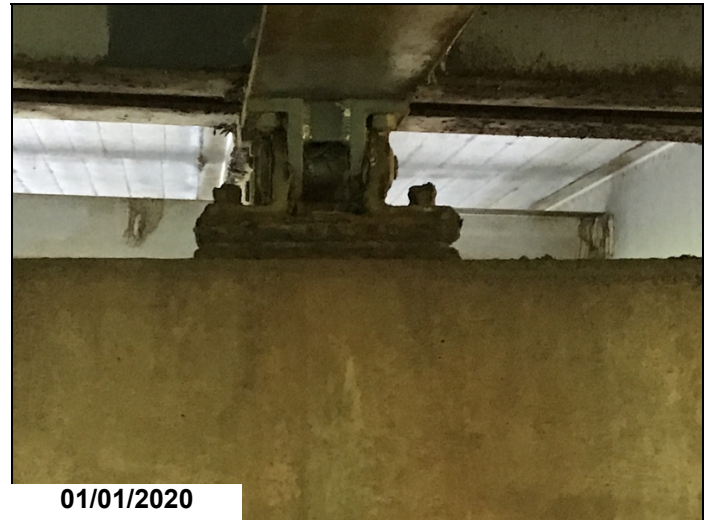
Bent 2 bearing 3 back has heavy flaking rust.

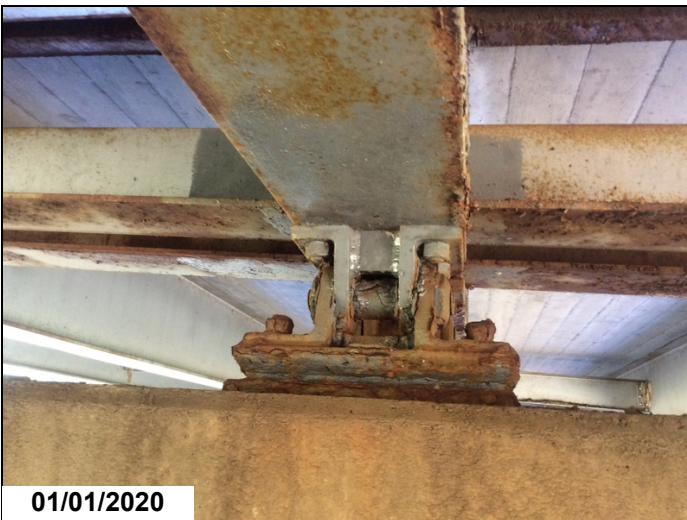
Span 1 Bearing 3 @ Bent 2: Corrosion

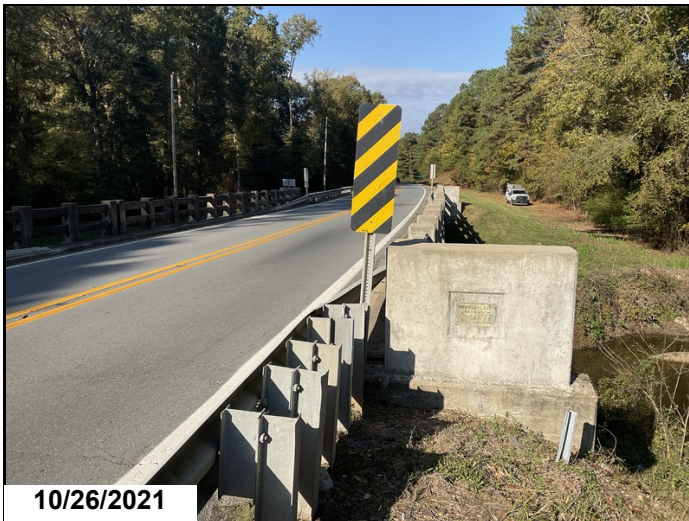
Sign - Bent 4 left: No log mile sign - object marker and post in place.

Sign - Bent 4 left: No log mile sign

**A-63 - Missing/Incorrect Log Mile Signage (Yes)**
