## Bridge 03551 Inspection Report

Asset #03551(Routine)

US 425-02 LM 2.29 over Chemin-A-Haut Creek

Team Lead: Sharon Hooks Inspection Date: 05/17/2023

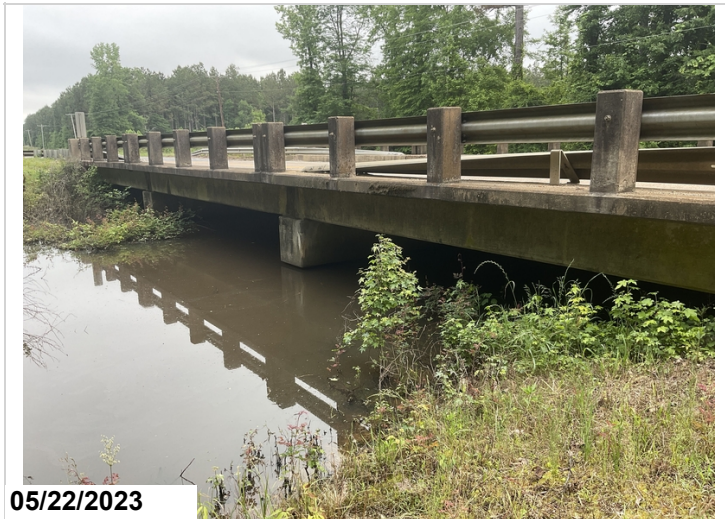
Elevation.

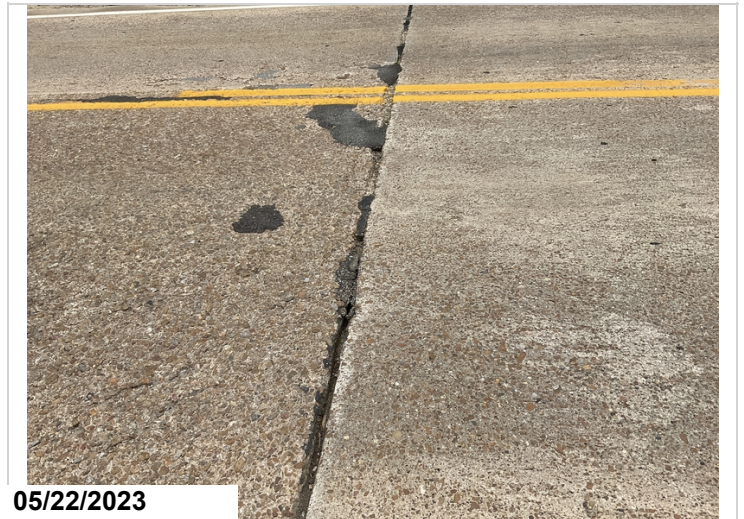
ELEMENTS	DESCRIPTION	UNITS	TOTAL	CS1	CS2	CS3	CS4
2350	Debris Impaction	LF	56	0	56	0	0
(301) Joints: 28' each / Bents 1-4. Pourable joint material has deteriorated and joints are mostly filled with dirt and debris.							
321	Reinforced Concrete Approach Slab	SF	408	306	102	0	0
1130	Cracking (RC and Other)	SF	102	0	102	0	0
(321) Approach slabs: 2 each (24' wide x 34' long = 816 sqft each) / Bents 1 & 4. NOTE: Slab @ Bent 1 and half of slab @ Bent 4 have been overlaid and can no longer be inspected. Bent 4: Some scattered cracks.							
330	Metal Bridge Railing	LF	150	150	0	0	0
515	Steel Protective Coating	SF	375	0	375	0	0
3410	Chalking (Steel Protective Coatings)	SF	375	0	375	0	0
(330) Railing: 75' each side. Coating: 2.5 square feet per linear feet of railing. Railing is dull and has no luster.

Bent 3 joint seal has lost bond with debris impaction.

Joints - Bents 1-4: Pourable joint material has deteriorated and joint is mostly filled with dirt and debris.

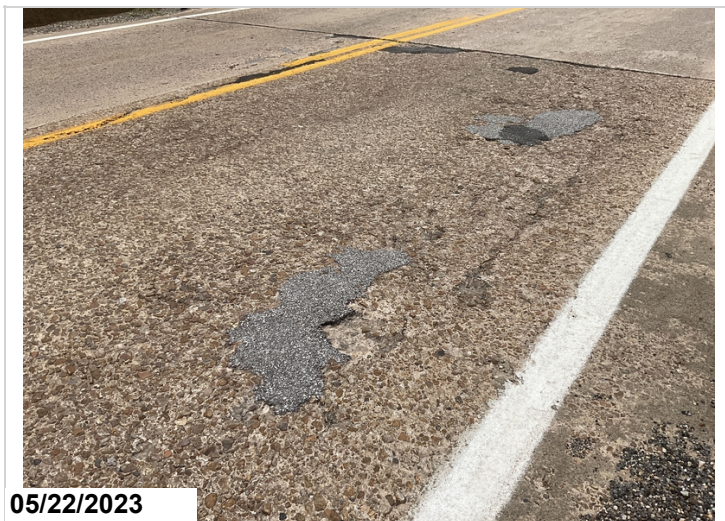
Span 2 deck abrasion with asphalt patches.

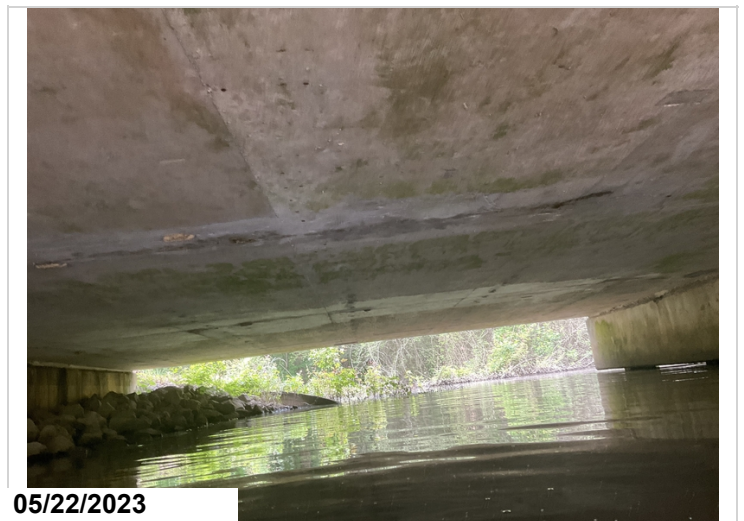
Span 1 soffit has large crack in same location as top of deck.  
Staining and moisture present.

Cracking with efflorescence at various locations – heaviest in Span 3.

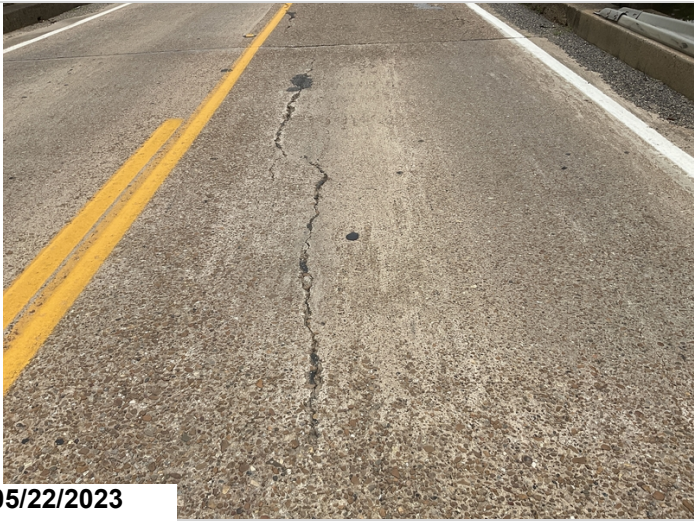
Deck span 1 large unsealed cracks.

Span 1: One large-sized longitudinal full-depth crack just right of centerline.

Some sealable cracks with some very large cracks.

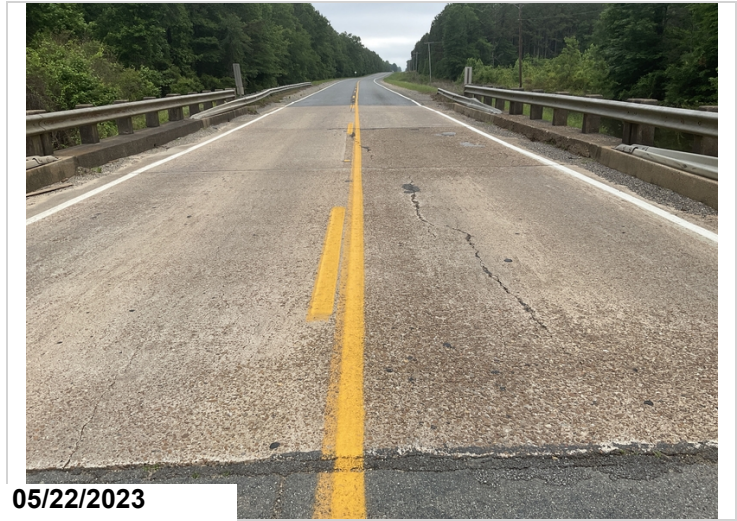
Deck overview.

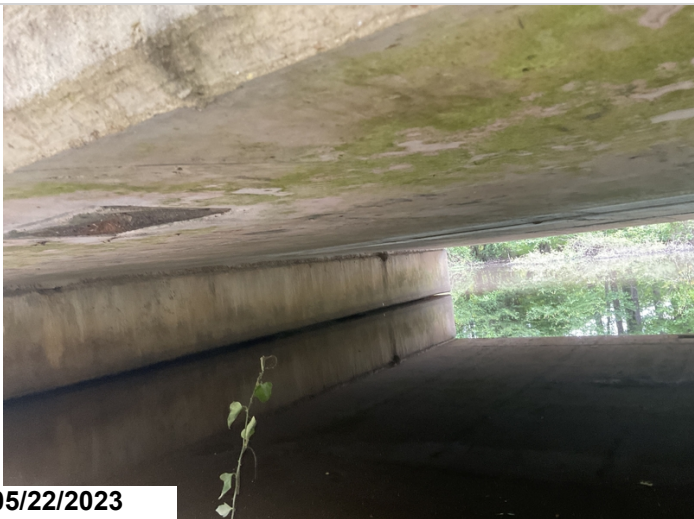
Overview of soffit.

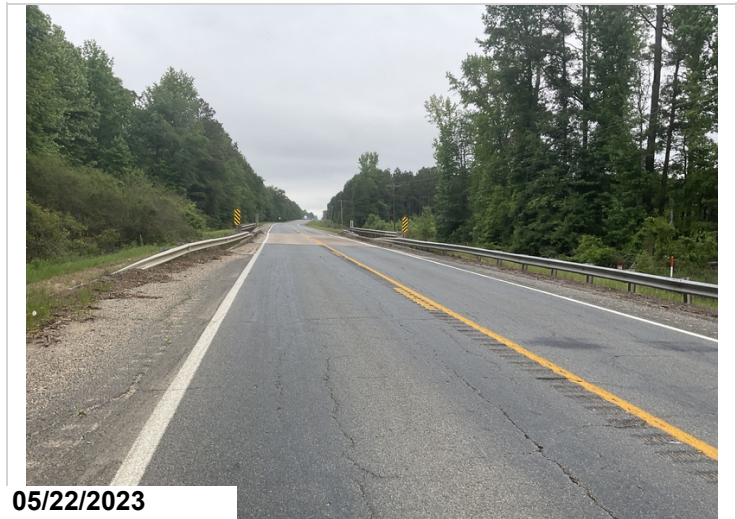
Approach.

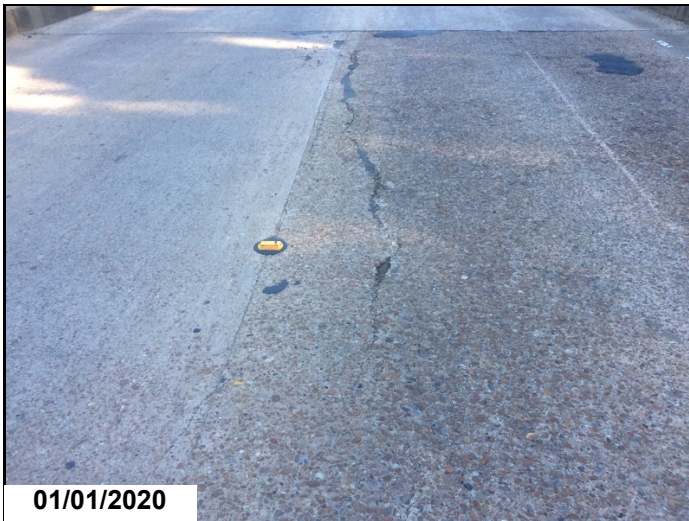
01/01/2020

Span 2: A couple large-sized full-depth longitudinal cracks in right lane with some heavy deterioration/scaling with right outer wheel-rut and just left of centerline near Bent 3.

Span 2 deck cracking completely through to soffit with efflorescence.

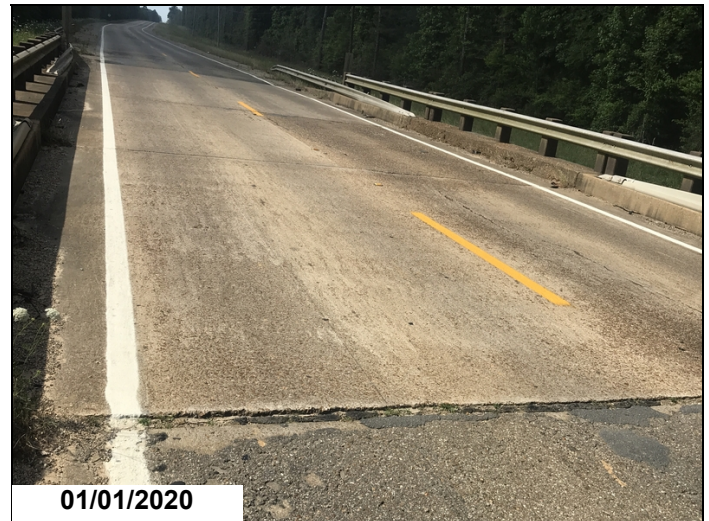
01/01/2020

Deck - Spans 1-3 : Typical

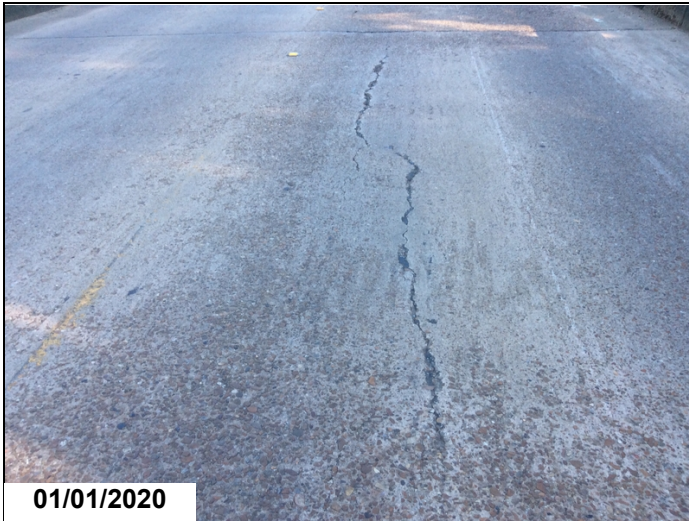
Span 1 Deck cracking

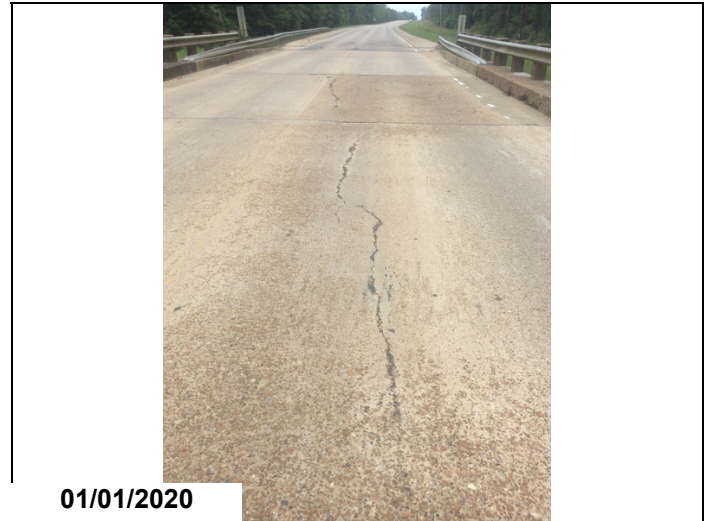
Deck spans 1-2 large unsealed longitudinal cracks up to 1/8" wide.
