Bridge 03552 Inspection Report

Route:425 Section:02 Log:6.67

District 02, 3 - Ashley County

Asset #03552(Routine, Underwater type 2)
US 425-02 LM 6.67 over S Fork Fountain Creek
Location: 6.67 Mi N US 82-Hamburg
Team Lead: Sharon Hooks Inspection Date: 04/28/2025

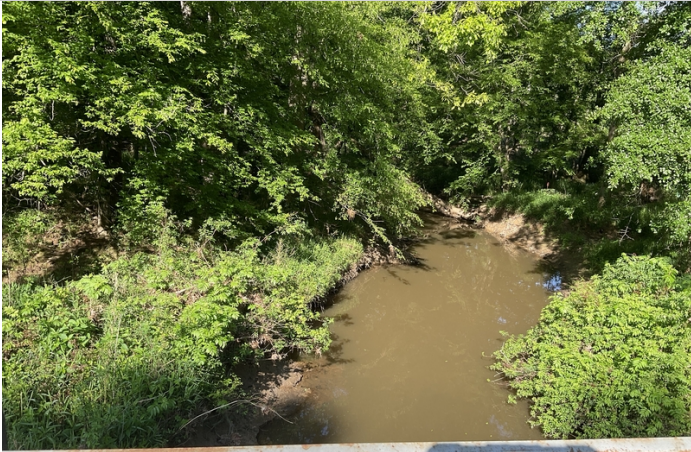
Channel: Left side view.

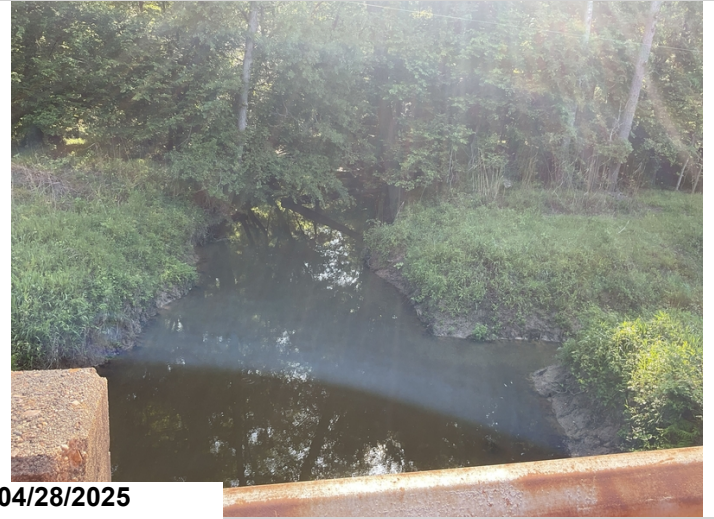
Channel: Right side view.

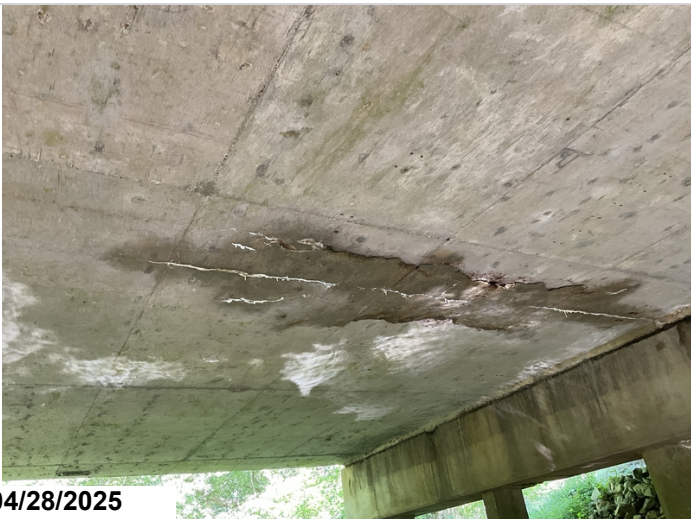
(38) Deck (with voids): 30' wide (1'-9" STEP-UP each side) x 100' long = 3000 SF							
All spans: Several unsealed, minor- to large-sized longitudinal cracks (with reflective cracking, efflorescence, and rust-staining on soffit, especially along centerline and heaviest on Spans 3 & 4). Several unsealed, minor- to moderate-sized transverse cracks, heaviest on Spans 3 & 4 on right side. Cracking = 16' wide (half deck) x 25' (Span 2) = 400 SF CS3 Cracking. Travel lanes have abrasive wear with loss of mortar on surface, but aggregates and remaining mortar is intact and fully bonded. Abrasion/ Wear = 28' wide x 100' (Spans 1-4) = 2800 SF less other defects. 2050 SF CS2 Abrasion. Side of slab – Span 1 at Bent 2 right: Vertical crack efflorescence on side of slab with spalling. 5 SF CS3 Cracking; 75 SF CS3 Efflorescence Undersurface - Span 3: Area of delamination/efflorescence/rust-staining along centerline from 1/3 to end of span. Span 4 left: Large delamination with efflorescence/rust-staining. 75 SF CS3 Delaminations; 200 SF CS3 Efflorescence;

Undersurface Span 3: Large delamination with staining.

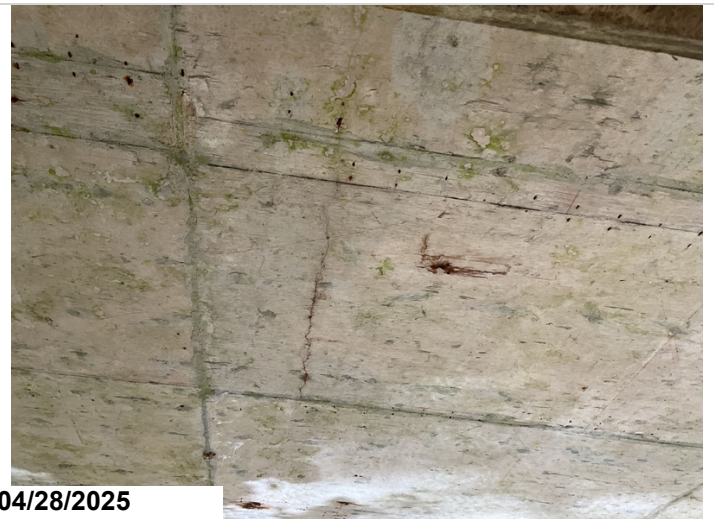
Deck - all spans: Several unsealed, minor- to large-sized longitudinal cracks with reflective cracking, efflorescence, and rust staining on undersurface, especially along centerline and heaviest on Spans 3 & 4 - Several unsealed, minor- to moderate-sized transverse cracks, heaviest on Spans 3 & 4 on right side.

Undersurface Span 2: Large unsealed cracks with staining.

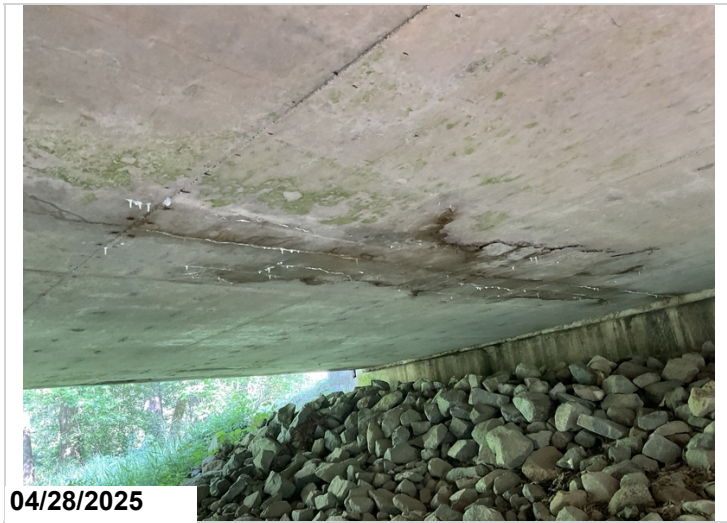
Undersurface Span 4: Large delamination with staining.

Undersurface -Span 4 left lane : Large delamination with staining near mid span.

Repair as you can fit in your schedule

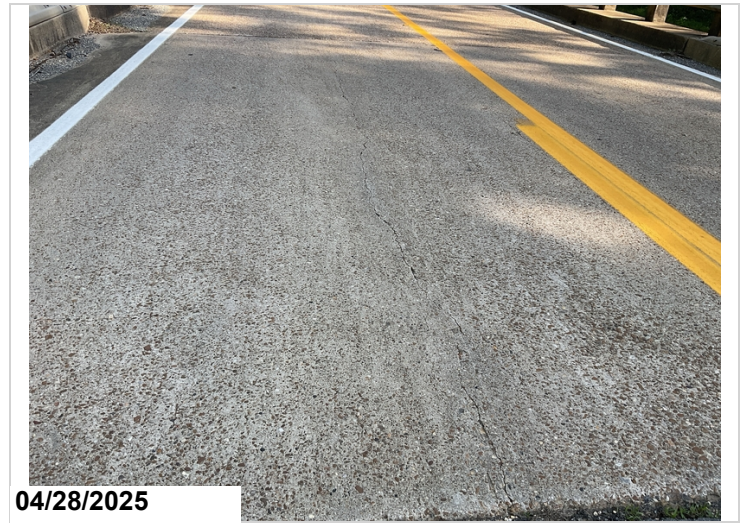
Deck Span 1: Large unsealed cracks.

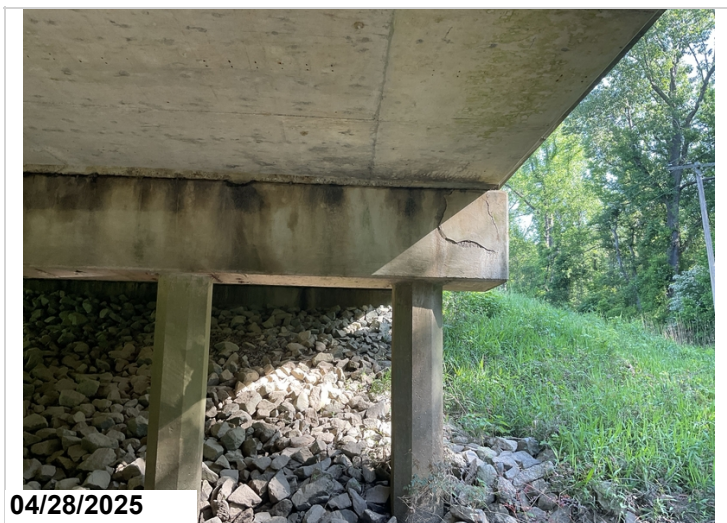
(234) Caps-Bents 2-4.: 30'-6" = 31' each x 3=93 LF Total Bents 2-4 bottom face: Small spalls with exposed rebar. 10 LF CS3 Exposed Rebar. Bent 4 back: Large delamination right end. 3 LF CS2 Delamination							
301	Pourable Joint Seal	LF	140	0	29	111	0
2320	Seal Adhesion	LF	70	0	29	41	0

Cap Bent 4 Back: Large delamination on right end.

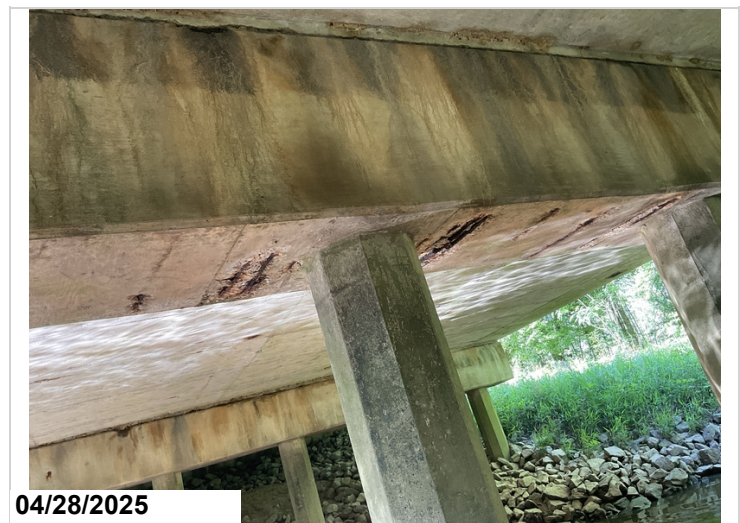
Cap Bent 3: Spalls with exposed rebar on bottom.

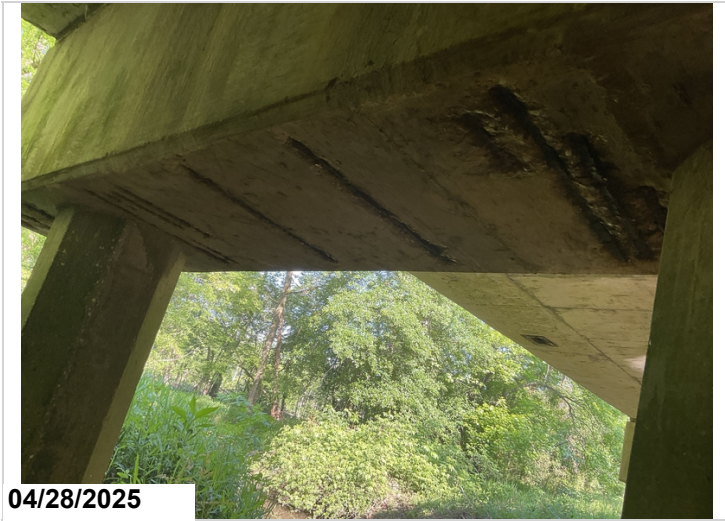
Cap Bent 2: Spalls with exposed rebar on bottom.

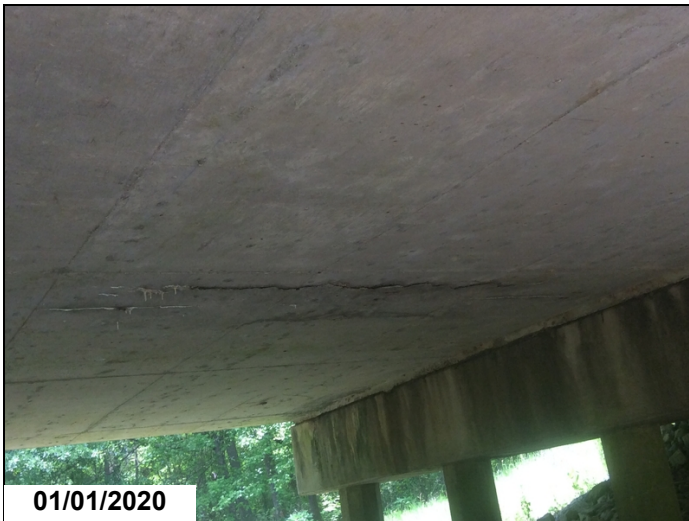
Span soffit Delams.

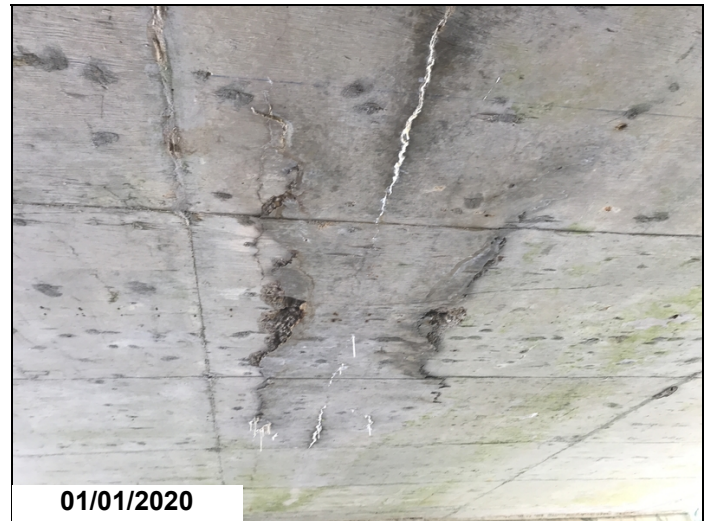
Span 3 longitudinal cracking reflecting thru to soffit with efflorescence.

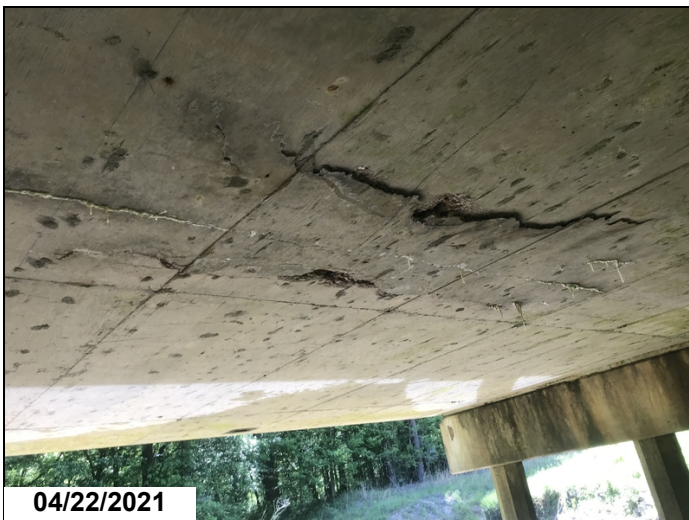
Undersurface - Span 3: Area of delamination/efflorescence/rust staining along centerline from 1/3 to end of span.

Span 3 soffit delam with staining.
