Bridge 03553 Inspection Report

Asset #03553(Routine, Underwater type 2)

US 425-02 LM 8.03 over NForkFountainCr/AshCo

Team Lead: Sharon Hooks Inspection Date: 04/28/2025

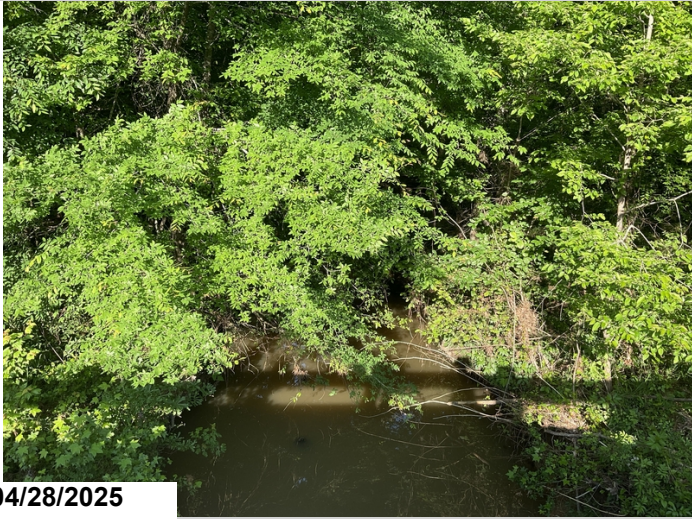
Channel: Left side view.

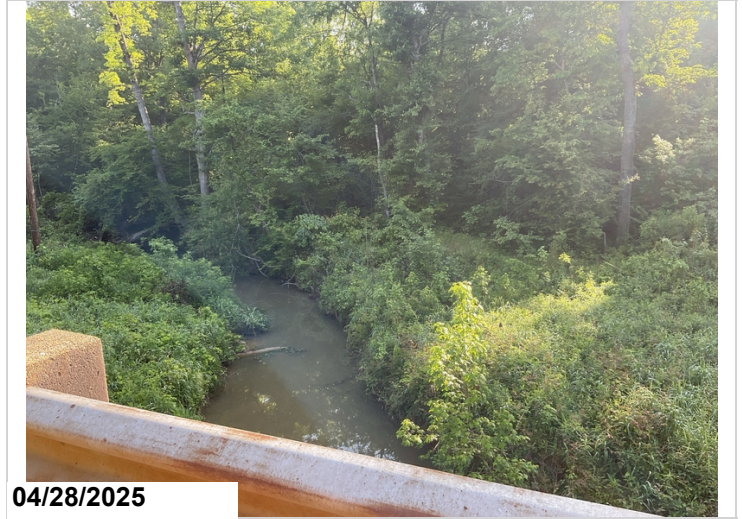
Channel: Right side view.

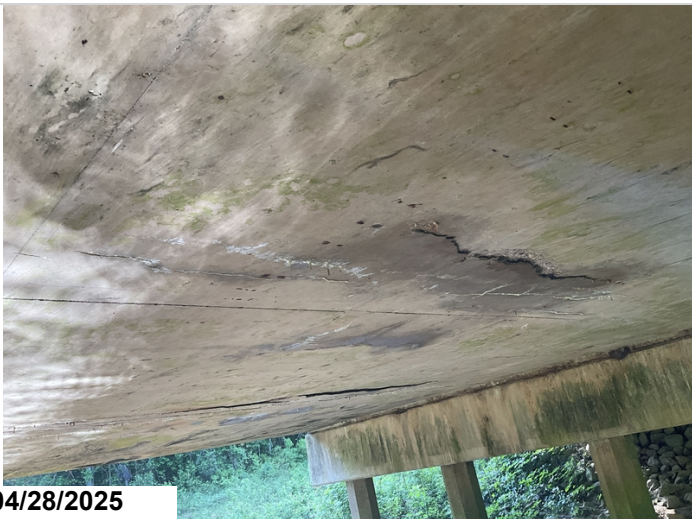
Undersurface Span 2: Large delaminations with staining.

Span 2 at center-line and left of center-line at mid-span: Large delaminated area with efflorescence/rust-staining.

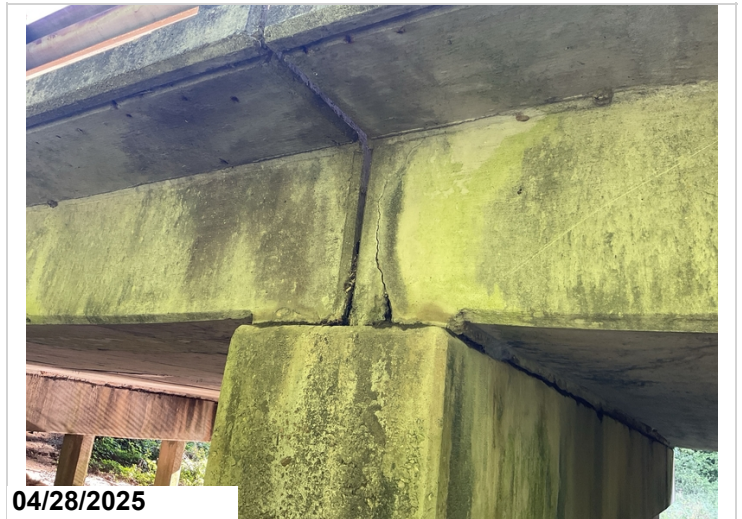
Span 1 Bent 2: Vertical crack/ delamination in side face of slab/deck.

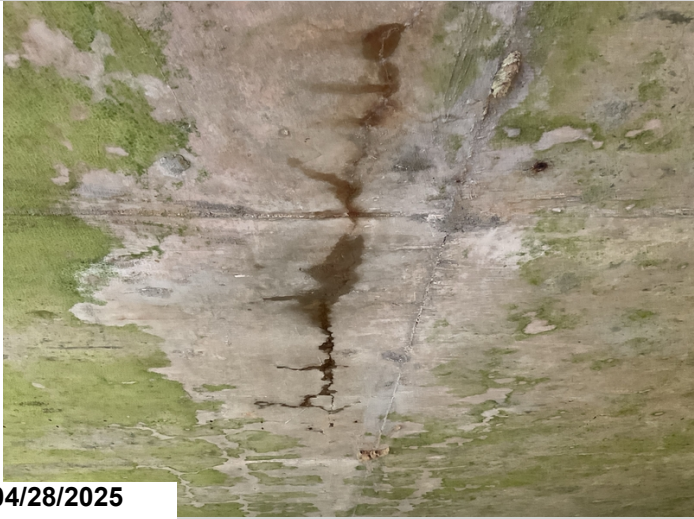
Undersurface Span 1: Large cracks with staining.

Span 1 right: A small (2' x 10') area of delamination/efflorescence/rust-staining.

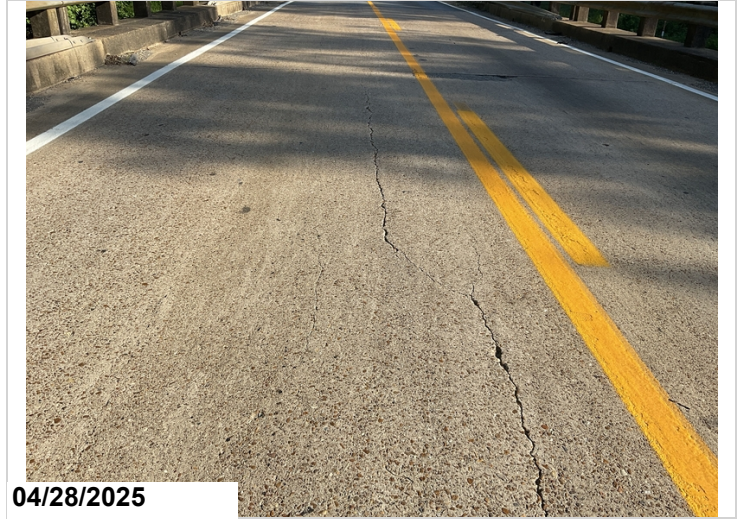
Deck - all spans: Unsealed, moderate to Large sized longitudinal cracks with reflective cracking, efflorescence, and rust staining to undersurface.

Deck Span 1: Large unsealed cracks.

A-54 - Sealable Deck Cracks (Yes)

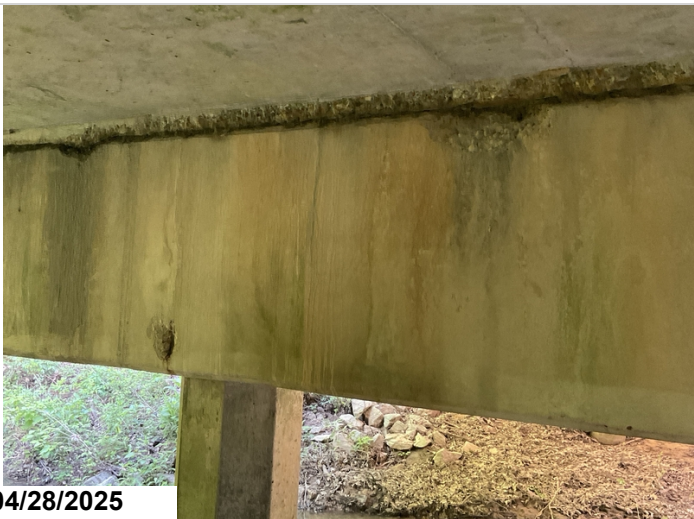
(234) Caps-Bents 2-3: 30'-6" = 31' each x 2= 62 LF Total Bent 2 back: Small contact spalls. 2 LF CS3 Spalling. Bents 2-3 bottom face: Small spalls with exposed rebar. 5 LF CS3 Exposed Rebar.							
301	Pourable Joint Seal	LF	112	0	0	112	0

Cap Bent 2 Back: Small spalls and exposed rebar.

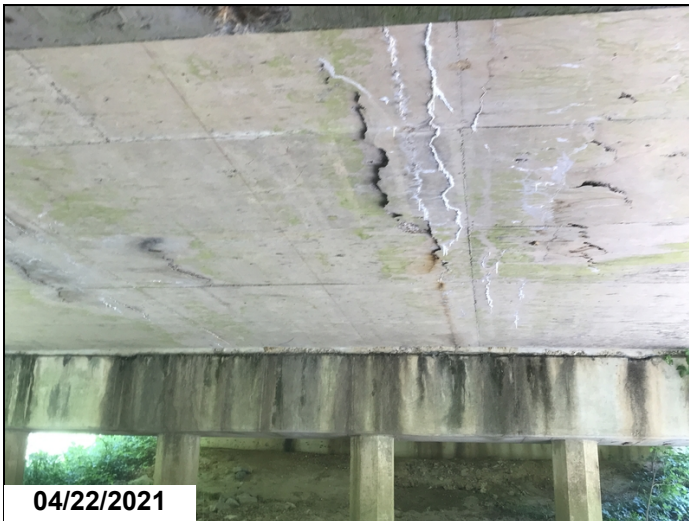
Span 2 near center line at mid span has large delam with staining.

Type of Work: Deck Repair
