## Bridge 03554 Inspection Report

**Asset #03554**(Routine)

**US 425-02 LM 10.30 over Flat Creek**

**Team Lead: Sharon Hooks Inspection Date: 05/17/2023**

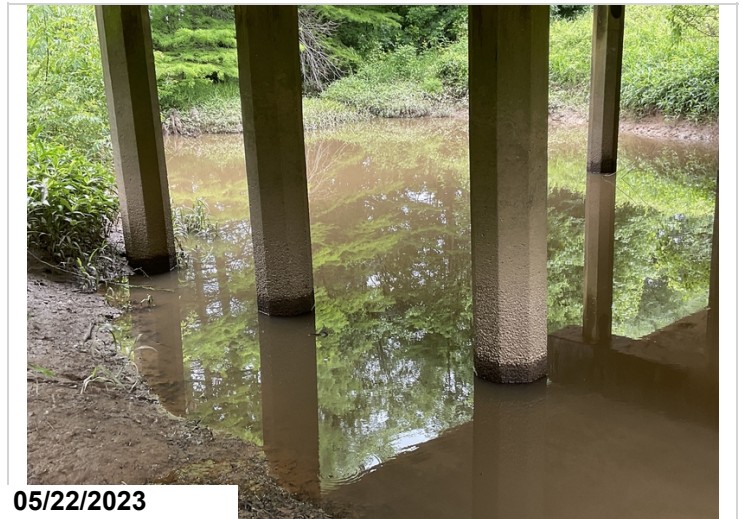
Bent 4 pile have abrasion.

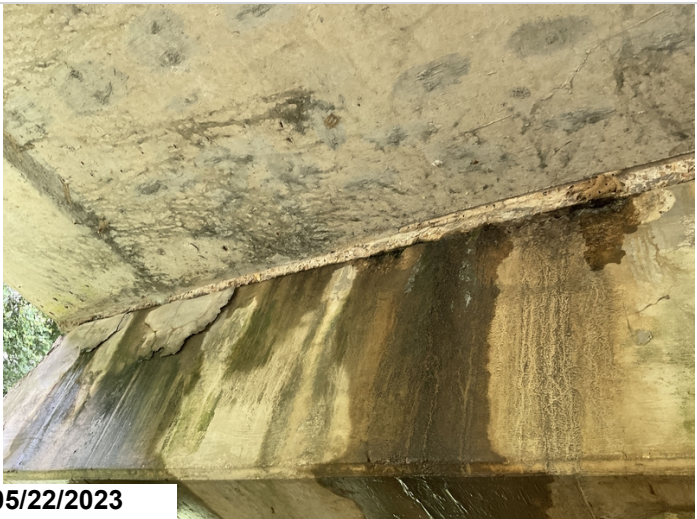
Bent 7 cap back has spalls and delams.

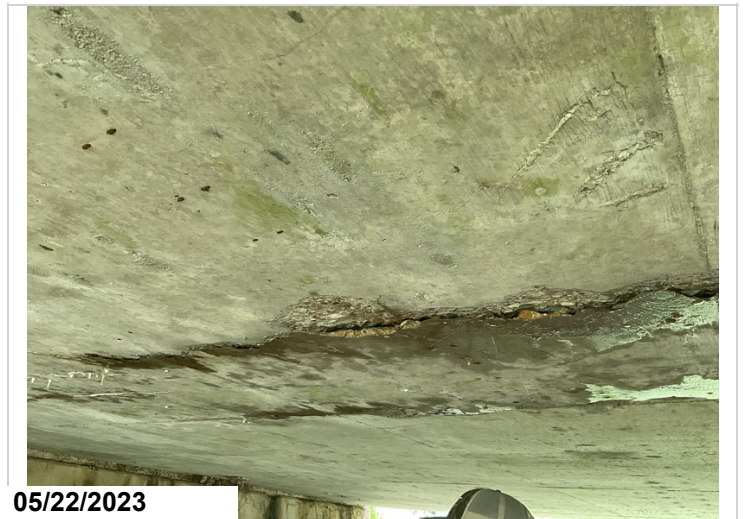
Span 7 large soffit delam.

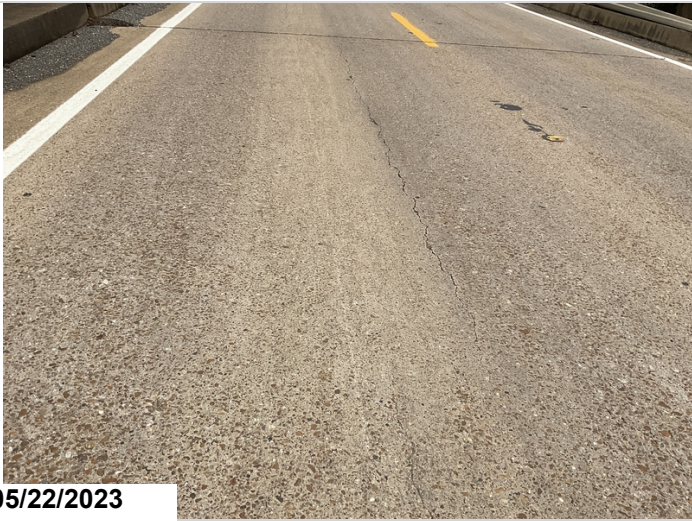
Span 6 deck cracking.

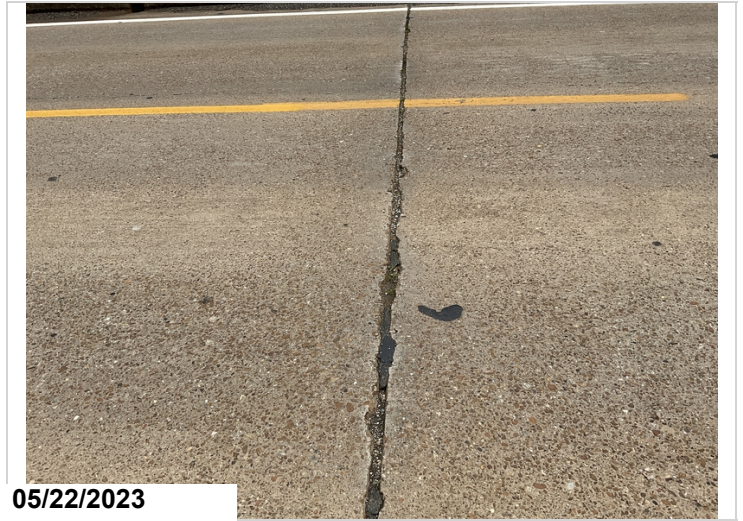
Joints - Bents 2-8: Pourable joint material has deteriorated and joint is mostly filled with dirt and debris.

Bent 4 joint seal has lost bond.

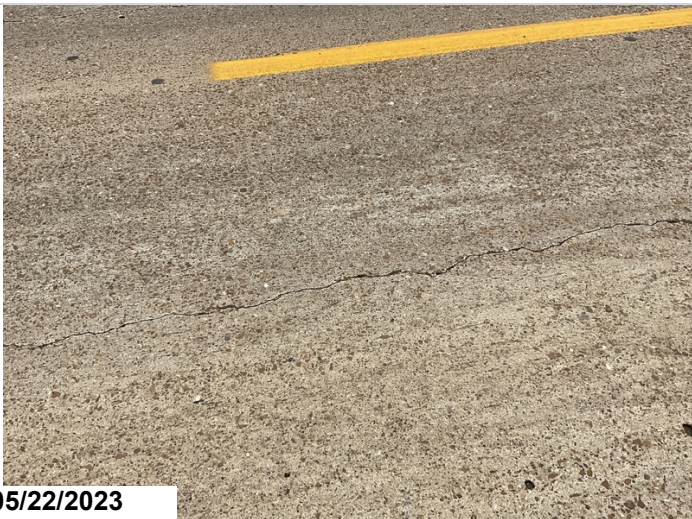
Span 1 deck cracking.

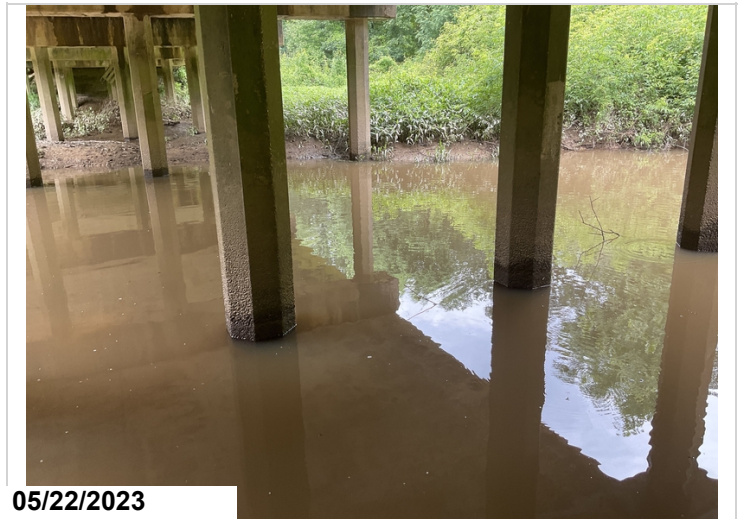
Bent 3 Pile have abrasion.

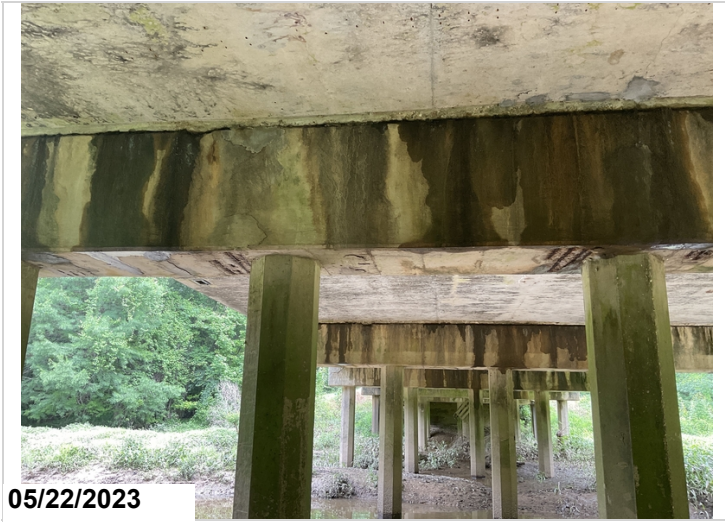
Bent 3 bottom of cap has spalls with exposed rebar.

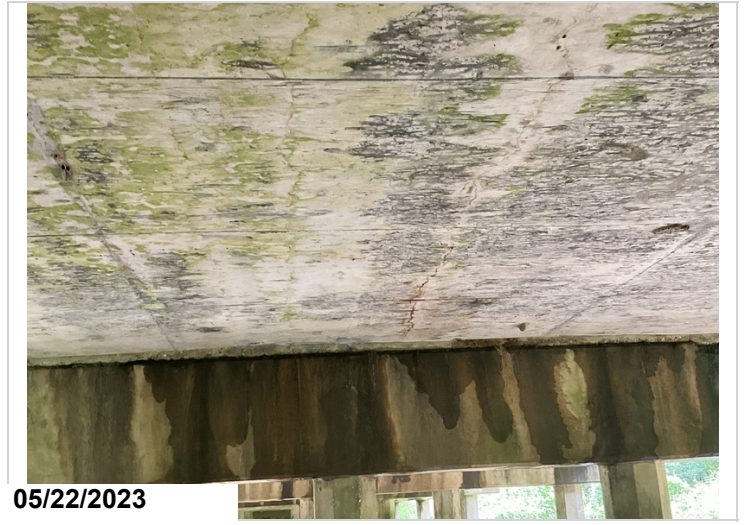
Span 2 soffit has large cracks with staining.

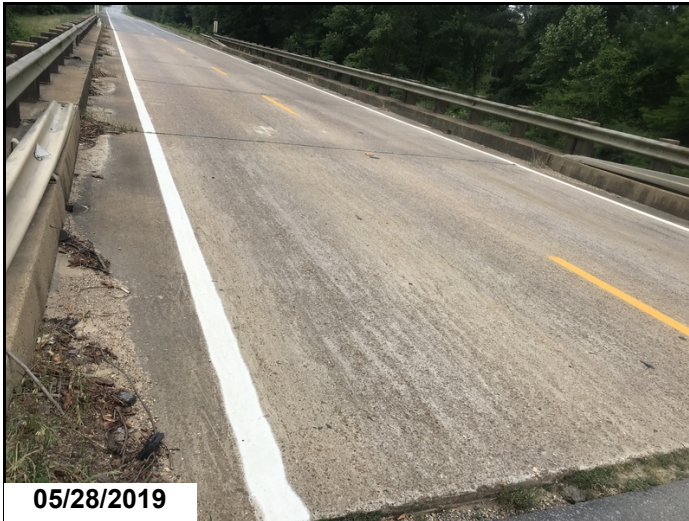
All spans: Several moderate-sized longitudinal full-depth cracks with delams to soffit/ a few scattered minor-sized transverse cracks / minor to significant abrasive wear with some scattered loss of aggregate.

Deck - Spans 1-7: Typical

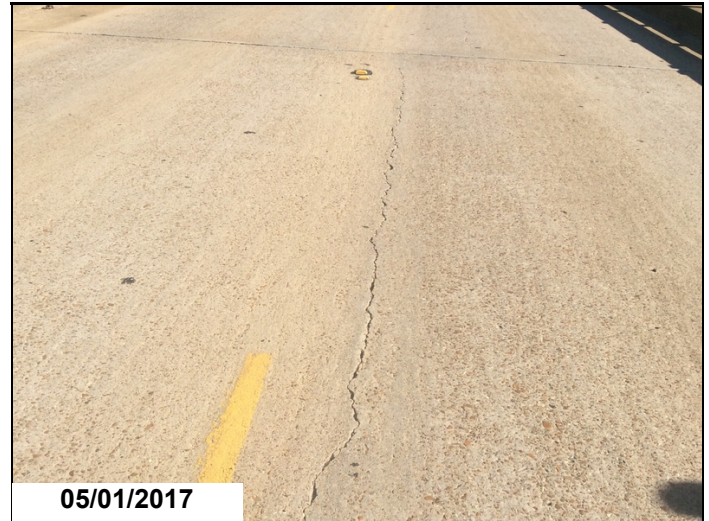
Large crack on span 4 near centerline but common on spans 1,3,4,5 & 6

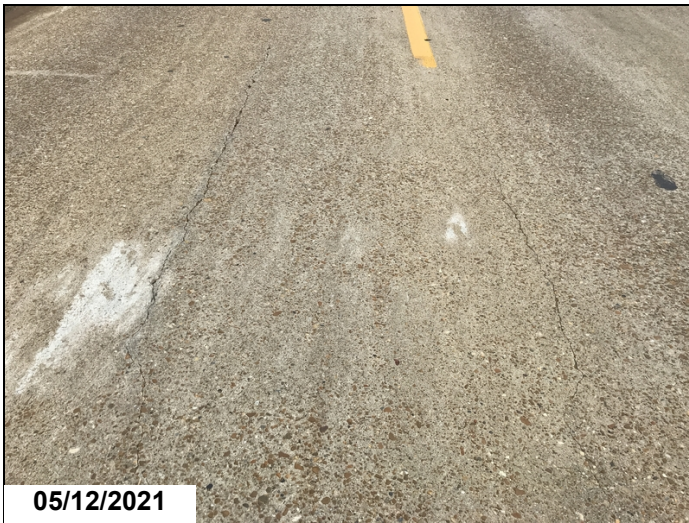
Span 2 large unsealed crack that reflect to soffit.

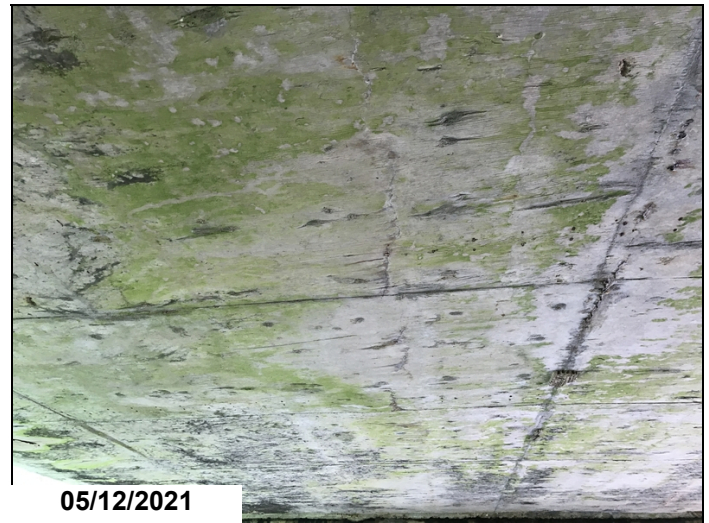
Span 2 cracking reflecting from top side of deck

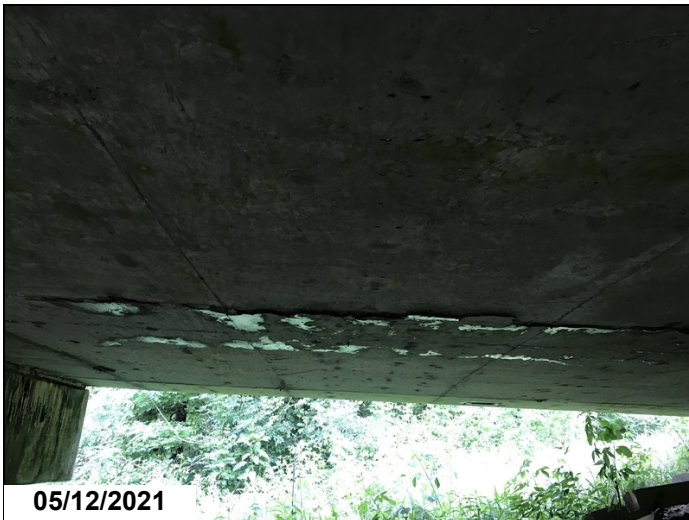
Span 8 soffit on left lane has large delam with cracking and staining.

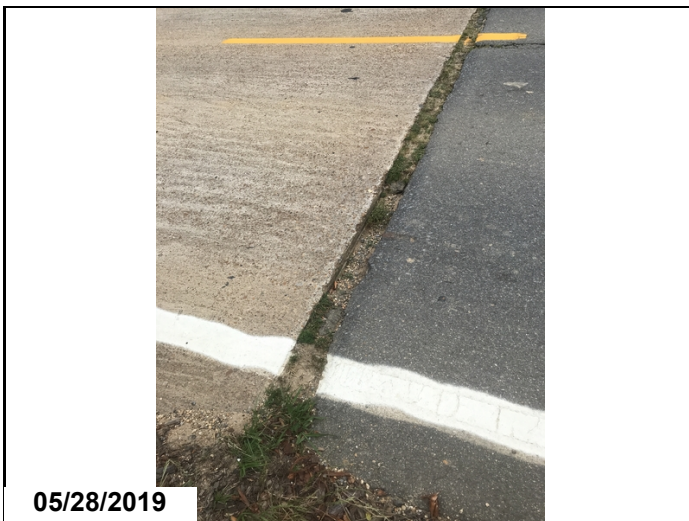
Joint - Bent 1: Joint at bridge end is considerably wider than normal (approximately 6"), making a bump for traffic coming onto and off of bridge.

Bent 1 - Left : Hole

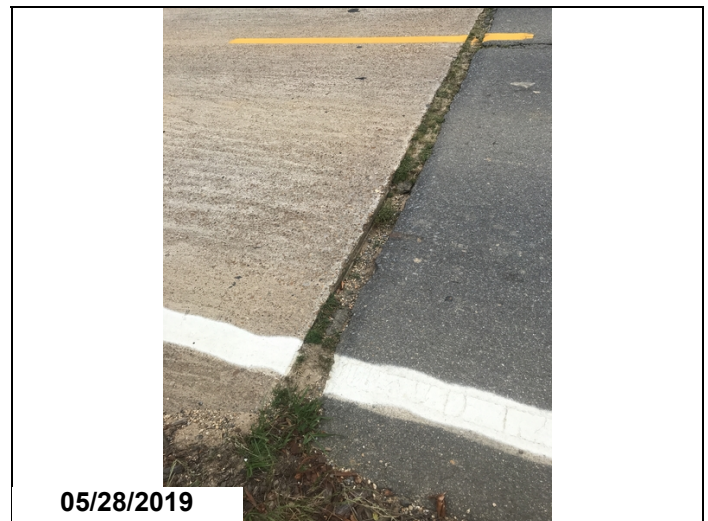
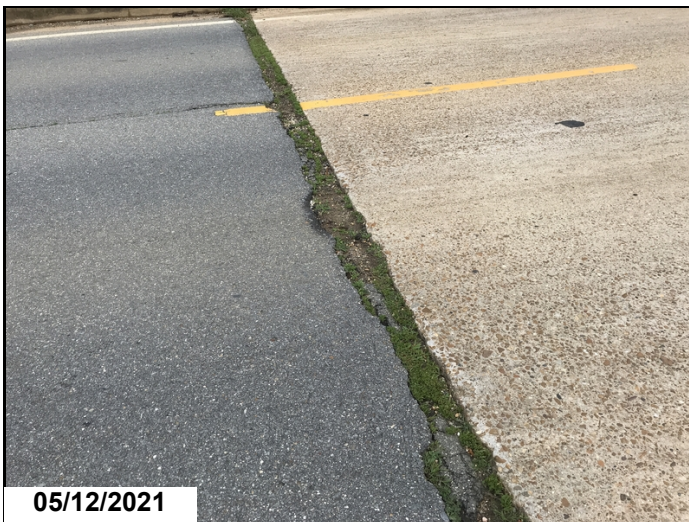
Bent 1 and roadway approach, Joint filled with debris.
