## Bridge 03930 Inspection Report

Asset #03930(Routine)

US 425-03 LM 1.40 over South Fork Panther Creek

Team Lead: Sharon Hooks Inspection Date: 07/25/2023

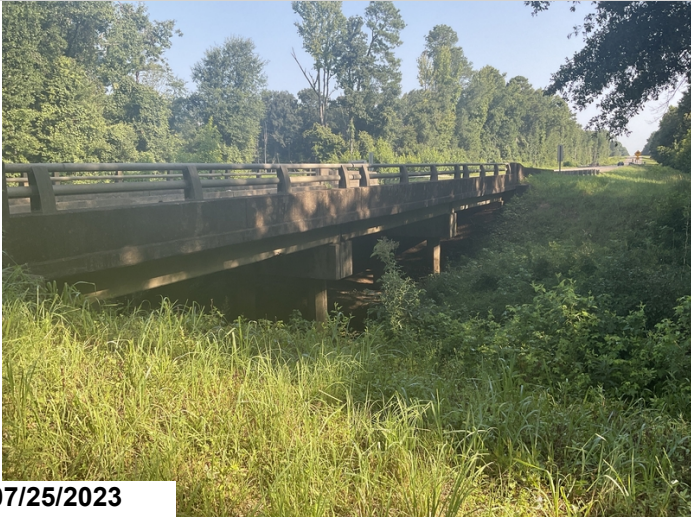
Elevation.

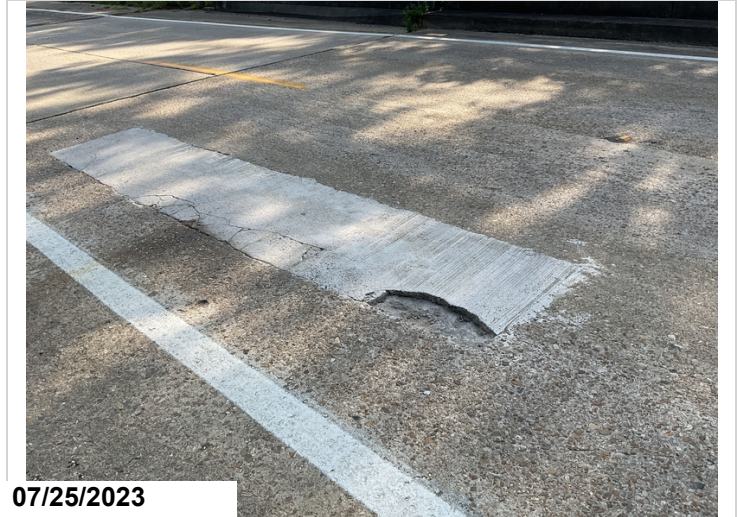
Deck span 3 left has spalling at previously patched area.

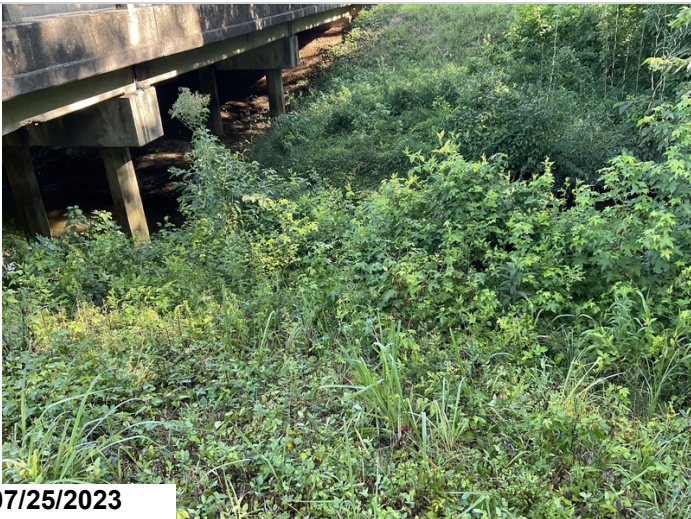
All end slopes have trees, vines and vegetation.

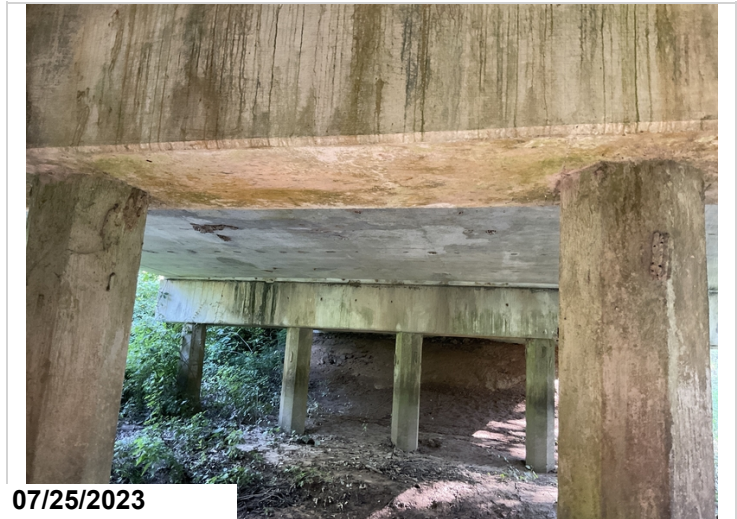
Span 2 Under view.

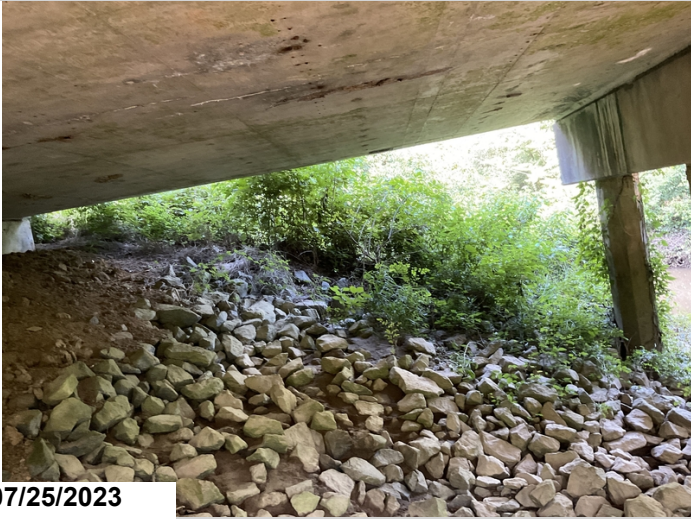
Span 1 left has trees, vines and vegetation impeding inspections.

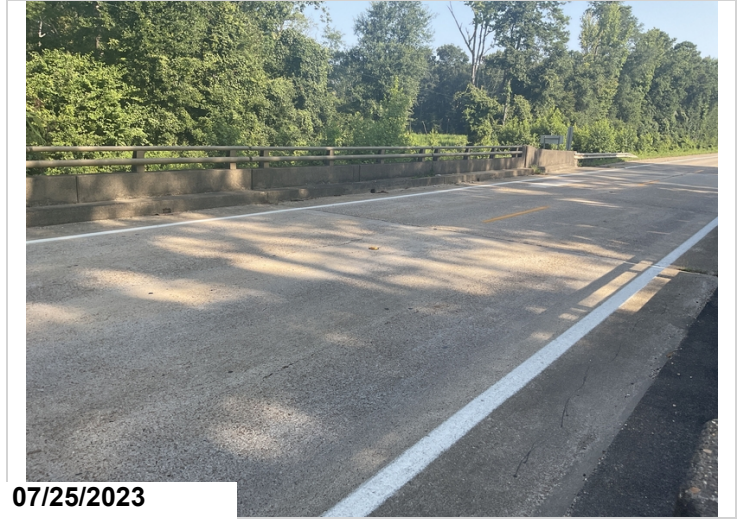
Deck over view.

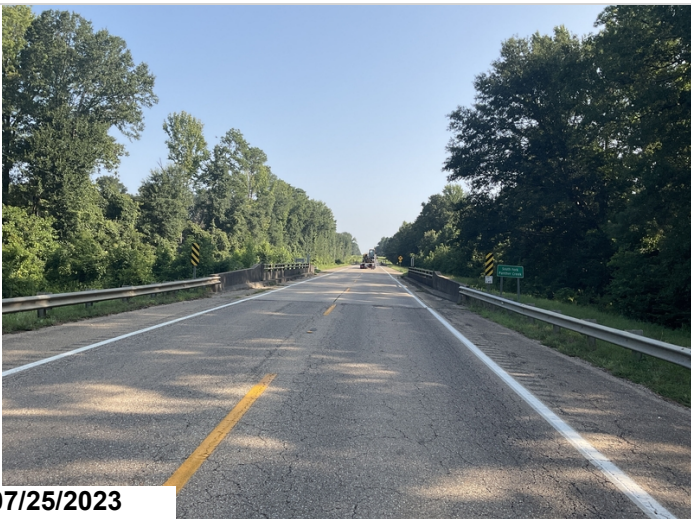
Approach.

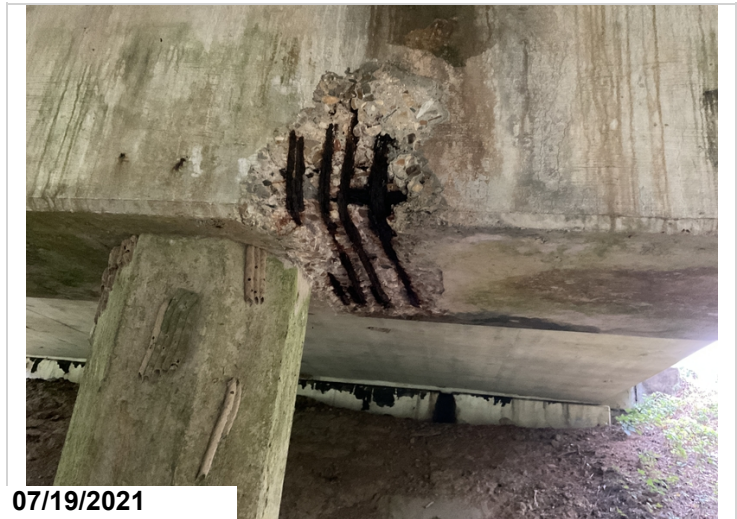
(234) Caps: 30.66' = 31' each / Bents 2-3. Bents 2 : Spalling with exposed rebar (heavy corrosion) on bottom face of cap right of Pile 4. Bent 3: Spalling with exposed rebar on back face near pile 4.							
301	Pourable Joint Seal	LF	132	0	0	122	10
2320	Seal Adhesion	LF	66	0	0	66	0
2330	Seal Damage	LF	10	0	0	0	10
2350	Debris Impaction	LF	56	0	0	56	0

Bent 3 cap has spalls with exposed rebar. near pile 4.

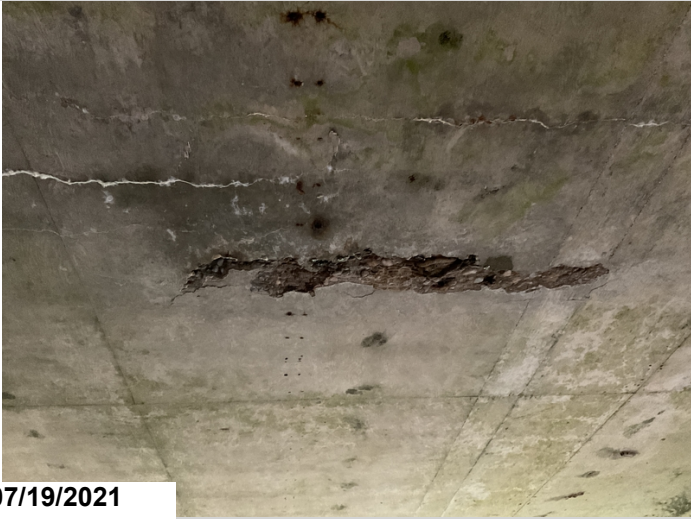
07/19/2021

Span 1 left lane on soffit has large cracks with staining and leakage.

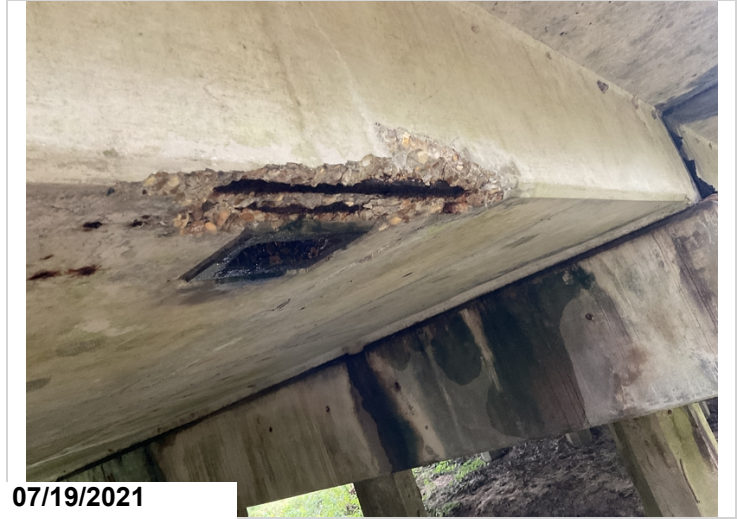
07/19/2021

Span 1 right side at drain opening, spalling with exposed rebar.

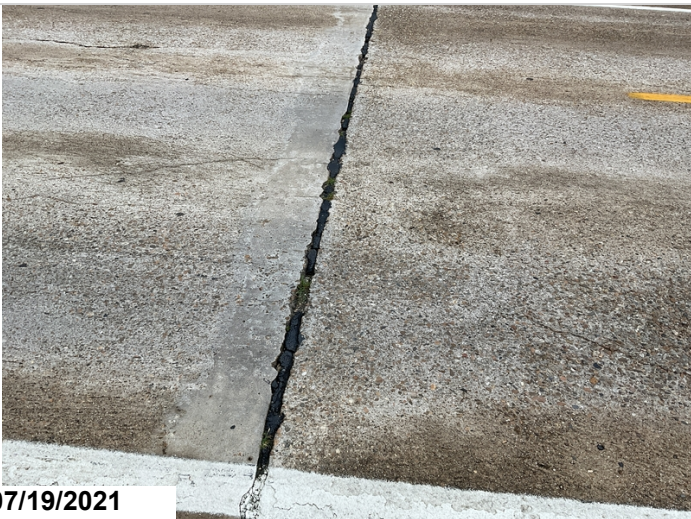
07/19/2021

(301) Joints: 33' each / Bents 1-4. Bents 1-4: Pourable joint material has deteriorated and joints are mostly filled with dirt and debris.							
321	Reinforced Concrete Approach Slab	SF	1680	0	1680	0	0

Bent 2 joint material has missing areas with loss of adhesion and debris impaction.

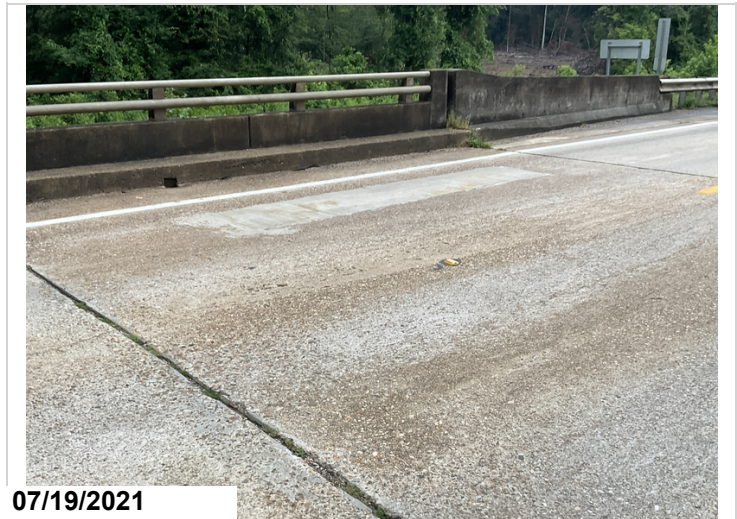
07/19/2021

Span 3 left lane patched area.

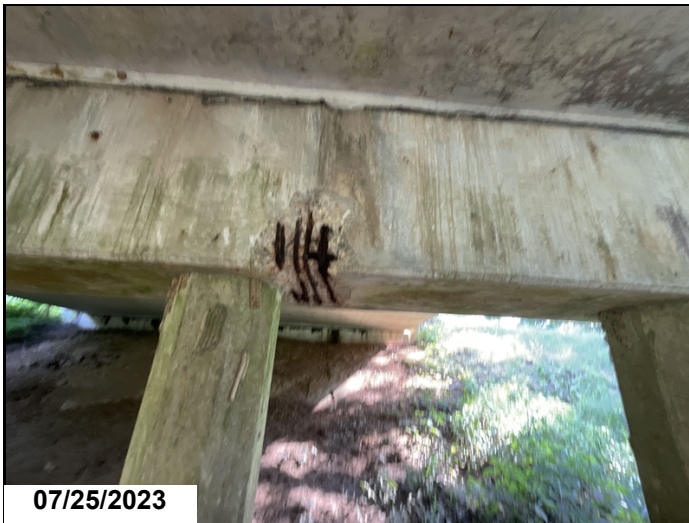
Caps: Bents 2 & 3: Spalling with exposed rebar (heavy corrosion) on bottom face of cap right of Pile 4.

Bent 3 cap back between piles 4 & 5 has large spall with exposed rebar.

Repair as you can fit into your schedule

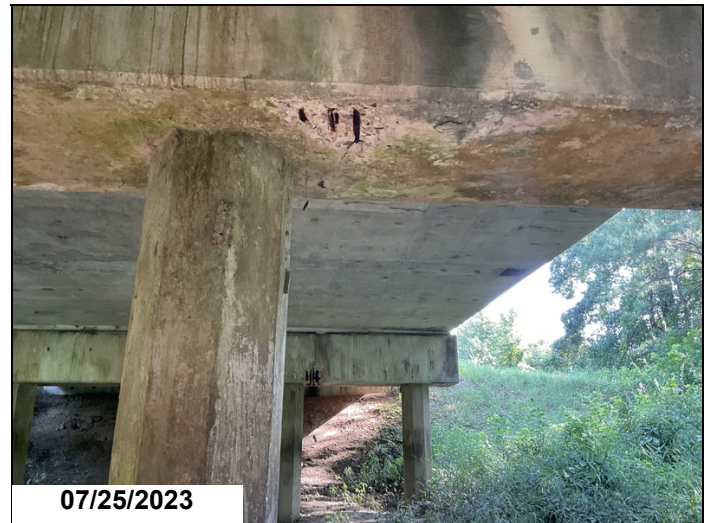
Bent 2 bottom of cap between piles 4 & 5 has spall with exposed rebar.

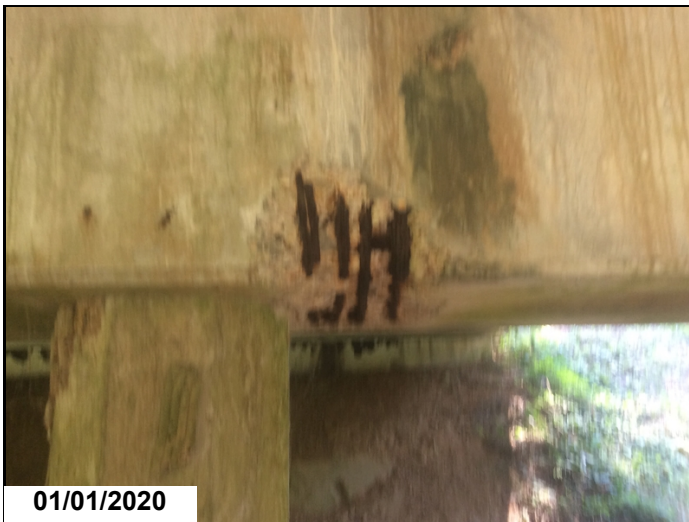
Bent 3 cap has spall with exposed rebar.

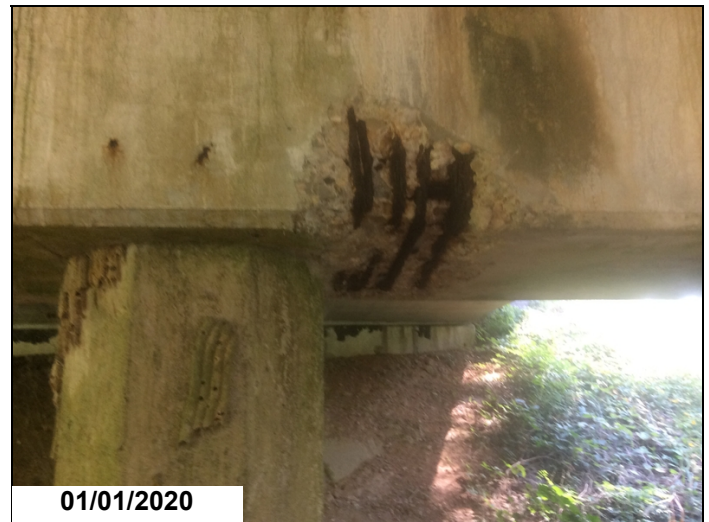
Bent 3 right of pile 4 spall with reposed rebar.

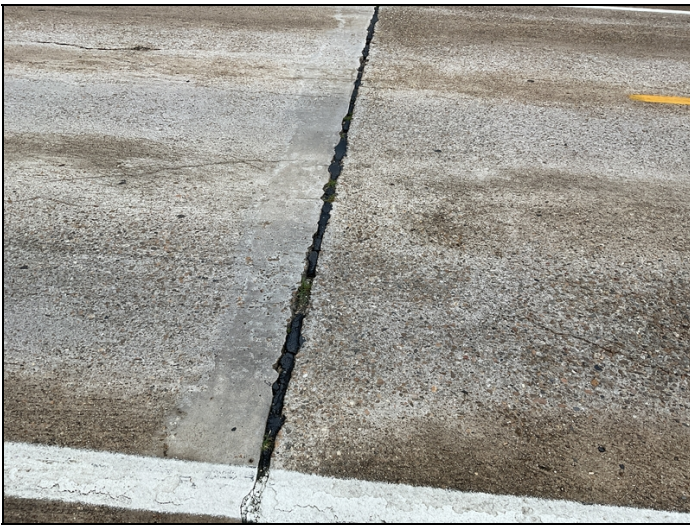
Joints: Bents 1-4: Pourable joint material has deteriorated and joint is mostly filled with dirt and debris.

Bent 2 joint material has missing areas with loss of adhesion and debris impaction.

**A-59 - Joint Repair Needed (Yes)**

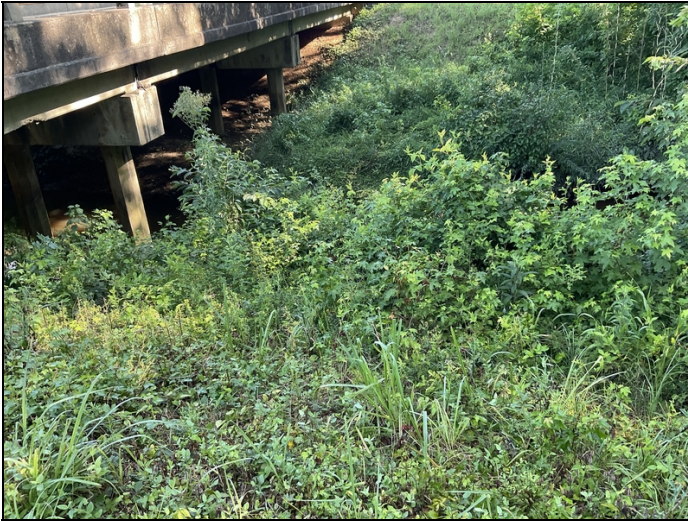
All end slopes have trees, vines and vegetation.

**A-64 - Vegetation Removal Requested (Yes)**

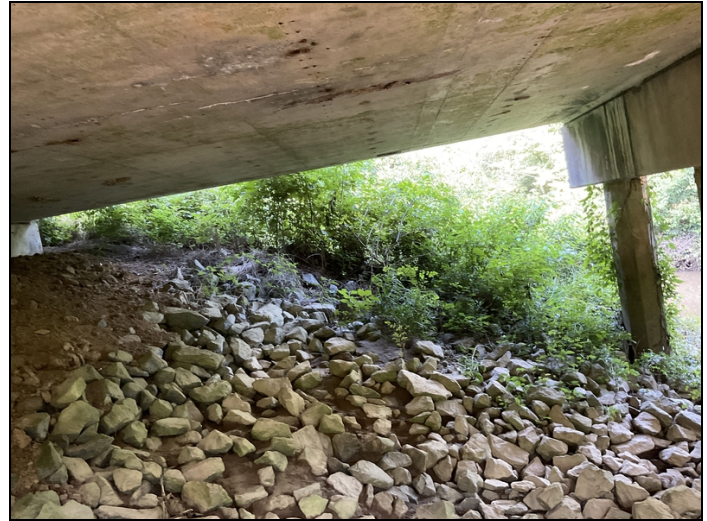
Span 1 left has trees, vines and vegetation impeding inspections.
