Bridge 03931 Inspection Report

Asset #03931 (Routine)

US 425-03 LM 1.51 over South Fork Panther Creek

Team Lead: Sharon Hooks Inspection Date: 07/25/2023

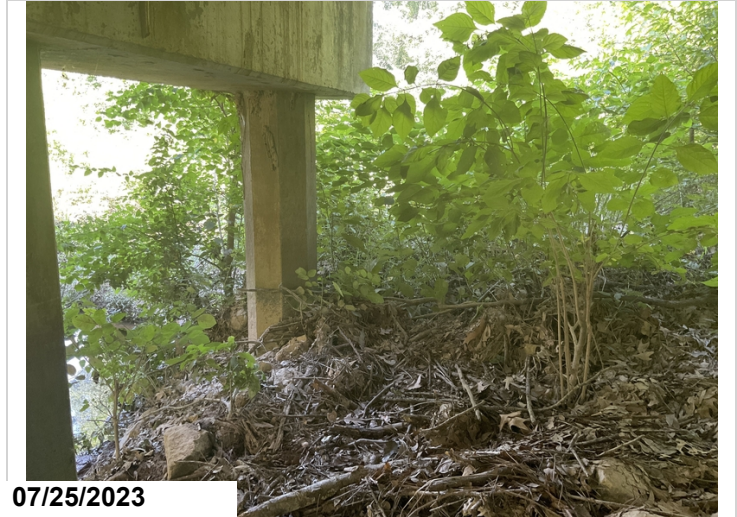
Span 3 left side has trees and vegetation growing under bridge.

A-64 - Vegetation Removal Requested (Y)

Tree's ,vines on all end slopes and under bridge.

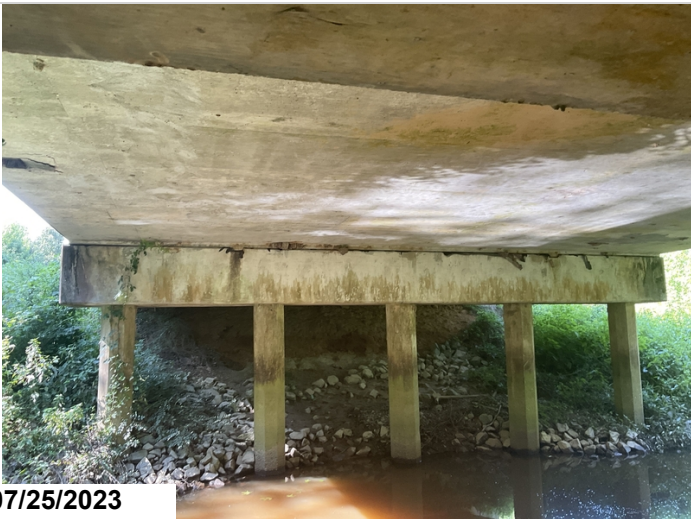
Span 2 under view of soffit.

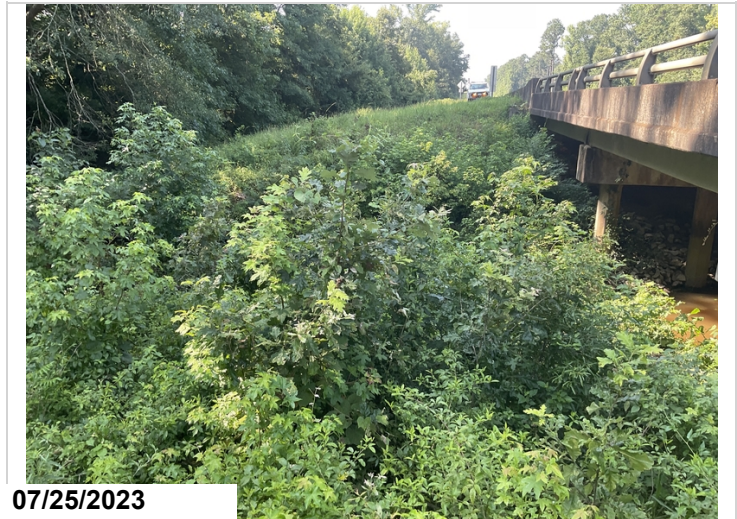
Trees, vines and vegetation impeding inspection process.

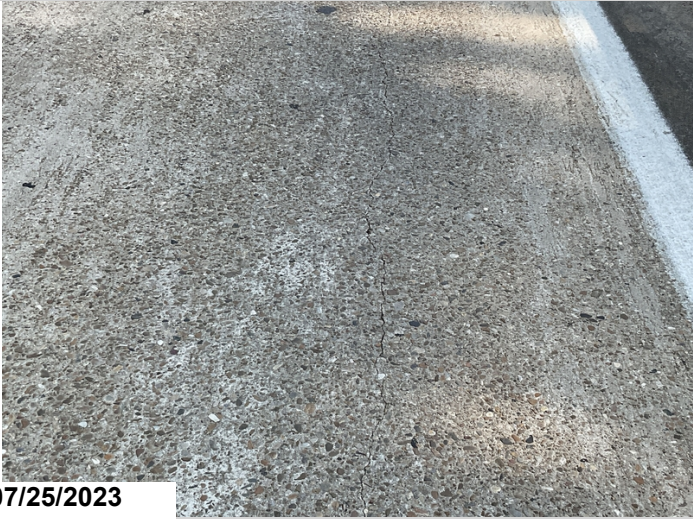
All spans: Several unsealed, hairline- to moderate-sized full-depth longitudinal cracks / minor to significant abrasive wear in travel lanes.

Span 3 deck right lane has large unsealed longitudinal cracks.

A-54 - Sealable Deck Cracks (Y)

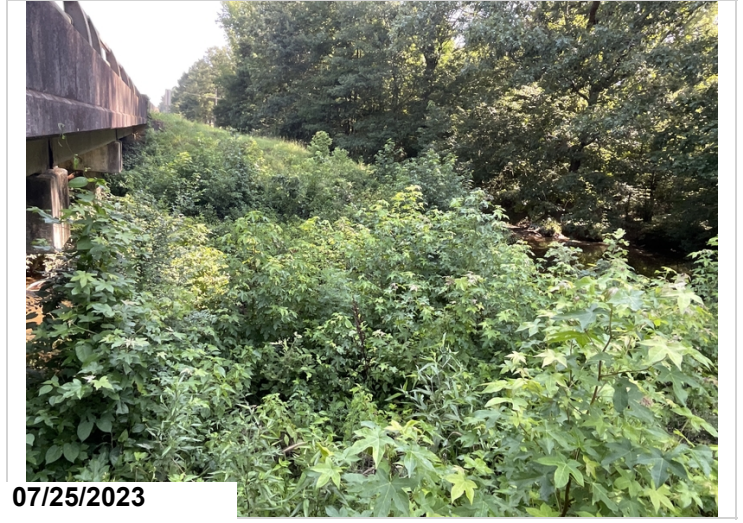
Trees, vines and vegetation impeding inspection process.

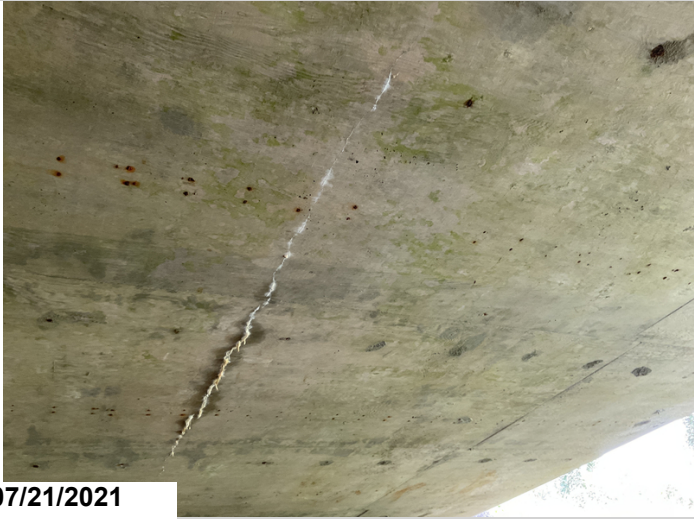
All spans: Cracking with efflorescence and rust staining, mostly reflective of cracking in deck surface / delaminations/spalling/exposed rebar around drain holes, especially Span 2 left and Span 3 right.

Span1 left side of soffit has cracking with efflorescence.

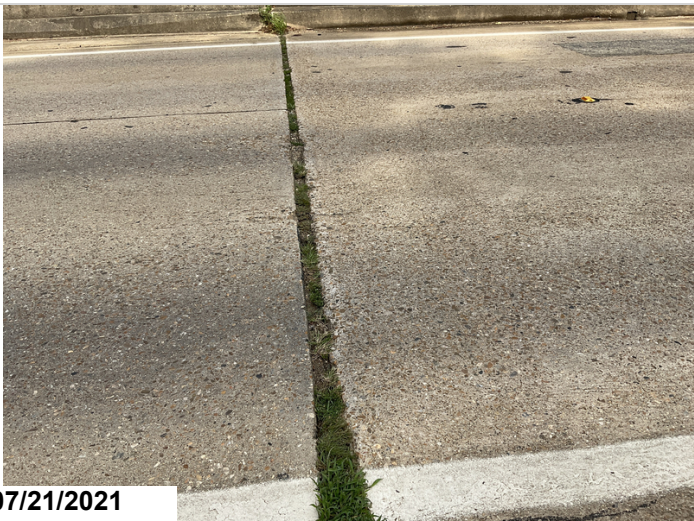
Bents 1, 3, & 4: Pourable joint material has deteriorated and joint is mostly filled with dirt and debris.

Bent 1 Joint seals have debris impaction.

A-56 - Joint Cleaning/Flushing Needed (Y)

A-59 - Joint Repair Needed (Y)

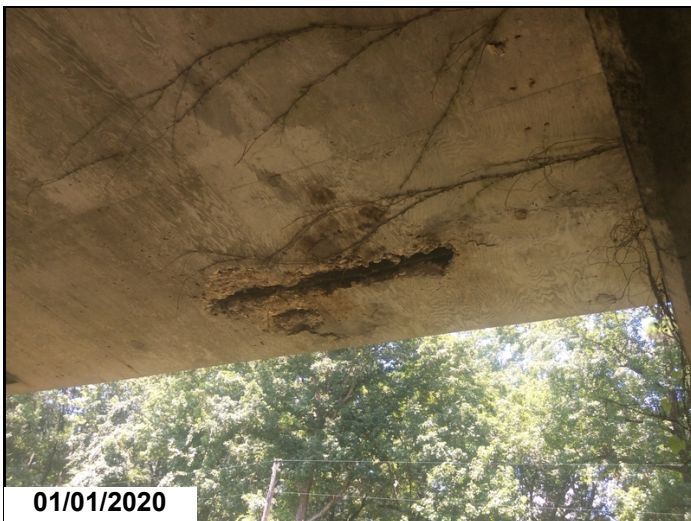
COMBINED - Span 2 left side and span 3 right side drain hole bottom of slab.
Spalling and exposed rebar.

Span 2 left side of soffit area has spall with exposed rebar and common on bent 3 soffit drain on right side .

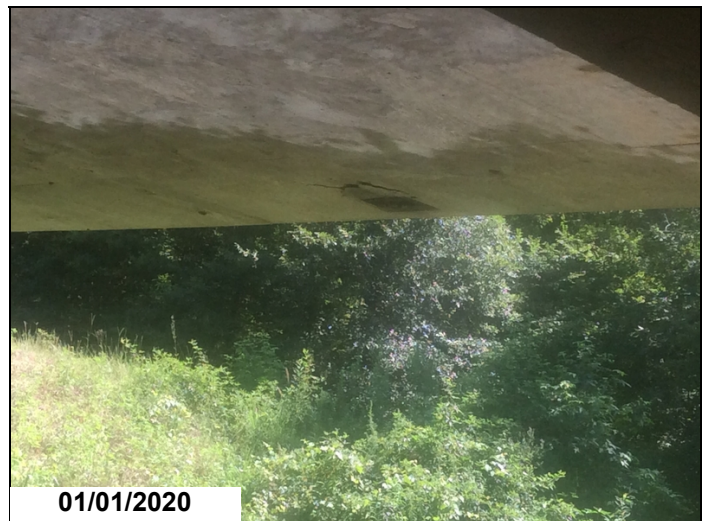
Span 2 delam under drain opening right side.

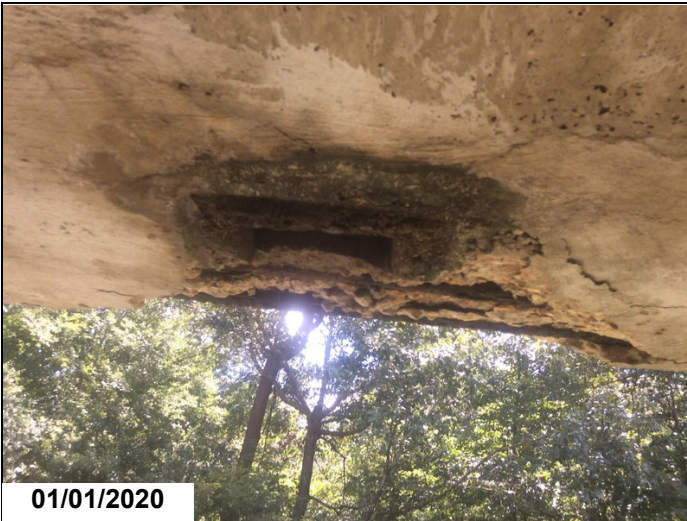
Bent 3 right side drain at soffit area has spall with exposed rebar.

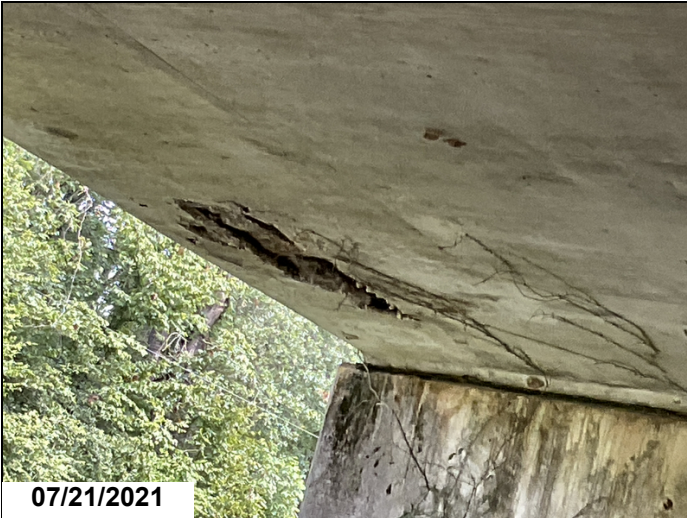
Bent 2 left near Bent 3 has spall with exposed rebar.

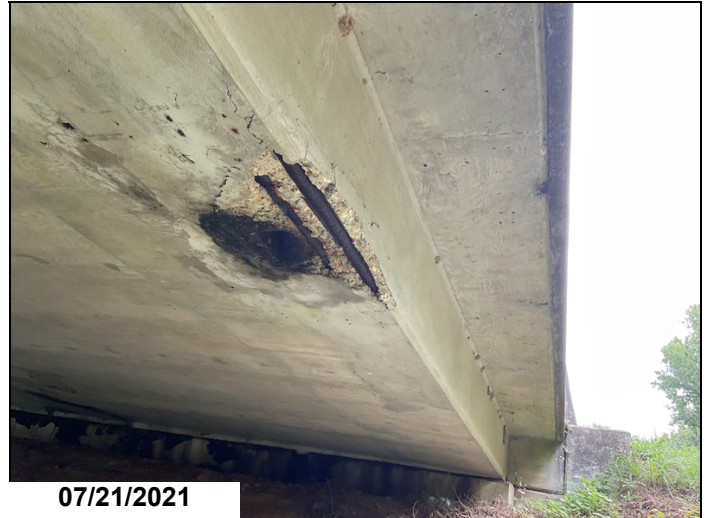
Bent 3 right at drain opening has spall with exposed rebar.

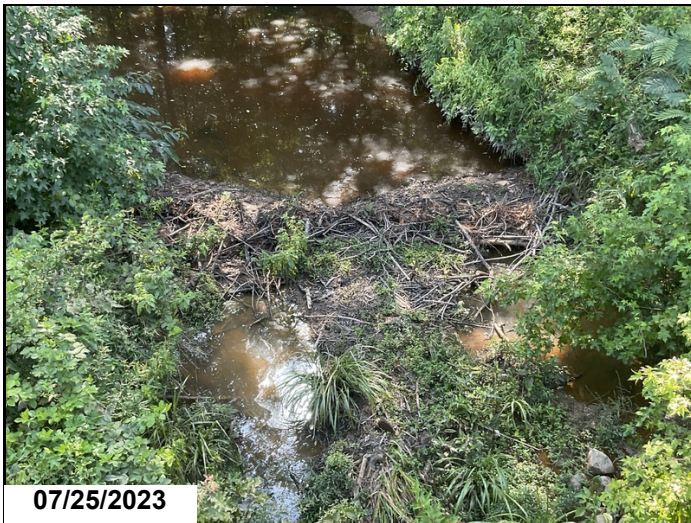
Channel right side (East) upstream has a beaver dam restricting water flow.

Beaver dam on right side (East) is restricting water flow.

Type of Work: Channel Work/Drift Removal

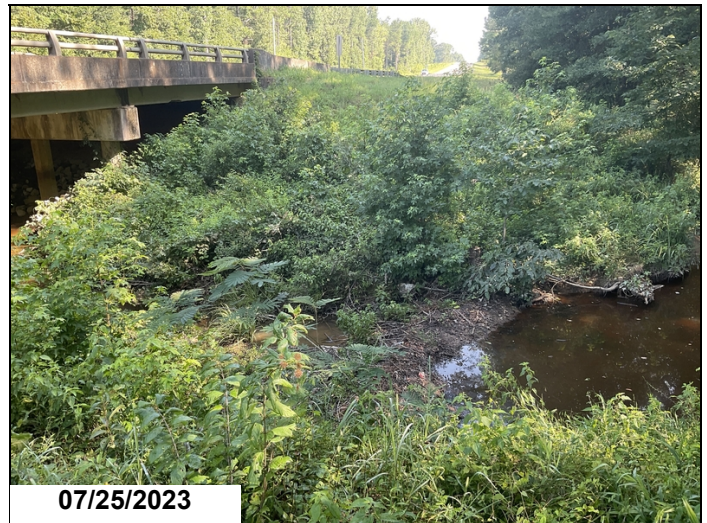
Right side of channel (east) has beaver dam restricting water flow.

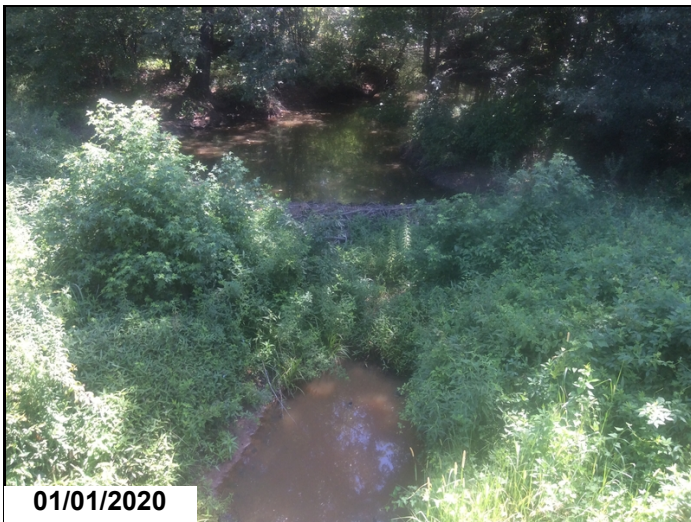
Beaver dam.

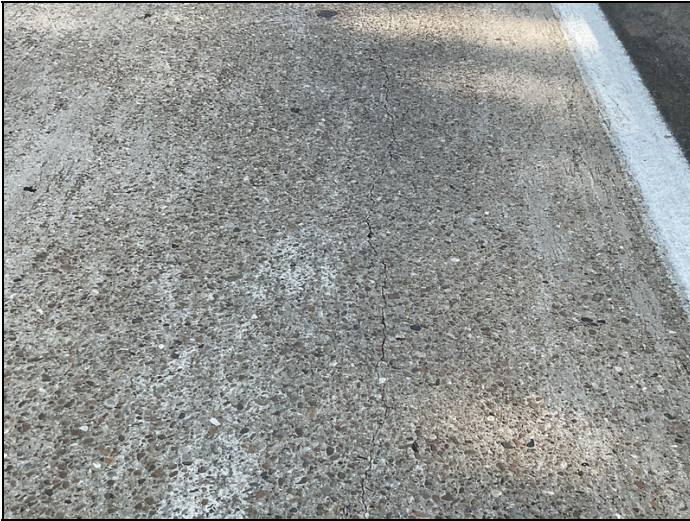
All spans: Several unsealed, hairline- to moderate-sized full-depth longitudinal cracks / minor to significant abrasive wear in travel lanes.

Span 3 deck right lane has large unsealed longitudinal cracks.

A-54 - Sealable Deck Cracks (Yes)

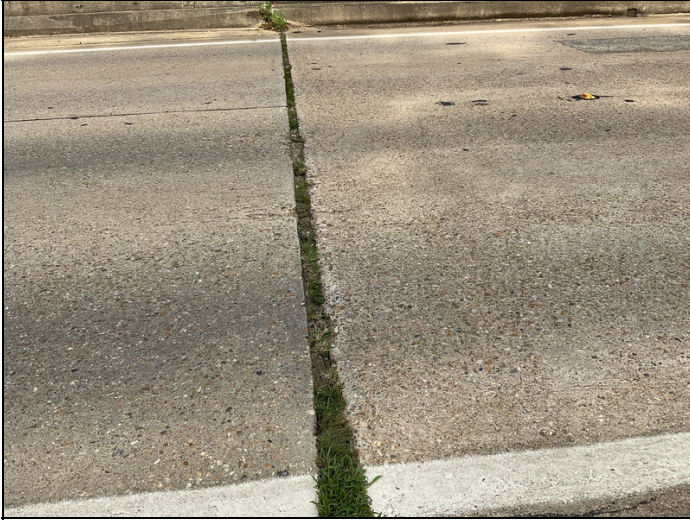
Bents 1, 3, & 4: Pourable joint material has deteriorated and joint is mostly filled with dirt and debris.
Bent 2: Joint has been re-sealed, but is losing adhesion in most places.

Bent 1 Joint seals have debris impaction.

A-59 - Joint Repair Needed (Yes)

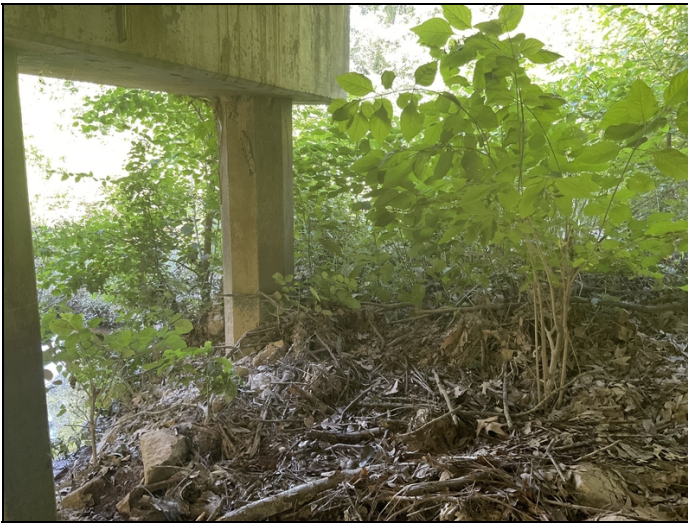
Tree's ,vines on all end slopes and under bridge.

Span 3 left side has trees and vegetation growing under bridge.

A-64 - Vegetation Removal Requested (Yes)

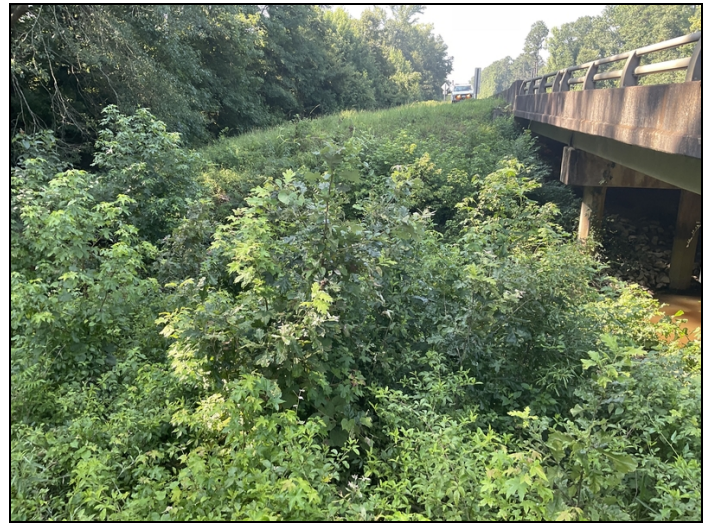
Trees, vines and vegetation impeding inspection process.

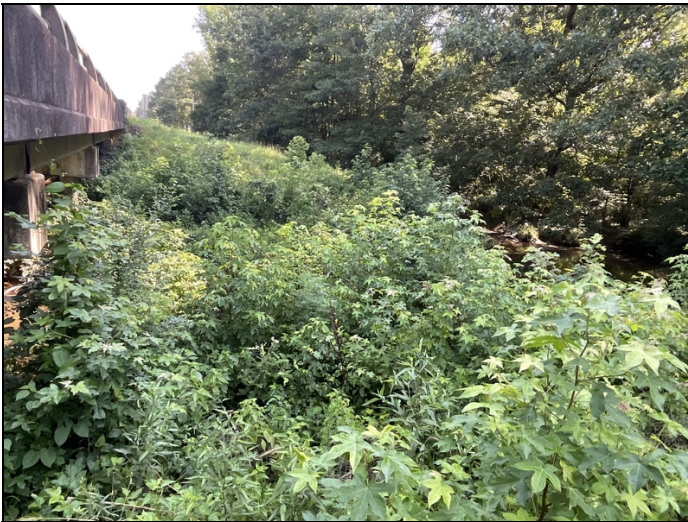
Trees, vines and vegetation impeding inspection process.
