Bridge 03932 Inspection Report

Asset #03932(Routine)

US 425-03 LM 2.09 over Panther Creek

Team Lead: Sharon Hooks Inspection Date: 07/25/2023

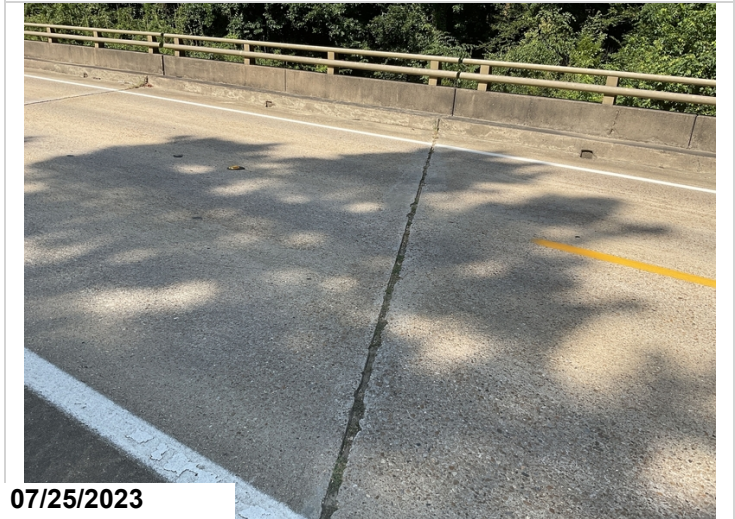
(301) Joints: 35' each (skewed) / Bents 1-4. Bents 1, 3, & 4: Pourable joint material has deteriorated and joint is mostly filled with dirt and debris. Bent 2: Joint has been re-sealed, but is losing adhesion in most places.							
321	Reinforced Concrete Approach Slab	SF	1680	0	1680	0	0
1190	Abrasion/Wear (PSC/RC)	SF	1680	0	1680	0	0

Bent 3 joint seal has loss of adhesion and is missing.

A-59 - Joint Repair Needed (Yes)

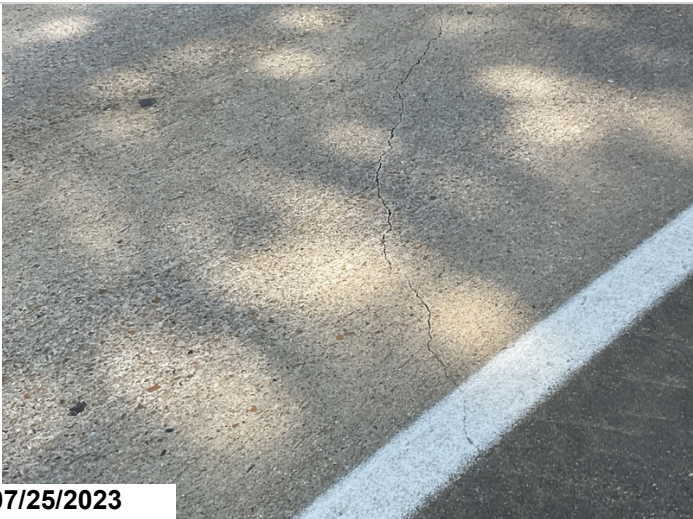
All spans: Several unsealed, moderate-sized longitudinal cracks / unsealed, moderate-sized diagonal (corner) cracks near gutterline/end of spans, largest at Span 1 left @ Bent 1 - beginning to spall (1/2" deep) along crack / minor to significant abrasive wear in travel lanes.

Span 2 deck right has large unsealed cracks.

A-54 - Sealable Deck Cracks (Yes)

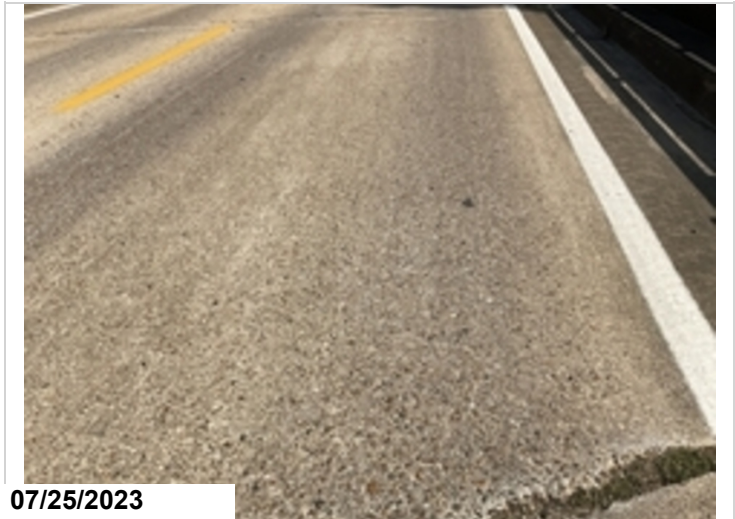
Span 1 deck right has large unsealed cracks.

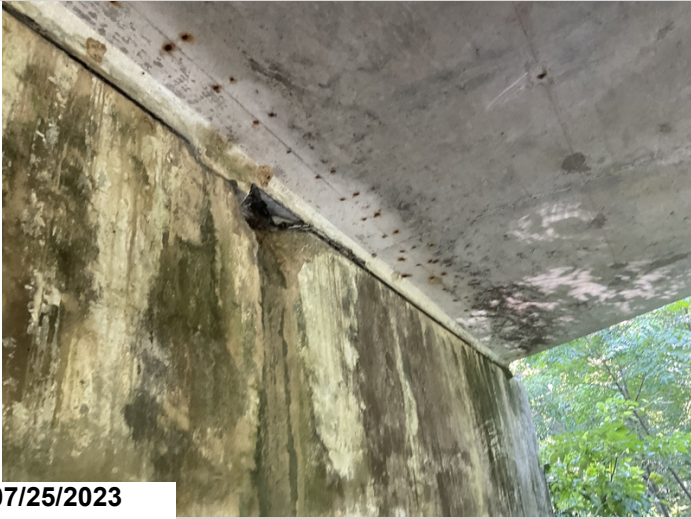
(234) Caps: 34' each (skewed) / Bents 2-3. Bents 2 & 3: Minor spalls and some rebar exposed.							
301	Pourable Joint Seal	LF	140	0	0	125	15
2320	Seal Adhesion	LF	70	0	0	70	0
2330	Seal Damage	LF	15	0	0	0	15
2350	Debris Impaction	LF	55	0	0	55	0

Bent 3 cap back right at keyway near pile 4.

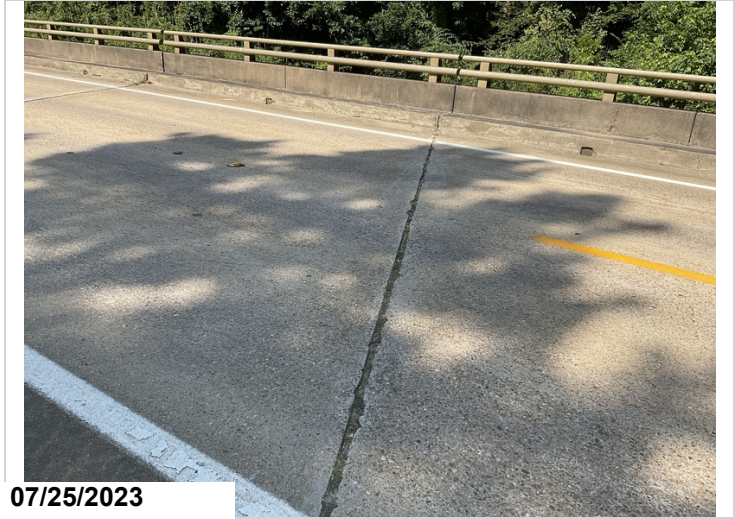
Bent 3 joint seal has loss of adhesion and is missing.

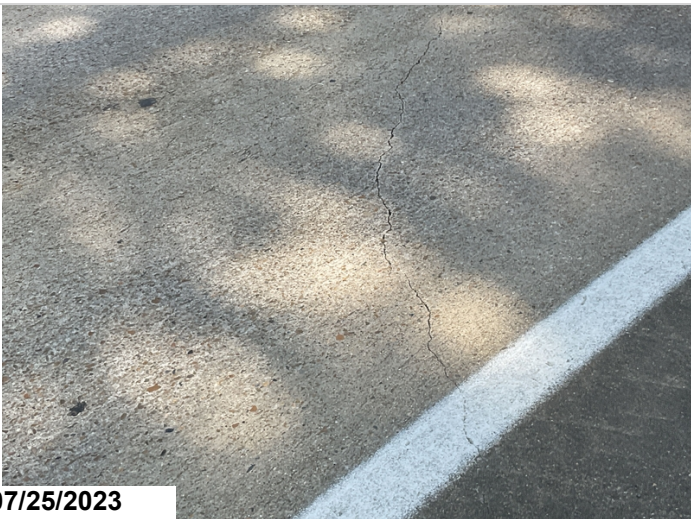
Span 2 deck right has large unsealed cracks.

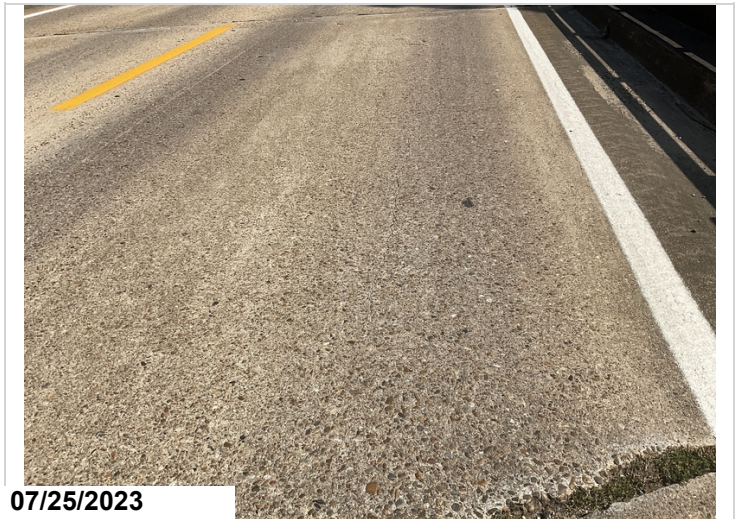
Span 1 deck right has large unsealed cracks.

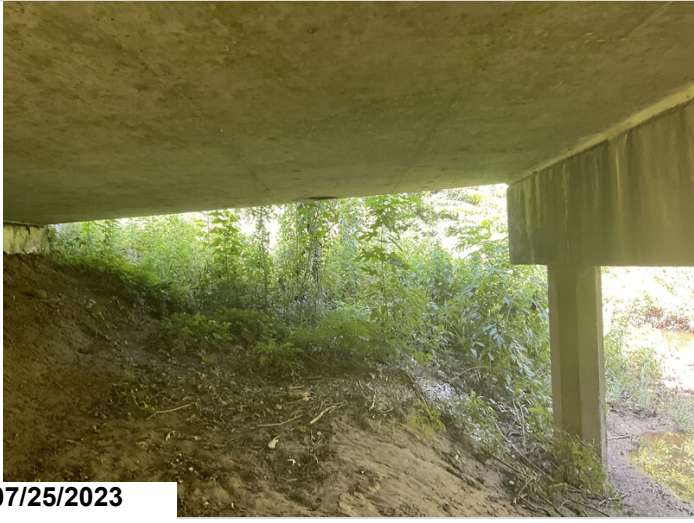
Tree's vines and vegetation on all ends lopes and under bridge impeding inspection process.

Trees,vines and vegetation on all endslopes.

A-64 - Vegetation Removal Requested (Yes)

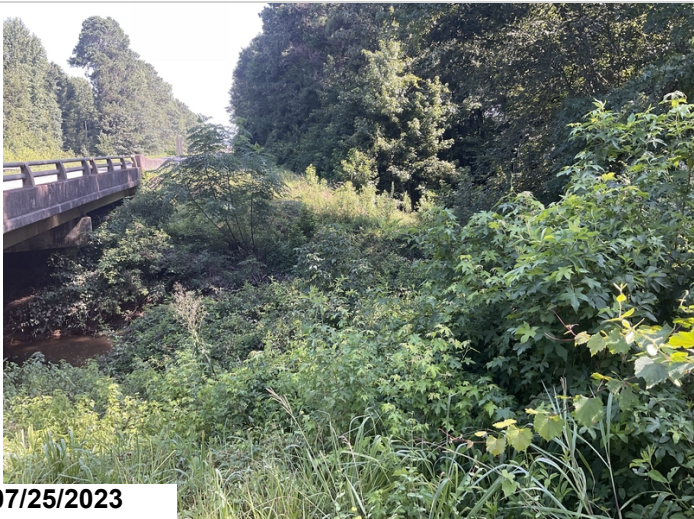
Trees, vines and vegetation.

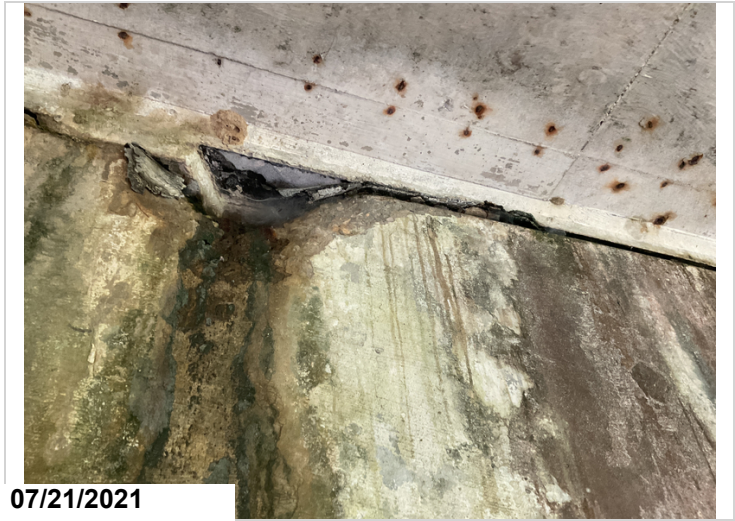
Bent 3 right key way in cap has spall with exposed rebar.

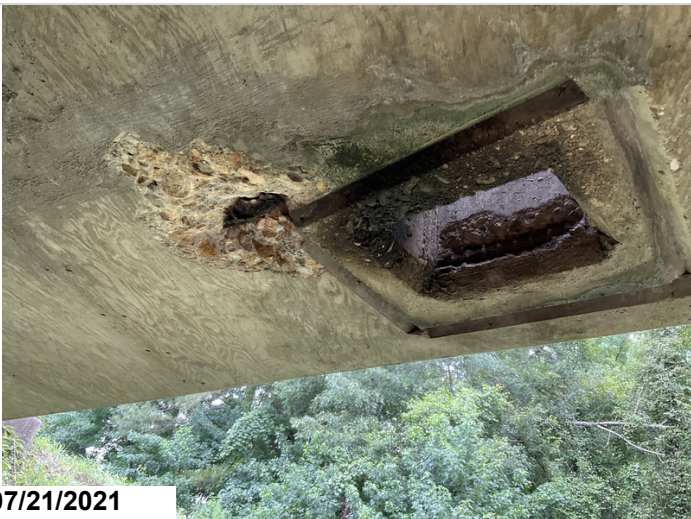
Span 3 right has soffit spall near drain opening.

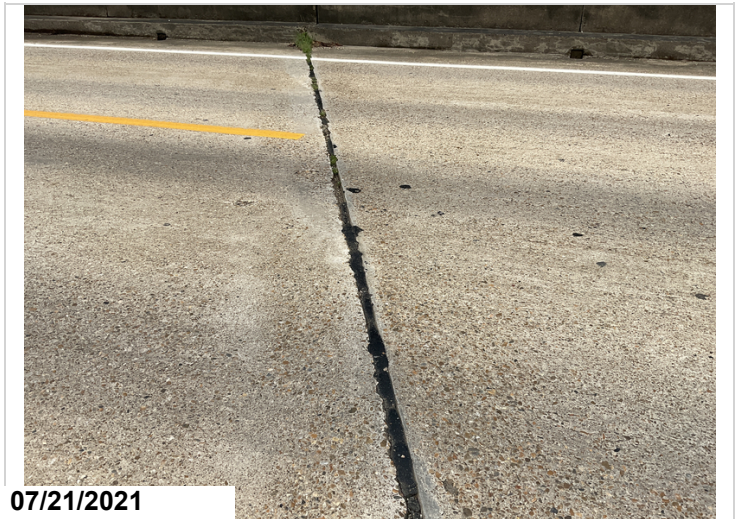
Bent 2: Joint has been re-sealed, but is losing adhesion in most places.

Bent 2 joint seals have lost bond with areas missing.

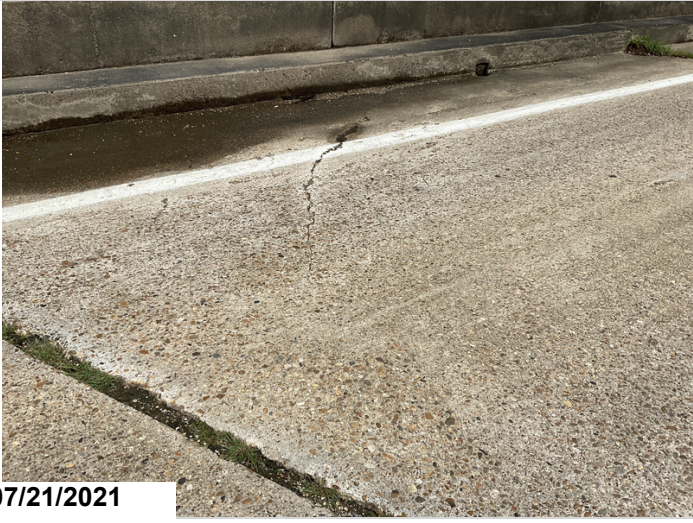
Span1 left has large diagonal crack.

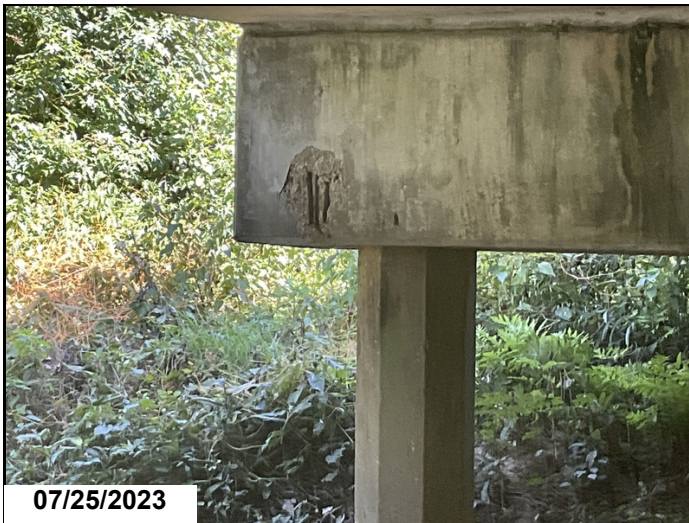
Caps: Bents 2 & 3: Minor spalls with some rebar exposed.

Bent 3 left ahead near pile 1 has spall with exposed rebar.

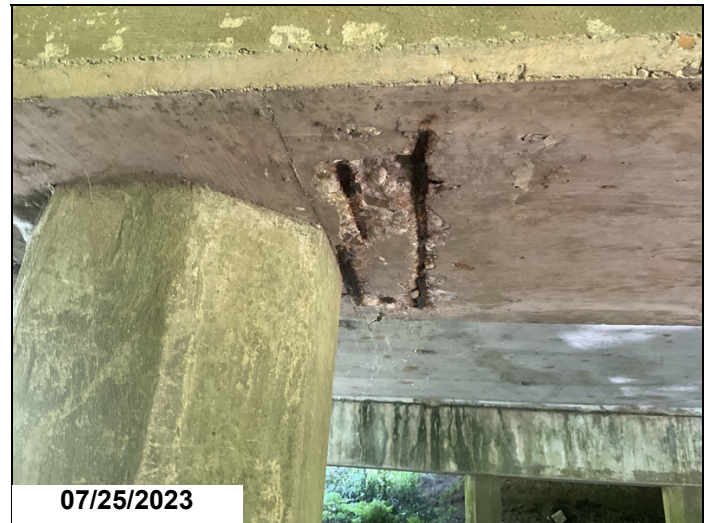
Bent 2 cap near pile 2 has spall with exposed.

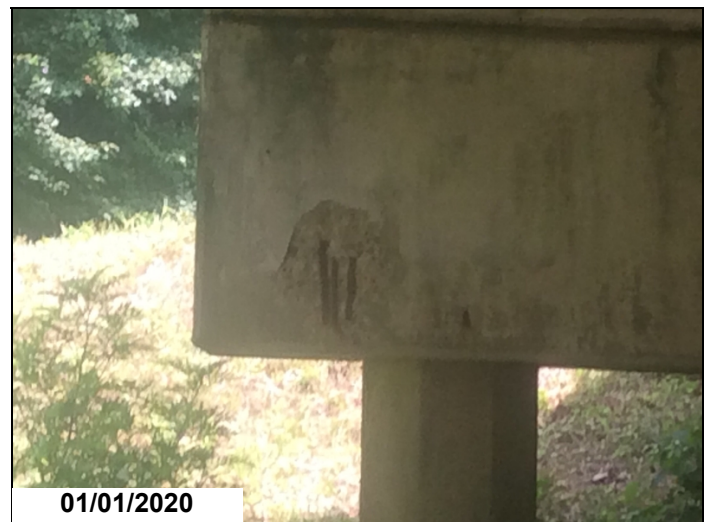
Bent 3 cap left has spall with exposed rebar.

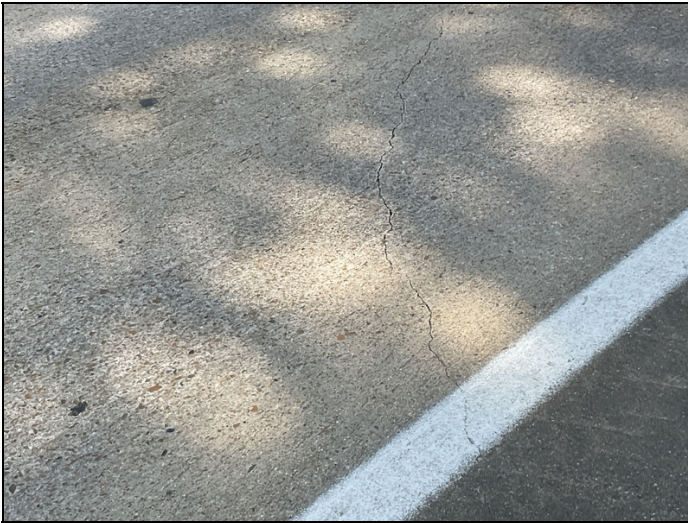
Span 2 deck right has large unsealed cracks.

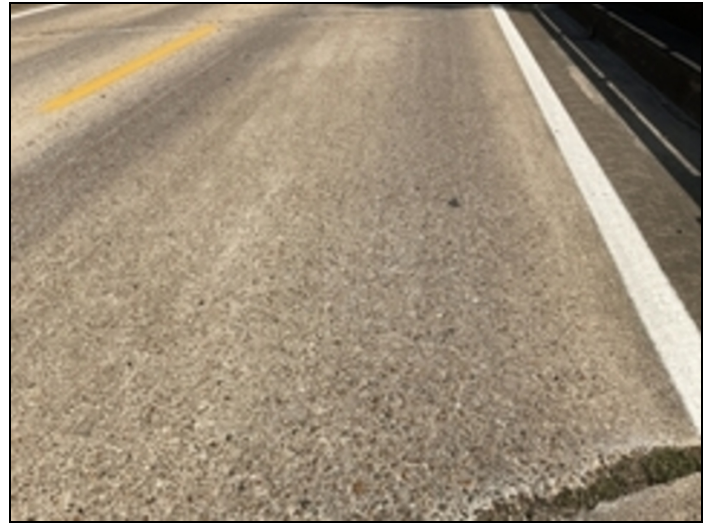
Span 1 deck right has large unsealed cracks.

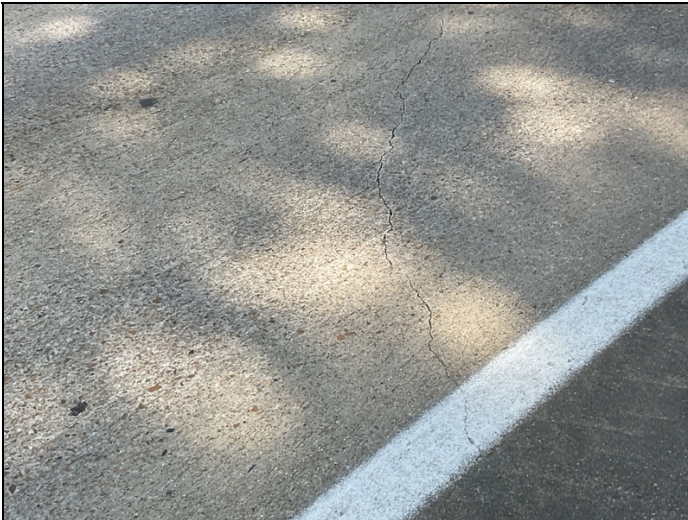
Span 2 deck right has large unsealed cracks.

A-61 - Polymer Overlay Advised (Yes)

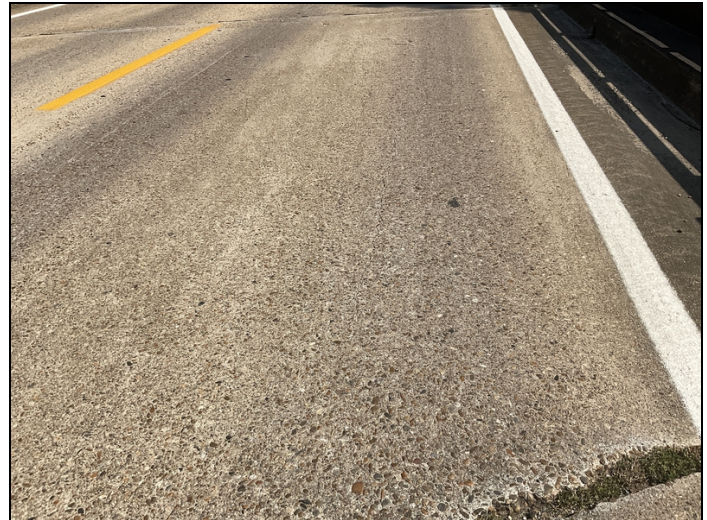
Span 1 deck right has large unsealed cracks.

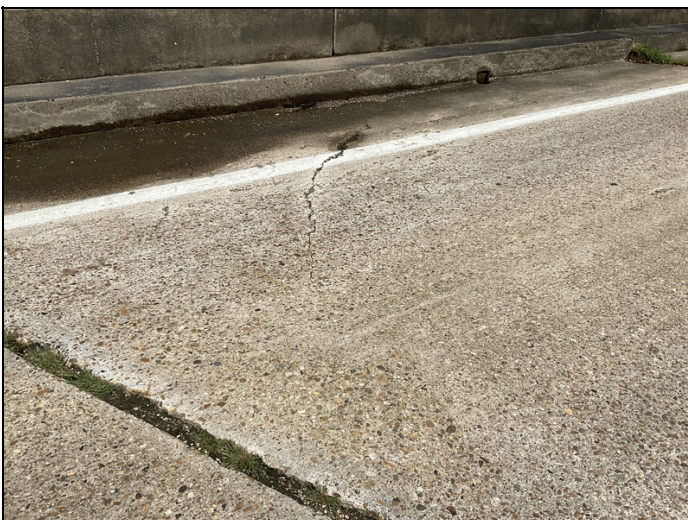
Span1 left has large diagonal crack.

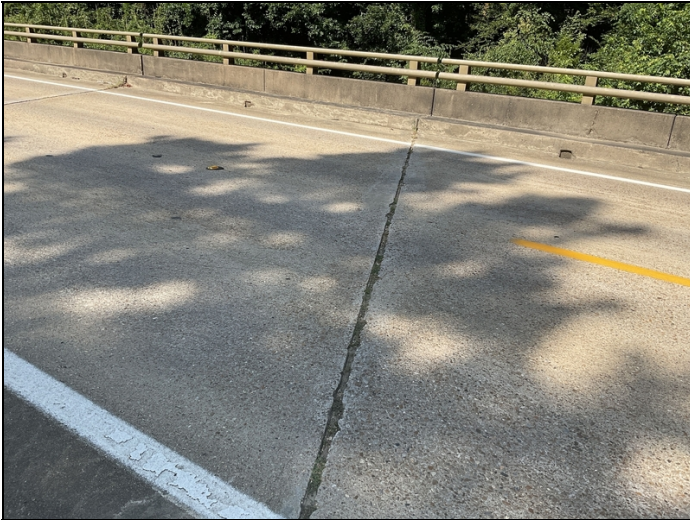
Bent 3 joint seal has loss of adhesion and is missing.

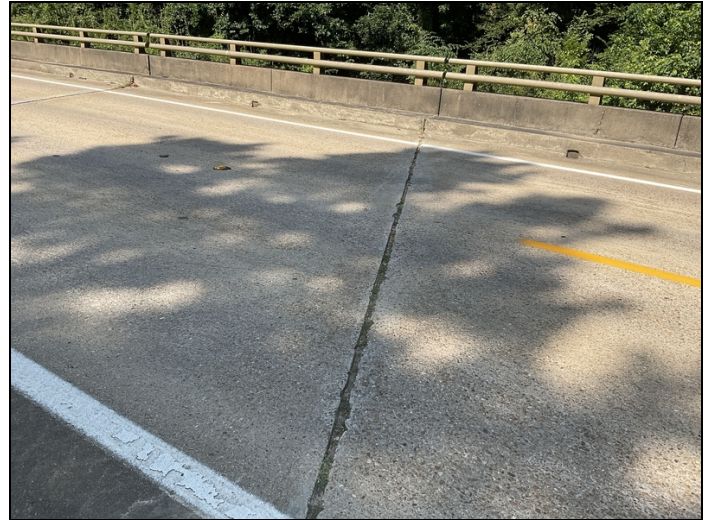
Bent 3 joint seal has loss of adhesion and is missing.

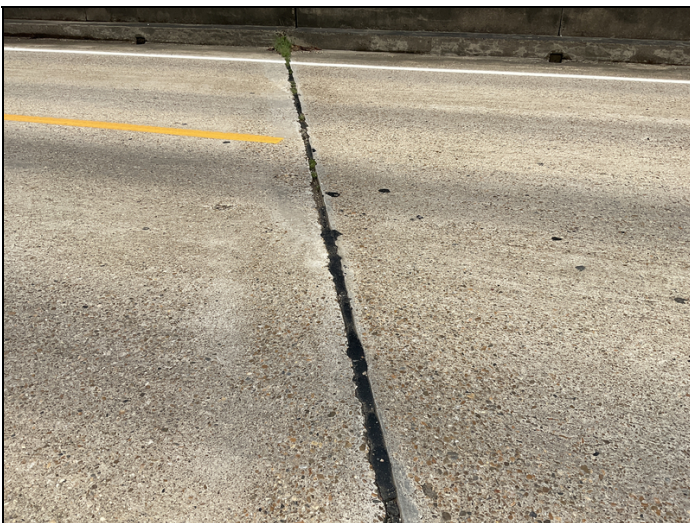
Bent 2 joint seals have lost bond with areas missing.

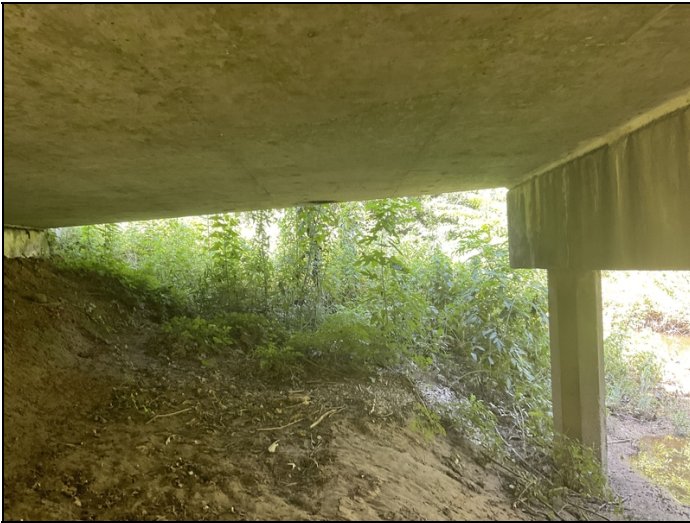
Tree's vines and vegetation on all ends lopes and under bridge impeding inspection process.

Trees,vines and vegetation on all endslopes.

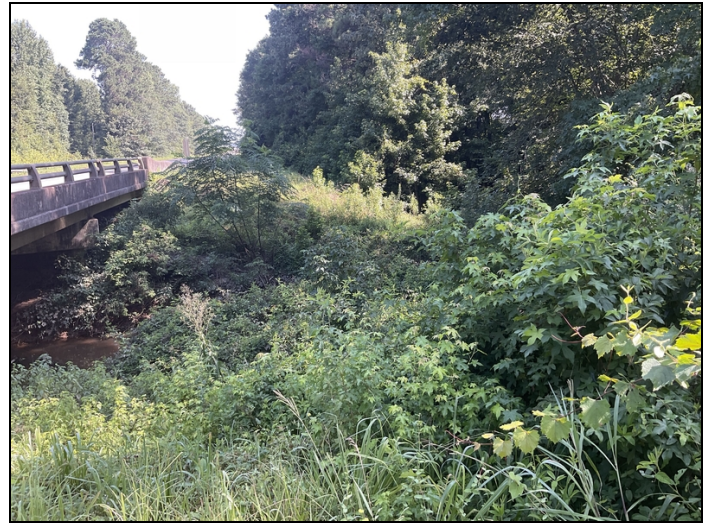
Trees, vines and vegetation.
