Bridge M1491 Inspection Report

Asset #M1491 (Routine)

US 425-02 LM 5.72 over Ditch

Team Lead: Sharon Hooks Inspection Date: 04/28/2025

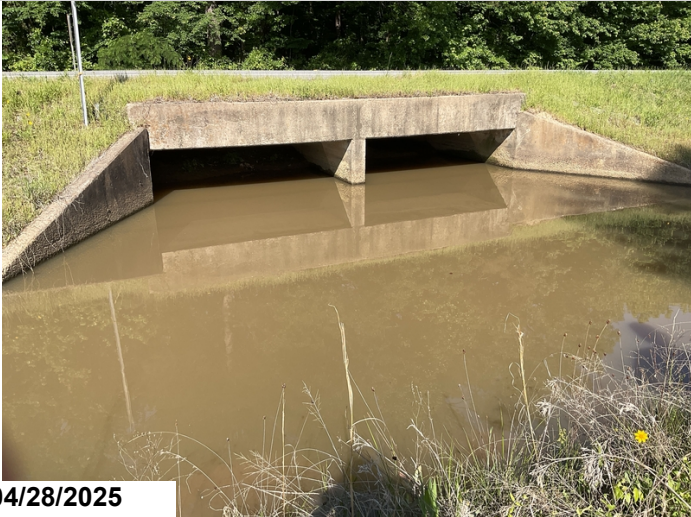
Elevation: Right side

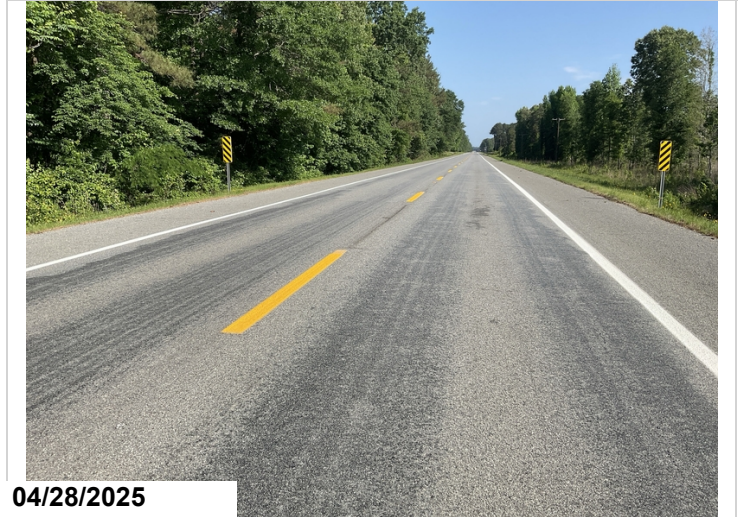
Approach: Inventory

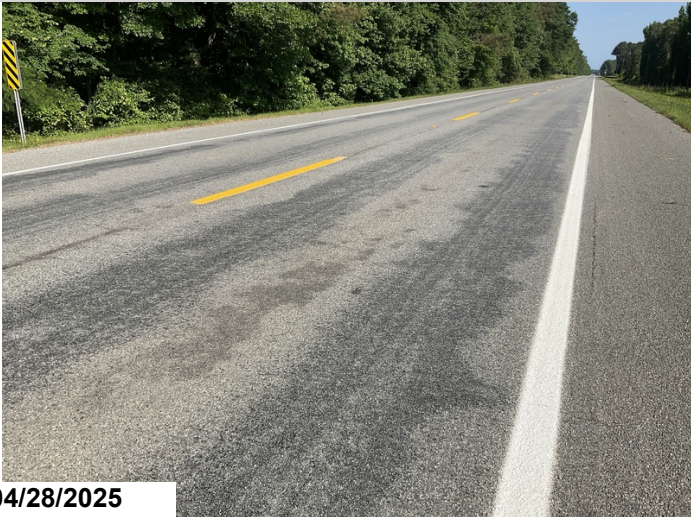
Roadway overview.

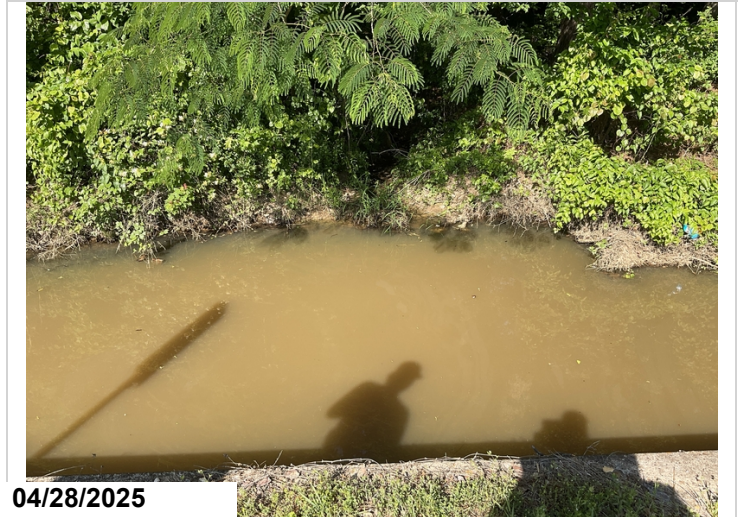
61 - Channel/Channel Protection (5 - Bank protection is being eroded. River control devices and/or embankment have major damage. Trees and brush restrict the channel.)
Channel is filled outside of R/W with no way for storm-water to drain. Water stands at culvert due to lack of creek channel.

Channel: Left side (No flow from R/W).

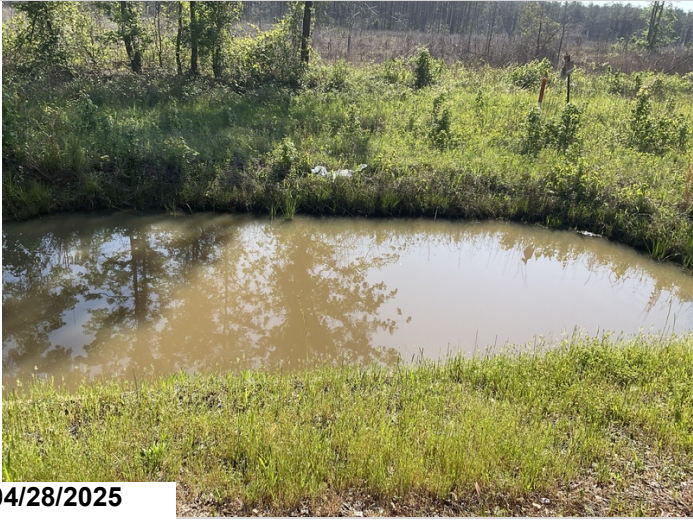
Channel: Right side

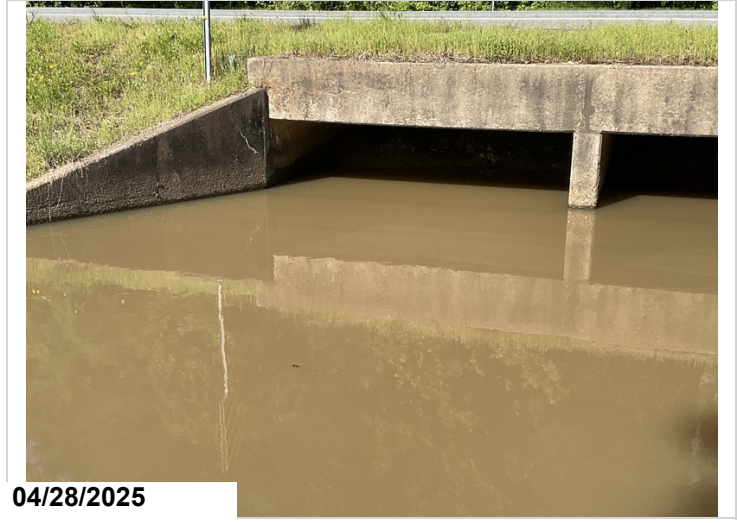
62 - Culverts (7 - Shrinkage cracks, light scaling and insignificant spalling which does not expose reinforcing steel. Insignificant damage caused by drift with no misalignment and not requiring corrective action. Some minor scouring has occurred near curtain walls, wingwalls or pipes. Metal culverts have a smooth symmetrical curvature with superficial corrosion and no pitting.)
Culvert is in good condition with minor cracking, abrasion and debris in barrels.

Culvert Right Side: Abrasion to lower 1/3 of walls.

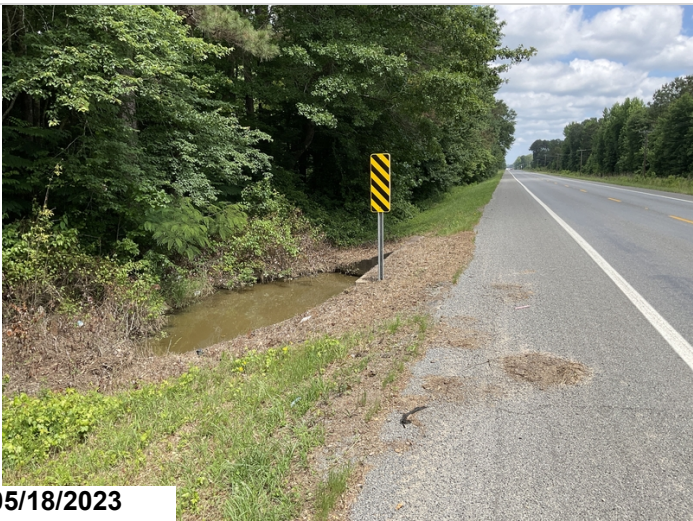
Sign - left and right side: No log mile sign - object marker and post in place.

Sign - left side: No log mile sign

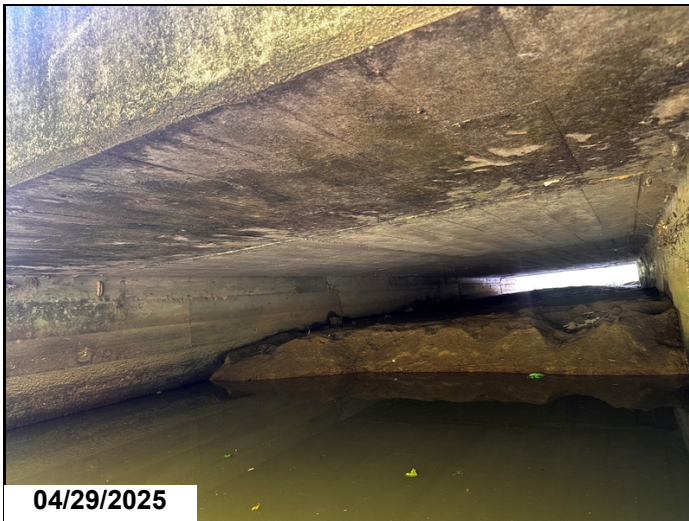
Channel - both barrels: Significant silt build-up -80% (4') full.

Barrel 1: Filled with debris.

Type of Work: Channel Work/Drift Removal

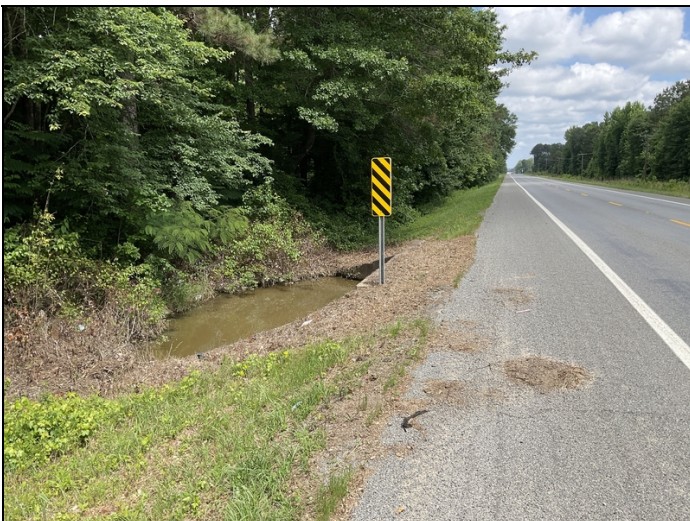
Sign - left and right side: No log mile sign - object marker and post in place.

Sign - left side: No log mile sign

A-63 - Missing/Incorrect Log Mile Signage (Yes)
