Bridge M1492 Inspection Report

Asset #M1492(Routine)

US 425-02 LM 12.10 over Creek

Team Lead: Phillip Dowell Inspection Date: 10/14/2025

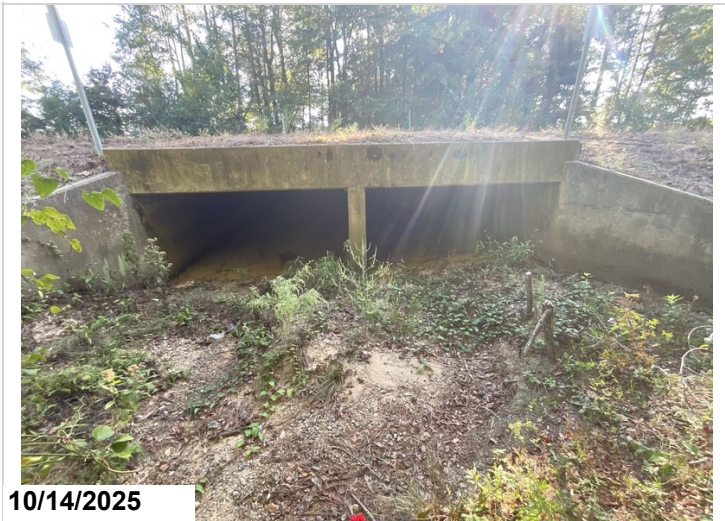
Culvert is in satisfactory condition with some abrasion/wear and some minor erosion on right end.

Elevation - Left side view

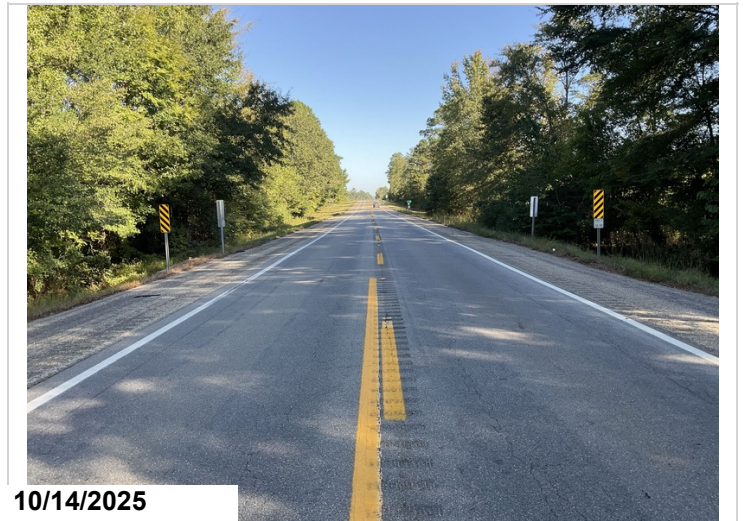
Approach roadway view

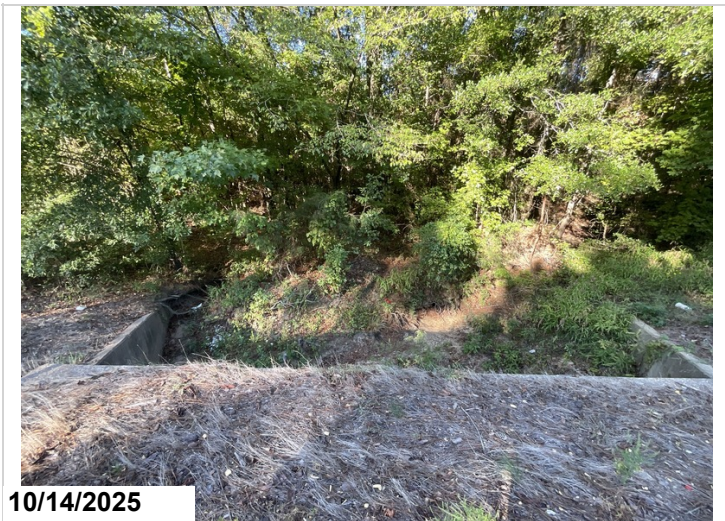
Channel is in good condition with some minor erosion on right end.

Channel - Left side view

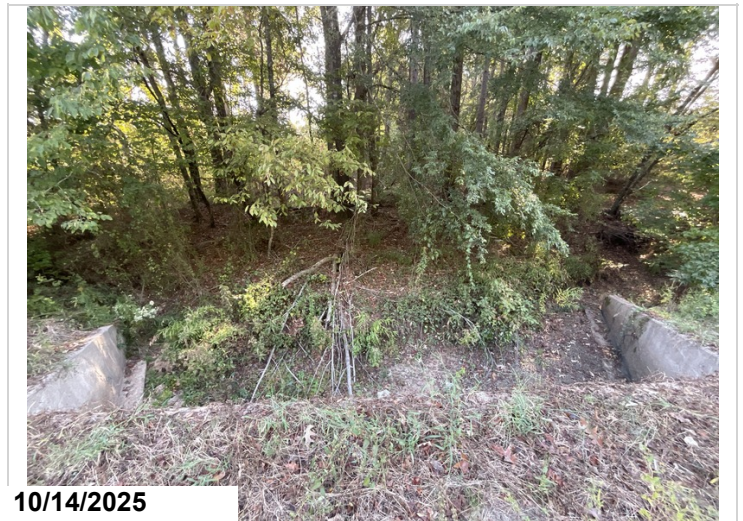
Scour condition is good with some minor erosion on right end.

Channel - Right side view
