Asset #00833(Routine)

US 425-07 LM 3.20 over Deep Bayou

Location: 3.20 Mi N Lincoln Co Line

Team Lead: Greg Loomis Inspection Date: 01/30/2024

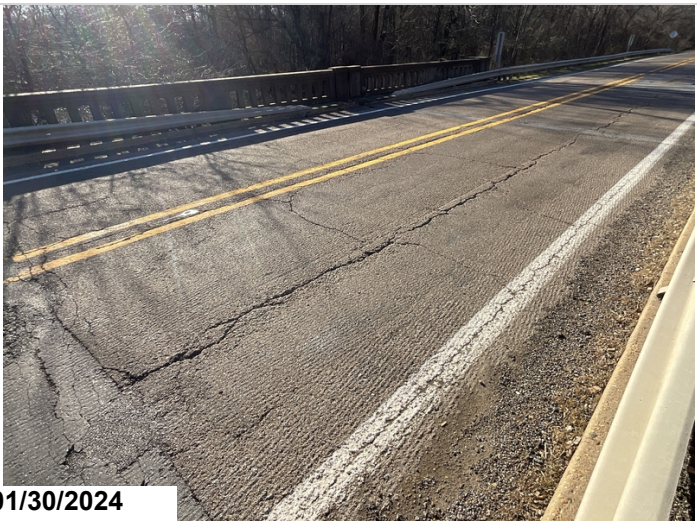
Deck is in good condition with some deterioration of wearing surface and some minor efflorescence on soffit.

Deck - Spans 1-2: Typical

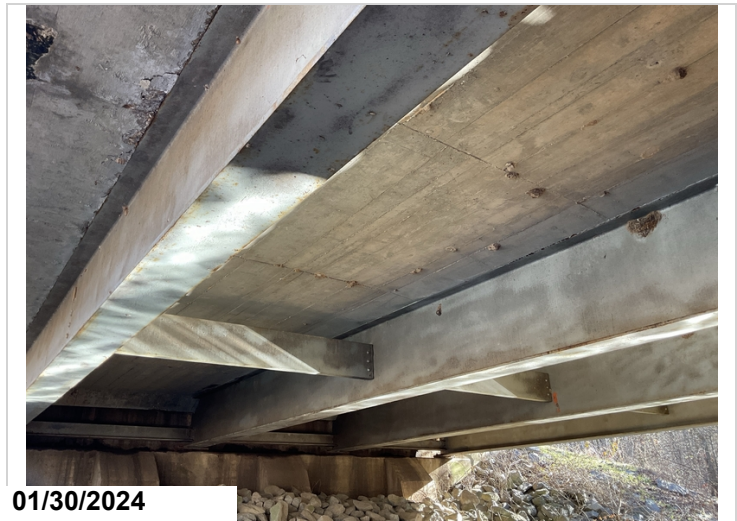
Soffit - Span 1: Typical

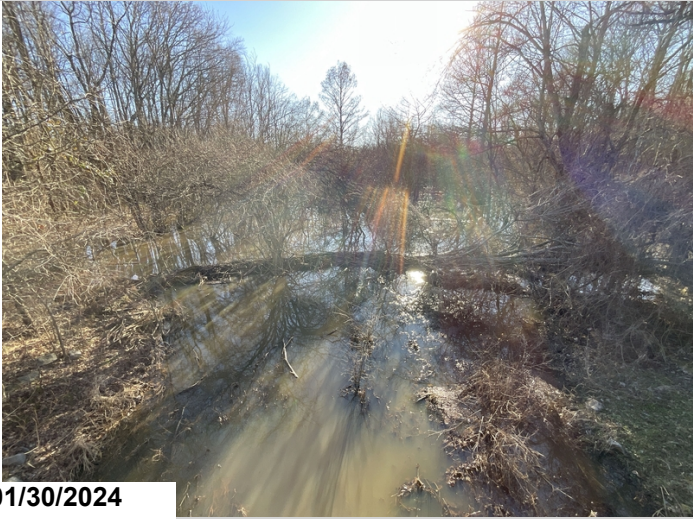
Channel is in very good condition with no notable problems.

Channel - left side

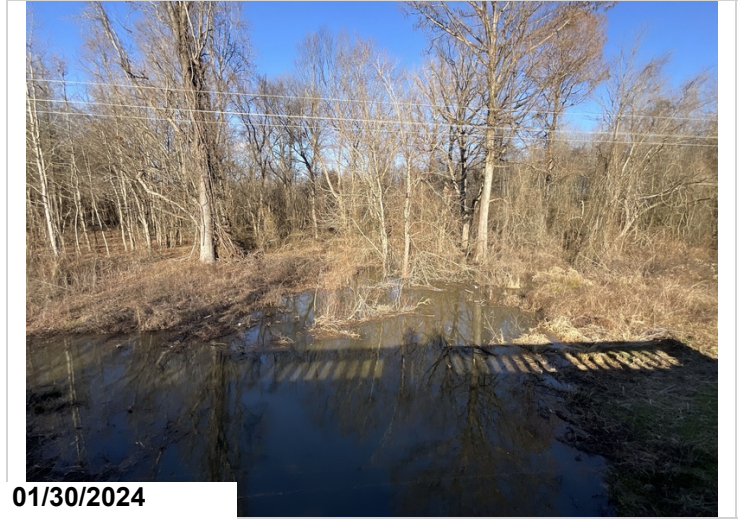
Channel - right side

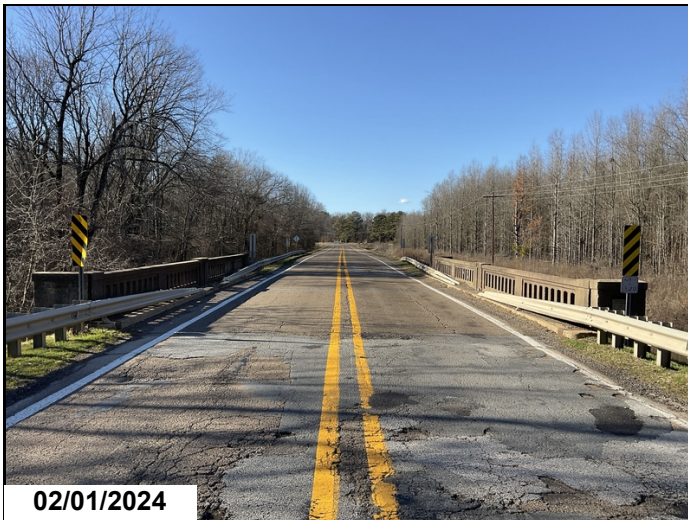
Cracking and deterioration of asphalt wearing surface at bridge end - asphalt spalling up causing small potholes / some settlement - bump going onto bridge.

Significant "hole" in approach roadway, right at bridge end - at centerline and right inner wheel rut, causing large bump going onto bridge.

Approach roadway - Bent 1: Deterioration / "hole" - bump  
- going onto bridge

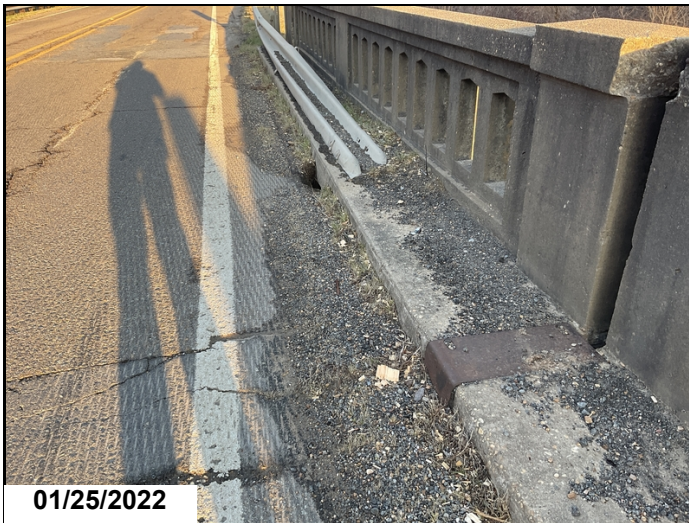
Gutterlines - both sides: Build-up of gravel, grit, dirt, and other debris, blocking drainage and restricting stormwater run-off.

Right gutter line filled with debris.

need to clean out

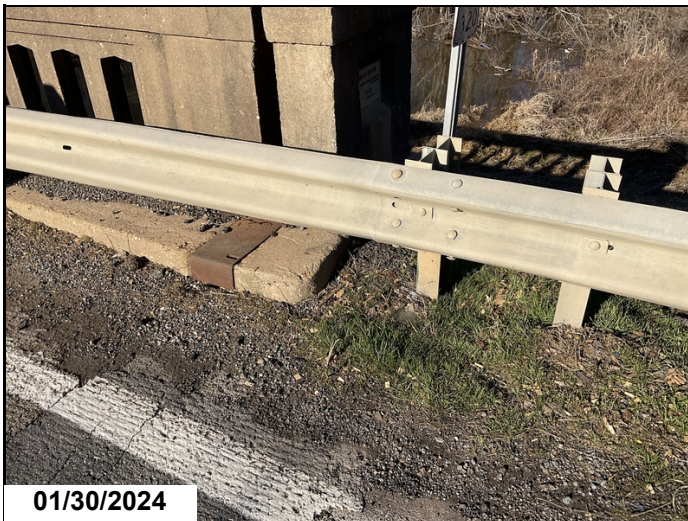
Roadway slopes - Bent 1 right: Some erosion (small hole) between approach railing and edge line - right at end of bridge/curb.

CORRECTED - Approach roadway - Bent 1 right : Hole filled

01-30-2024 GGL-PRD: Approach roadway - Bent 1 right: Hole has been filled.

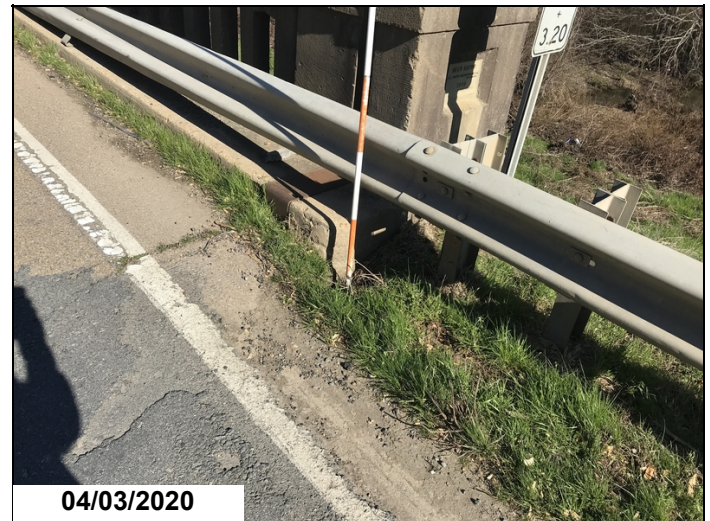
Approach roadway - Bent 1 right : Hole
