Bridge 03385 Inspection Report

Asset #03385(Routine)

SH 1-05 LM 1.00 over Little Lagrue Bayou

Team Lead: Greg Loomis **Inspection Date:** 04/18/2023

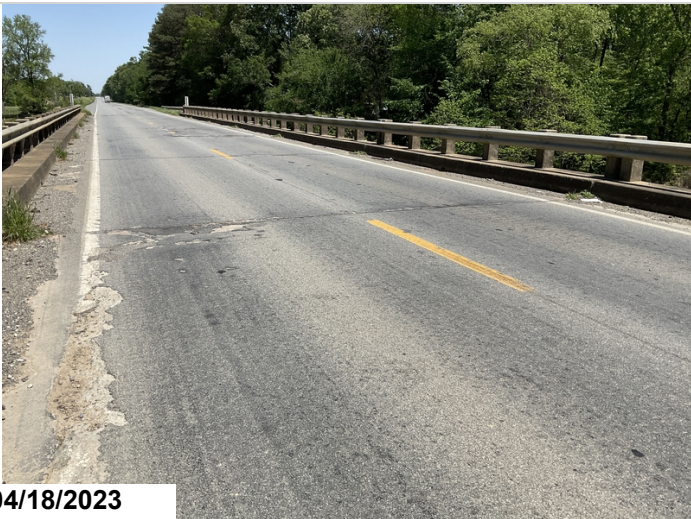
(38) Deck (sonovoids): 30' wide (1'-9" STEP-UP each side) x 210' long = 6300 sqft. Wearing surface (thin asphalt/chip seal): 24' wide x 210' long = 5040 sqft. Wearing surface: Scattered small- to moderate-sized spalls (potholes) with a few patches, especially on Span 4 (10%). Wearing surface has lost adhesion in numerous locations. Deck - various locations: Some scaling, spalling, and delaminations, especially outside asphalt wearing surface on Spans 5 & 7 left. Spalls go through asphalt wearing surface and into concrete deck. Various locations have been patched with asphalt mix. Sides of slabs: Some cracking and minor spalling above caps at bents (4 sqft/ bent). Soffit – Span 1 left: Minor- to moderate-sized transverse cracking with rust-staining - 50 sqft. Spans 2-6: Delaminations and spalls on outside edges of deck around drains – left and right sides, worse on right side. Some minor rust and section loss to reinforcing steel at these locations. (9 sqft/location with Spans 3-6 right in State 3)(3 sq/ft at Bent 6 left in State 3). Various soffit drains and points of contact at deck and caps also have small areas of exposed rebar.

Deck - Spans 1-3: Typical

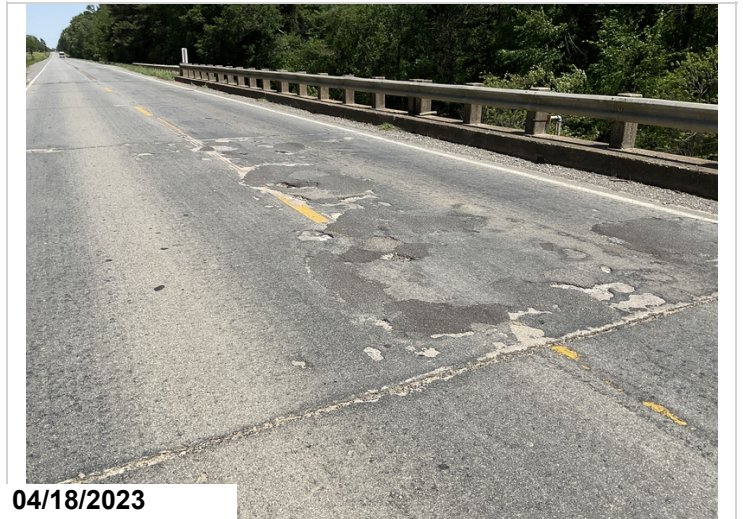
Deck - Spans 4-6: Typical

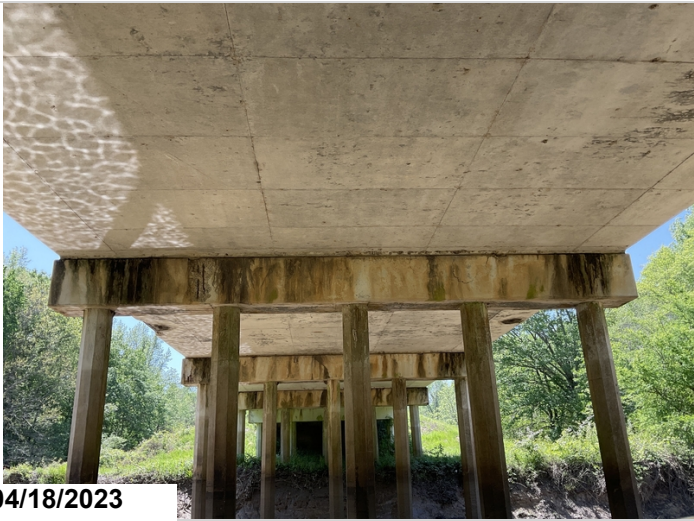
Soffit - Span 5: Typical

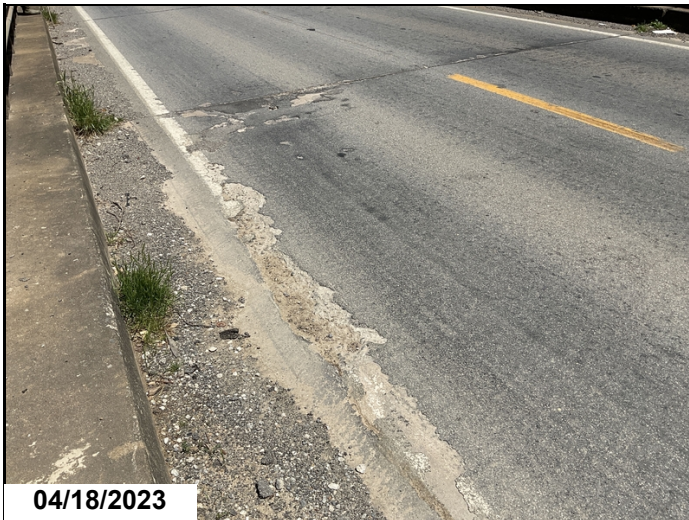
Deck - various locations: Some scaling, spalling, and delaminations, especially outside asphalt wearing surface on Spans 5 & 7 left.

Spalls go through asphalt wearing surface and into concrete deck.

Various locations have been patched with asphalt mix.

Deck - Span 1 left @ 1/2-3/4 span: Scaling

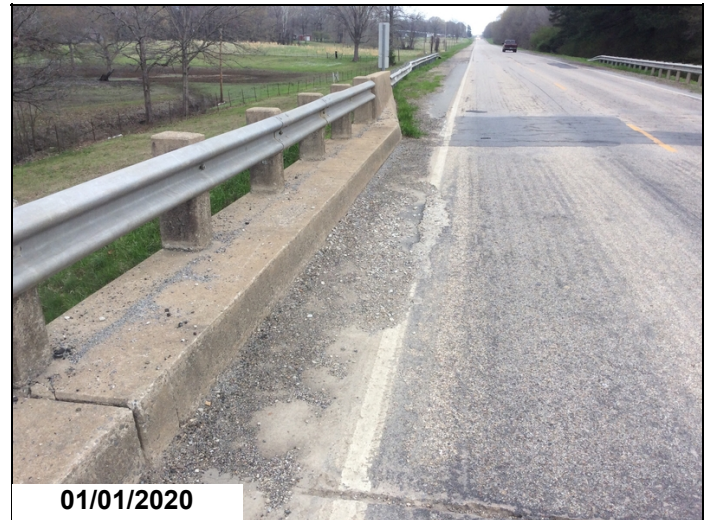
Gutterline - Span 7 left

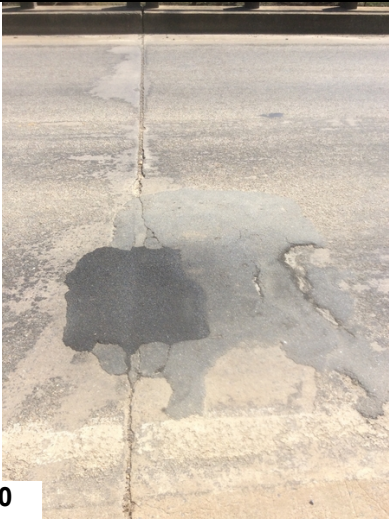
Deck @ Bent 2: Joint damage and patch

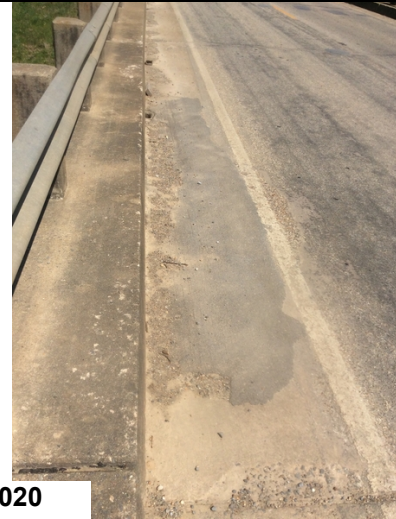
Deck - Span 5 left: Patches

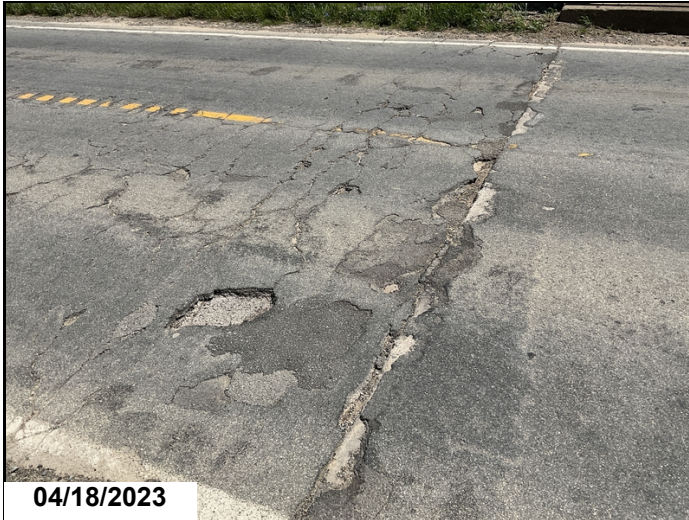
Approach roadway - Bents 1 & 8: Significant cracking/deterioration/spalling of asphalt wearing surface.

Approach roadway - Bent 8: Deterioration/cracking

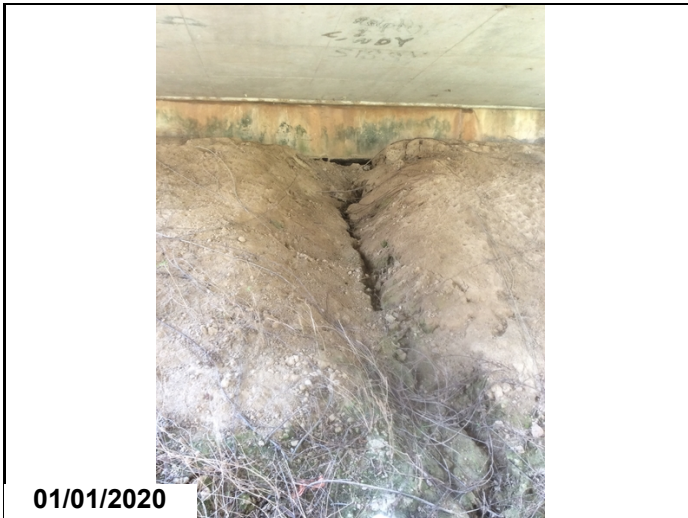
End-slope - Span 1: Some minor erosion along centerline of slope, beginning at abutment cap.
04-18-2023 GGL-PRD: Priority changed from "G" to "D".

Endslope - Span 1: Minor erosion

No action at this time. Continue to monitor and advise if condition worsens.

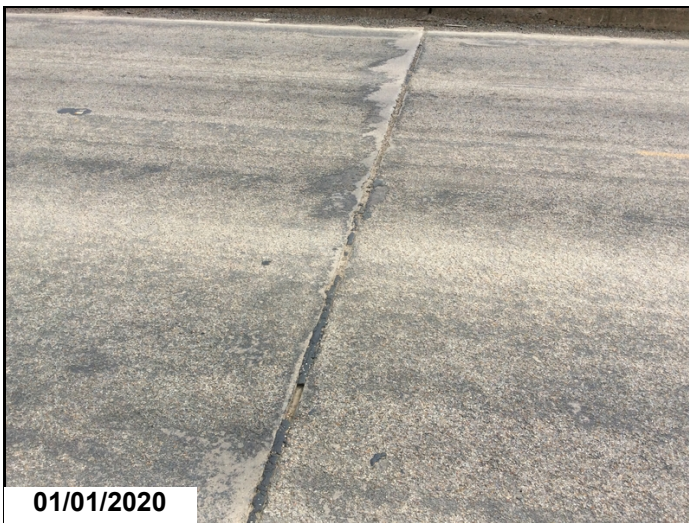
Joint - Bent 3

Joints - Bents 2-7: Poured joint material has deteriorated and has lost adhesion and is allowing stormwater to leak through
- joints filled with dirt and debris.

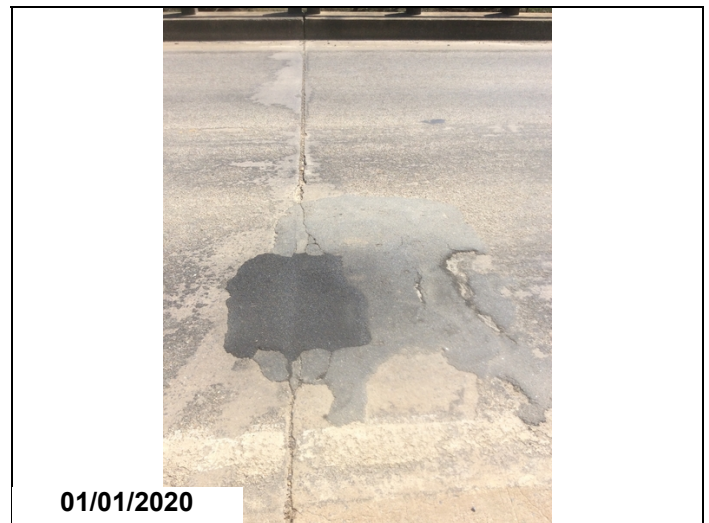
Deck @ Bent 2: Joint damage and patch

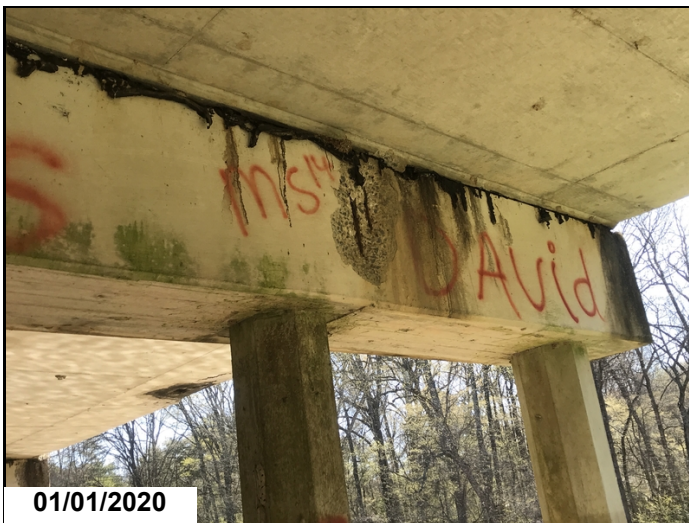
Caps:
Bents 2-7 - various locations: Some small, shallow delaminations and spalls with some small amounts of steel exposed.

Bent 3 cap back has spall with exposed rebar.

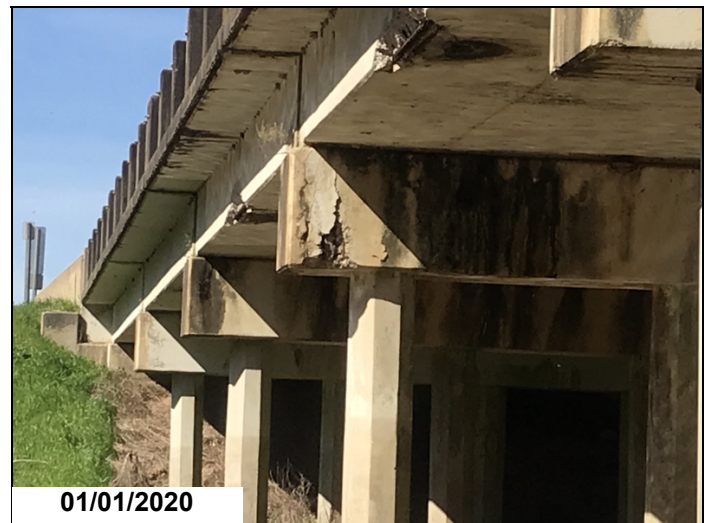
Bent 4 cap ahead right has spall with exposed rebar.

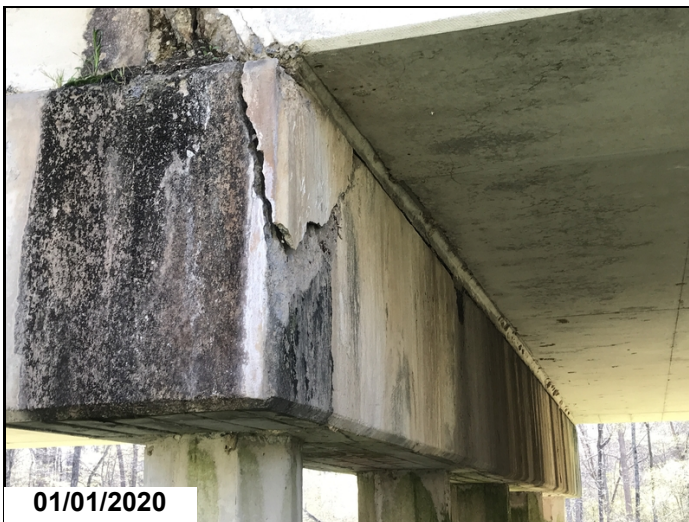
Bent 2 left side of cap has large delam. Common bent 3 left.

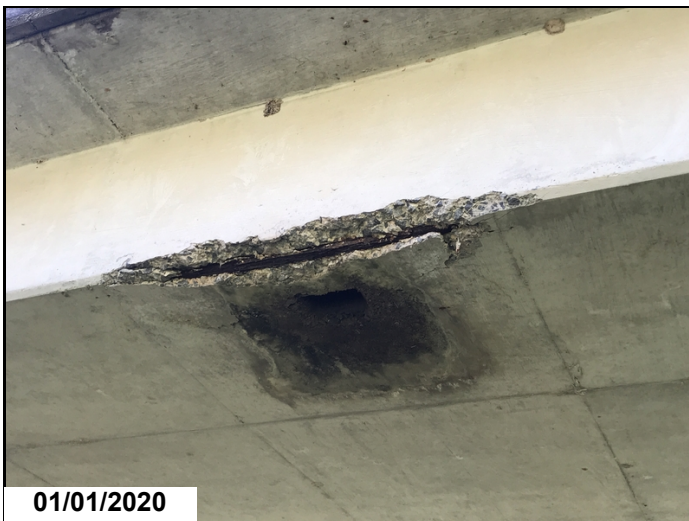
Soffit – Spans 2-6: Delaminations and spalls on outside edges of deck around drains – left and right sides, worse on right side. Some rust and section loss to reinforcing steel at these locations.

Span 2 left drain opening has spall with exposed rebar.

Repair as you can fit into your schedule

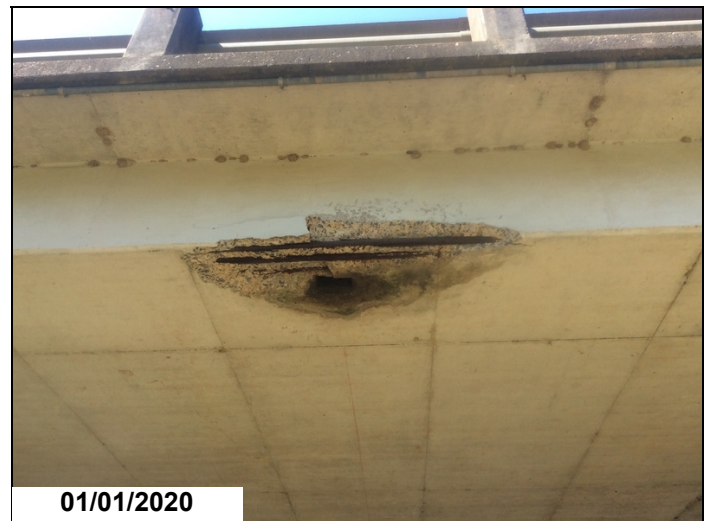
Soffit - Span 6 right: Rebar exposed

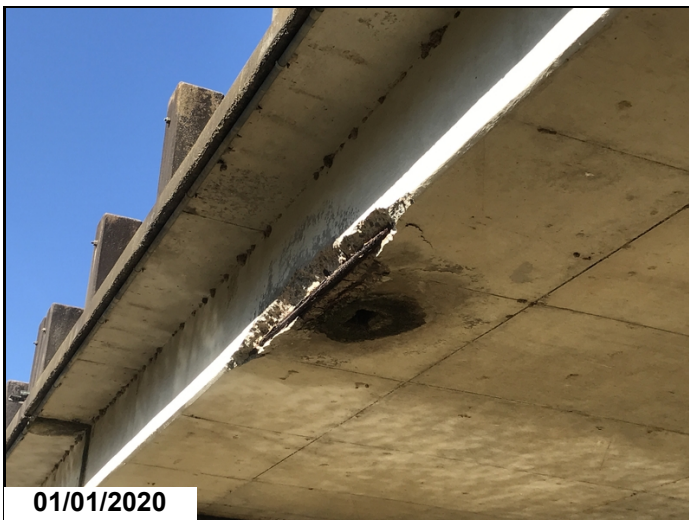
Span 5 right at drain opening has spall with exposed rebar. Common on span s 2,3,4 & 6.

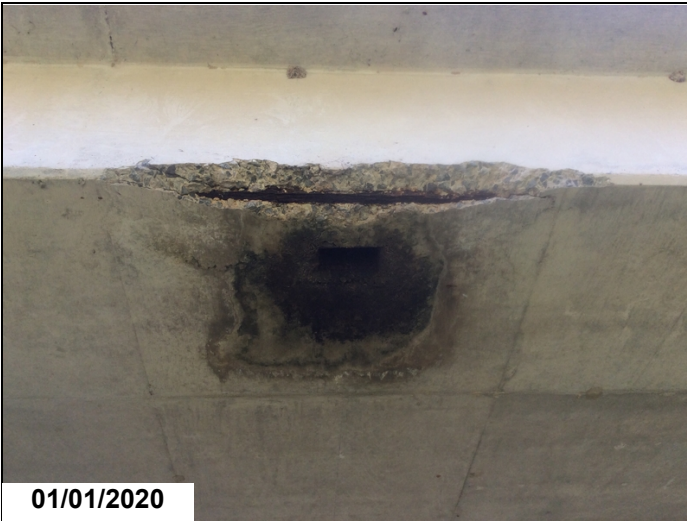
Soffit - Span 2 left: Rebar exposed

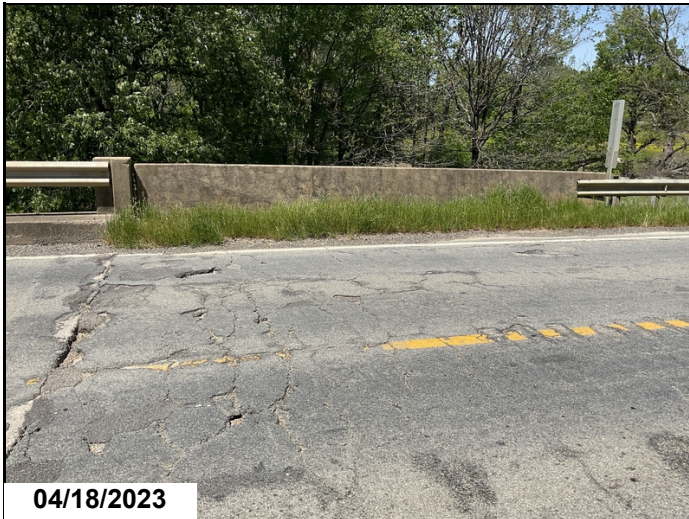
Approach gutter-lines - Bents 1 & 8: Significant build-up of dirt and other debris with grass growing up.
Gutter-lines - left & right side: Build-up of dirt, sand, and other debris.
Debris build-up is restricting stormwater from flowing off bridge as intended.

Approach gutter-line - Bent 8 left: Debris build-up

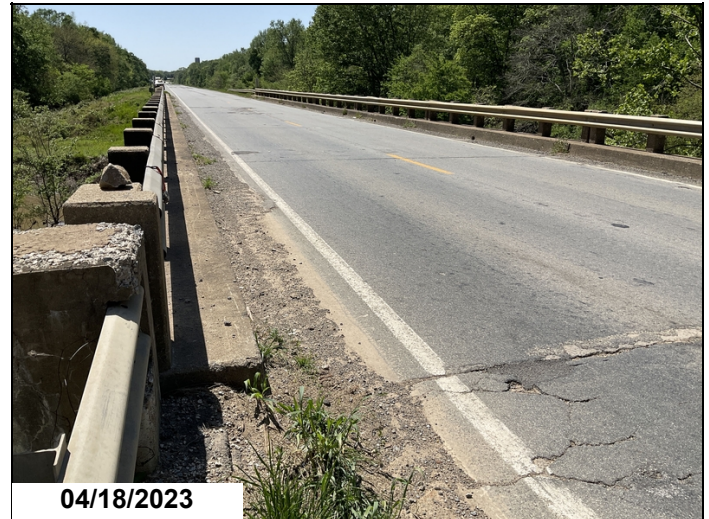
Gutter-line - right side: Debris build-up
