## Bridge 03386 Inspection Report

Route:1 Section:05 Log:2.96

Arnold Road ID:1x1x5xA, Arnold Log mile:2.961

**Asset #03386**(Routine, Underwater type 2)  
**SH 1-05 LM 2.96 over Lagrue Bayou-Arkansas Co**  
**Location: 1.0 Mi SW SH 153-DeWitt**  
**Team Lead: Greg Loomis Inspection Date: 07/01/2025**

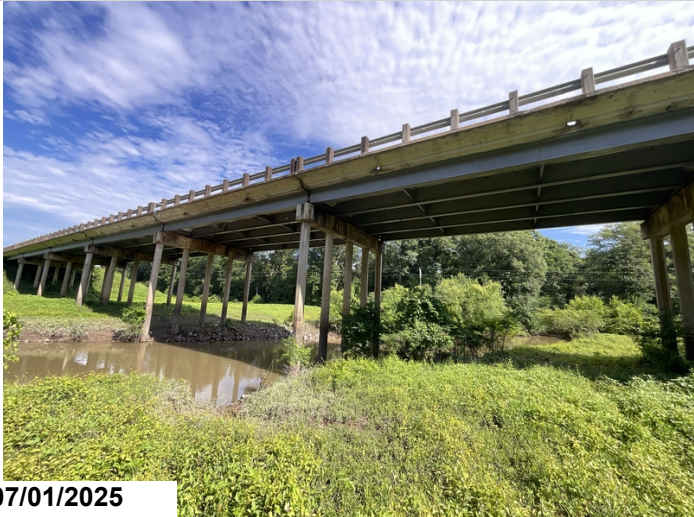
Elevation - Right side view

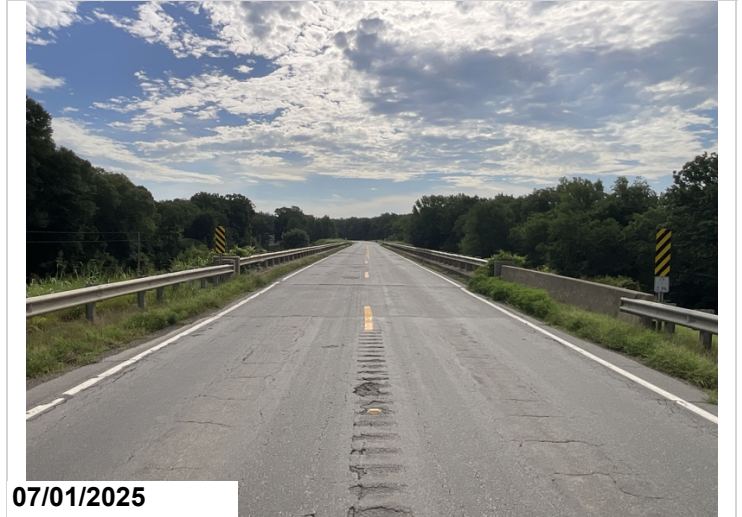
Roadway view

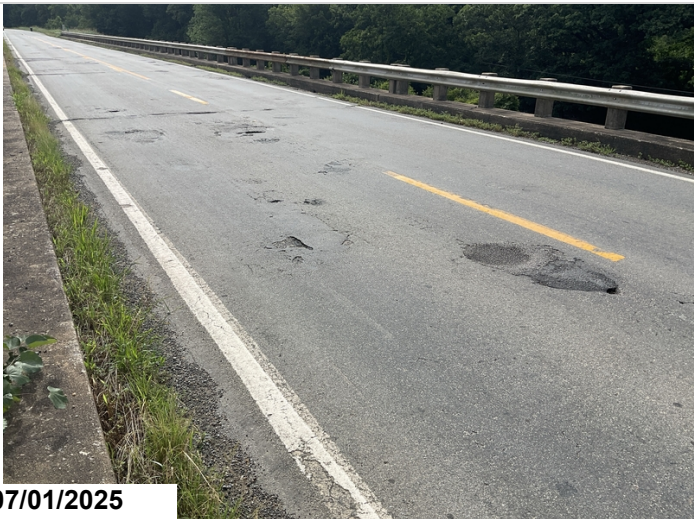
Deck - Spans 1-8: Overview

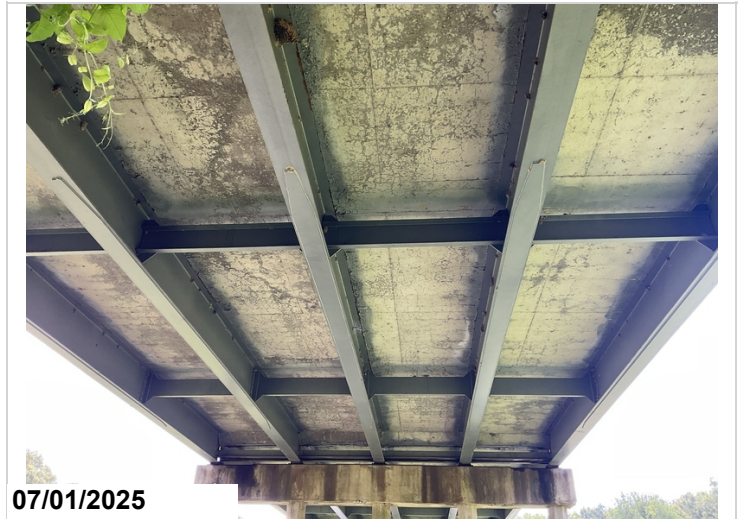
Undersurface - Span 2: Overview

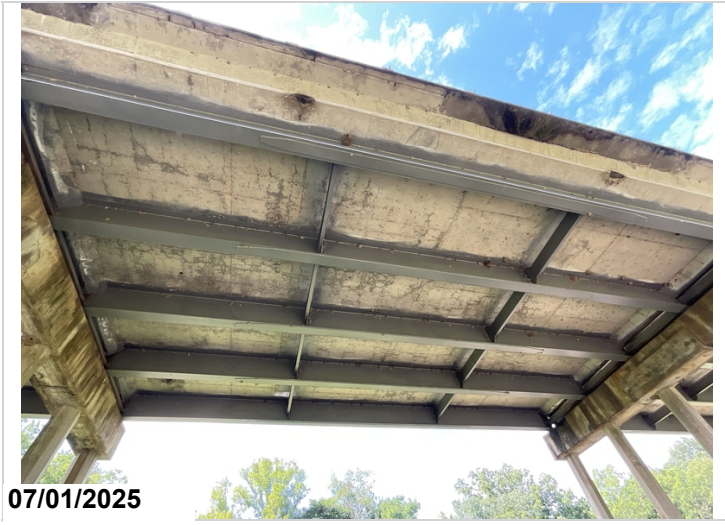
Undersurface - Span 6: Overview

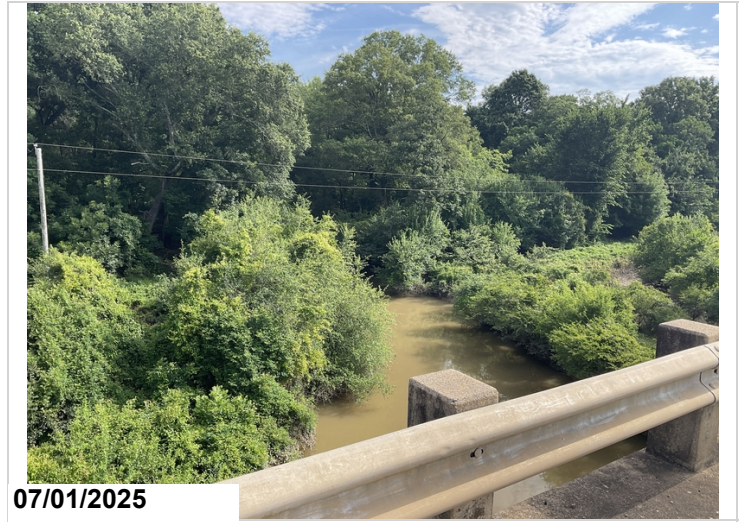
Channel - Left side view

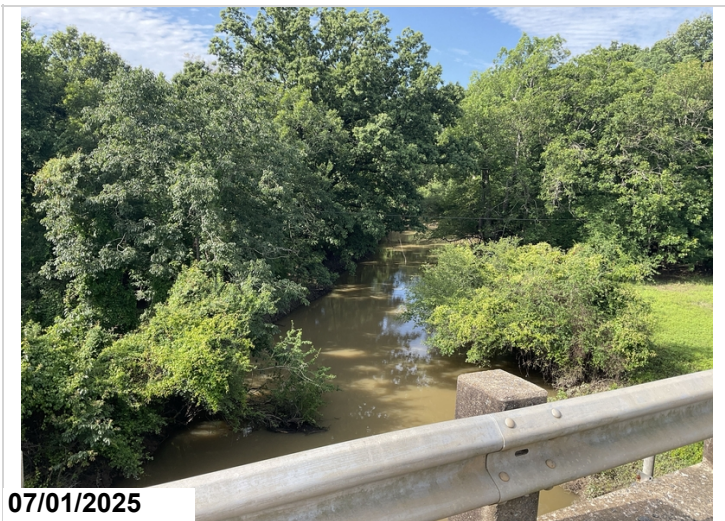
Channel - Right side view

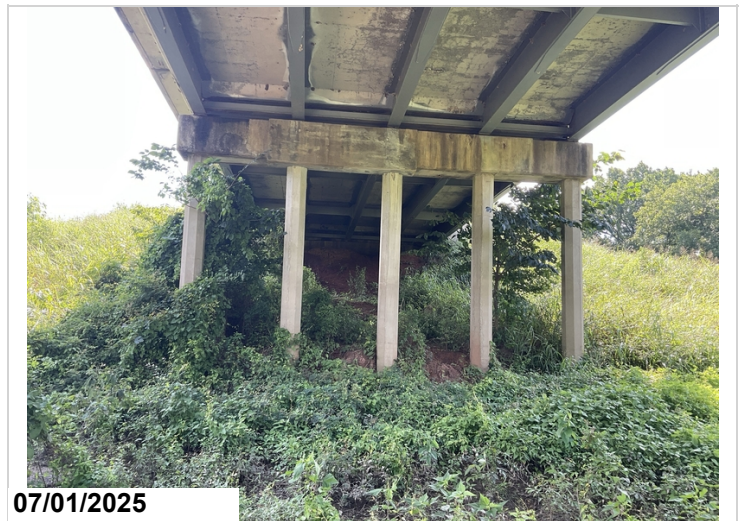
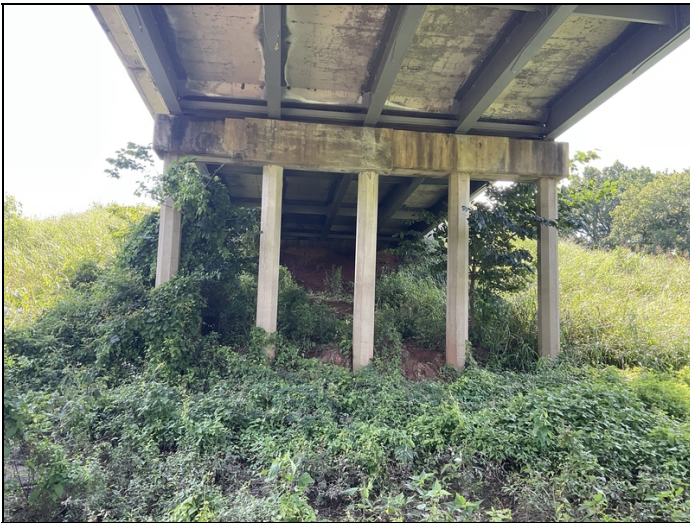
End-slope/channel - all spans: Some small trees, bushes, vines, tall grass/weeds, and other vegetation growing up under bridge.

End-slope - Span 8: Vegetation

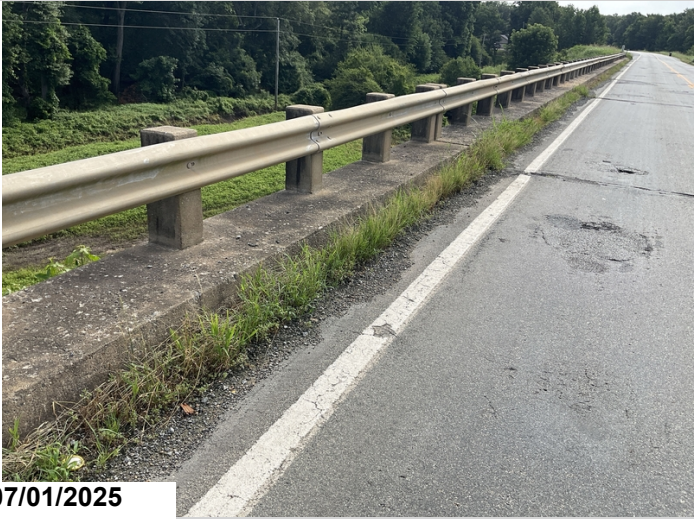
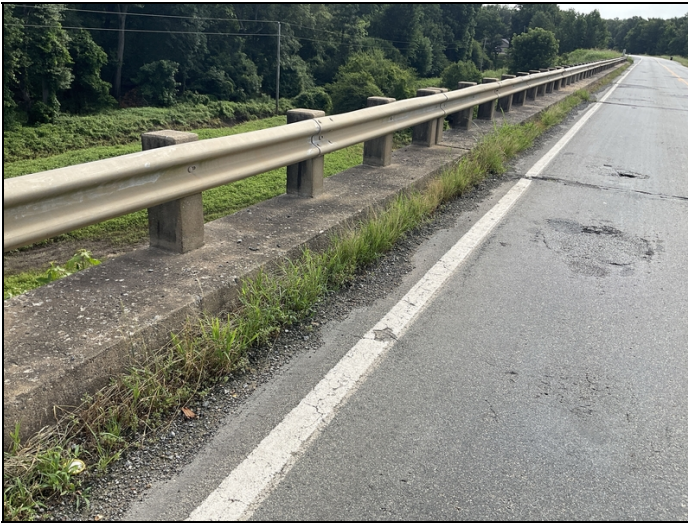
Gutter-lines - both sides: 2-6" build-up of gravel and debris throughout full-length of bridge, restricting stormwater from flowing off bridge.

Gutterline - left side: Debris build-up

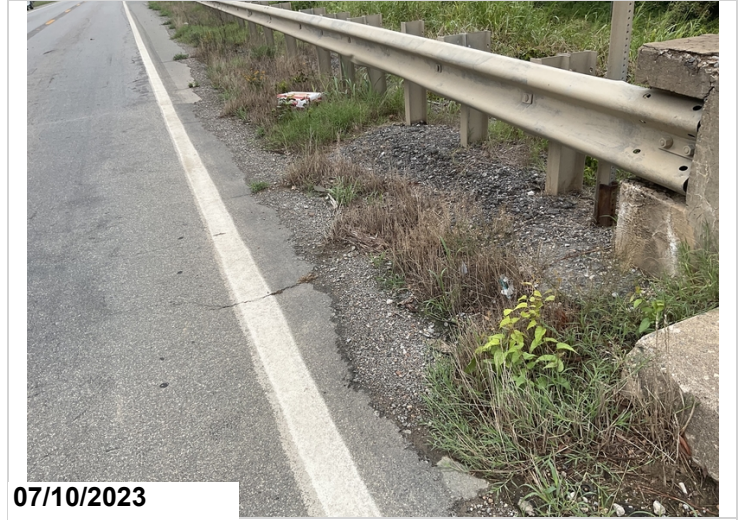
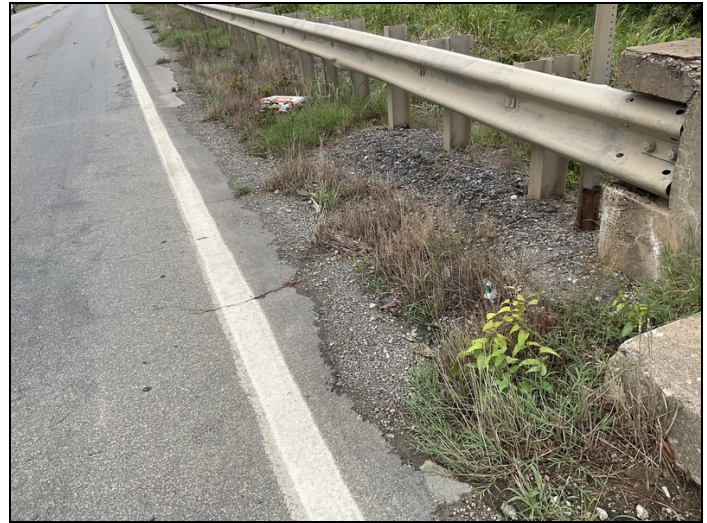
Approach gutters also have build-up and heavy growth of grass, further restricting stormwater from flowing off bridge.

Approach gutter - left side: Debris build-up

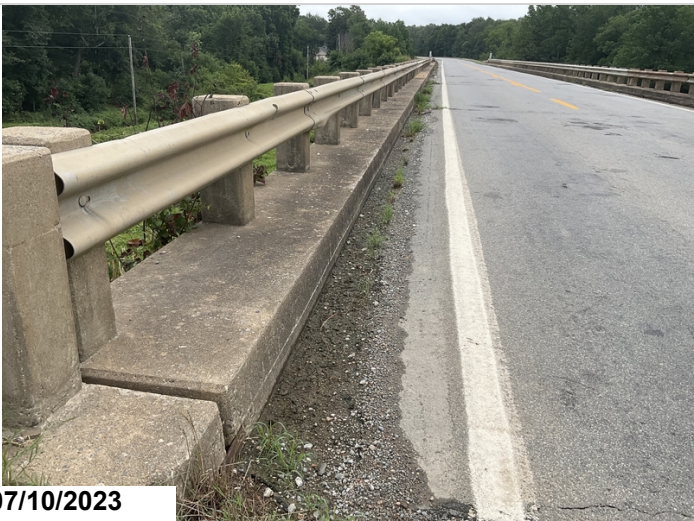
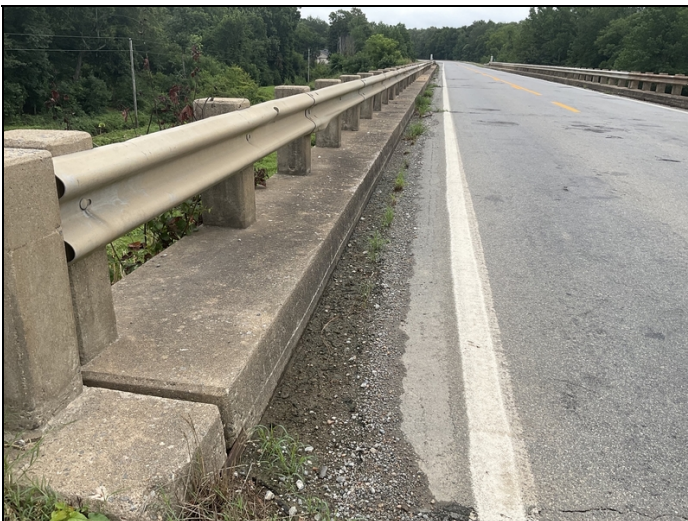
Gutter-line - left side: Filled with debris, restricting storm water runoff

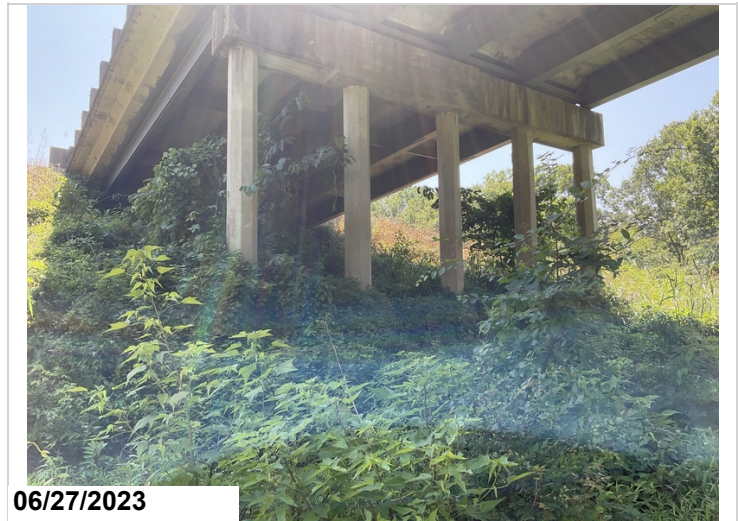
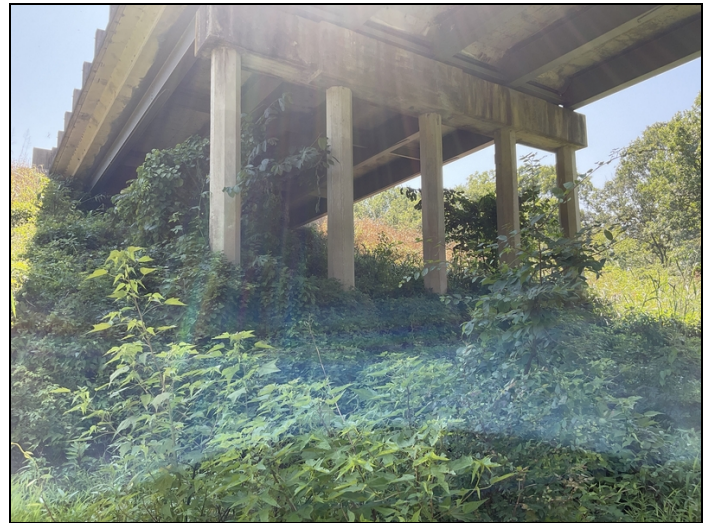
Span 8 vegetation growing under bridge

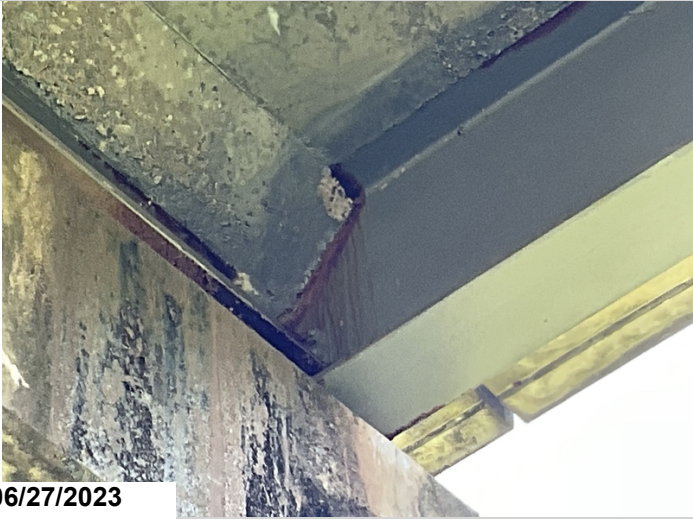
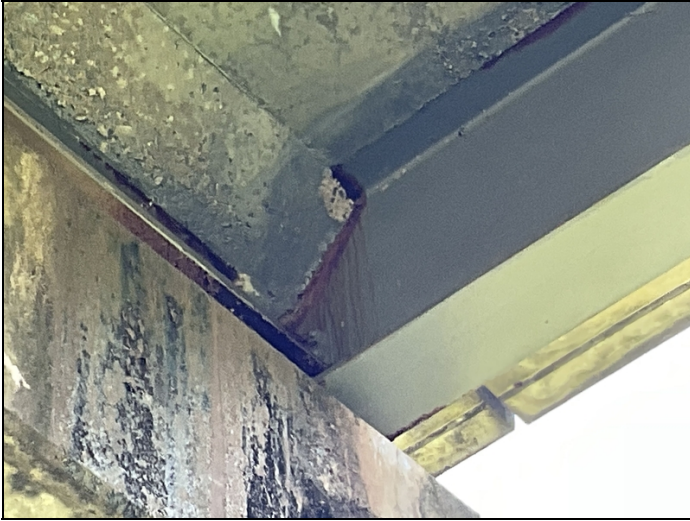
Some peeling paint with some light rust near haunch areas.

Bent 3 girder 1 rust near haunch area

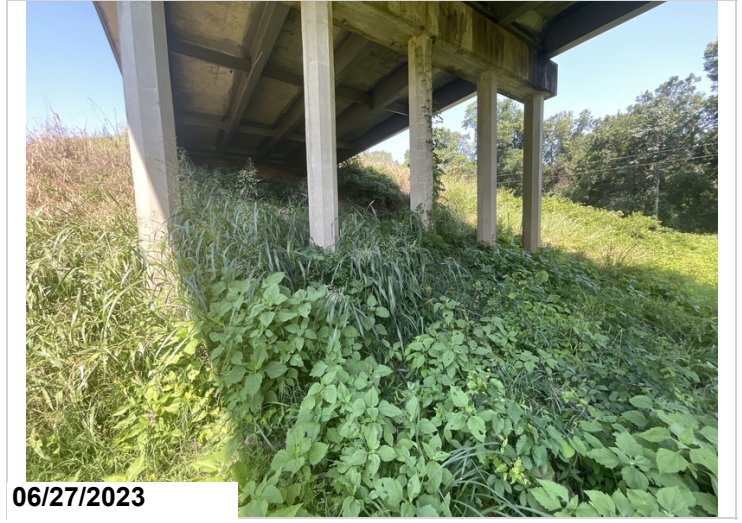
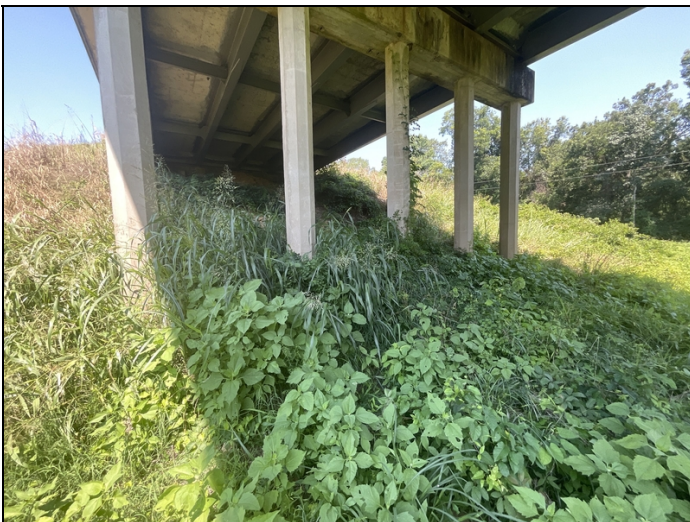
Vegetation under bridge

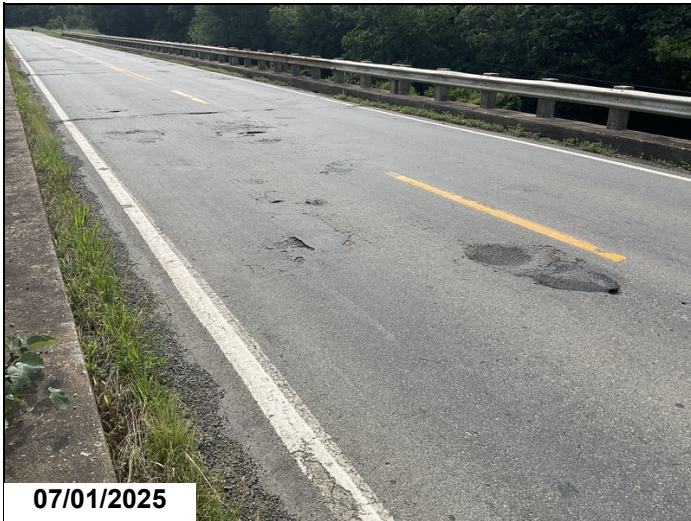
Some moderate- to large-sized transverse cracking at bents/joints with some scattered spalls (potholes) - several of these spalls continue through to concrete deck.

Wearing surface / Deck - Spans 1-8: Overview

NOTE: Scattered spalling (potholes) - some go through into concrete deck

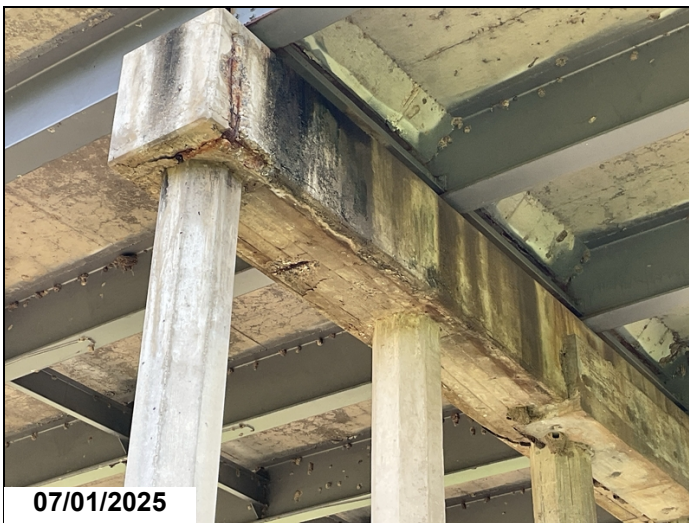
Caps – Bents 2-7: Some scattered delaminations and spalls on ahead and back faces and bottoms of caps. Some rusting and section loss to exposed steel, especially at Bent 4 right (up to 100% on a couple of bars).

Cap - Bent 6 right: Exposed Rebar

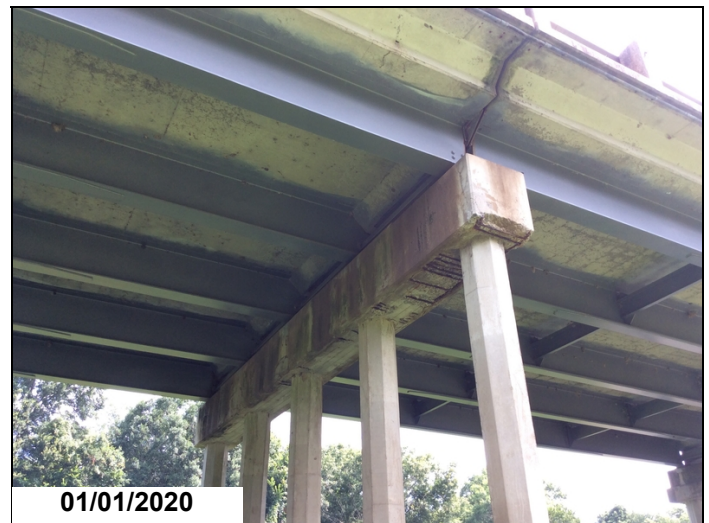
Cap - Bent 4 right

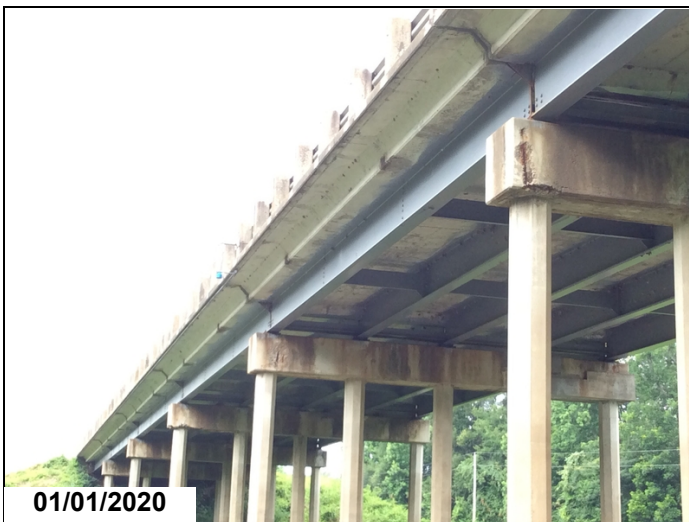
Caps - Bents 4-6 right

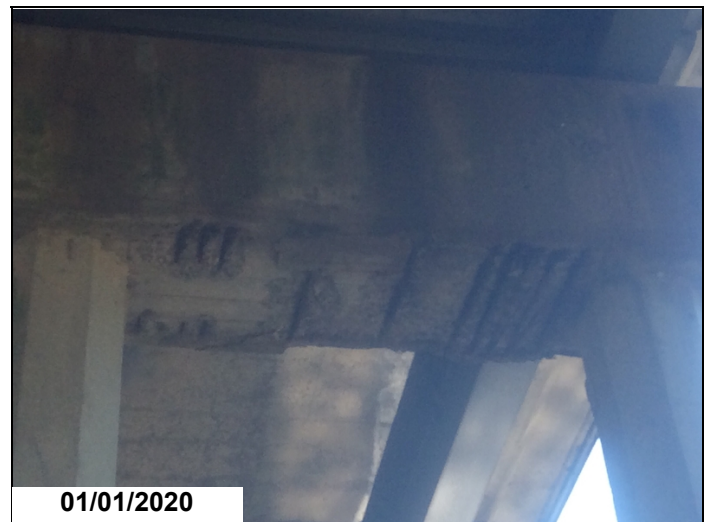
Bent 4 bottom of cap right side has spall with exposed rebar with up to 100% section loss.

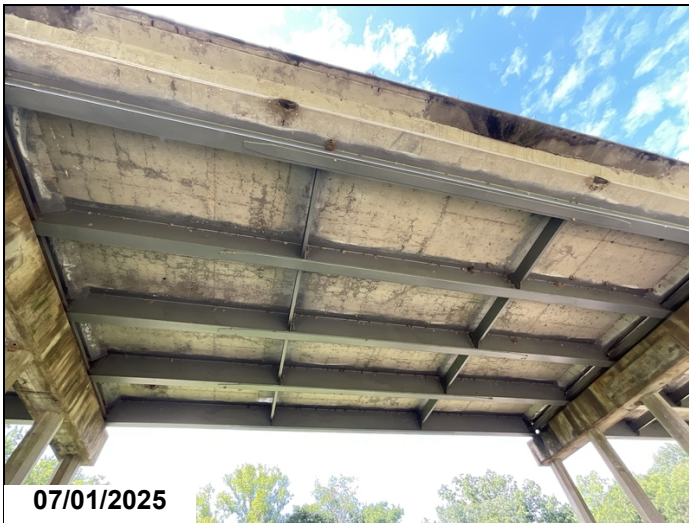
Undersurface of deck – various locations: A few scattered small spalls with some steel exposed (little or no section loss).

Undersurface - Span 6: Overview

NOTE: Spall with exposed rebar in Bay 4 near Bent 7.

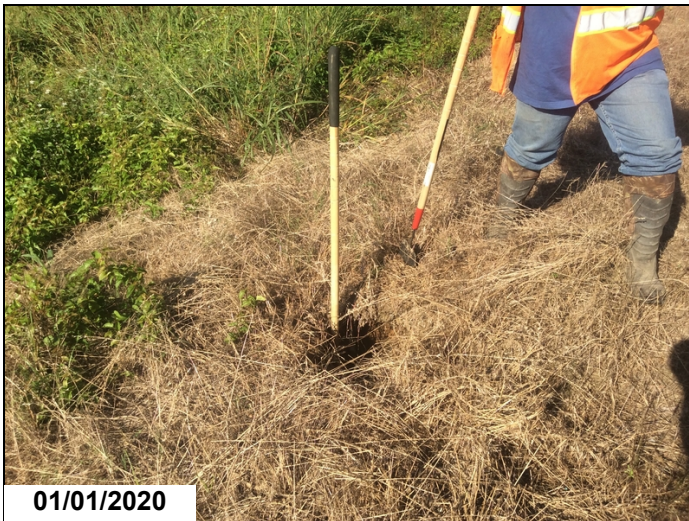
End/side-slopes - Bents 1 & 9 left & right: Fill material on corners of bridge is sliding/eroding, resulting in gaps and holes in slope and drops-offs.

Small washout on right side of approach but on both sides and ends of bridge .

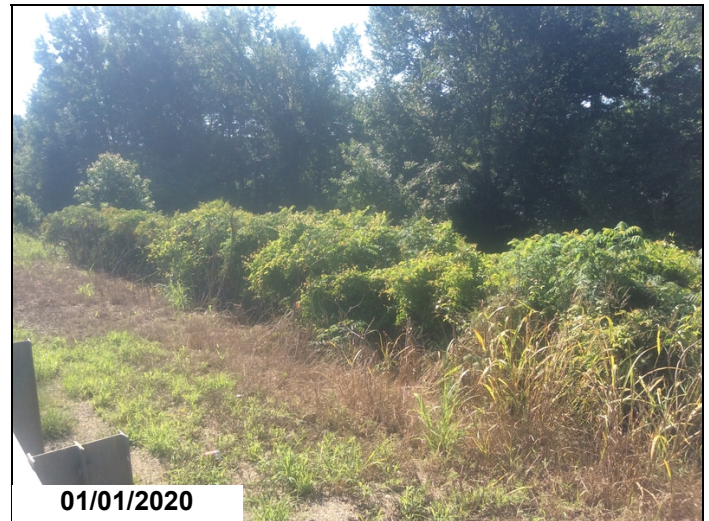
Moderate sized trees and vegetation growing on end slope of bridges near bent 9 right side up common on slope on all ends of bridge .

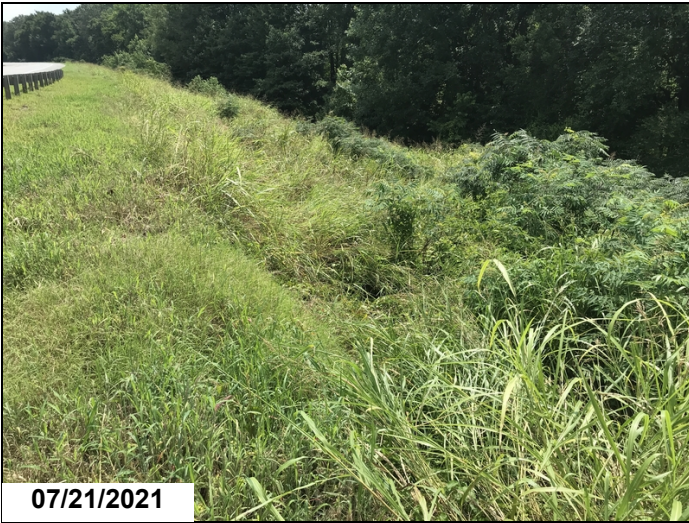
Roadway slope - Bent 9 right: Erosion/slope slumping

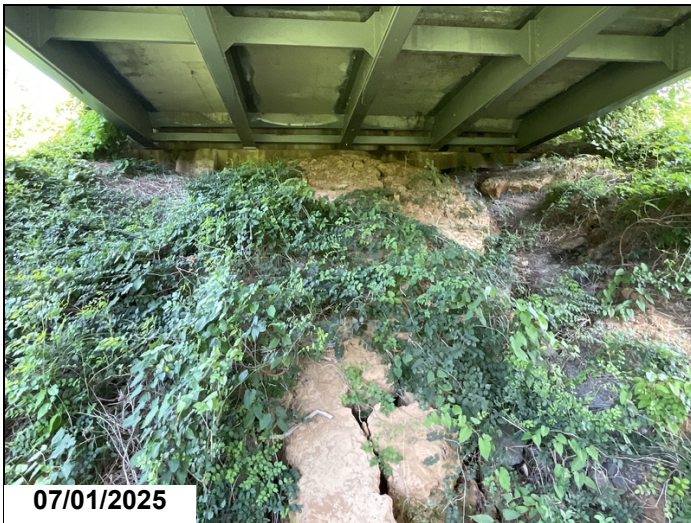
End-slopes - Bents 1 & 9: Some erosion/washing of slope material, especially at Bent 1.

End-slope - Bent 1: Erosion

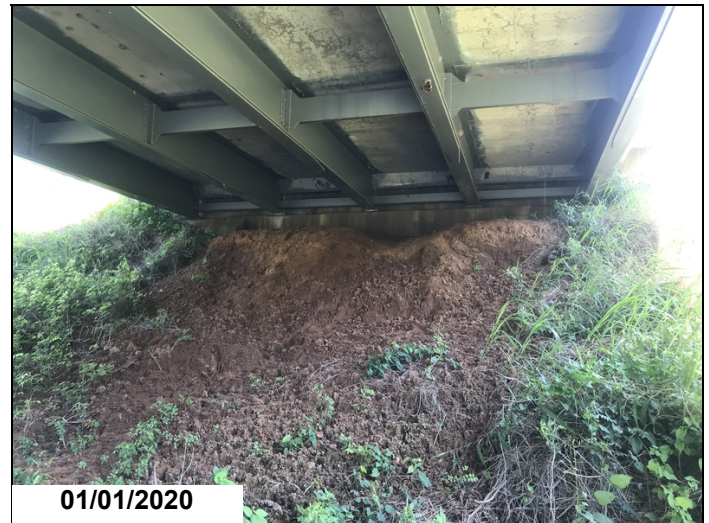
Overview - Bent 9

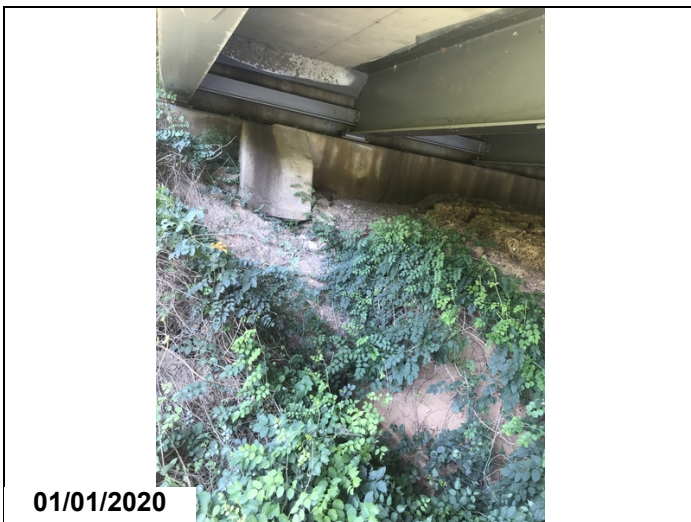
Abutment - Bent 1 right : Erosion

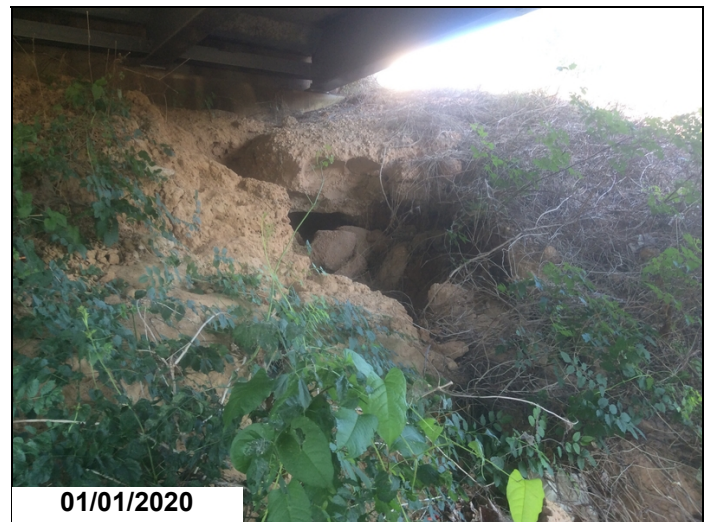
Abutment 1 end slope has moderate to heavy scour exposing bottom of cap.

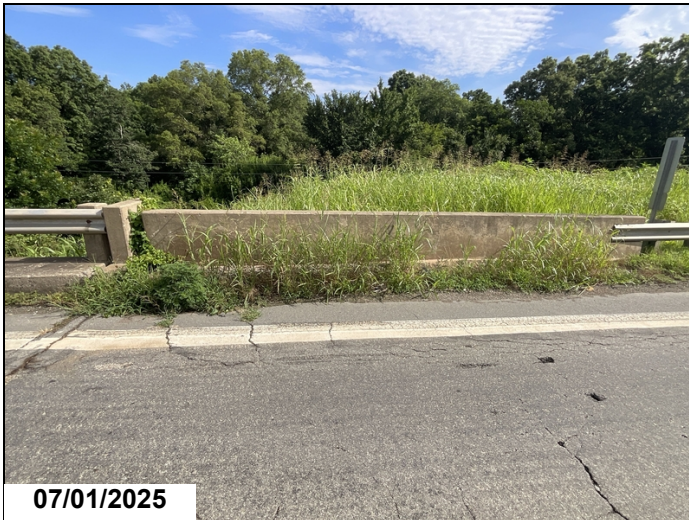
Approach railing transitions - Bents 1 & 9: Concrete transition posts/railing is deteriorating with cracking/scaling/spalling of the surface of the posts/railing.

Approach railing transition - Bent 9 left: Cracking/scaling

David: repair as time permits

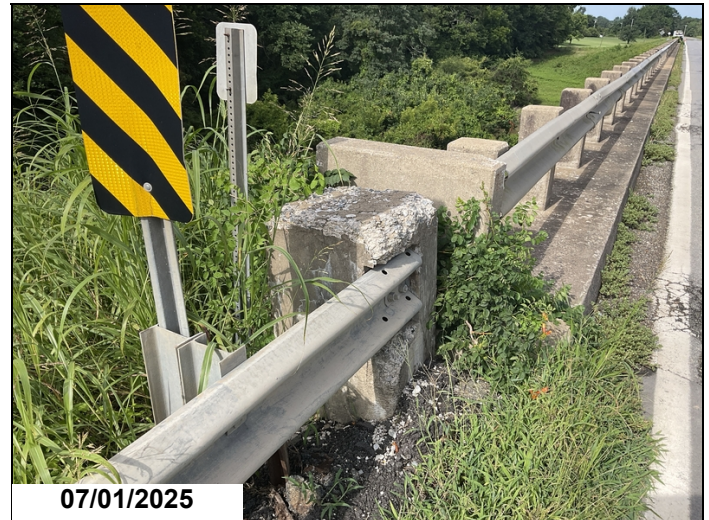
Approach railing transition - Bent 9 right: Scaling

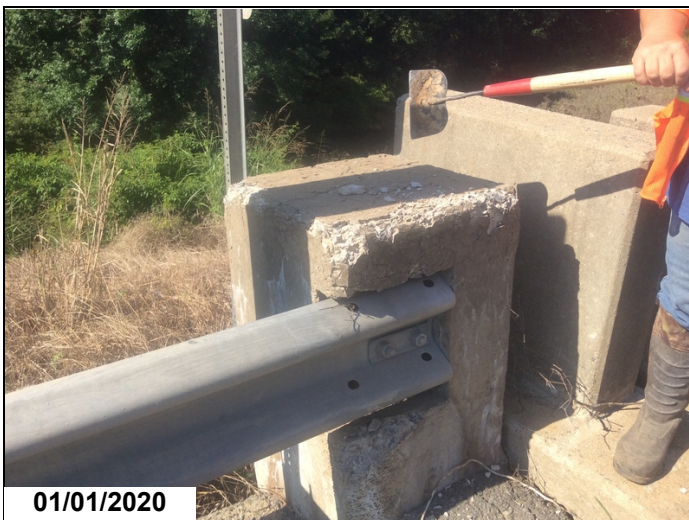
Concrete guard rail end post has efflorescence and has small spalls with delams .
