Bridge 03939 Inspection Report

Asset #03939(Routine)

SH 1-05 LM 7.36 over Big Creek

Team Lead: Sharon Hooks **Inspection Date:** 03/06/2023

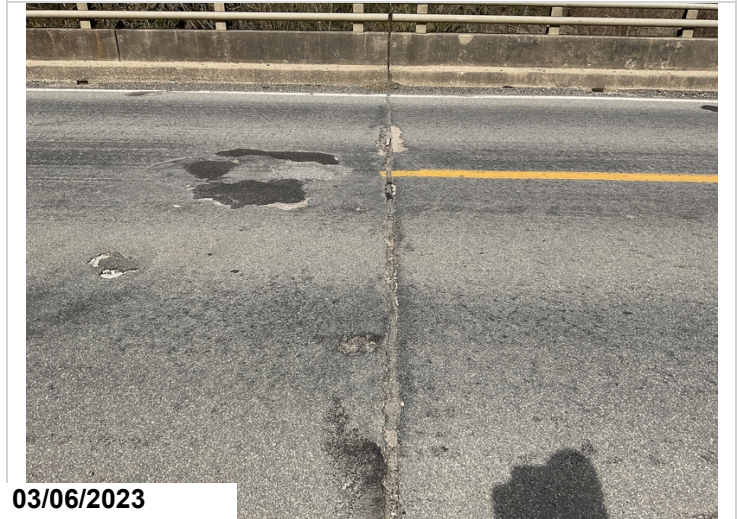
(301) Joint: 34' each / Bents 1-4. Joint has been sealed over/overlaid - 112' CS3 debris impaction. Joint material had lost adhesion and fallen out on curbs.							
330	Metal Bridge Railing	LF	180	180	0	0	0
515	Steel Protective Coating	SF	378	0	378	0	0

Bent 3 joint seal has debris impaction.

A-59 - Joint Repair Needed

Pourable joints are filled with asphalt and debris.

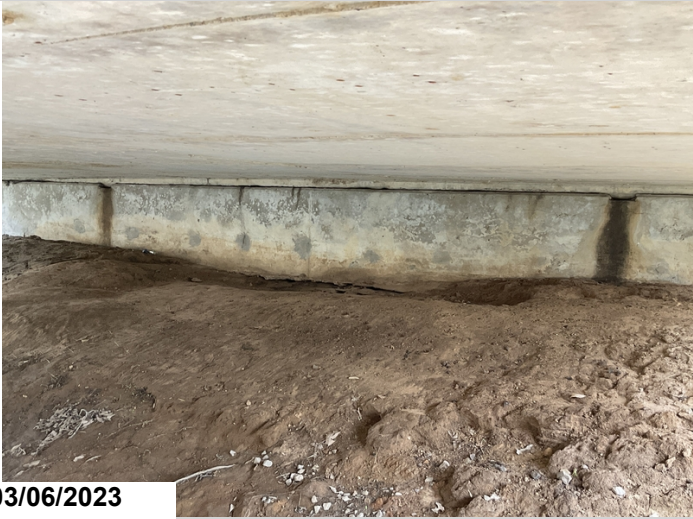
(215) Abutments: 30'-6" = 31' each (with 3'-6" wings each corner) / Bents 1 & 4. Bent 4: Small areas (tie-rod holes) have recently been filled/grouted over.							
227	Reinforced Concrete Pile	EA	10	0	5	5	0
1190	Abrasion/Wear (PSC/RC)	EA	10	0	5	5	0

Bent 4 abutment has minor erosion.

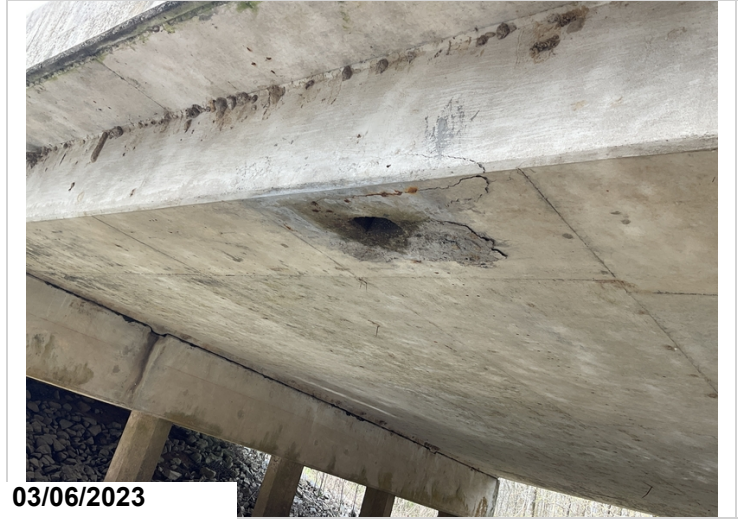
Span 2 right at midspan at drain opening has cracking and delams.

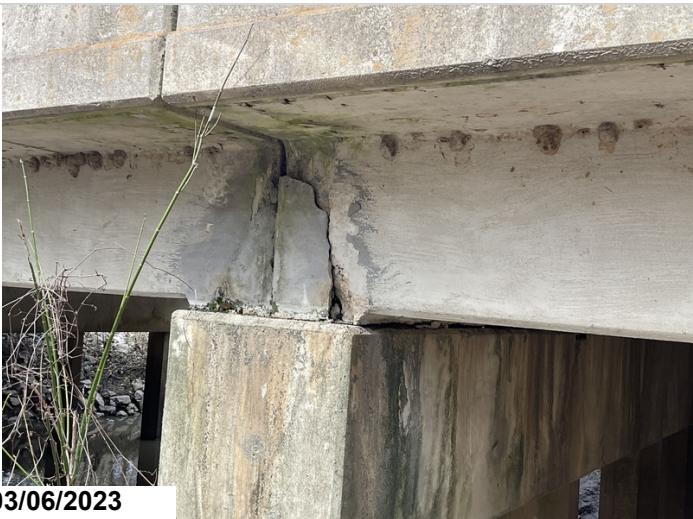
(234) Caps: 30'-6" = 31" each / Bents 2 & 3. Bent 2: Bottom face on left and right ends have delamination/spalling/exposed rebar with section loss – 4' CS3 exposed rebar. Bent 3: Numerous areas that have sound patches, mainly on back face – 10' CS2 patch.							
301	Pourable Joint Seal	LF	136	0	0	112	24
2320	Seal Adhesion	LF	24	0	0	0	24
2350	Debris Impaction	LF	112	0	0	112	0

Bent 3 right has cracking delams and spalls.

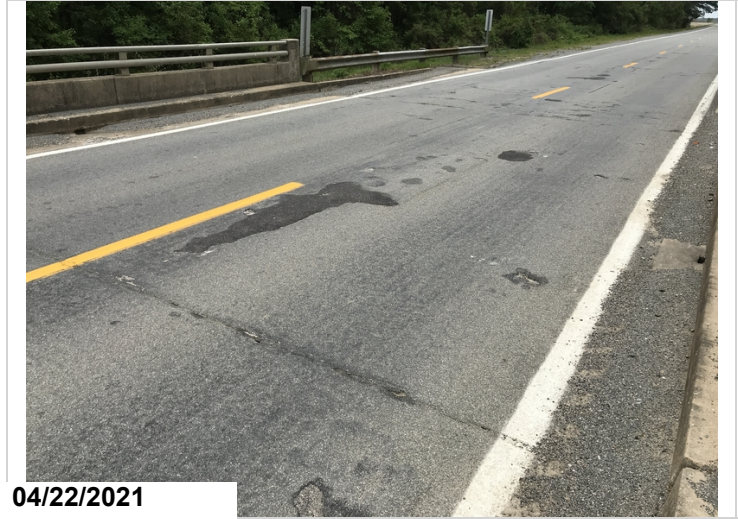
(38) Deck (sonovoids): 30' wide (1'-9" STEP-UP each side) x 90' long = 2700 sqft. Wearing surface (thin asphalt/chip seal – latest layer added in April 2019): 24' wide x 90' long = 2160 sqft. Wearing surface: Scattered small- to moderate-sized spalls (potholes). Gutterlines: Some scattered light scaling with a small spall (with some steel exposed) at drain @ Span 1 right – 1 sqft exposed rebar. Soffit – *Spans 1-3: Delaminations and spalls on outside edges of deck around drains – left and right sides, worse on Spans 1 & 2 right side. (Some minor rust and section loss to reinforcing steel at these locations.) *Repaired/patched by state forces – 10 sqft CS2 patch.							
215	Reinforced Concrete Abutment	LF	76	76	0	0	0

Wearing surface - Span 1 left: Spalling (potholes)
