Bridge 05825 Inspection Report

Route:1 Section:05 Log:13.94

Team Lead: Demetric Jones, Inspection Date: 07/14/2025

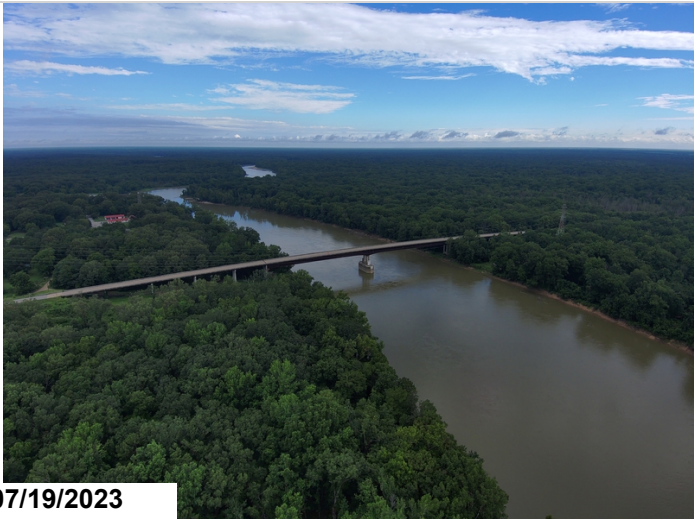
Elevation.

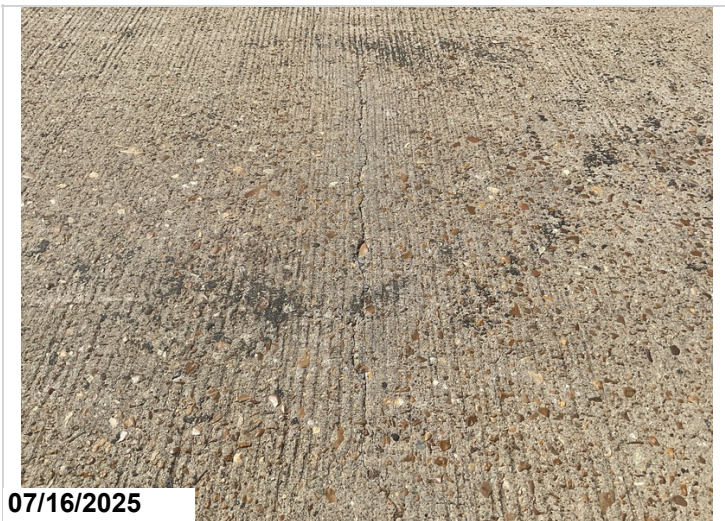
Unsealed moderate width cracks longitudinal and transverse
920 SF in CS2.

Unsealed moderate width cracks longitudinal and transverse 920 SF in CS2.

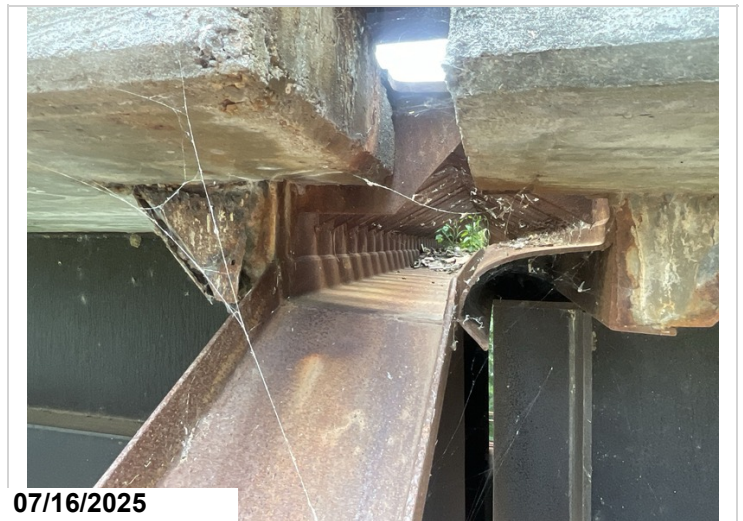
Bent 8 debris impaction

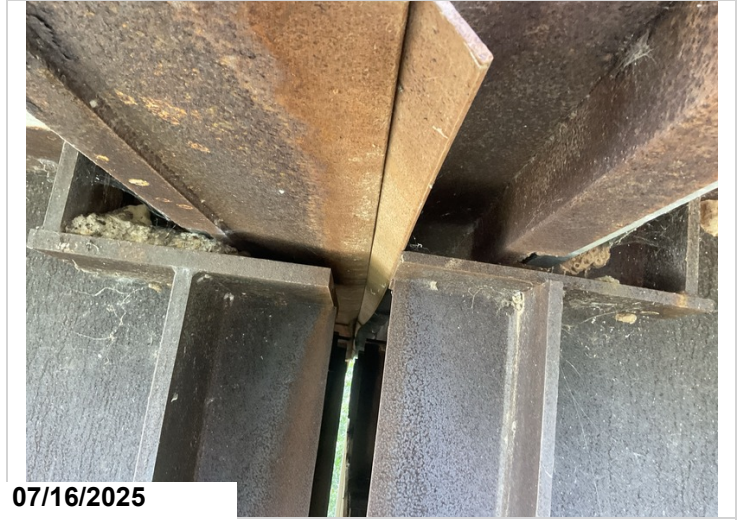
Bent 8 joint seal failure.

Corrosion caused by failed joint seal allowing water and material onto girder and cap, issues will continue without repair of joint seal as well.

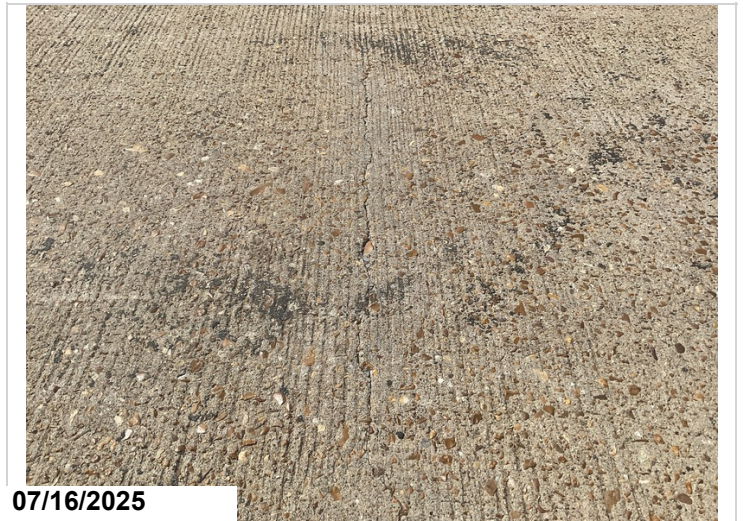
Unsealed moderate width cracks longitudinal and transverse
920 SF in CS2. photo 2.

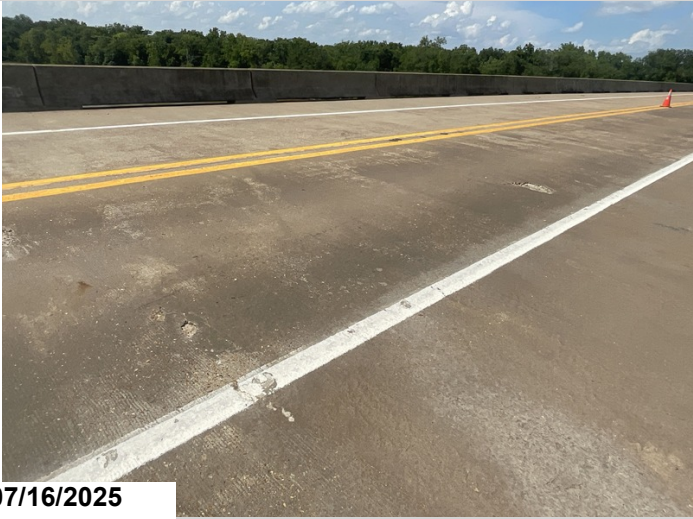
43 1' spalls 1x1 6 2x2 spall 2 2x2 spall with exposed rebar
12' crack in span 6.

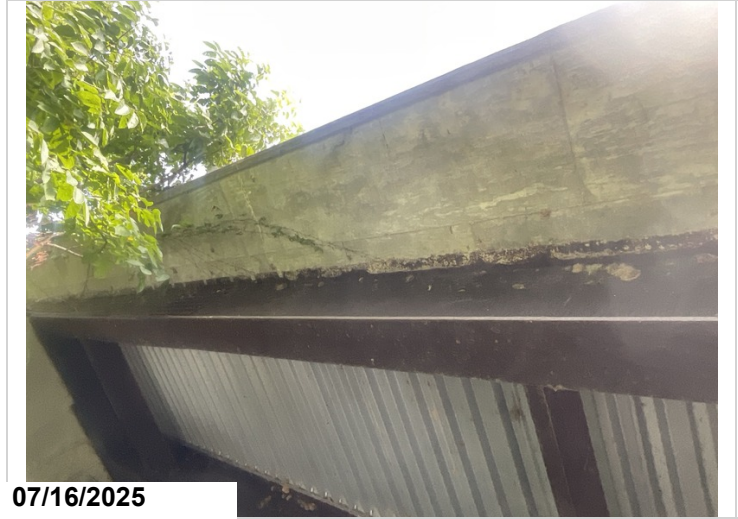
span 21, left overhang, cracking with efflorescence, 8SF
CS2
Span 21, right overhang, exposed rebar, 4SF CS3.

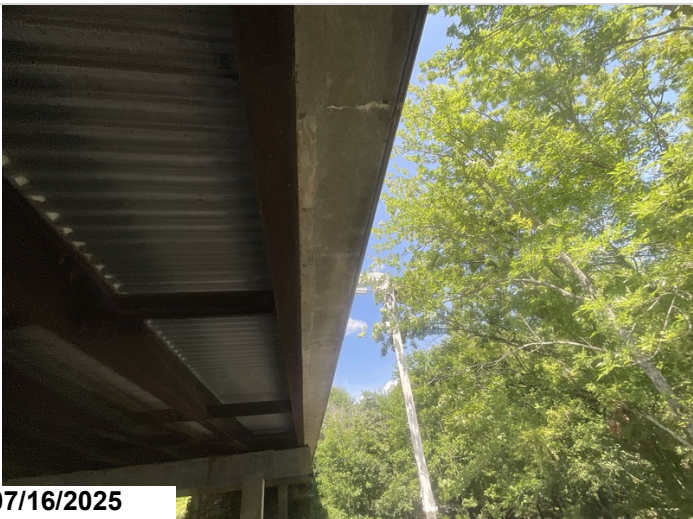
Span 20, left overhang, cracking with efflorescence, 6SF
CS2.
Span 20, right overhang, cracking with efflorescence, 6SF
CS2, exposed rebar, 1LF CS2.

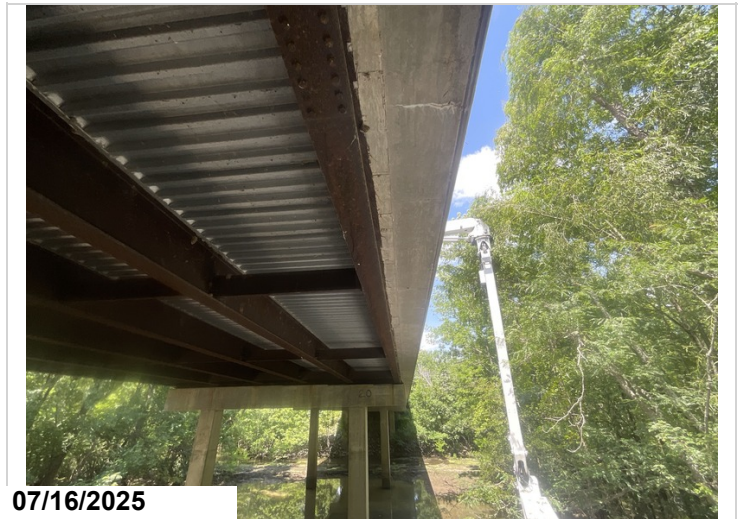
Span 19, left overhang, cracking, 6SF CS2.
Span 19, right overhang, cracking, 4SF CS2.

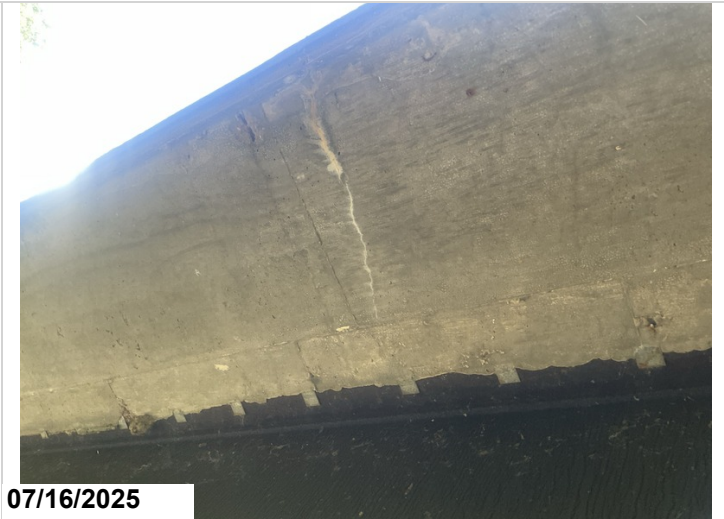
Span 18, left overhang, cracking with efflorescence, 2SF CS2.
Span 18, right overhang, cracking with efflorescence, 4SF CS2.

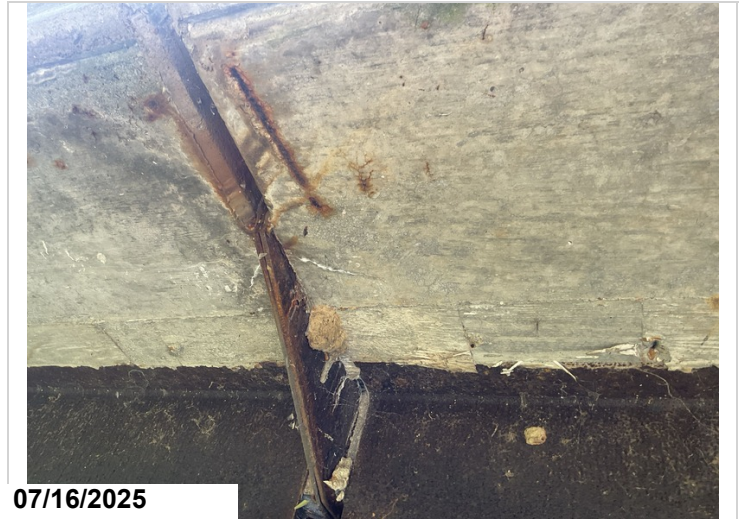
Bent 18, ahead, right overhang, exposed rebar, 2SF CS2.

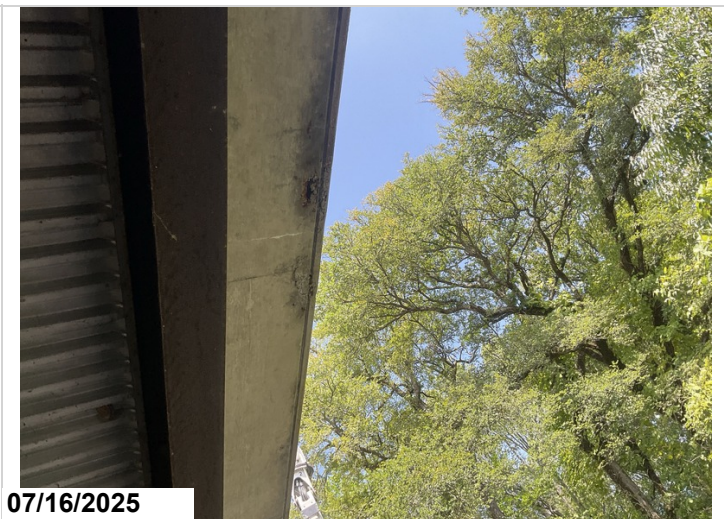
Span 17 right overhang, exposed rebar, 1SF CS2, cracking with efflorescence, 1SF CS2.

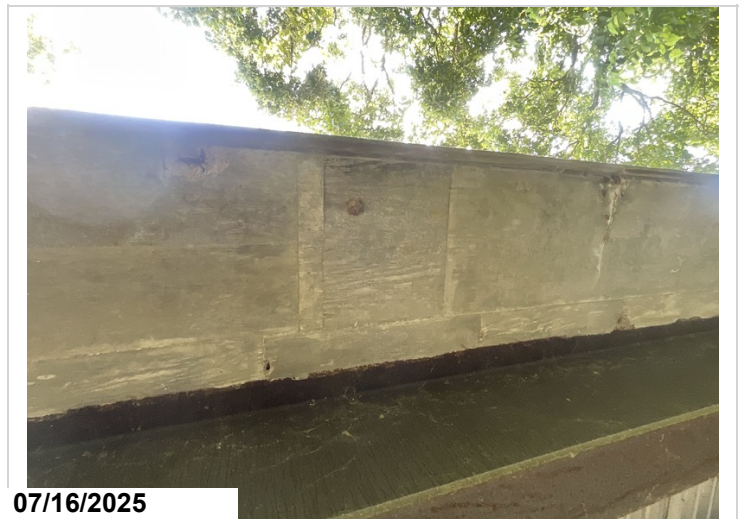
Span 17 left overhang, exposed rebar, 1SF CS2, cracking with efflorescence, 1SF CS2.

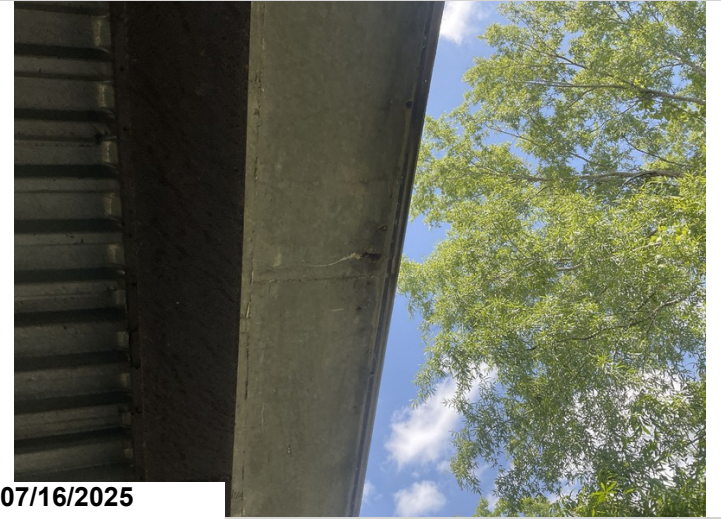
Span 15, left overhang, cracking with efflorescence, 10SF, CS2.
Span 15, right overhang, cracking with efflorescence, 4SF, CS2.

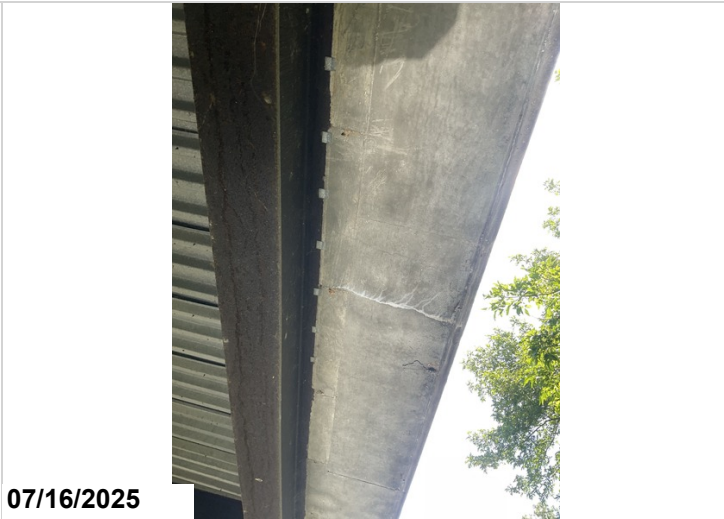
Span 13, left overhang, exposed rebar, 1SF CS2, cracking with efflorescence, 4SF, CS2.
Span 13, right overhang, cracking with efflorescence, 4SF, CS2.

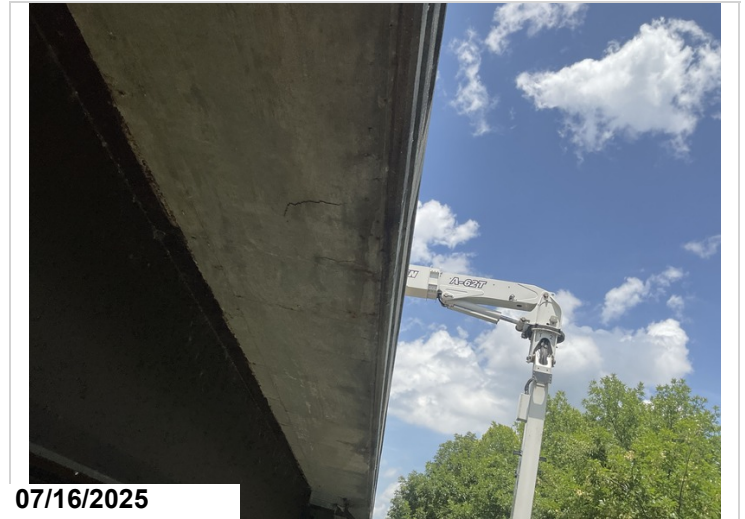
Span 12, right overhang, delaminated area, 2SF CS2.

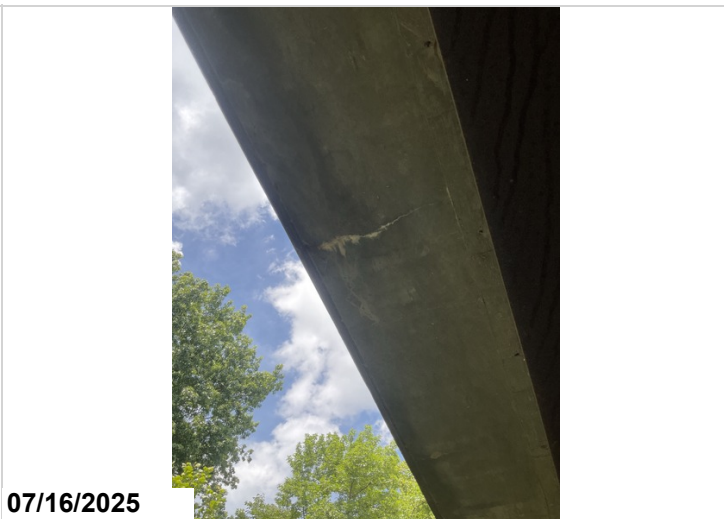
Span 12, left overhang, cracking with efflorescence, 6SF CS2.
Span 12, right overhang, cracking with efflorescence, 10SF CS2.

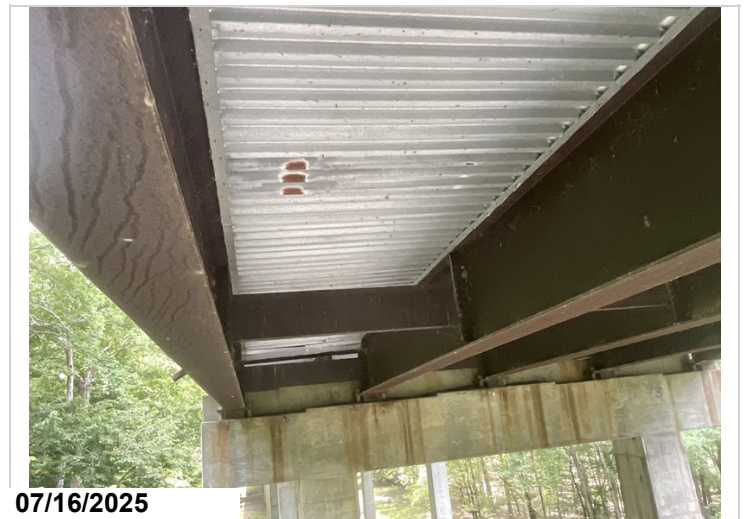
Deck pan corrosion in bay 1 span 12.

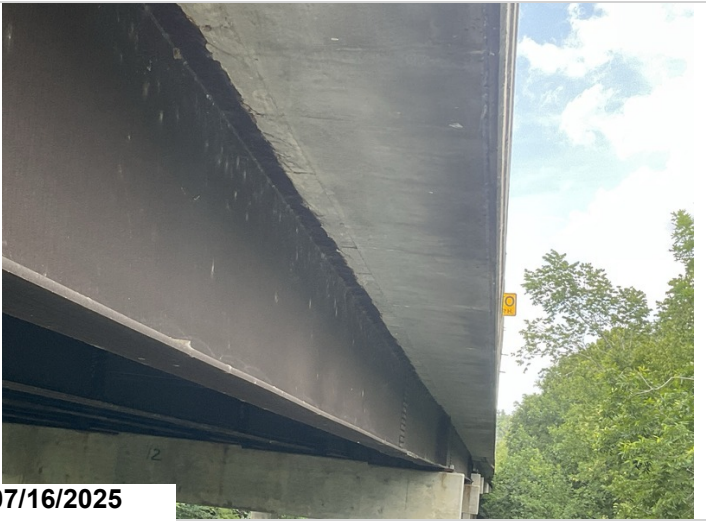
Span 11, left overhang, cracking with efflorescence, 14LF CS2.
Span 11, right overhang, cracking with efflorescence, 16LF CS2.

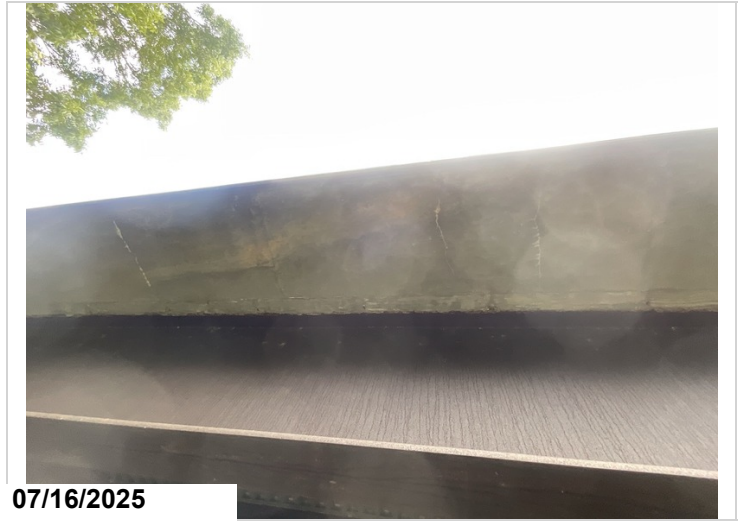
Span 10, left overhang, cracking with efflorescence, 20SF, CS3.
Span 10, right overhang, cracking with efflorescence, 10SF, CS3.

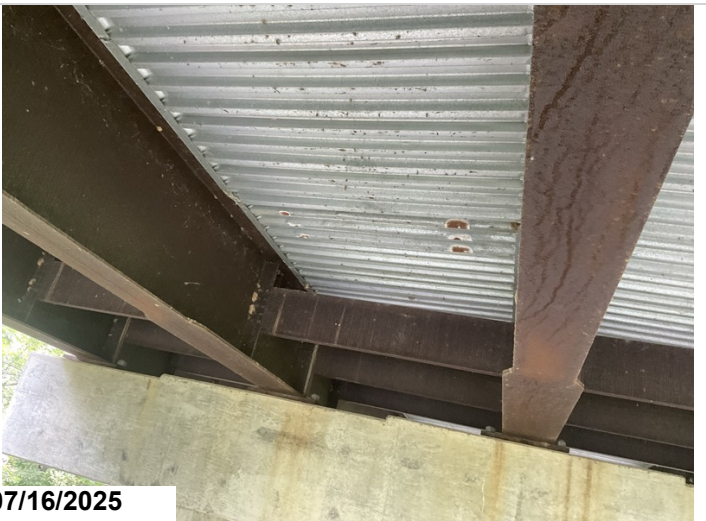
Span 9 bay 2 corroded deck pan.

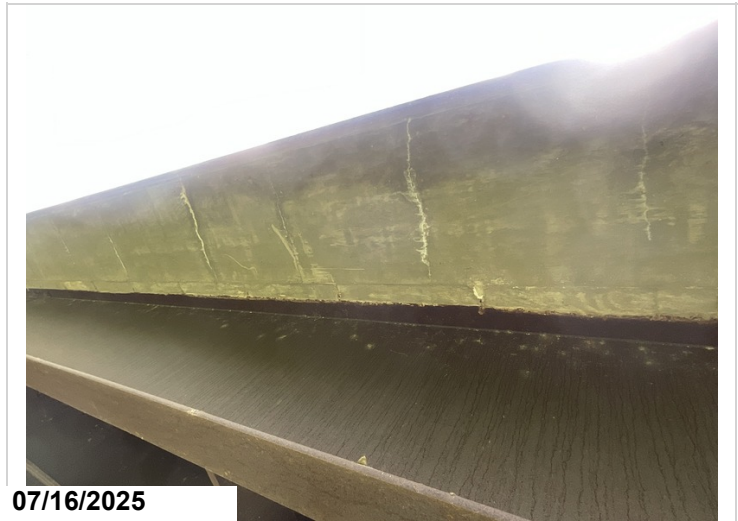
Span 9, overhangs, cracking with efflorescence, 11SF, CS3.

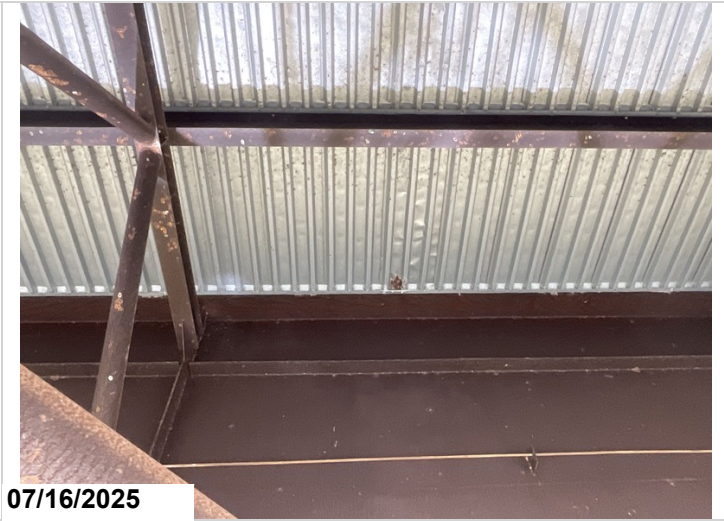
span 7 mid span, corrosion in deck pan.

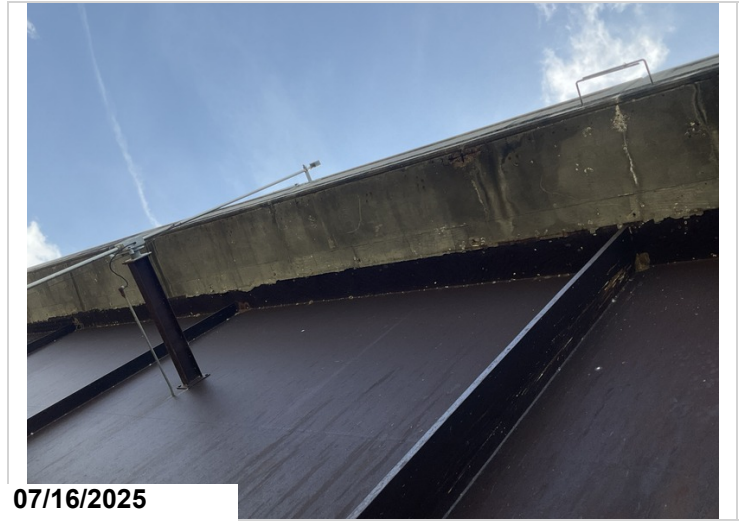
Span 7 Bent 7, spall with exposed rebar in overhang, 1SF CS2.

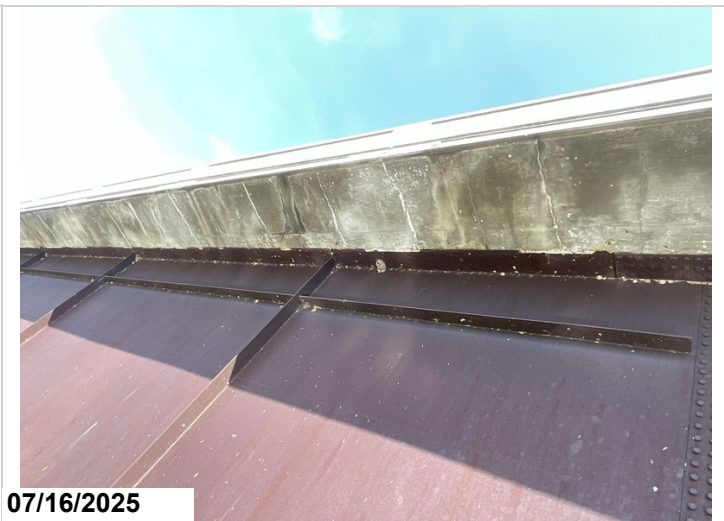
Main spans, right overhang, cracking with efflorescence, 730SF, CS2.

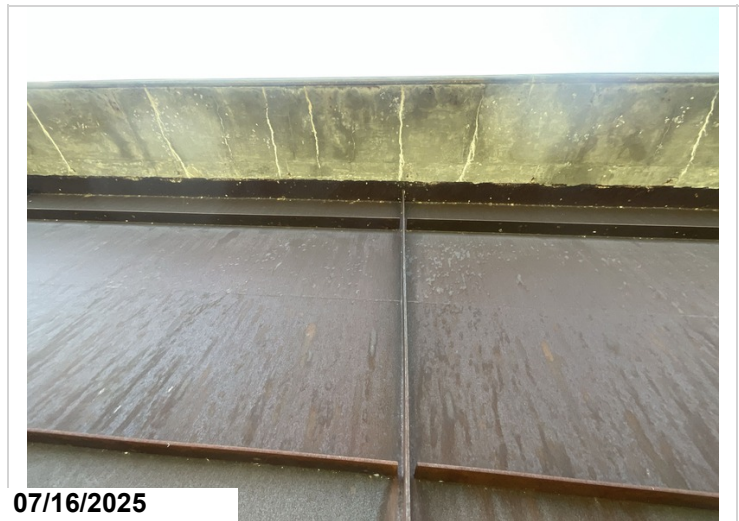
Main spans, left overhang, cracking with efflorescence, 365SF, CS2.

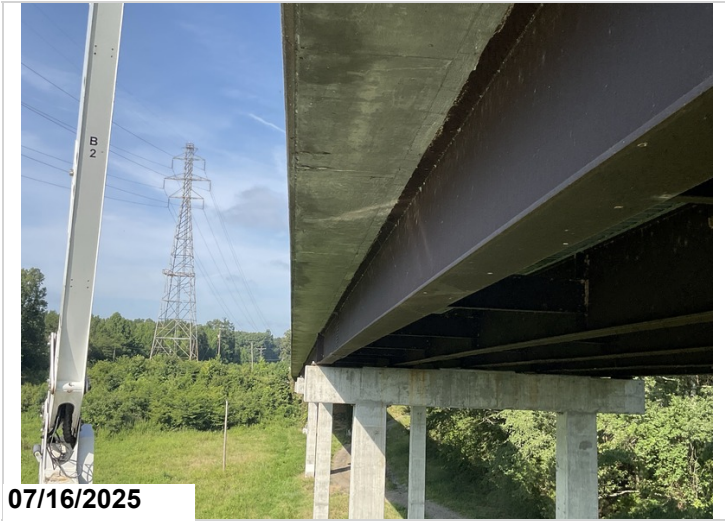
Span 5, mid span right overhang spall with exposed rebar, 2SF CS2.

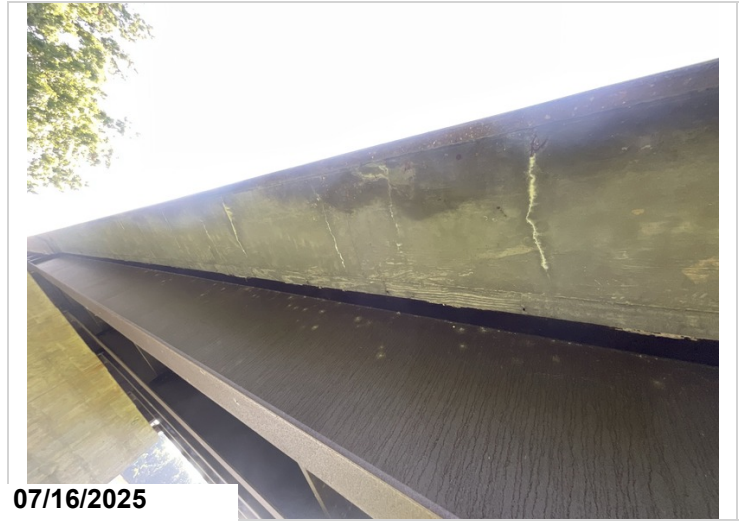
Span 5, left overhang, cracking with efflorescence, 16SF, CS2.
Span 5, right overhang, cracking with efflorescence, 24SF, CS2.

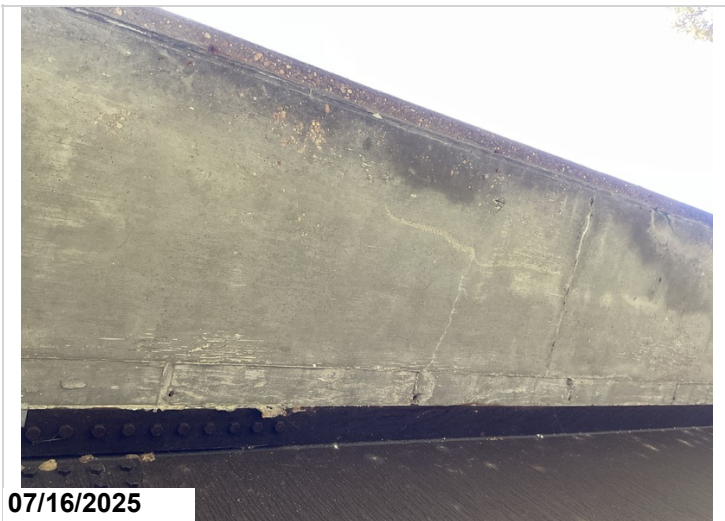
Typical pop out throughout spans.

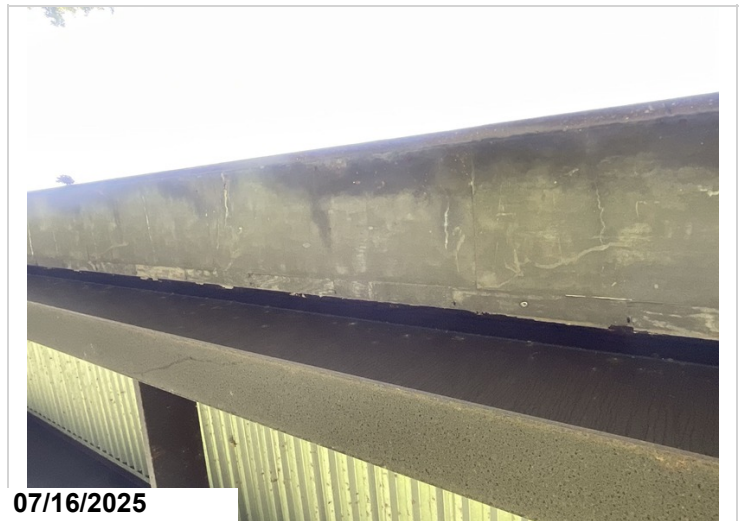
Span 4, left overhang, cracking with efflorescence, 20SF CS2.
Span 4, right overhang, cracking with efflorescence, 32SF CS2.

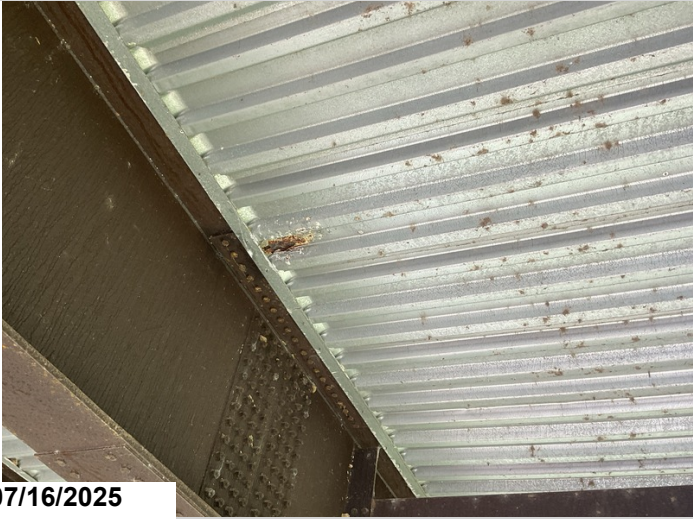
Span 3 bent 4 back, corrosion in deck pan.

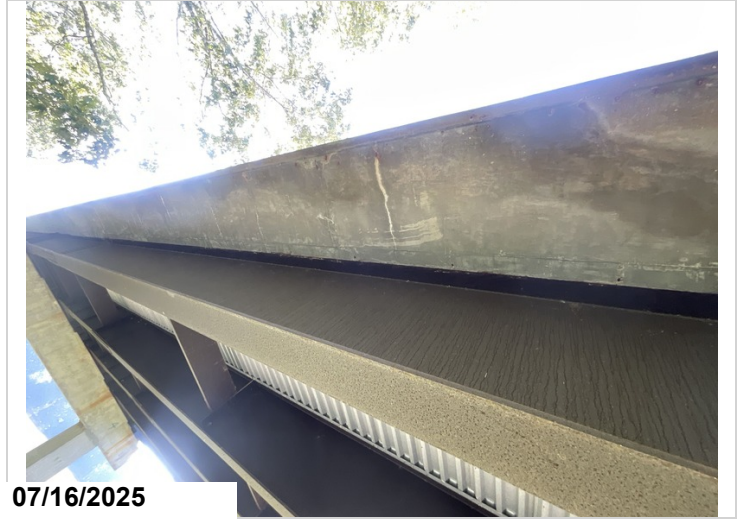
Span 3, left overhang, cracking with efflorescence, 38SF CS2.
Span 3, right overhang, cracking with efflorescence, 36SF CS2.

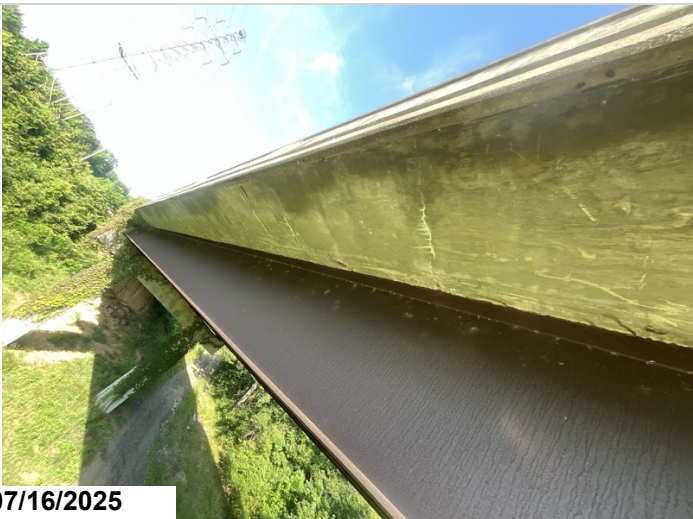
Span 2, left overhang, cracking with efflorescence, 26SF CS2.
Span 2, right overhang, cracking with efflorescence, 26SF CS2.

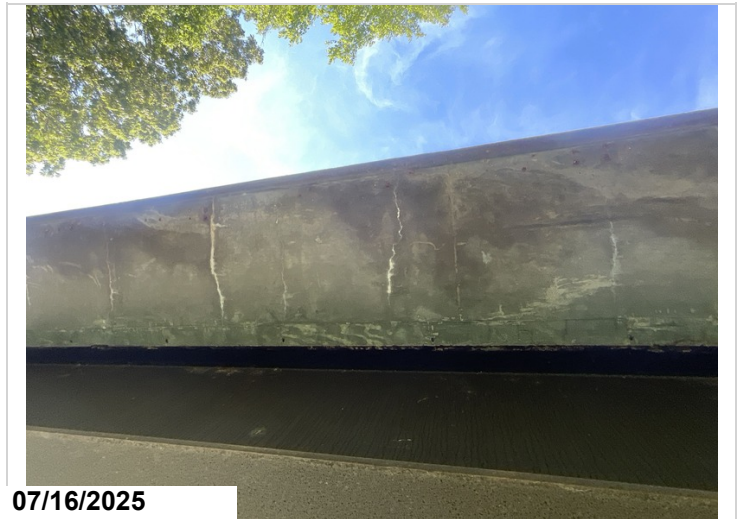
typical cracking with efflorescence in overhangs.

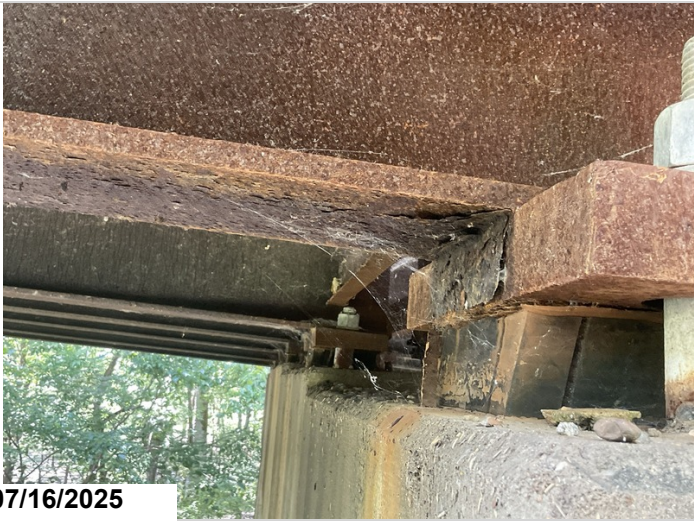
Bent 18, span 17, girder 4 and 5, bottom flange, corrosion, 4LF CS2.

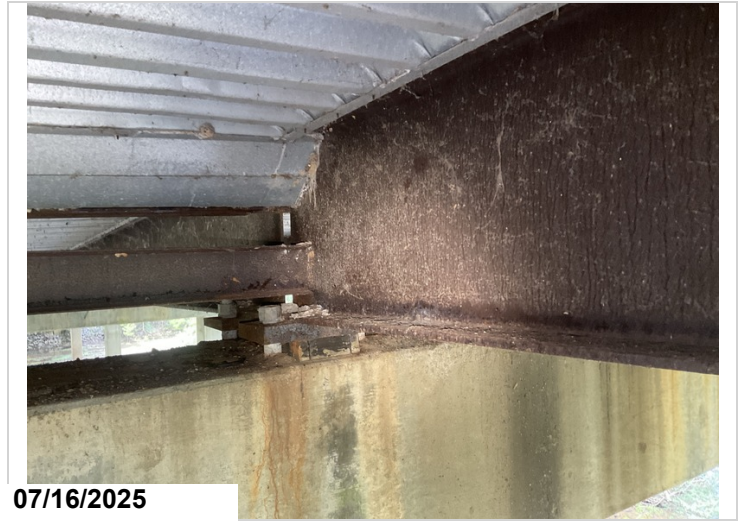
Bent 18, Span 17, girder 3, section loss, 5LF CS3.

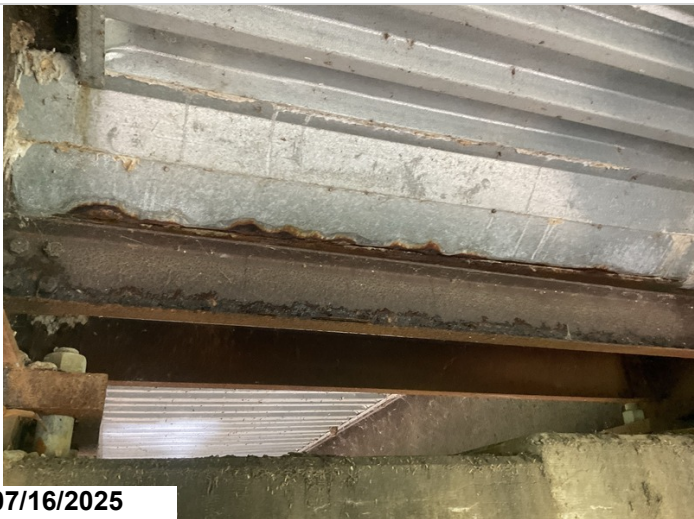
Bent 18 typical diaphragm corrosion.

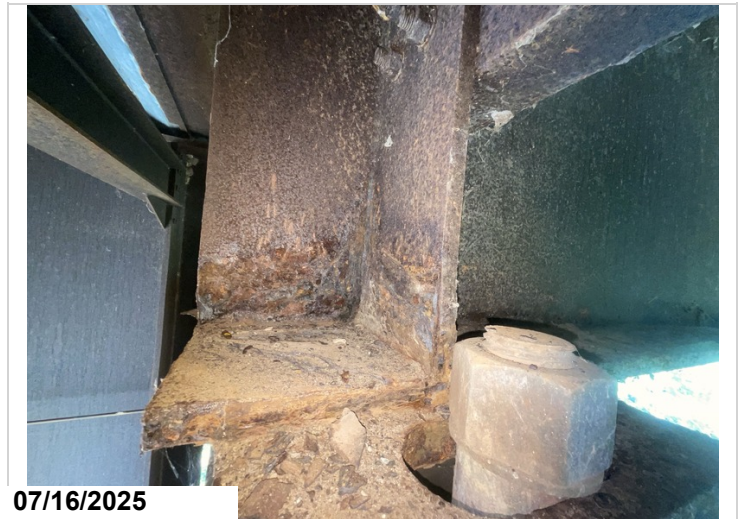
Bent 8, Span 8, girder 2, beam end section loss up to 1/8" to web, 3LF CS3.

SUPERSTRUCTURE: - Bent 8, ahead girders 2, 3, and 4 significant corrosion around bearing stiffeners with holes in web in ends of girders 3 and 4. Girder 4 has started crushing due to section loss.

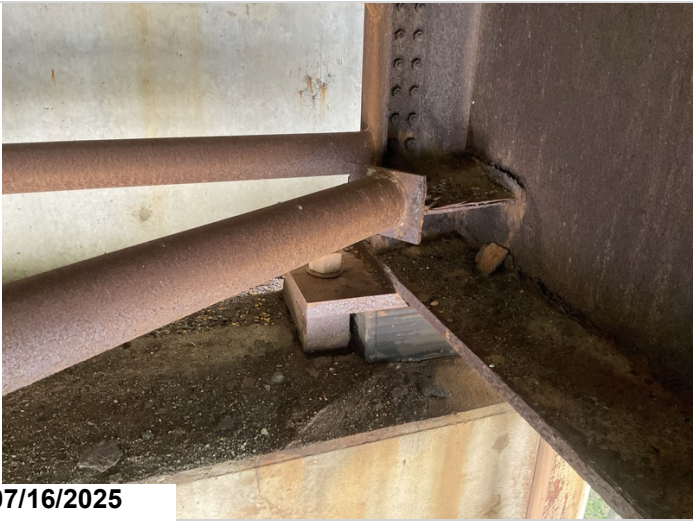
Bent 8, span 7, girder 3, laminating rust on bottom flange, 10LF CS3, laminating rust on web above flange 10LF CS3.

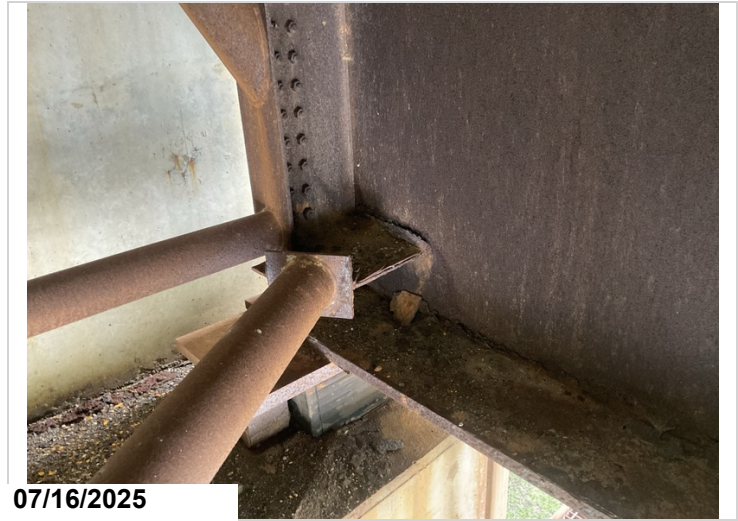
Bent 8, span 7, girder 3, laminating rust on bottom flange, 10LF CS3, laminating rust on web above flange 10LF CS3.

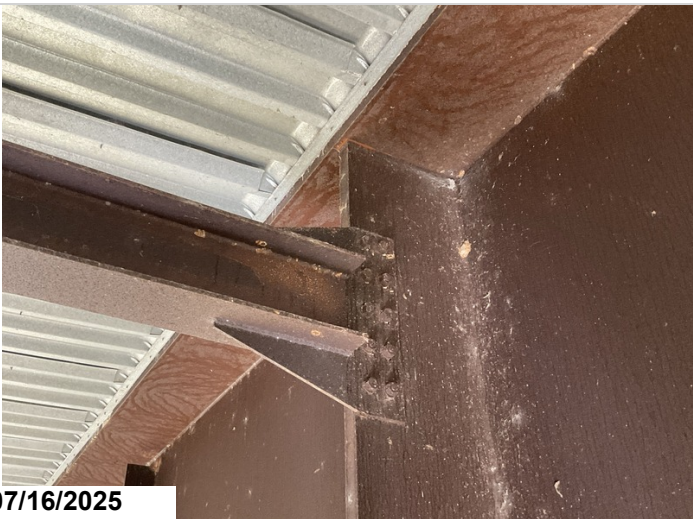
Bent 7, girder 2 right, stiffener above bent, fretting rust.

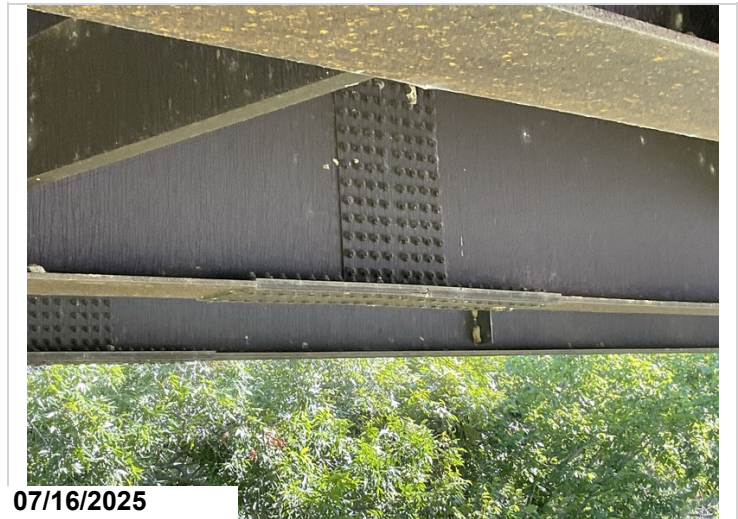
Span 5 girder 2 splice plate bottom flange, pack rusting, 1LF CS3.

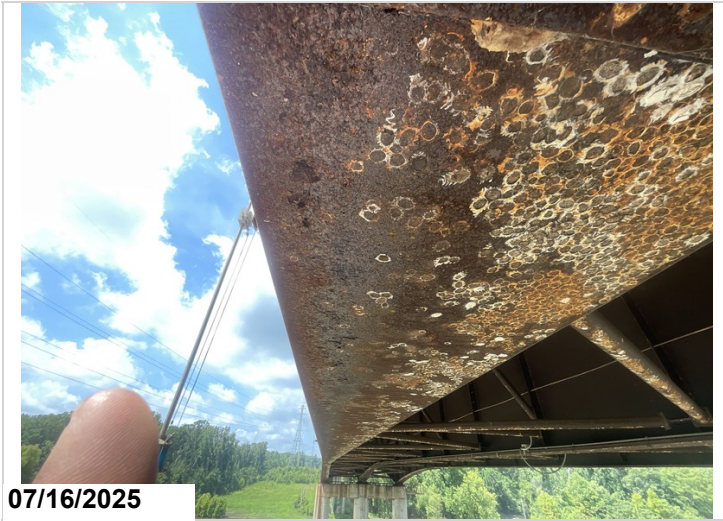
Span 7, pier 2 bottom flange of all girders, flaking rust, 9,855SF CS3.

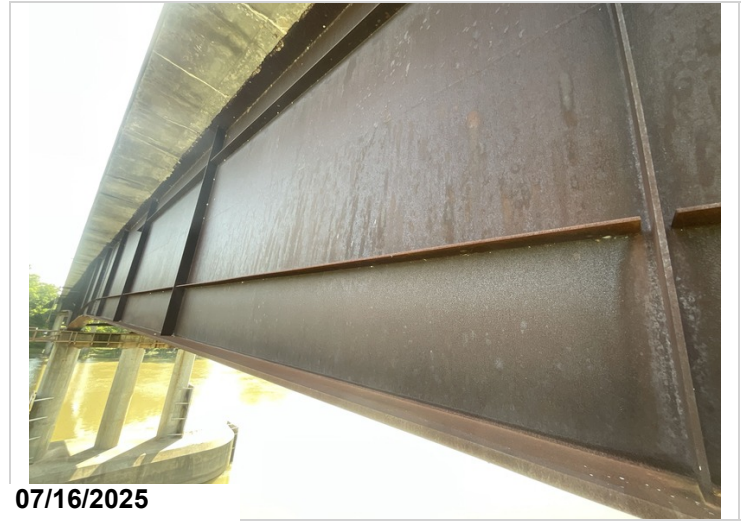
Bent1, span 6 full length falling protective coating 66,840SF CS3.

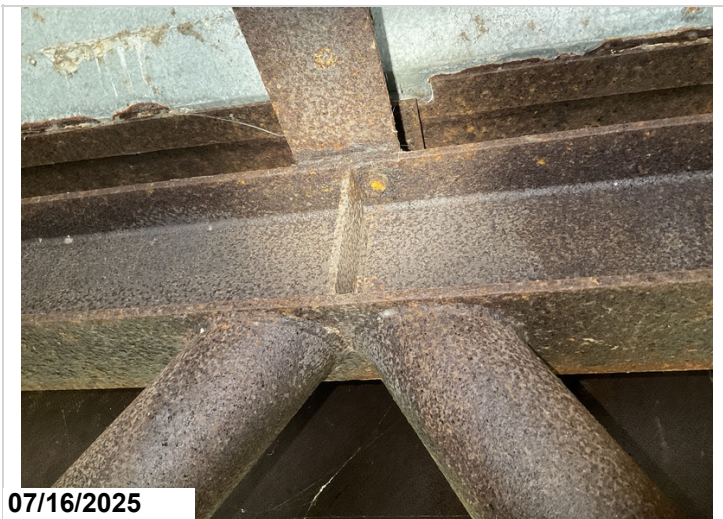
Span 7 bent 8 stringer/floor beam connection area corrosion around bolt.

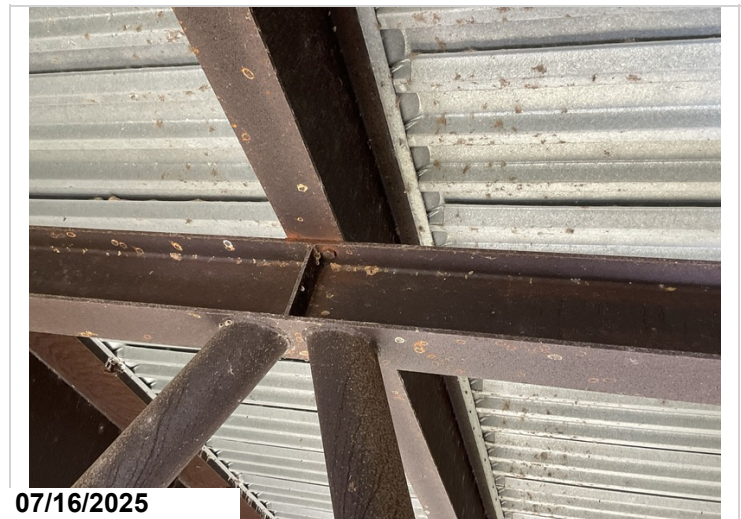
Bent 7, floor beam and stringer connection has loose bolt can't reach with Aspen A62T.

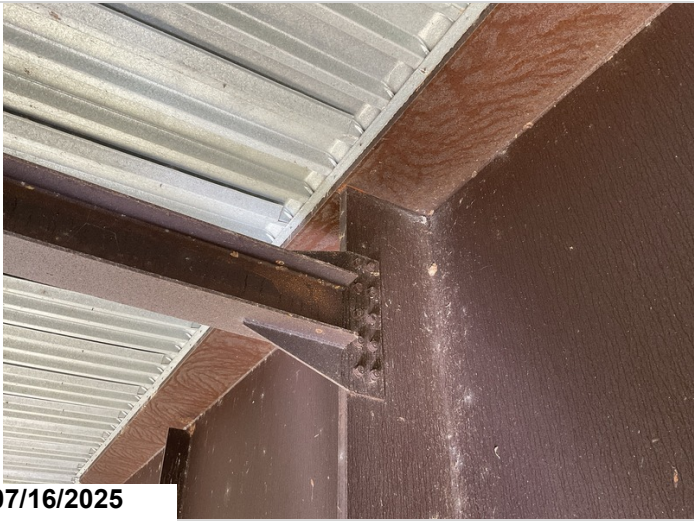
Bent 7, floor beam connector, loose bolts can't reach with Aspen A62T.

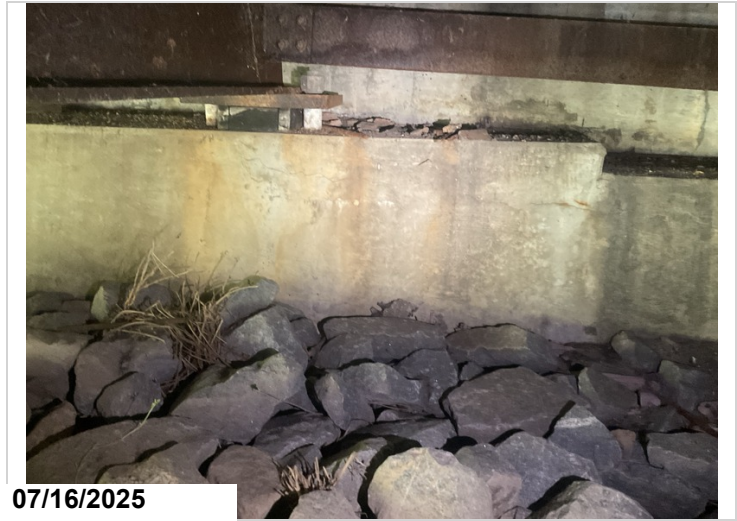
Abutment 23, Bearing 3 bearing seat cracking

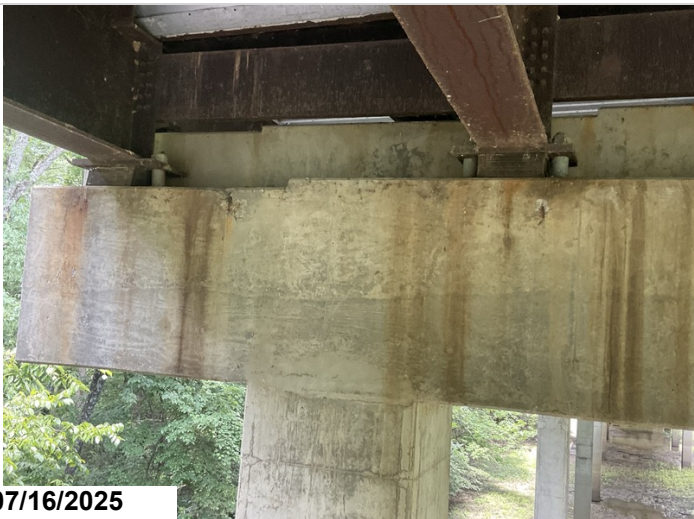
Bent 13, back, pier cap, exposed rebar, 2LF CS2, cracking with efflorescence, 1LF CS2.

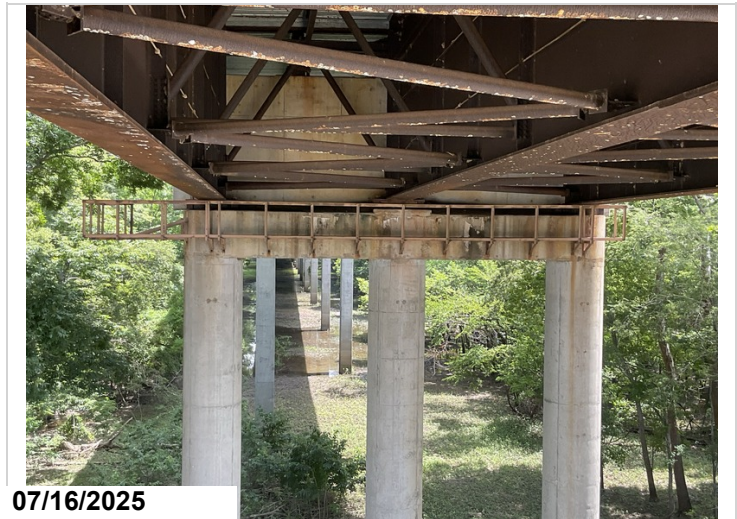
Bent 8, pier cap, cracking with efflorescence, 20LF CS3.

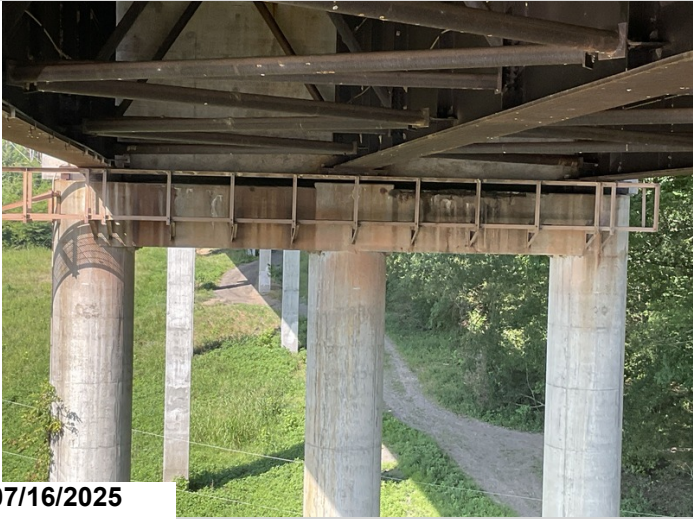
Bent 6 ahead, spalling with exposed rebar, 10LF CS2.

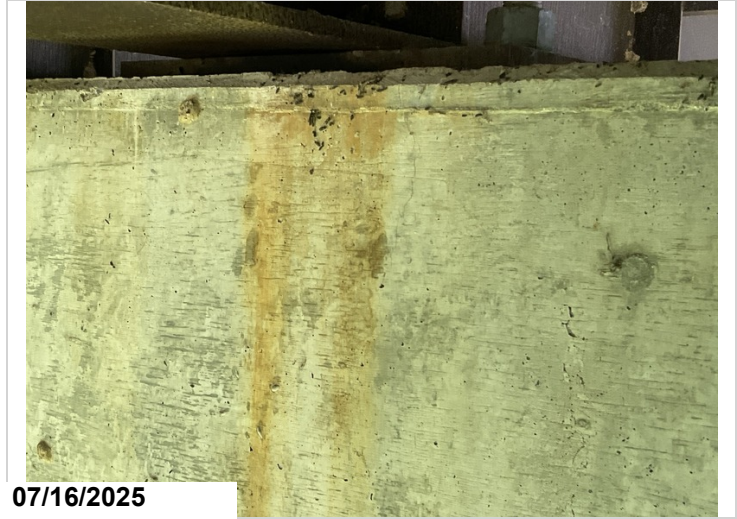
Bent 5 cap, cracking, 1LF CS2.

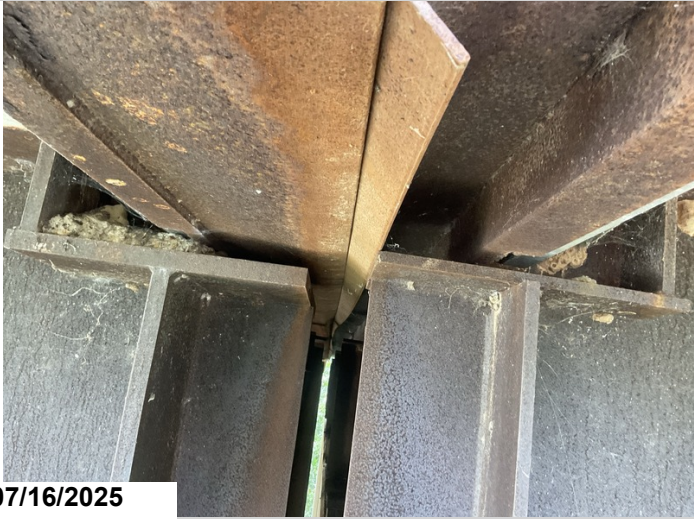
Bent 8 joint seal failure.

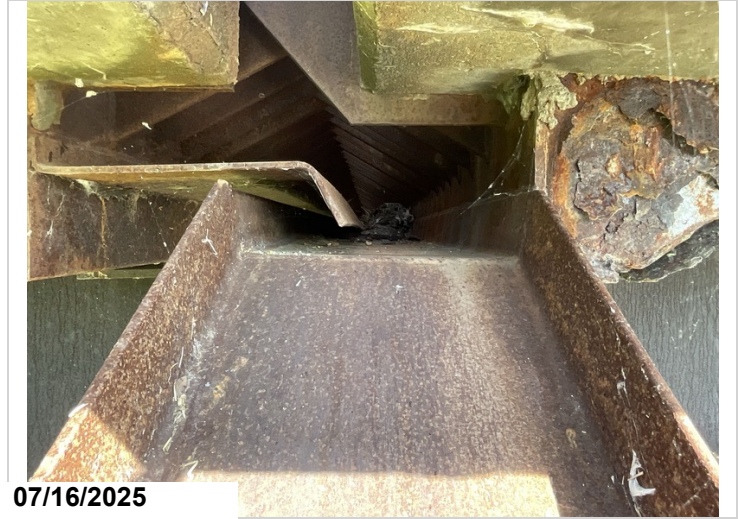
Bent 6 joint, debris impact, full width, CS2.

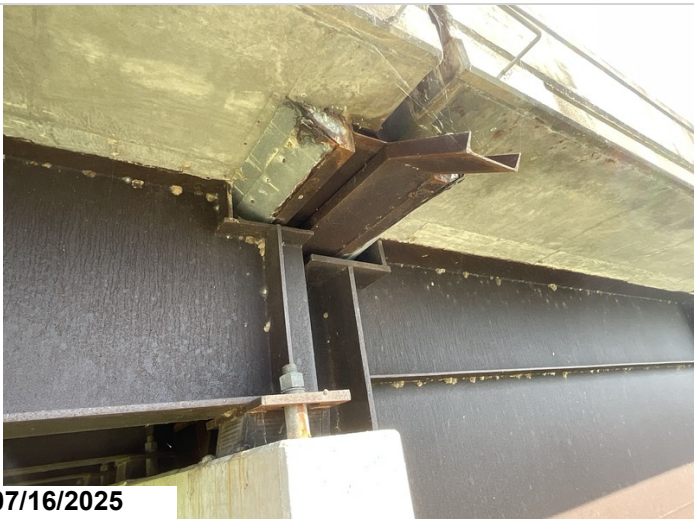
Joint system failure, Bent 6.

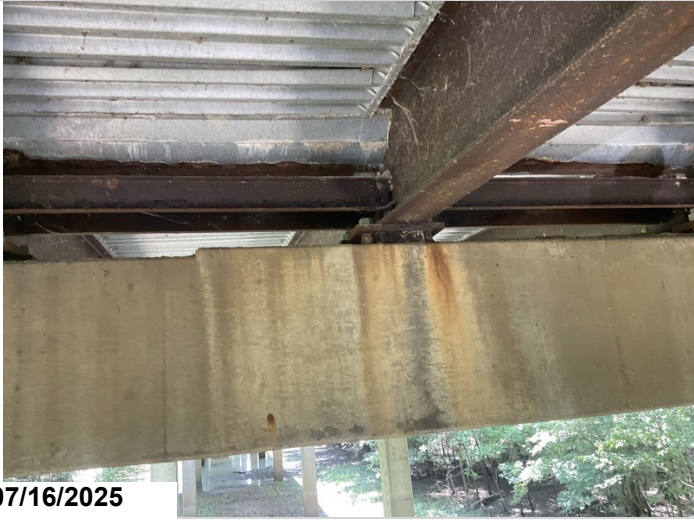
Bent 18 ahead bearing 1-6 sole plate and diaphragm corroded.

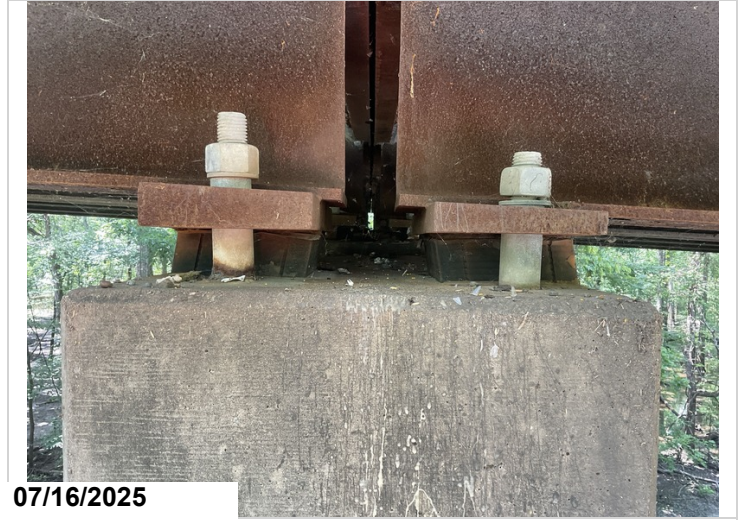
Bent 18 bearings misalignment.

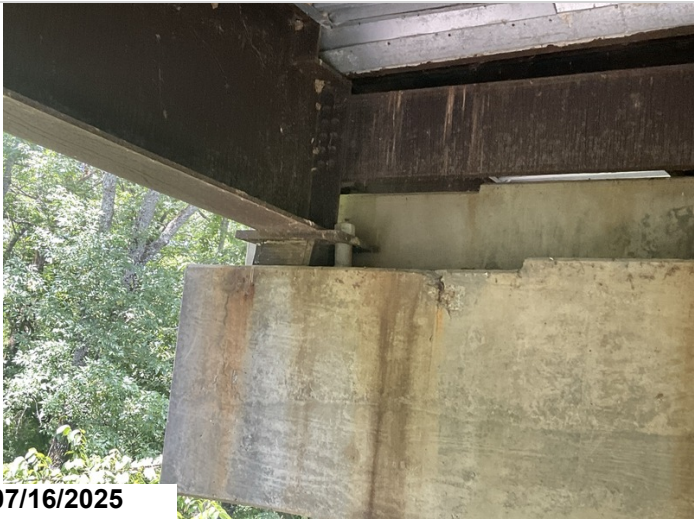
Typical condition of bearing misalignment on Bent 13, back, girder 1,3,4,5.
