Bridge 05825 Inspection Report

Route:1 Section:05 Log:13.94

Team Lead: Demetric Jones, Inspection Date: 07/14/2025

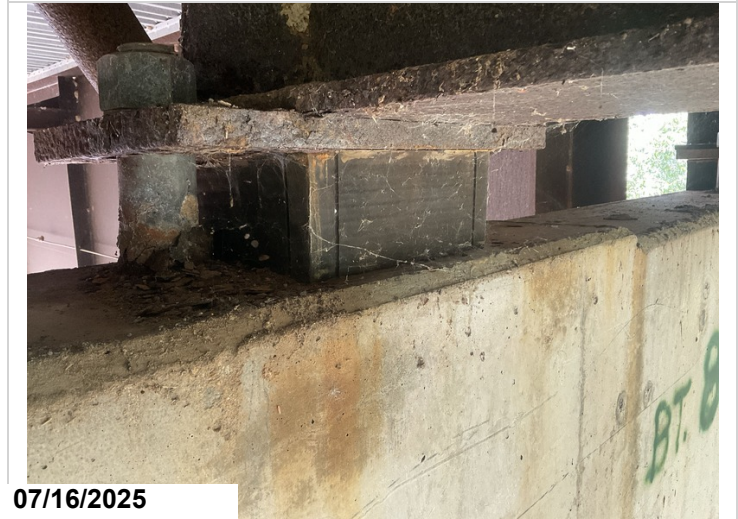
Bent 8 typical bearings.

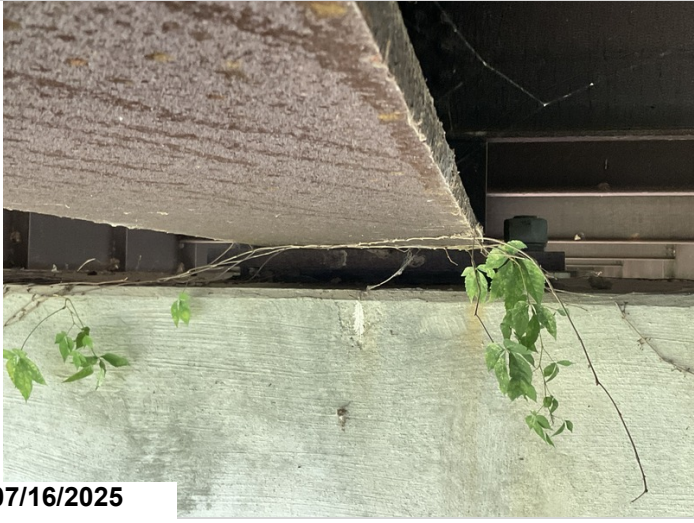
Typical bearing condition.

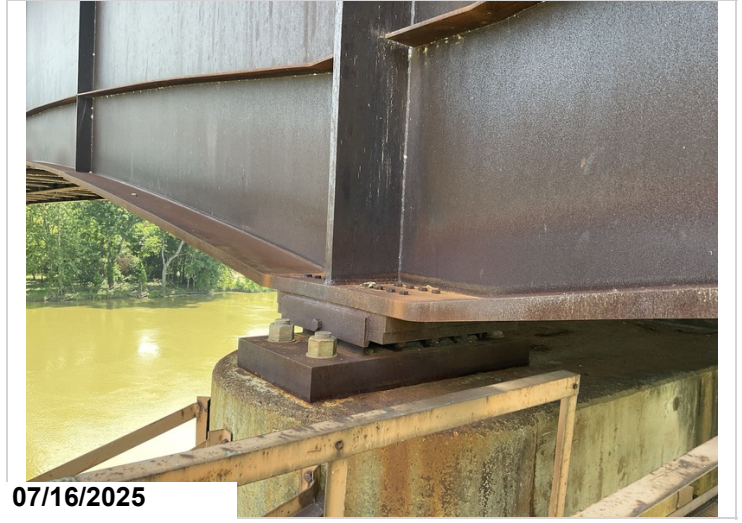
Typical condition of bearing at Bent 7.

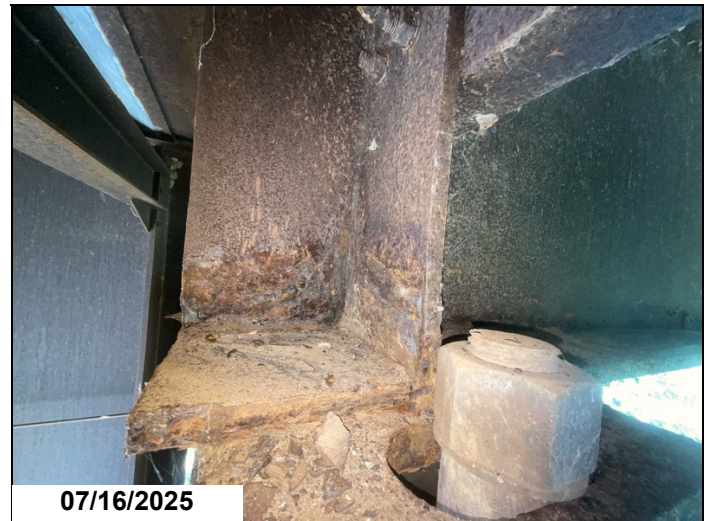
Span 7, Bent 8, Girder 2, beam end section loss up to 1/8" to web, 3LF CS3.

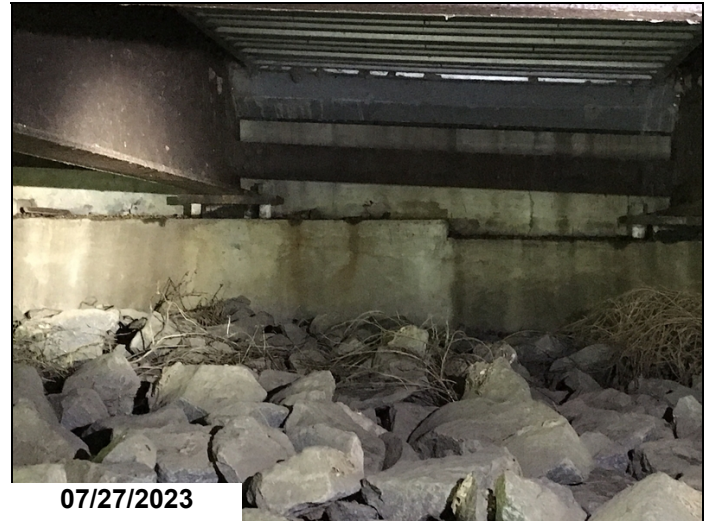
Bent 23, bridge seat, 10' horizontal cracking.

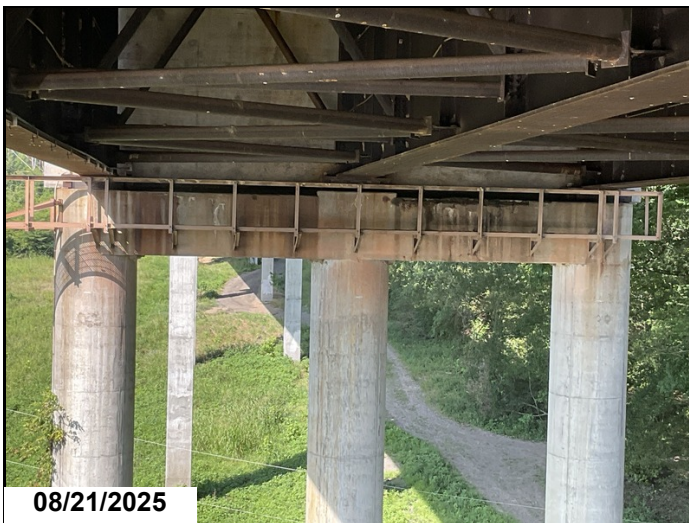
Bent 6 ahead, spalling with exposed rebar, 10LF CS2.

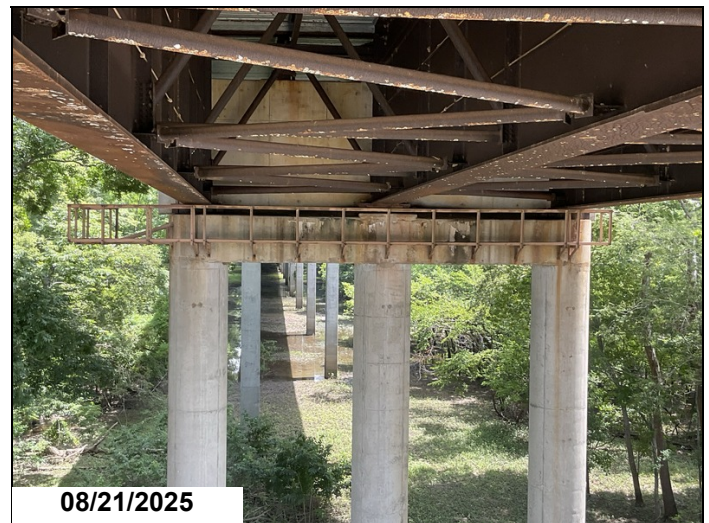
Bent 8, pier cap, cracking with efflorescence, 20LF CS3.

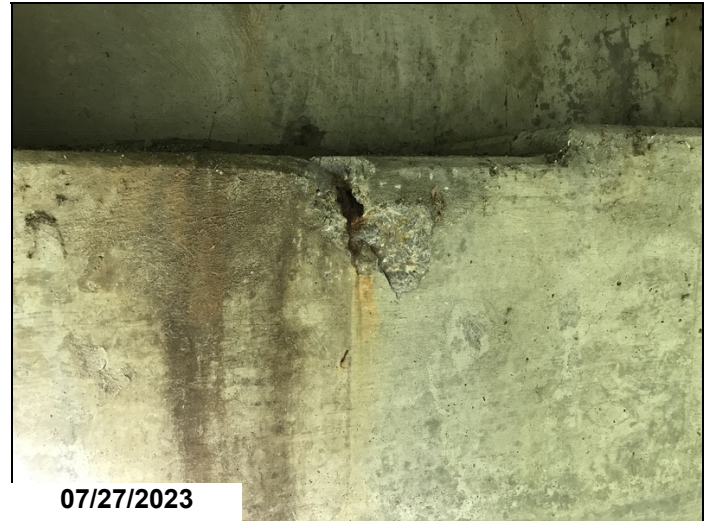
Bent 13, back, adjacent to girders 1 & 2, spalling with exposed reinforcing steel. 2ft.

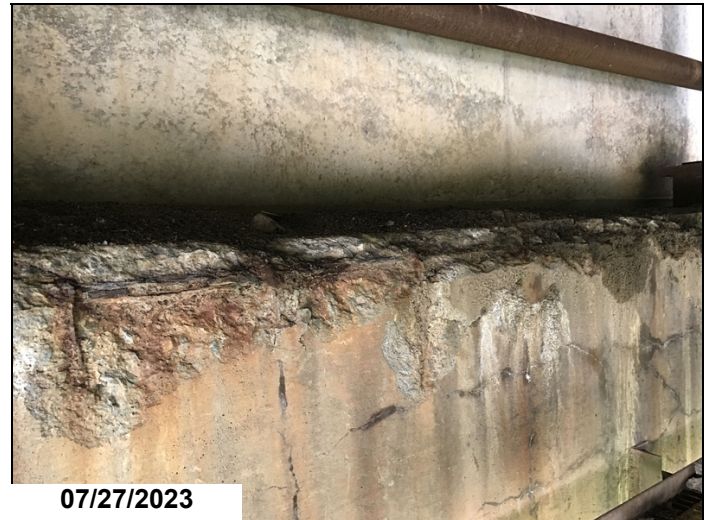
Bent 6, ahead, adjacent to bay 1, spalling with cs3 exposed reinforcing steel.
