Bridge X0025 Inspection Report

Asset #X0025(Routine)

SH 1-05 LM 8.63 over Tarleton Creek-Ark Co

Team Lead: Greg Loomis Inspection Date: 04/08/2025

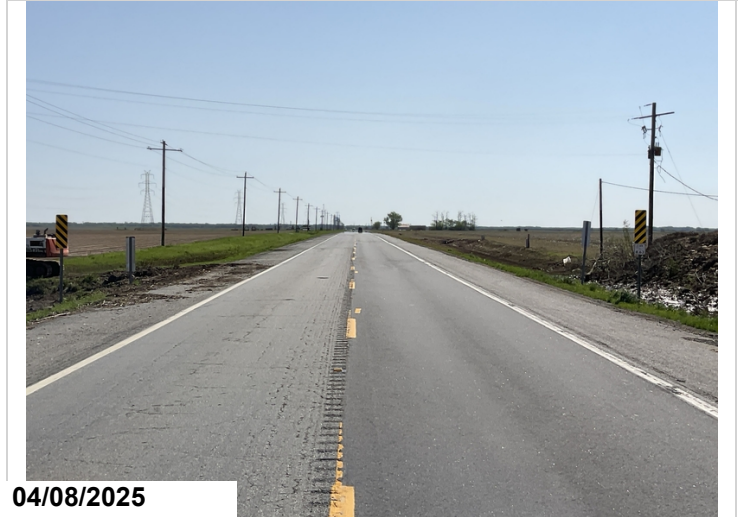
Roadway view

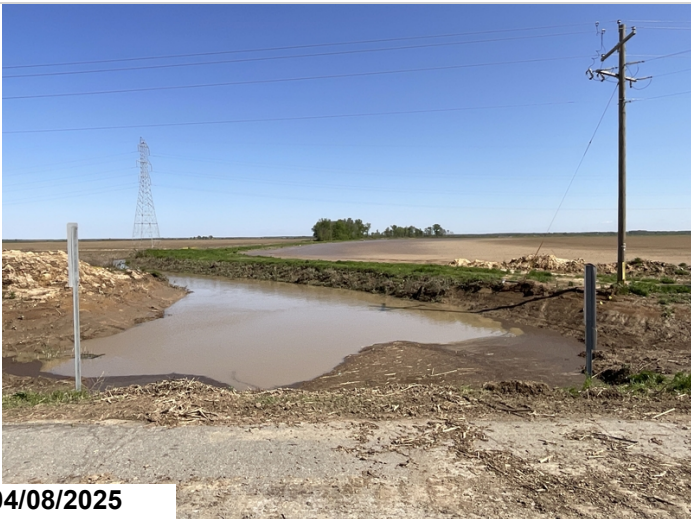
Channel - Left side view

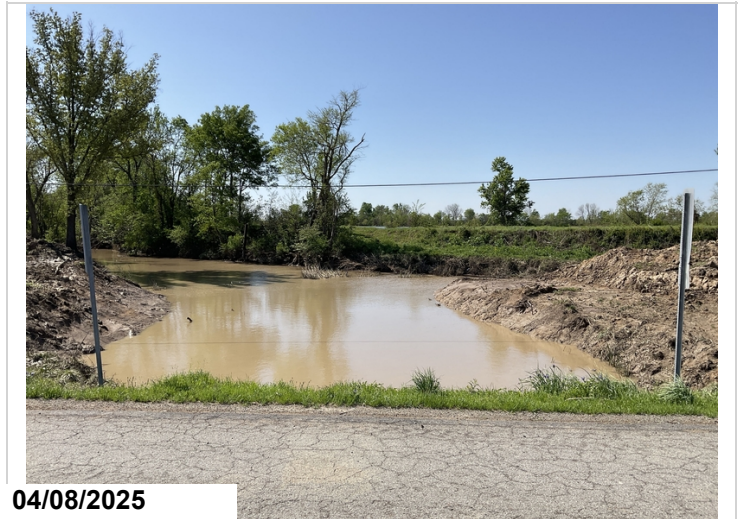
Channel - Right side view
