Bridge 02149 Inspection Report

US 79-09 LM 5.40 over Big Creek

Location: 0.5 Mi S SH 54-Faith - Jefferson County

Team Lead: Greg Loomis Inspection Date: 11/13/2025

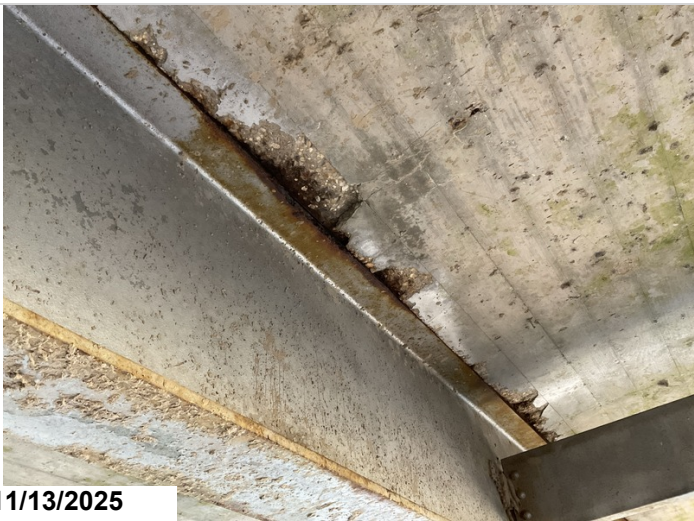
Some scattered, minor-sized cracking and shallow spalling along edges of top flange of girders, especially Spans 3 & 4 adjacent to Girder 3, both sides.

Span 3 Bay 2 @ Girder 3: Spall along edge of girder

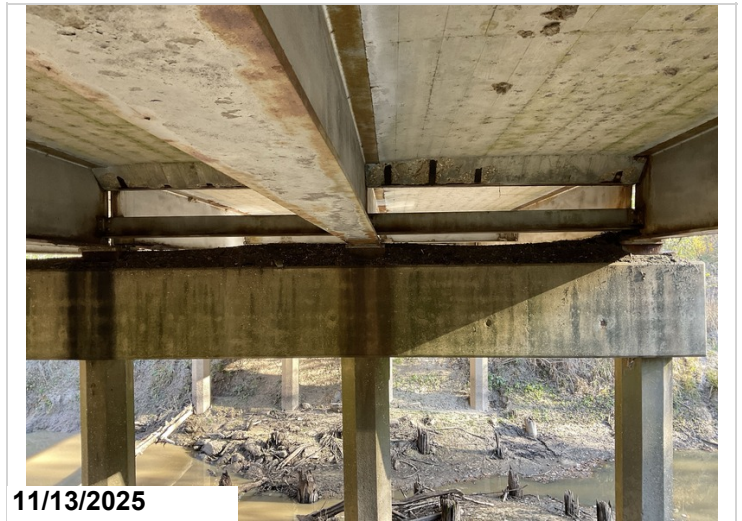
Cap – Bent 2: Significant build-up of dirt and debris on top of cap and around bearings, retaining moisture in these areas.

Cap - Bent 2: Debris build-up

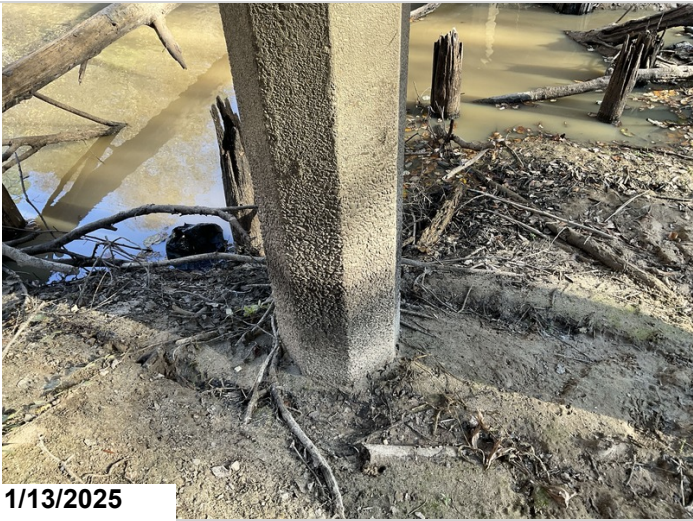
Substructure is in good condition with some minor abrasion/wear on pile and some minor erosion on Bent 5 end-slope.

Bent 2 Pile 2: CS2 Abrasion/Wear

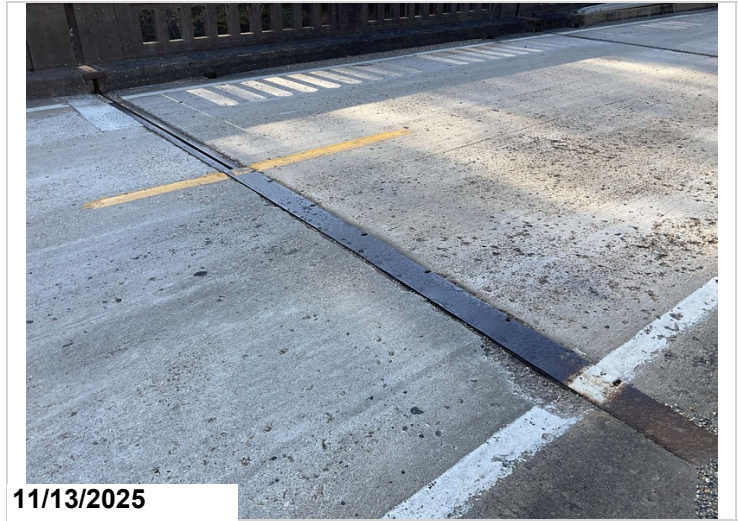
Joints – Bent 2, Bent 3 right side, & Bent 5 left side: Sliding plate missing, allowing dirt, debris, and water to build up on caps, bearings, and ends of girders.

Missing plates also leave an approximate 10" wide by ½" deep dip at each joint.

Joint - Bent 3: Sliding plate missing

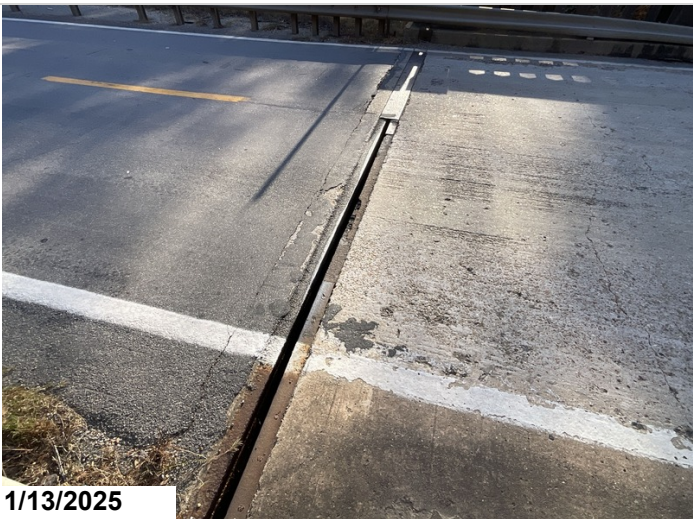
Joint - Bent 5: Sliding plate missing

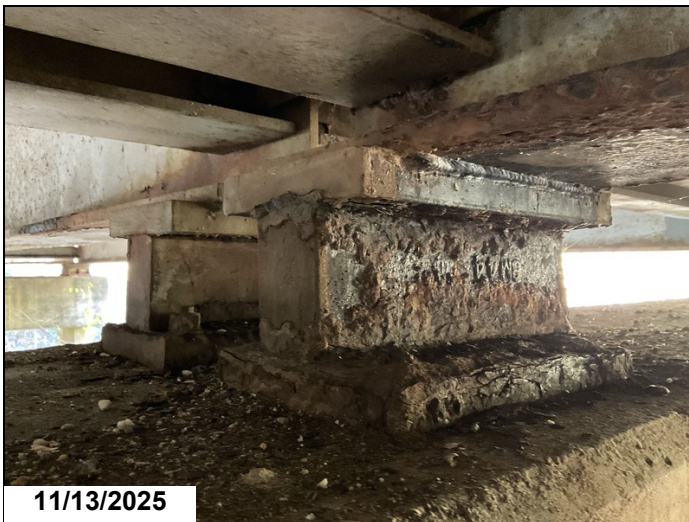
Bearings – all bents: Light surface corrosion with some minimal section loss in most locations, especially on masonry plate - heavier corrosion (some section loss) at Bents 1 & 5.

Bent 4 Bearing 2 ahead: Corrosion

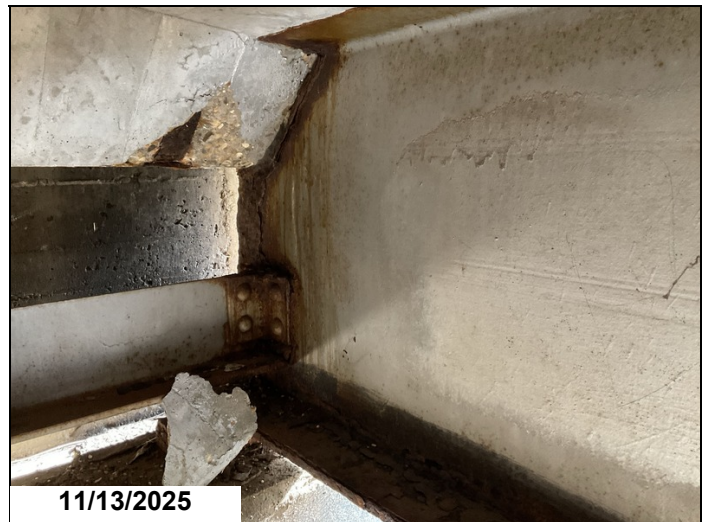
Significant corrosion with flaking and section loss on ends of girders – on bottom flange, web at haunch, and around diaphragm connection – worse at areas where joints are completely open.

Several locations have small holes (or notches) rusted completely through the webs at the haunch and a few locations have up to 50% section loss on the bottom flanges just out from the ends of girders.

Span 4 Girder 4 left @ Bent 5: Corrosion

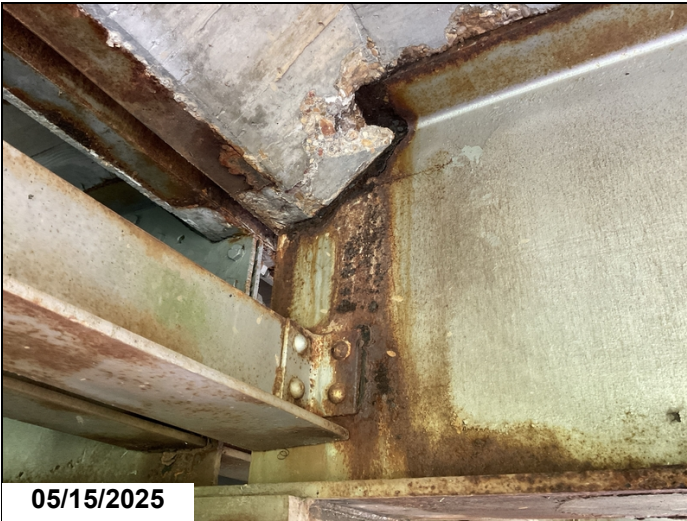
Span 3 Girder 2 left @ Bent 4: CS4 corrosion

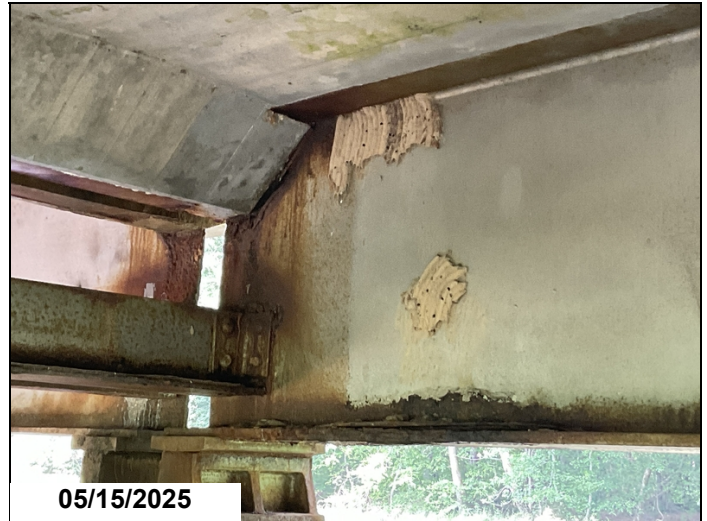
Spans 2-3 Girders 1 @ Bent 3: CS4 Corrosion

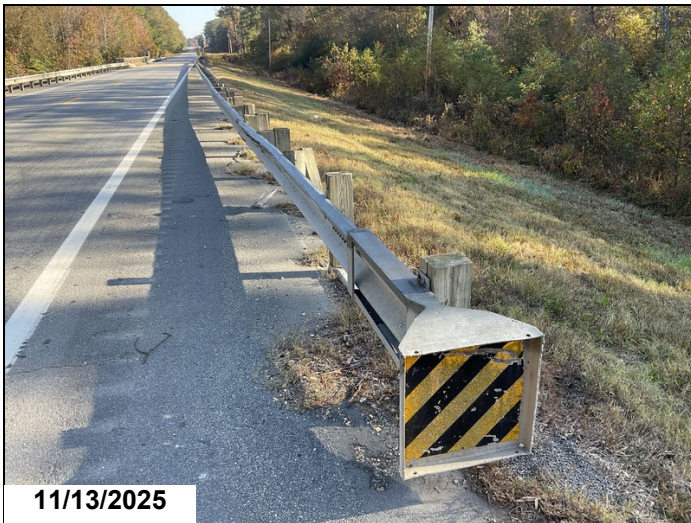
Approach railing - Bent 1 right: Third timber post from terminal end broken - see photo.

Approach railing - Bent 1 right: Post broken

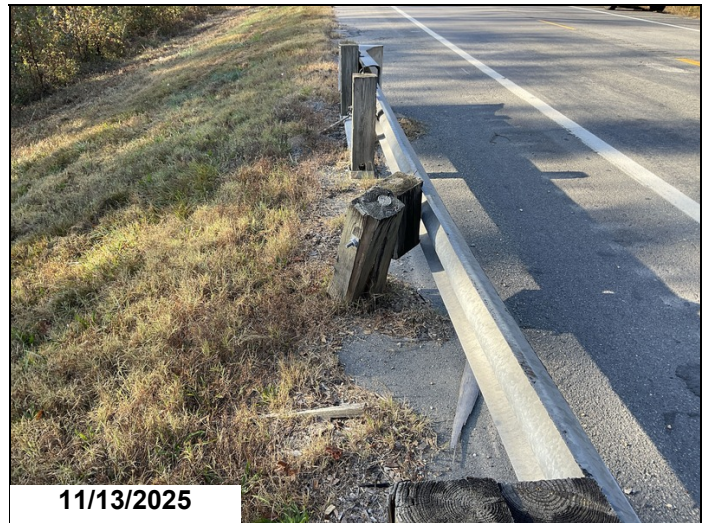
Approach railing - Bent 1 right: Damaged

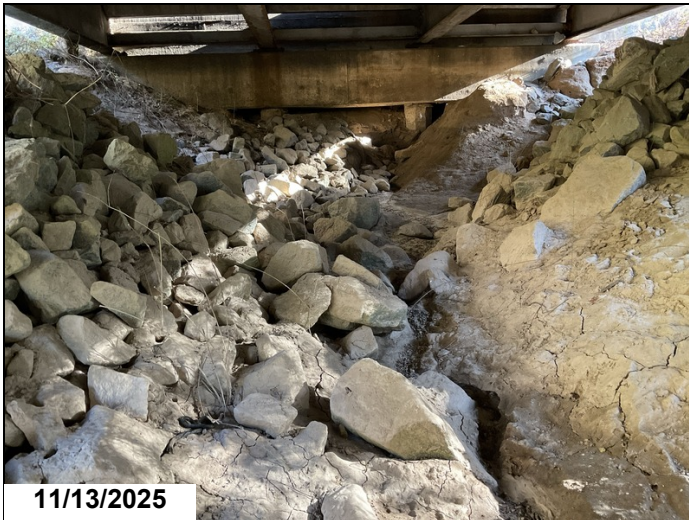
Endslope - Bent 5: Erosion in center of slope and up under cap. (10-12' wide x 1-2' tall x 2-2.5' deep) - Piles 2 & 3 in abutment are exposed.

End-slope - Bent 5: Erosion

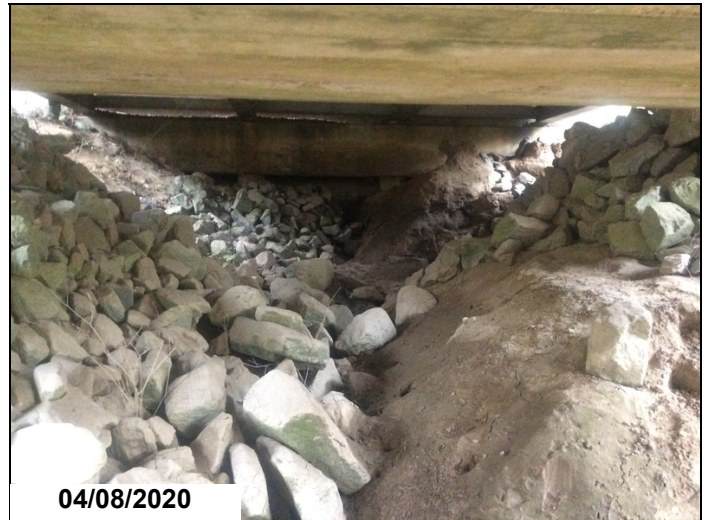
Endslope - Bent 5: Erosion

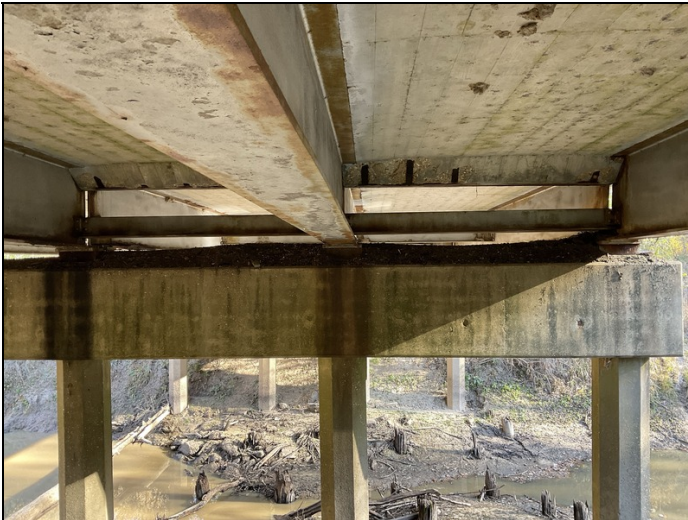
Cap – Bent 2: Significant build-up of dirt and debris on top of cap and around bearings, retaining moisture in these areas.

Cap - Bent 2: Debris build-up

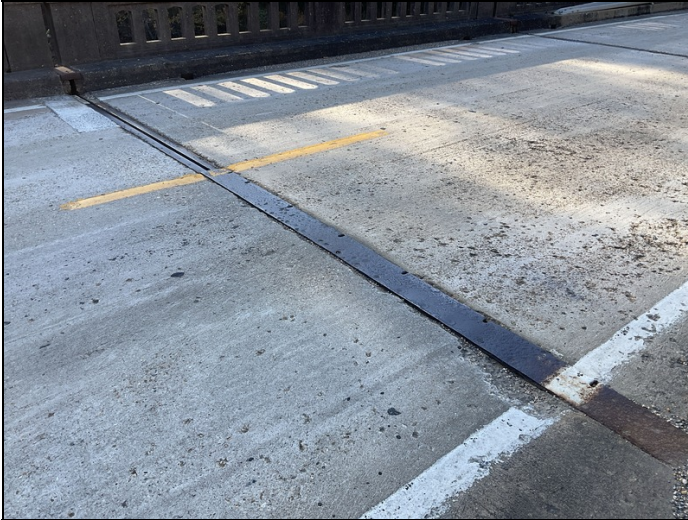
Joints – Bent 2, Bent 3 right side, & Bent 5 left side: Sliding plate missing, allowing dirt, debris, and water to build up on caps, bearings, and ends of girders.

Missing plates also leave an approximate 10" wide by 1/2" deep dip at each joint.

Joint - Bent 3: Sliding plate missing

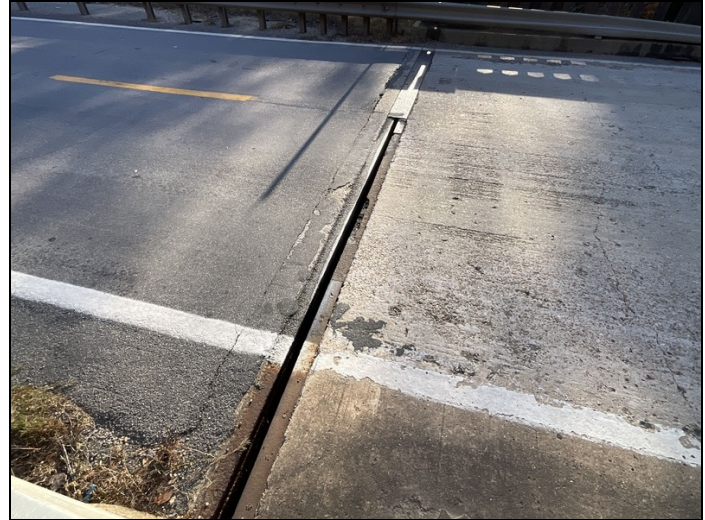
Joint - Bent 5: Sliding plate missing
