Bridge 06101 Inspection Report

(4) Place Code	0
(6) Features Intersected	Piney Creek
(7) Facility Carried	US 79-09 LM 9.04
(9) Location	3.12 Mi SW I-530-Watson Chapel - Jefferson County

Team Lead: Phillip Dowell, Inspection Date: 11/13/2025

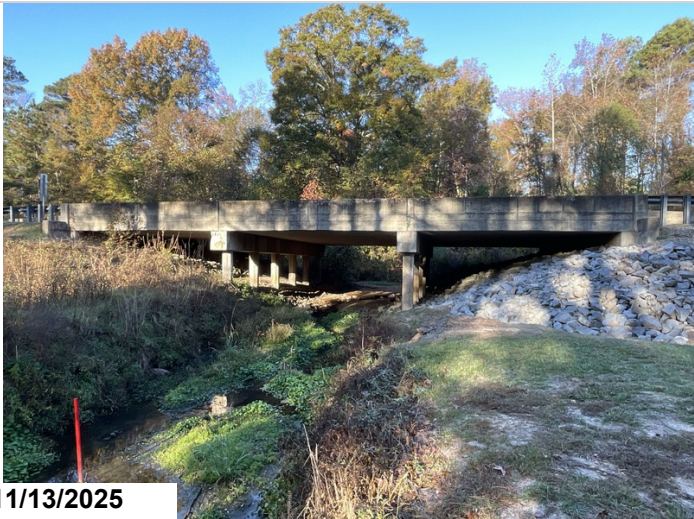
Elevation - Right side view

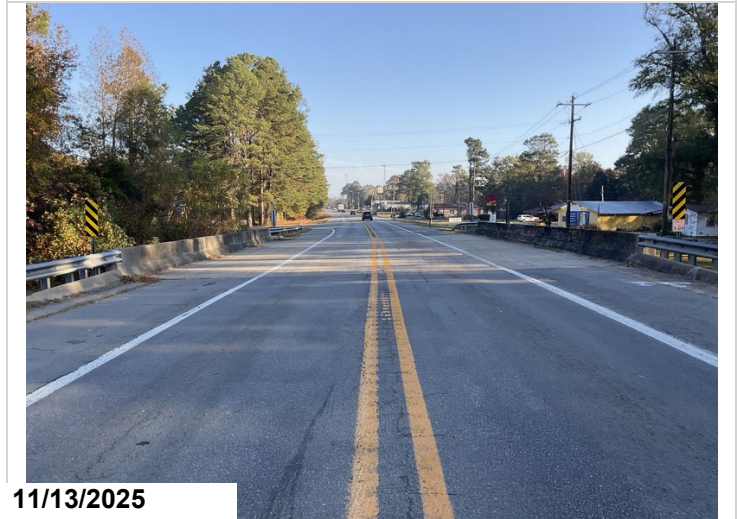
Approach roadway view

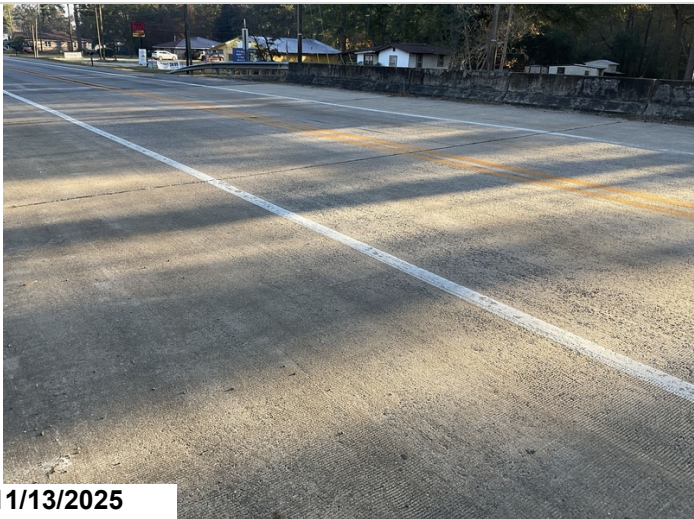
Deck is in good condition with minor cracking, efflorescence, and abrasion/wear.

Deck - Spans 1-3: Overview

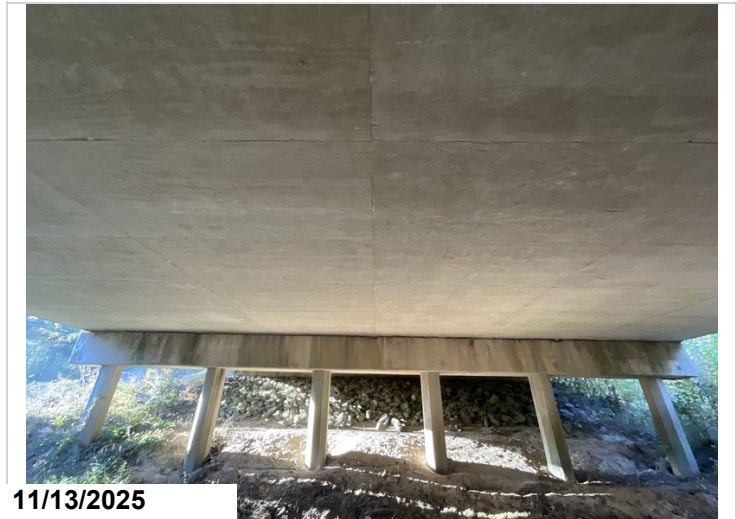
Undersurface is in good condition with a couple of cracks and some efflorescence.

Undersurface - Span 2: Overview

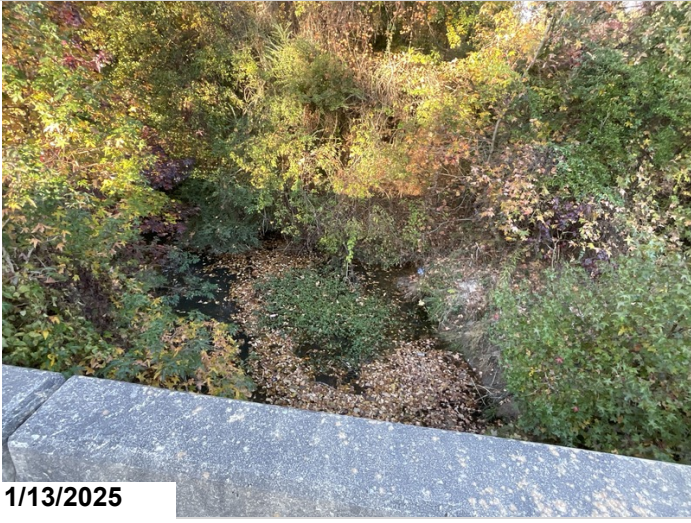
Channel is in very good condition with well vegetated and protected banks.

Channel - Left side view

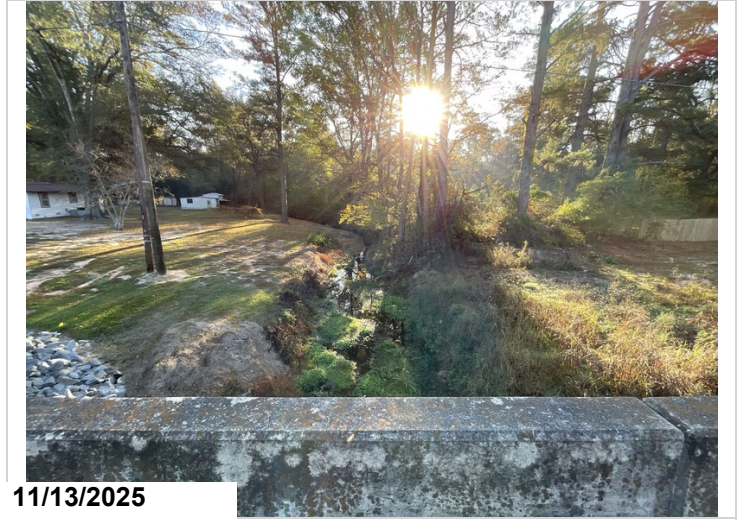
Channel - Right side view

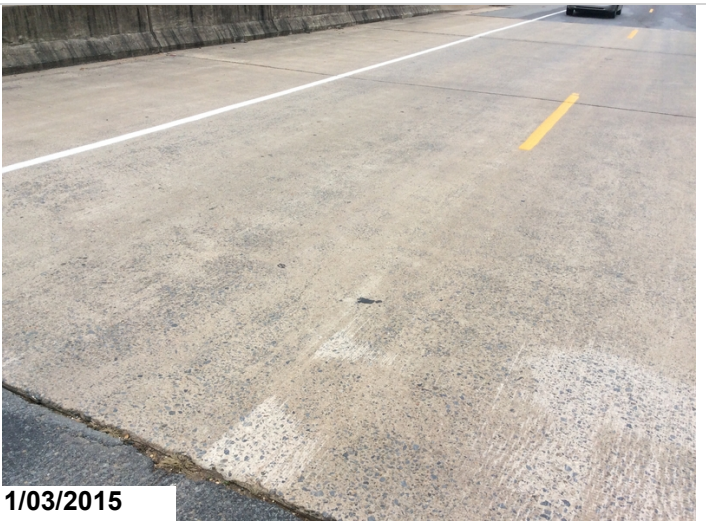
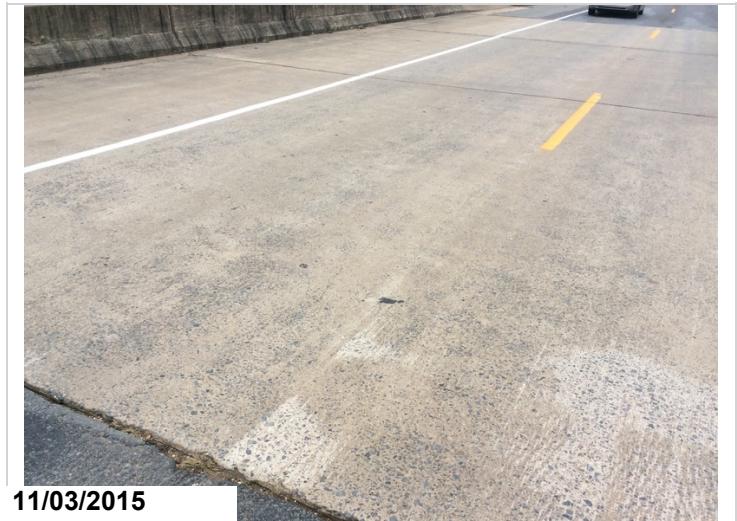
A few unsealed minor- to moderate-sized longitudinal cracks with some reflective efflorescence on undersurface.

Deck - Span 1 (longitudinal crack)

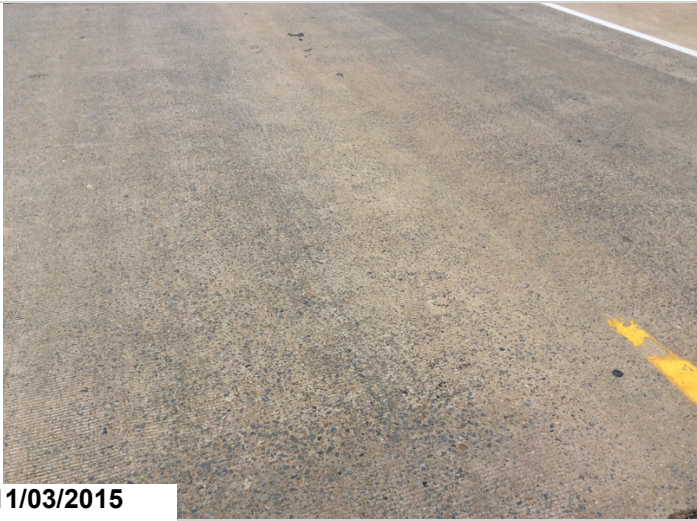
Deck - Span 2 (longitudinal crack)

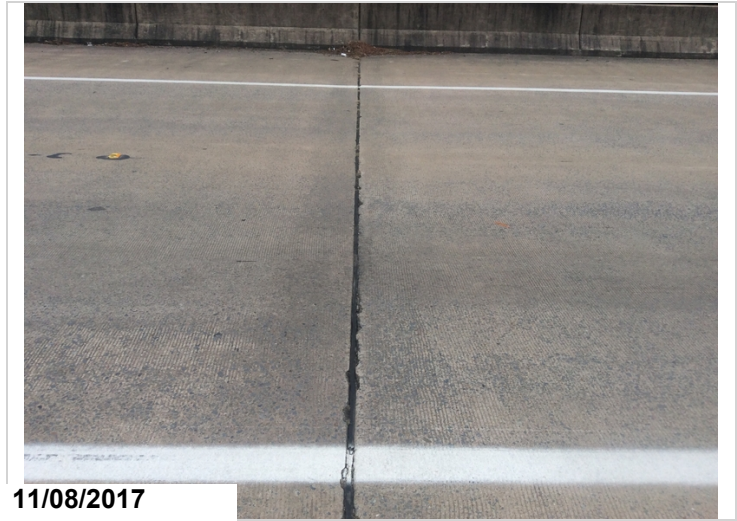
Joint – Bents 2 & 3: Pourable joint seal is mostly intact, but beginning to lose adhesion in many places.

(301) Joints: Bents 2-3 / 44' each = 88 LF total.							
Joints are leaking, have debris impaction, and loss of adhesion. 15 LF CS3 Leakage, 53 LF CS3 Seal Adhesion, 20 LF CS3 Debris Impaction							
331	Reinforced Concrete Bridge Railing	LF	150	150	0	0	0

Pourable joint seal at bent 3 has loss of adhesion and debris impact, and some loss of material.

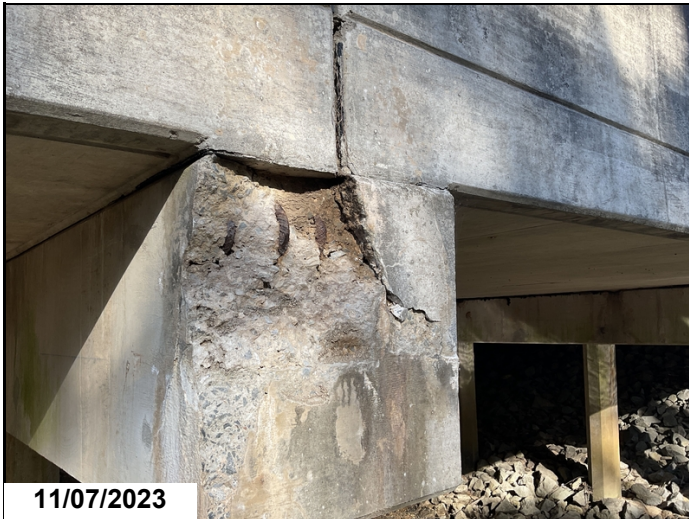
(234) Caps: Bents 2-3 / 47' each = 94 LF total.							
Bent 2 left: Spalling/delaminated on end of cap. 1 LF CS3 Delamination/Spall Bent 2 right: Spall with exposed rebar and efflorescence on end of cap. 2 LF CS3 Exposed Rebar, 1 LF CS3 Efflorescence Bent 3: Bottom face has very small spalls with exposed rebar. 2 LF CS2 Exposed Rebar							
301	Pourable Joint Seal	LF	88	0	0	88	0
2310	Leakage	LF	15	0	0	15	0
2320	Seal Adhesion	LF	53	0	0	53	0
2350	Debris Impaction	LF	20	0	0	20	0

Bent 2 right: spall with exposed rebar and efflorescence on end of cap. CS3- 2'

Bent 2 cap right has spall with exposed rebar.

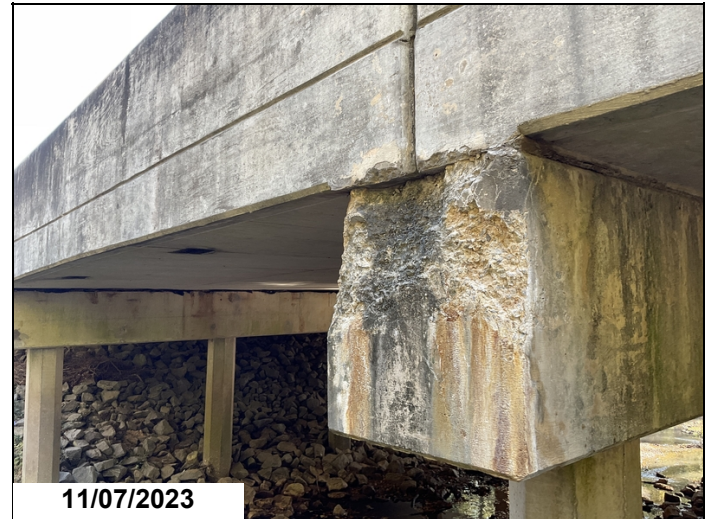
Bent 2 left: Spalling/delaminated on end of cap. CS2 - 2'

Bent 2 cap left has spalling at end.

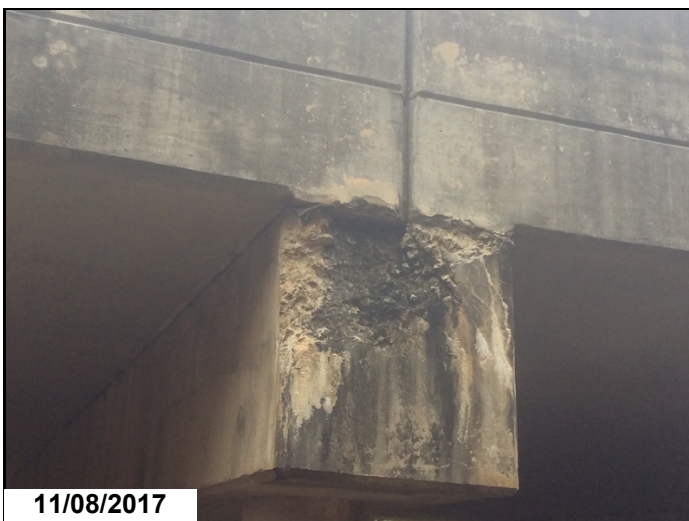
Spall at bent 2 cap on left side .

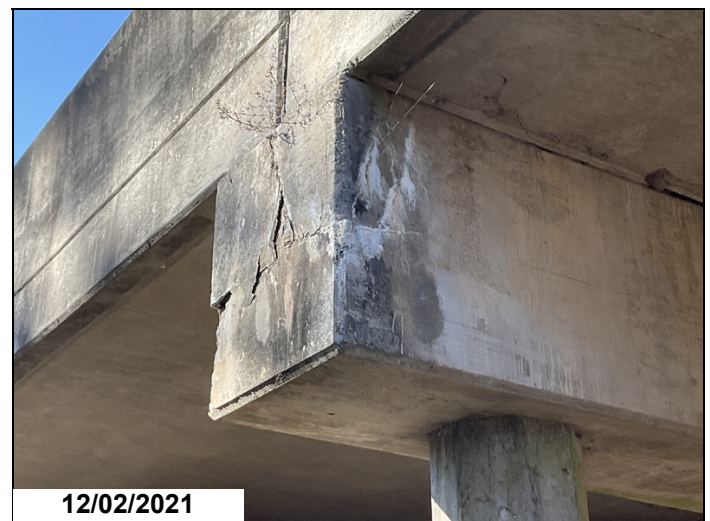
Cap - Bent 2 right: Cracking/delaminating

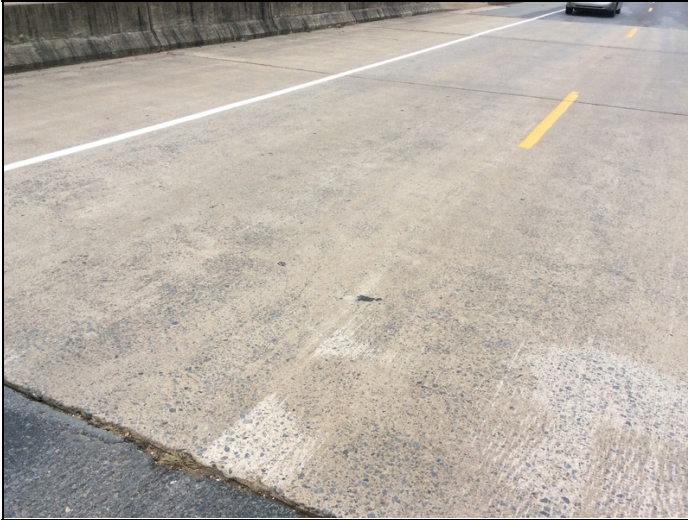
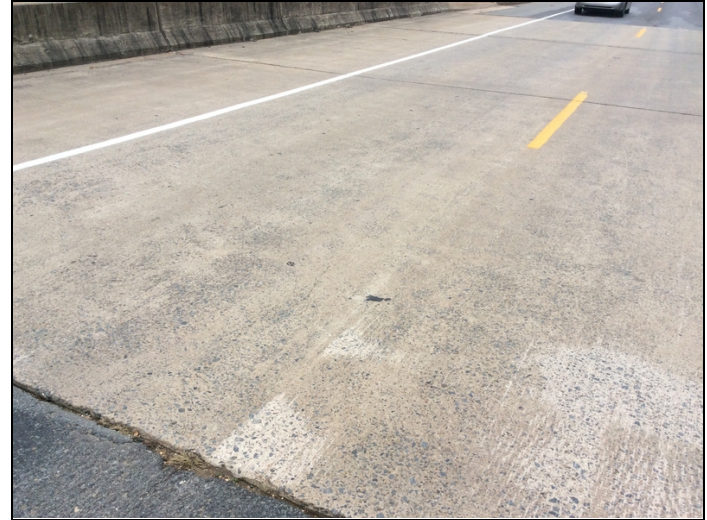
A few unsealed minor- to moderate-sized longitudinal cracks with some reflective efflorescence on undersurface.

Deck - Span 1 (longitudinal crack)

A-54 - Sealable Deck Cracks (Yes)

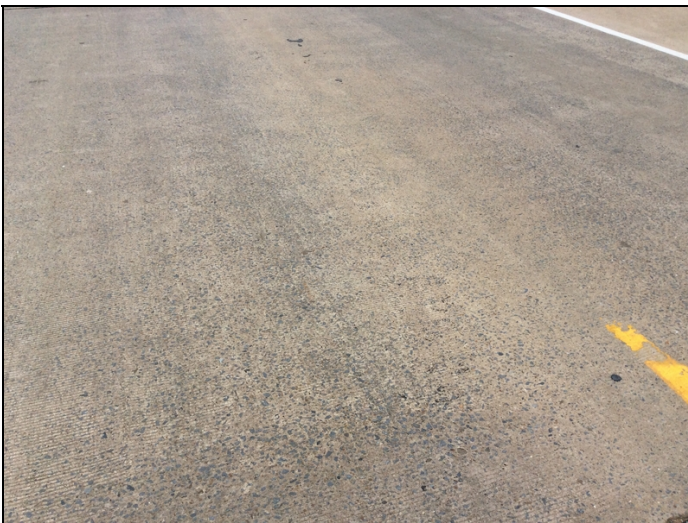
Deck - Span 2 (longitudinal crack)

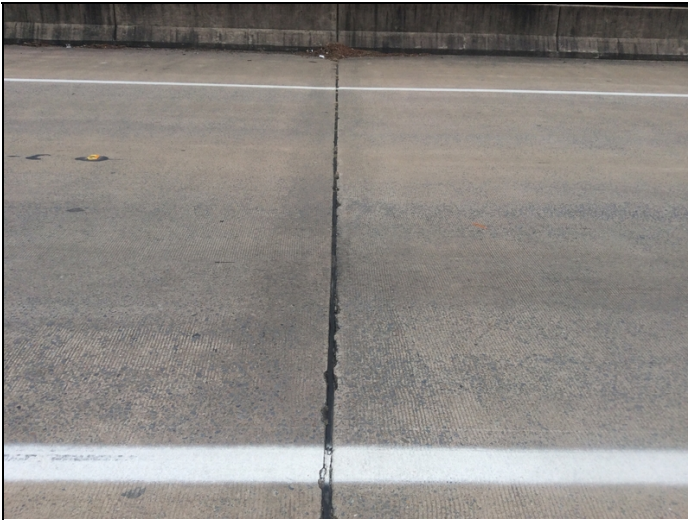
Joint – Bents 2 & 3: Pourable joint seal is mostly intact, but beginning to lose adhesion in many places.

Pourable joint seal at bent 3 has loss of adhesion and debris impact, and some loss of material.

A-59 - Joint Repair Needed (Yes)
