Bridge X0025 Inspection Report

Asset #X0025(Routine)

SH 1-05 LM 8.63 over Tarleton Creek

Team Lead: Phillip Dowell Inspection Date: 02/04/2026

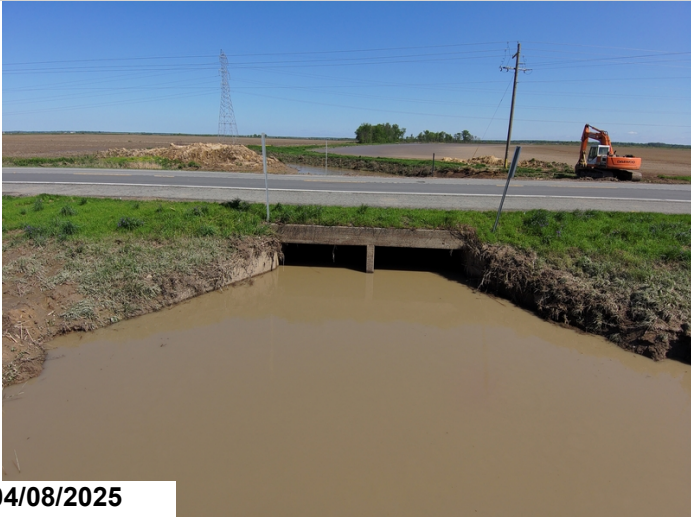
Elevation - Right side view

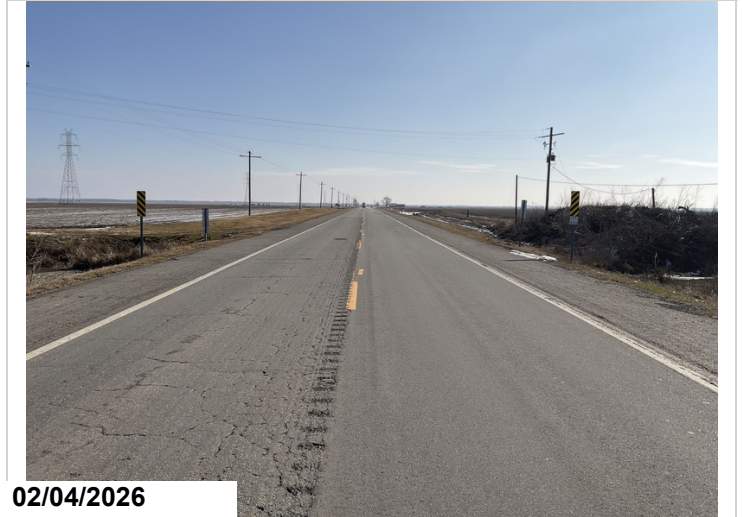
Inventory - Approach Roadway

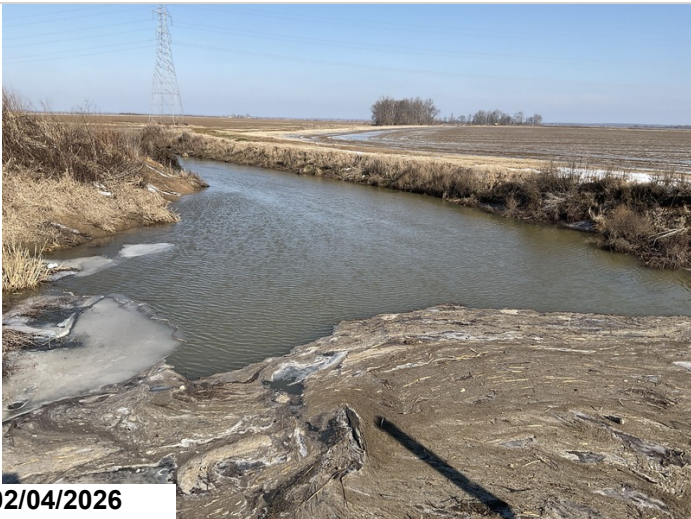
Channel is in good condition, with minor erosion both up and down stream.

Channel - Left side view

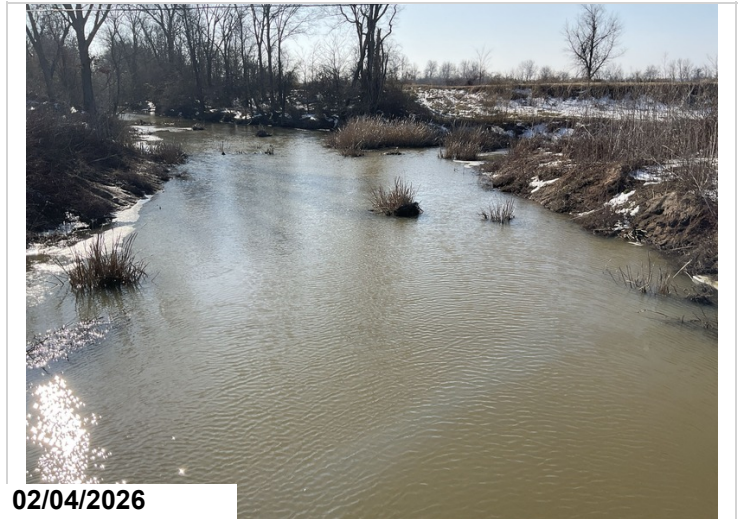
Channel - Right side view
